A 3D Measurement and Computerized Meshing Study to Promote Bus Ridership Among People Using Powered Mobility Aids

Unsworth CA, Chua J and Gudimetla P (2020) A 3D Measurement and Computerized Meshing Study to Promote Bus Ridership Among People Using Powered Mobility Aids. Front. Built Environ. 6:90. doi: 10.3389/fbuil.2020.00090

People who use powered mobility aids such as wheelchairs and scooters need and want to use public transport. Buses are the most affordable and efficient form of public transport, capable of connecting people across local communities. However, with curbside rather than platform boarding and internal space limitations, buses also present many accessibility challenges for people using mobility aids during ingress, egress, and interior maneuverability. In Australia, people using mobility aids board low floor buses that are required to comply with the national bus accessibility standard, using the front doors. A new standard was recently created to provide a Blue Label identification for powered mobility aids suitable to access public transport. The accuracy of this standard to identify mobility aids suitable to use on buses has not been verified. This research

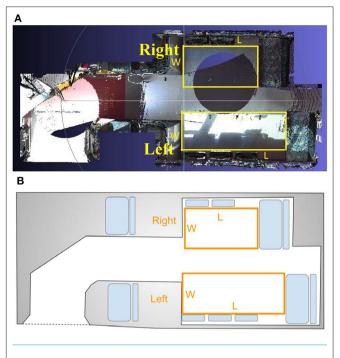
FIGURE 2 Example of Allocated Spaces (L-length \times W- width) on a bus and how they vary, to determine compliance with Disability Standards for Accessible Public Transport (2011) using both aerial scans and line drawings. **(A)** 3D aerial scan of bus interior (plan view) showing allocated spaces.

(B) Line drawing of aerial scan from (A).

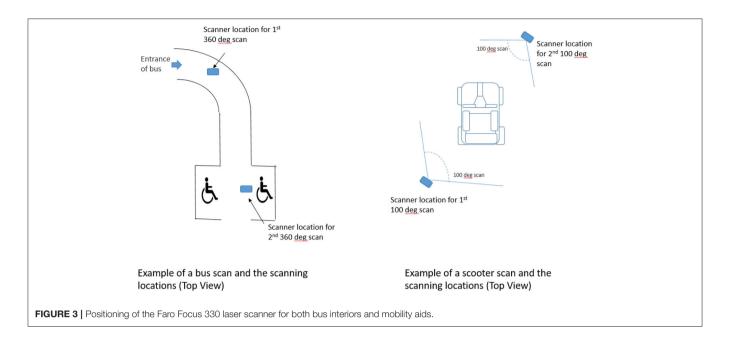
3D scanning collects data of interiors or objects and saves these in a digital format that can be converted into computer-aided design (CAD) models. These CAD models can then be used to take measurements or run computer simulations. Three-dimensional scanning of mobility aids has been successfully undertaken over the past 15 years (Paquet and Feathers, 2004). The scanner used in this research was a tripod-mounted Faro Focus X330 laser scanner (Faro, Lake Mary FL, USA). This scanner is capable of scanning the environment 360° in the horizontal (azimuthal) and vertical axes with a precision of ± 2 millimeters at distances up to 10 meters. While the buses took approximately 45 min to scan, each mobility aid only took ~25 min. The primary output from a laser scanner is a "point cloud" of reflection positions. Poisson surface reconstruction (Kazhdan et al., 2006) can then be used to generate a tet-mesh of the point cloud, and render the required model. The positioning of the Faro Focus X330 laser scanner to scan both bus interiors as well as mobility aids is provided in Figure 3.

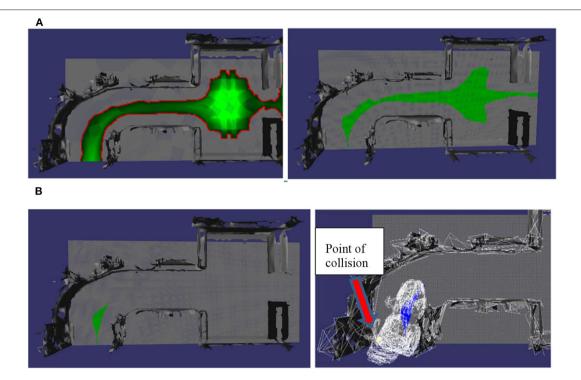
FIGURE 5 | Examples of Find Path, and Collision images demonstrating where mobility aids could or could not access the bus and allocated space. (A) Example of Collision image (Left) and Find Path image (Right) of a mobility aid that matched a bus (pass). (B) Example of Find Path image (Left) of a mobility aid that could not enter a bus (fail) and a 3D Find Path image (Right) showing a point of collision.

Access Path. All these features essentially reduced the functional width of the Swept Path area and prevented many of the larger powered mobility aids or those with smaller turning radii to enter, often causing a collision in the entry point as shown in **Figure 5B**.
