## Analysis of elastic nonlinearity for impact damage detection in composite laminates

2015 J. Phys.: Conf. Ser. 628 012103

A Frau<sup>1</sup>, L Pieczonka<sup>2</sup>, M C Porcu<sup>1</sup>, W J Staszewski<sup>2</sup> and F Aymerich<sup>1</sup>

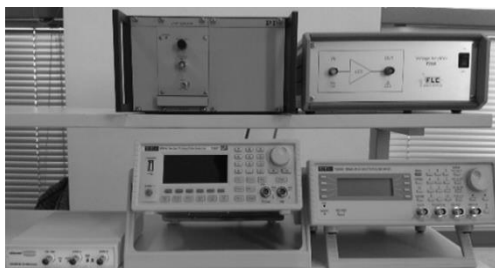
Figure 3. Experimental equipment.

The excitation signals transmitted to the piezoceramic transducers were generated using a *TTI TGA5011A* function generator and amplified twenty times with a *FLC F20A* high voltage linear amplifier. The signals exciting the stack actuator were generated by a *TTI TG2000* function generator and amplified ten times with a *PI E-508 PICA* piezo amplifier. The main equipment used in the experimental investigation is shown in figure 3. A drop-weight impact testing machine with a 2.2 kg impactor was used in order to introduce damage onto the plate. The impactor was provided with a hemispherical indenter of 12.5 mm diameter and instrumented with a semiconductor strain-gauge bridge for dynamic load acquisition. An impact of 4.6 J energy was introduced at central position of the plate in order to obtain a delamination in the area of Barely Visible Impact Damage (BVID).

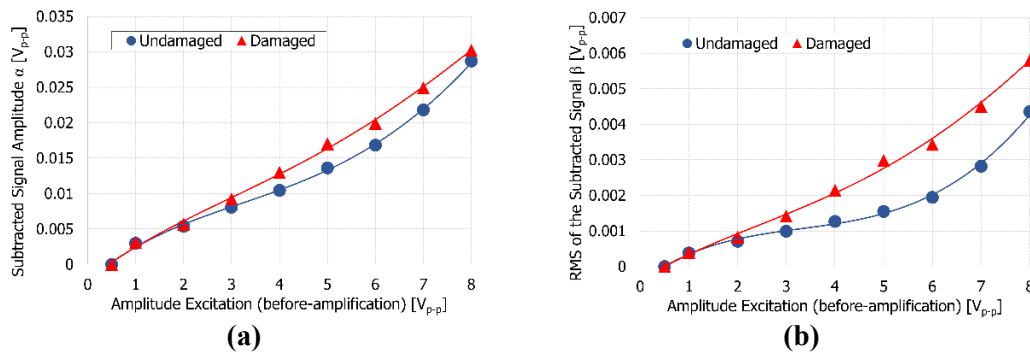
**Figure 8.** Nonlinear indicators  $\alpha$  (a) and  $\beta$  (b) of the subtracted signal obtained for sensor D.

The nonlinear indicators  $\alpha$  and  $\beta$ , are plotted in figures 6, 7 and 8 against the amplitude of the excitation signal (before amplification). Diagrams refer to the signals acquired from sensors B, C and D when the excitation is applied at sensor A. Both indicators  $\alpha$  and  $\beta$  show that the difference between the linearly rescaled signals and the corresponding acquired ones increases as the input excitation increases. Although a nonlinear behaviour is detected also in the intact case, the extent of nonlinearities in the damaged case is found to be rather more marked.

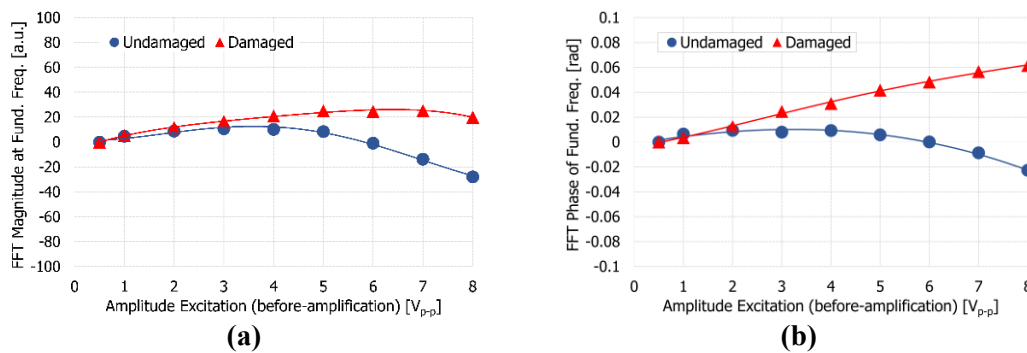
**Figure 9.** Amplitude (a) and phase (b) differences obtained in correspondence of the fundamental frequency peak.

To highlight the contribution to nonlinearities given by amplitude and phase variation, the recorded signals were analysed in the frequency domain. Figures 9 and 10 show the amplitude and phase

differences between undamaged and damaged cases. Relevant to the fundamental frequency, the difference in amplitude between the linearly rescaled signals and the recorded ones is plotted in figure 9a as a function of the amplitude of the input excitation (in this case the signals are recorded at sensor B). In the damaged case, the peak amplitude of the rescaled signal is slightly lower than that of the recorded signal (this leads to positive values of the difference between the two signals as shown in figure 9a). A similar behaviour is found in the intact case for lower excitation values whilst an opposite trend can be seen for higher values. Phase differences are plotted in figure 9b, showing that in the damaged case the rescaled signal always exhibits a phase delay with respect to the acquired one, which actually increases as the excitation amplitude increases. On the contrary, in the intact case the phase delay is very small, at least for low amplitude excitations. Figures 9 and 10 show that both amplitude and phase differences contribute to the damage indicators, even if a slightly larger influence of phase may be noted.
