# Behavior of Half-Joints: Design and Simulation of Laboratory Tests

**Abstract:** European countries are characterized by an extensive infrastructural network, mainly built around the 1960s and 1970s. In that period prefabrication processes were starting to gain ground, and one of the most spread and studied typologies of bridges was constituted by reinforced or prestressed concrete decks. Those structures have gone through years of service, which caused the inevitable degradation of the materials and relevant deterioration of structural elements. Moreover, the design and construction processes of that period have soon become obsolete, and the knowledge relative to the influence of detailing increased significantly. One particular element that has been commonly used has been the half-joint, which is easy to prefabricate and has a strategic impact. However, in recent years this solution is showing critical aptitudes in resisting structural degradation and material decay. In addition, structural health monitoring (SHM) strategies are gaining attention since they are a very useful tool for gathering information on the current state of the structure and then for evaluating interventi

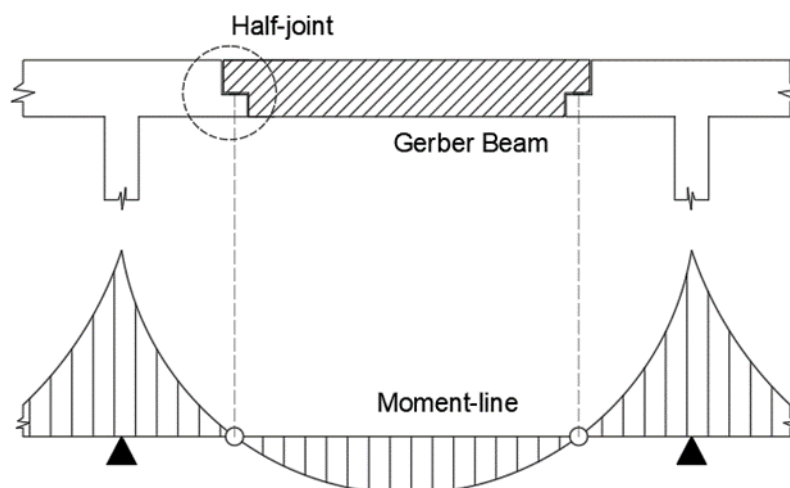
Figure 1. Geometry of a half-joint.

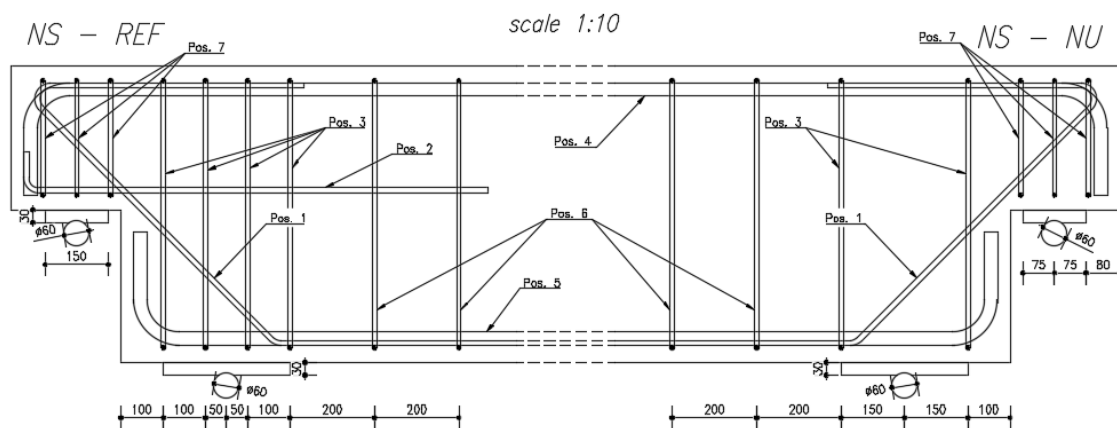
Figure 3. Reinforcement description and geometry—NS-REF and NS-NU.

- NS-REF: is the reference beam, with a complete reinforcement layout. It is composed of inclined, horizontal, and vertical steel rebars.
- NS-NU: is based on NS-REF with the removal of the horizontal rebars.

Figures 3 and 4 report the four different configurations of the half-joint that are considered for the experimental campaign (NS-REF, NS-NU, NS-ND, NS-RS). These refer to different arrangements of inclined, horizontal, and vertical reinforcements at the critical areas where major cracks, responsible for the brittle behavior of the component, are expected to develop. The reinforcement layouts that have been chosen are those usually present in existing half-joints. However, the case of prestressed half-joints is not considered in this work.

The four half-joints are named as follows and they are inspired by the paper of Desnerck, Lees, and Morley [16] (Figures 3 and 4):

The beam ends are composed as follows: NS-REF strong element with NS-NU weak element (Figure 3); NS-RS strong element with NS-ND weak element (Figure 4).

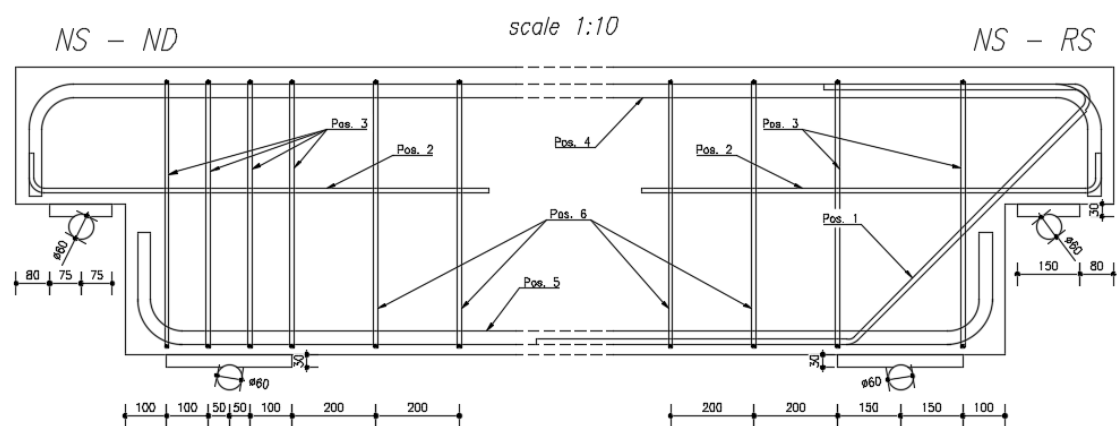
Figure 4. Reinforcement description and geometry—NS-ND and NS-RS.

- NS-ND: is based on NS-REF with the removal of the diagonal rebars.
- NS-RS: is based on NS-REF with the reduction of the stirrups nearby the nib.
- Figure 5 summarizes the reinforcement arrangement in the longitudinal section. Figures 6–8 depict the remaining sections and rebar positions.

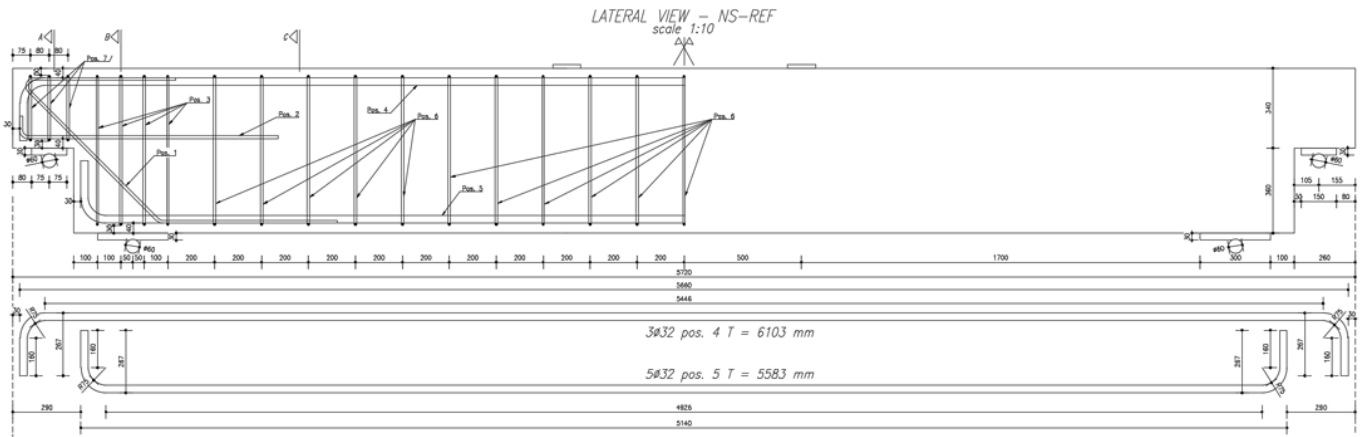
Figure 5. Lateral view and rebars in pos. 4 and pos. 5.

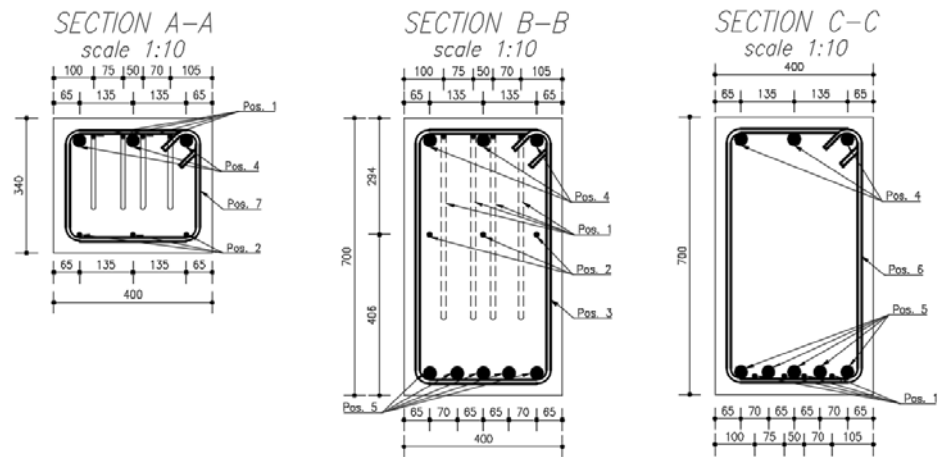
Figure 6. Cross sections A–A, B–B, and C–C.

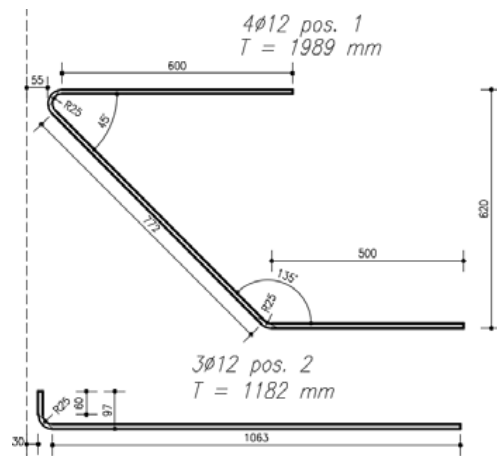
Figure 7. Rebars in pos. 1 and pos. 2.

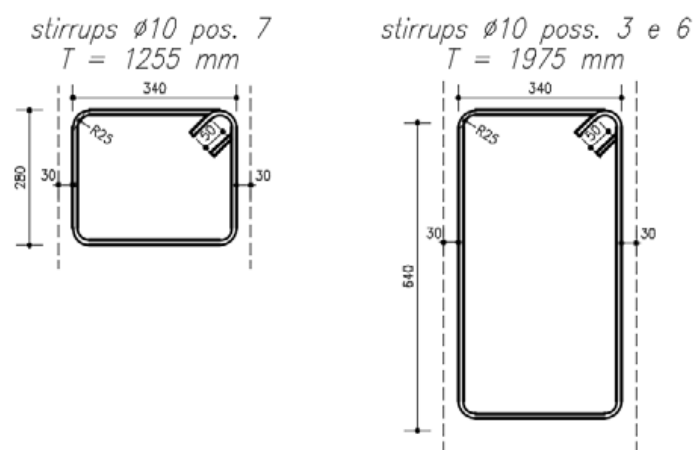
**Figure 8.** Rebars in pos. 3, pos. 6, and pos. 7.

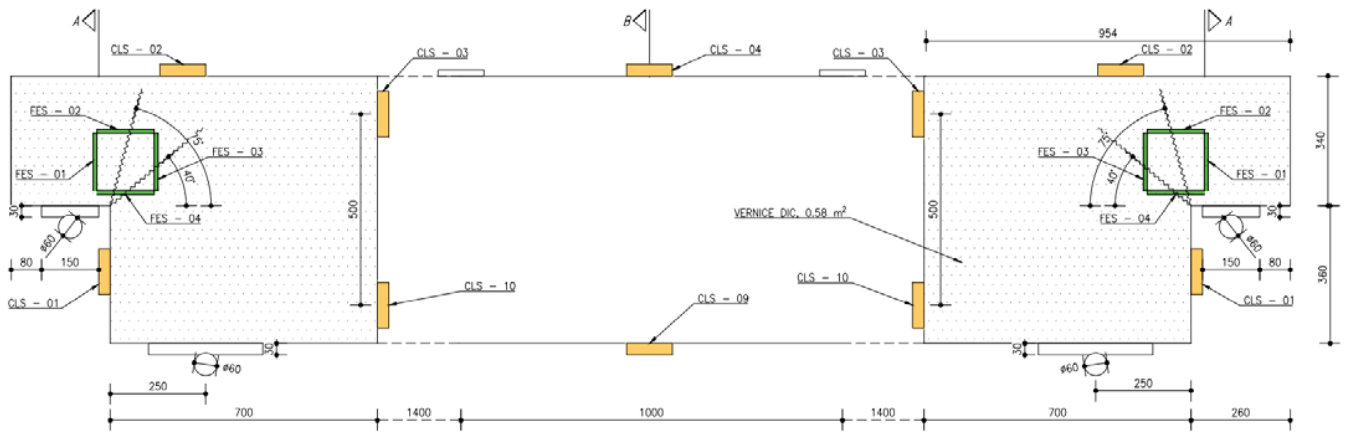
The load will be applied in a quasi-static configuration, and sensing devices will be applied to the specimens in several positions to track the behavior of the half-joint at several levels (Figure 9):

- There will be 4 + 2 strain gauges on the external concrete surface at the half-joint under evaluation (4) and at the mid-span (2) (in yellow);
- Crack meters in squared configuration will be placed at the re-entrant corner where the main cracks are expected (in green);
- Two strain gauges for each main reinforcement (diagonal, horizontal, and four stirrups) will be applied to the reinforcement rebars (in Figure 10).

Moreover, the D-region of the half-joint will be painted (speckle pattern) with the purpose of DIC measuring (dotted area in Figure 9). Figure 11 depicts the simplified layout of the specimen (deformed and undeformed) with the boundary conditions.

Figure 9. Lateral view of the beam specimen with the monitoring devices.

The monitoring layout has been designed with the aim of detecting the most valuable technology for damage quantification. It is worth underlining how the speckle pattern region for DIC analyses will not be instrumented with crack meters, that are in fact applied to the opposite side of the beam.

- Strain gauges on the concrete surface will be necessary to match the information coming from the DIC at the deformed stages of the half-joint.
- Crack meters at the nib corner will be applied to quantify the crack width and to match the results coming from the DIC technique. The chosen position of the crack meters

considers possible inclinations (varying from  $40^\circ$  to  $75^\circ$  [13]) of the main crack, which will develop at failure.

- The strain gauges to be applied to steel reinforcement will monitor bar stresses, highlighting their exploitation, and providing interesting data to be compared with the original reinforcement layout by Desnerck et al. [13].
- The speckle pattern region for the DIC registration will comprise the entire disturbed region of the element. The results coming from the application of digital image correlation will be strengthened by the information provided by the strain gauges on concrete and the crack meters at the nib. With the purpose of avoiding compromising the interaction between several monitoring techniques, the strain gauges will be applied in the perimetral dotted area for the DIC, and the crack meters are fixed at the opposite side of the beam.

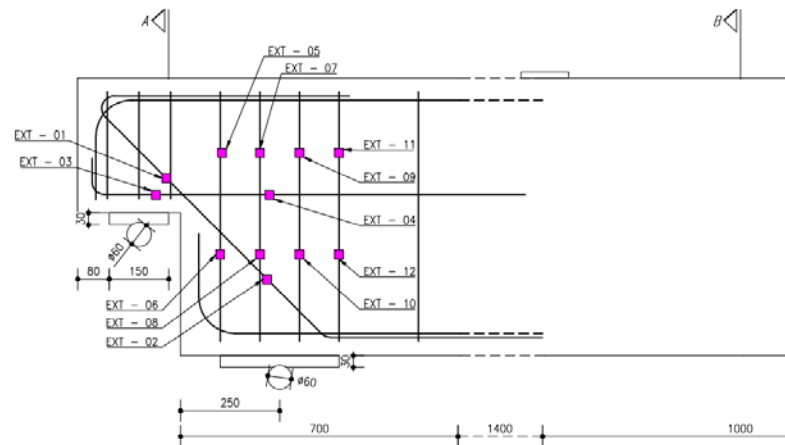
Figure 10. Detail of the strain gauges applied to the reinforcement.

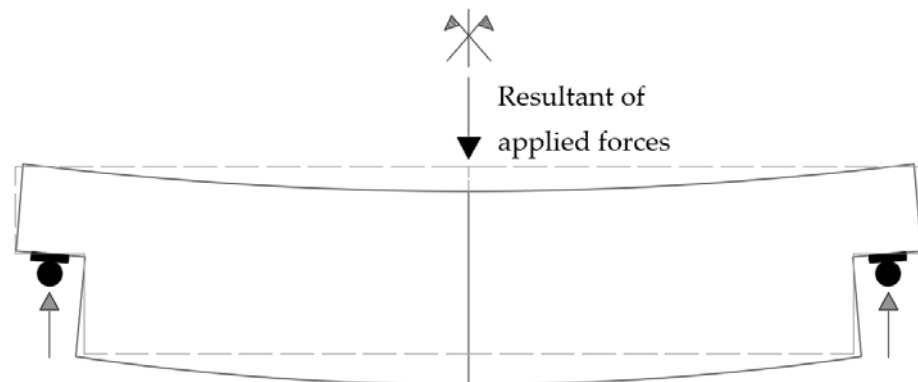
Figure 11. Simplified geometry of the specimen and boundary conditions.

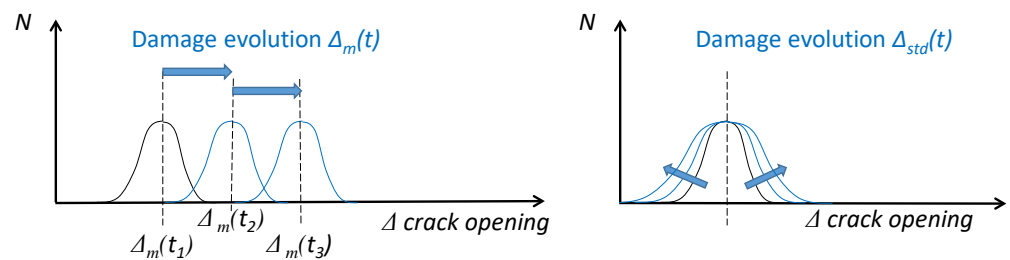
Figure 12. Damage development.

Considering periodic monitoring without traffic interruption (output-only), a possible damage detection scheme could be focused on the statistical distribution of crack opening (see Figure 12), evaluating the damage progression in terms of mean variation  $\Delta_m(t)$  and/or standard deviation variation  $\Delta_{std}(t)$ .

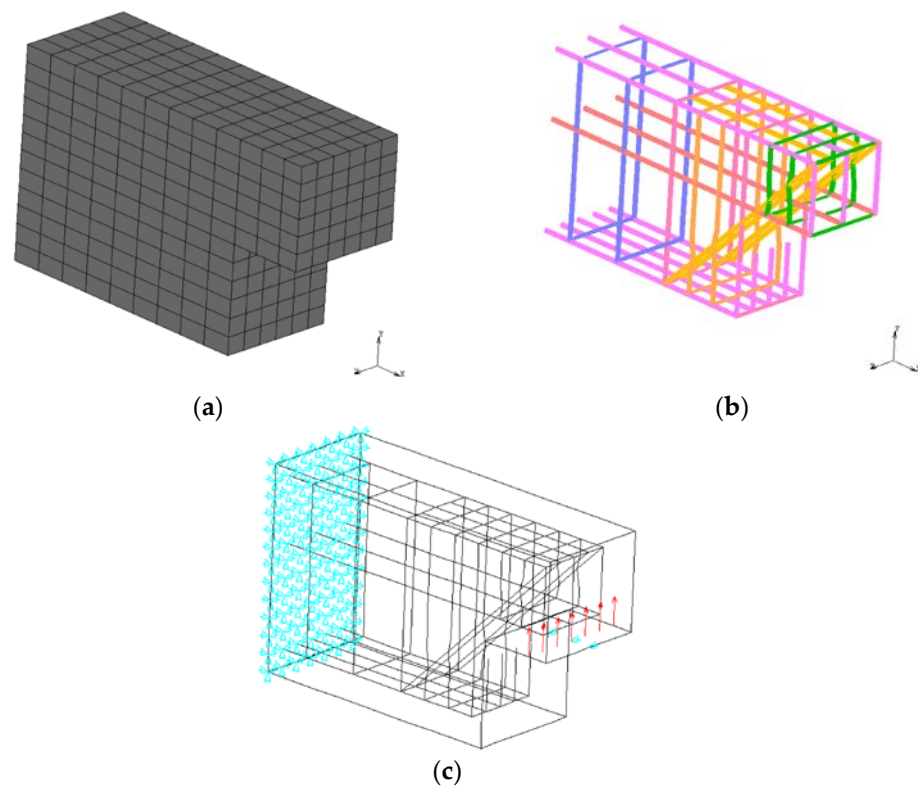
Steel reinforcement has been modeled in a discrete fashion between consecutive nodes and positioned according to the design drawings. Two-node TRUSS180 [24] elements were used, without flexural stiffness and with action in tension and compression. The constitutive law is elastic perfectly plastic with a yielding stress of 235 MPa. The discrete fashion of reinforcement modeling is in contrast with the smeared one allowed by the SOLID65 element, implemented for example in [24]. This choice of discrete bar modeling arises from the complexity of the reinforcement distribution that characterizes the joint and involved several constraints in preparing the mesh to achieve the correct alignment of the nodes (Figure 13).

**Figure 13.** (a) SOLID65 concrete matrix mesh; (b) TRUSS180 steel reinforcement; (c) boundary conditions.

The final model in its complete configuration consists of 756 SOLID65 elements, 371 LINK180 elements, and 1058 nodes [24] (Figure 13).

The nonlinear model with a longitudinal axis along the z direction is subjected to external forces linearly incremented during the static analysis time, directed as the y-axis, with a total final intensity of 800 kN (Figure 13c).

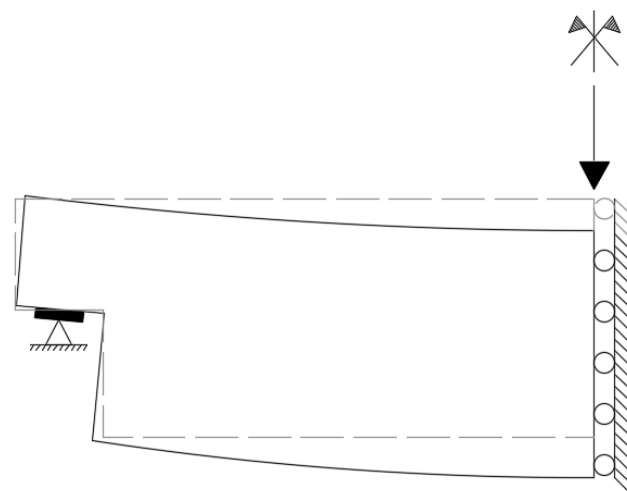
Due to the symmetry of the specimen shown in Figure 14, only half the beam has been analyzed. However, in order to focus specifically on the half-joint area, to reduce the size of the model, and to simplify the computational burden in terms of the number of degrees of freedom, calculation time, and output size, the model was further reduced in its longitudinal dimension to a total length of 1.16 m (Figure 13).

**Figure 14.** Boundary condition of the FE model.

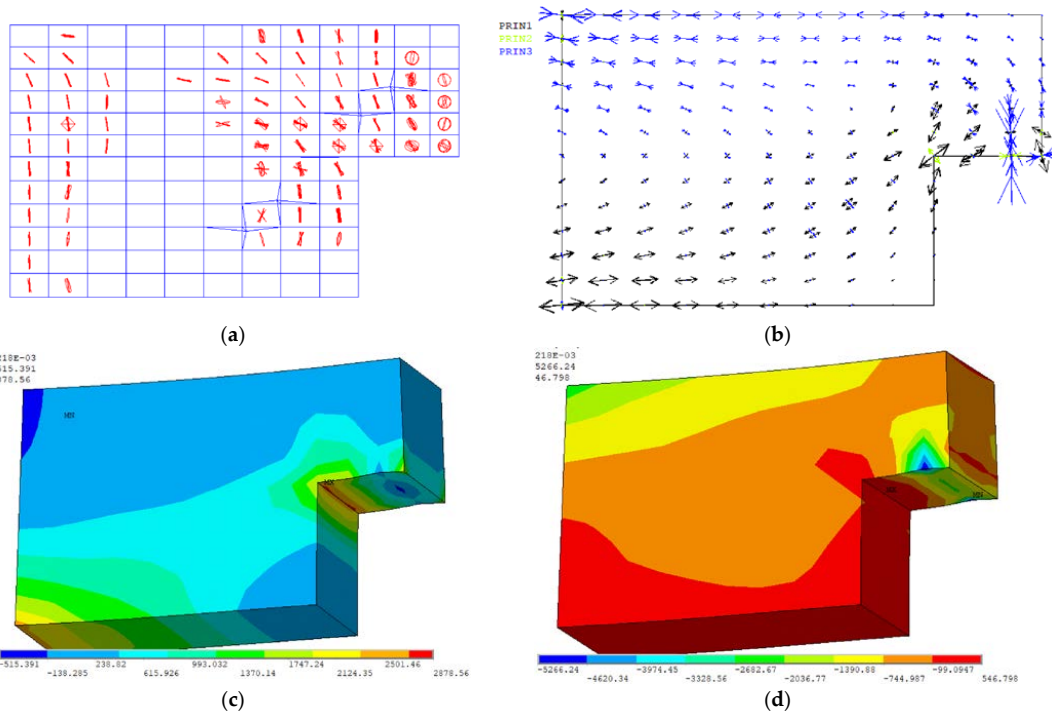
The beam configuration without steel reinforcement highlights the spreading of cracks in the whole model at the ultimate state (Figure 15a). The first principal stress at the re-entrant corner is clearly oriented for a crack opening at  $45^\circ$  due to shear effects (Figure 15b). The collapse occurs when the tensile limit (2400 kPa) is reached for the first principal stresses at the re-entrant corner (Figure 15c). The third principal stress remains far from its characteristic limit of 2000 kPa (Figure 15d).

**Figure 15.** Half-joint without steel reinforcement. (a) Cracking surfaces at collapse (78% final load); (b) vector plot of principal stresses just before collapse; (c) 1st principal stress just before collapse [kN/m<sup>2</sup>]; (d) 3rd principal stress just before collapse [kN/m<sup>2</sup>].

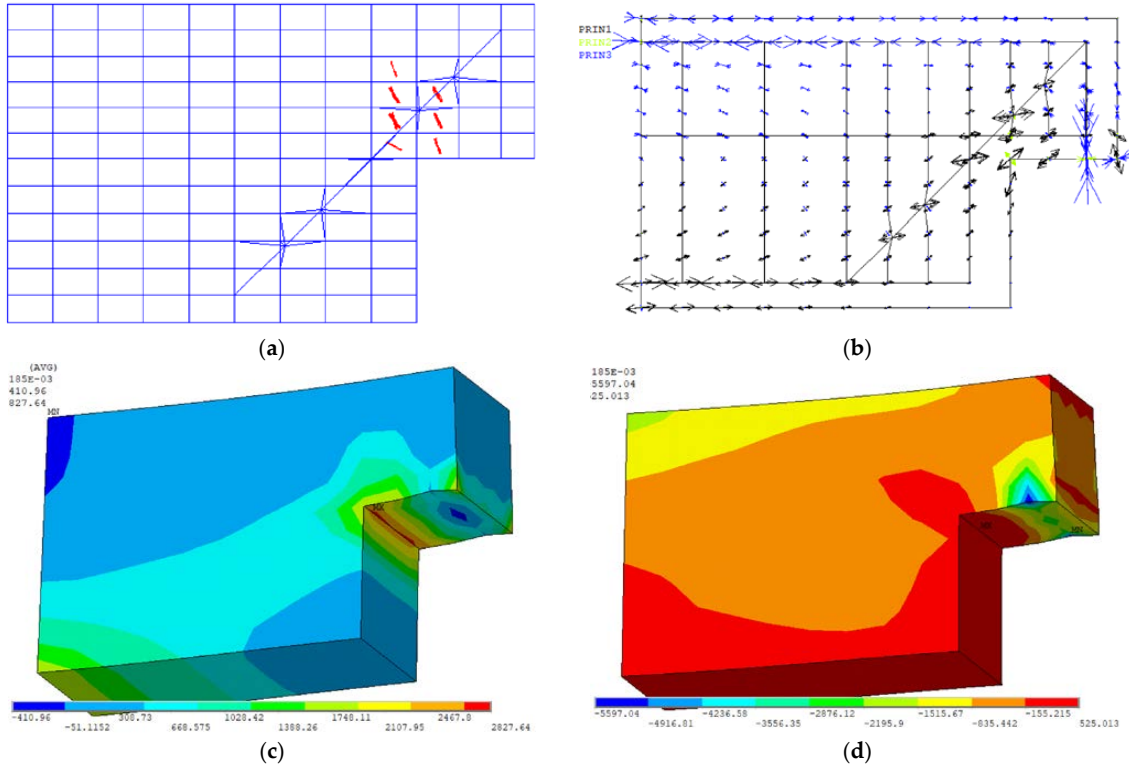
**Figure 16.** Half-joint in NS-REF configuration. (a) Cracking surfaces at collapse (87% final load); (b) vector plot of principal stresses just before collapse; (c) 1st principal stress just before collapse [kN/m<sup>2</sup>]; (d) 3rd principal stress just before collapse [kN/m<sup>2</sup>].

- The NS-NU case (Figure 16) has collapse damages diffused to the area where the beam height is reduced from 0.7 m to 0.34 m. This is in reasonable agreement with the crack path of real beams reported by Desnerck et al. in 2016 [13] and 2017 [22]. In both studies, the most effective arrangement seems to be NS-REF (Figure 15), as also highlighted in this numerical study.

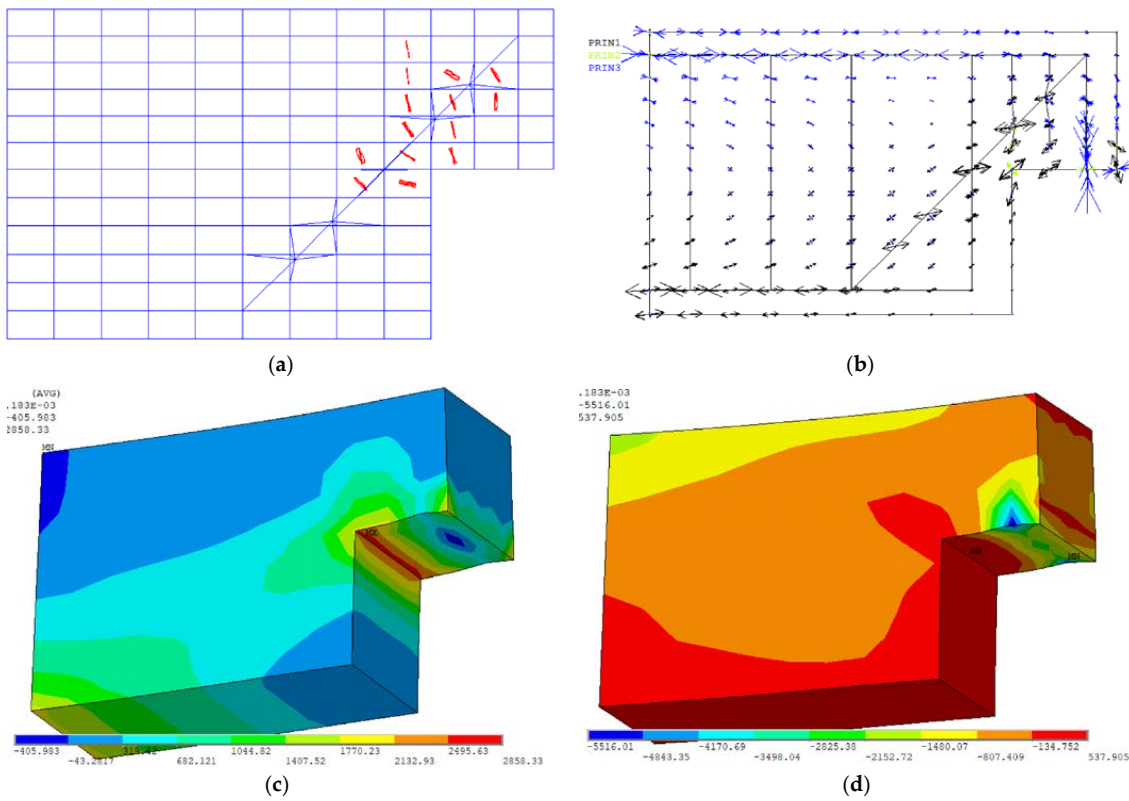
**Figure 17.** Half-joint in NS-NU configuration. (a) Cracking surfaces at collapse (86% final load); (b) vector plot of principal stresses just before collapse; (c) 1st principal stress just before collapse [kN/m<sup>2</sup>]; (d) 3rd principal stress just before collapse [kN/m<sup>2</sup>].

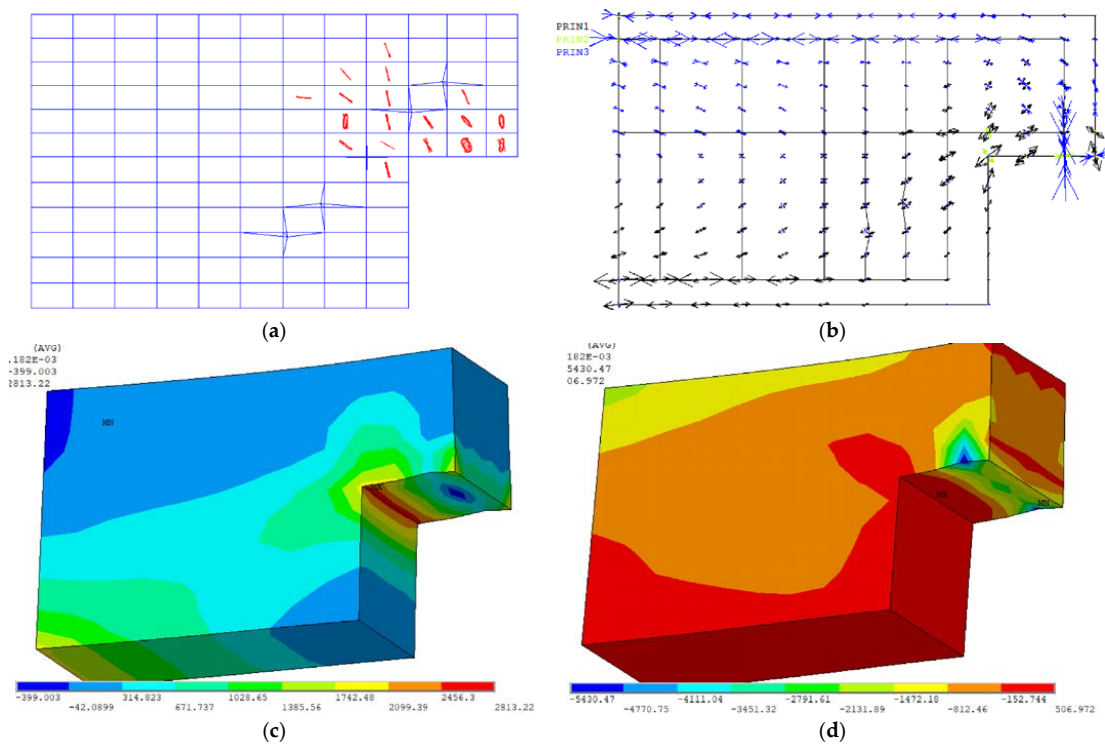
**Figure 18.** Half-joint in NS-ND configuration. (a) Cracking surfaces at collapse (87% final load); (b) vector plot of principal stresses just before collapse; (c) 1st principal stress just before collapse [kN/m<sup>2</sup>]; (d) 3rd principal stress just before collapse [kN/m<sup>2</sup>].

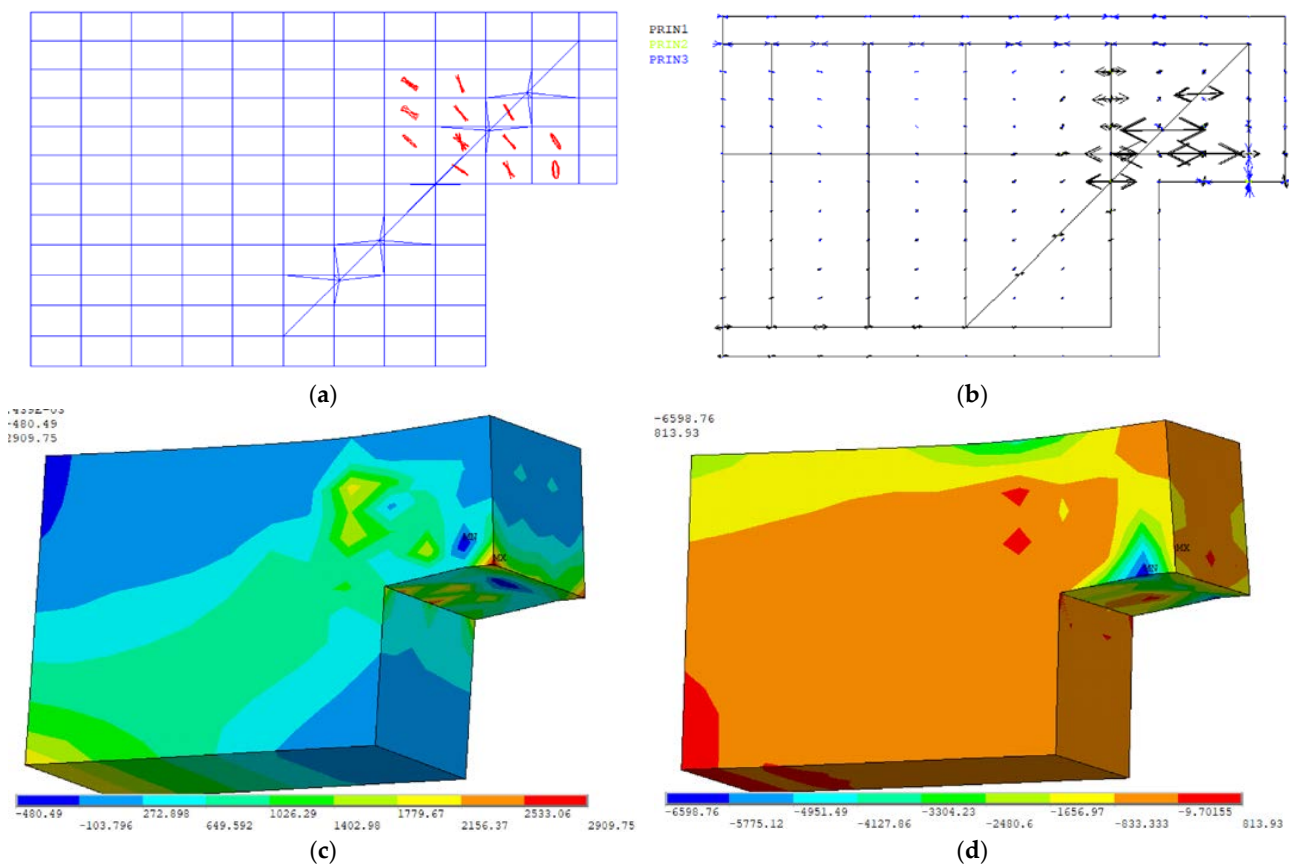
- Focusing on NS-RS configuration (Figure 18), the performed numerical analysis highlights a similar behavior with respect to the other cases. The evolution of the internal stresses is similar to up to 87% of the final load. Subsequently, NS-REF, NS-NU, and NS-ND cases show the beam collapse, while the NS-RS case is able to rearrange the stress path and absorb almost the whole of the final load (97%).

**Figure 19.** Half-joint in NS-RS configuration. (a) Cracking surfaces at collapse (97% final load); (b) vector plot of principal stresses just before collapse; (c) 1st principal stress just before collapse [kN/m<sup>2</sup>]; (d) 3rd principal stress just before collapse [kN/m<sup>2</sup>].

- The effect of stirrup thickening near the re-entrant corner positions 7 and 3, appears beneficial since it reduces the area affected by cracking damage, and allows for better confinement of the concrete in the area of the highest force concentration.
