IEEE JOURNAL OF PHOTOVOLTAICS, VOL. 4, NO. 4, JULY 2014

Light Unmanned Aerial Vehicles (UAVs) for Cooperative Inspection of PV Plants

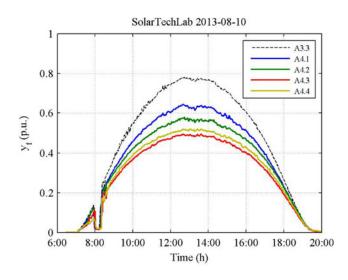
Fig. 3. PV modules performance evaluation: A4.1 to A4.4 modules are affected by snail trails; A3.3 is a healthy module.

Experimental tests show that the performance of PV modules affected by snail trails decreases by more than 20% if compared with a healthy module as shown in Fig. 3, where the instantaneous final yield y_f is reported

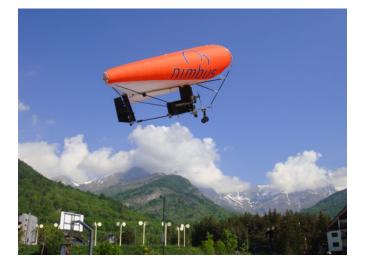
Fig. 4. Nimbus EosXi UAV platform.

In this investigation, two different UASs have been employed to inspect the PV modules' conditions: Nimbus EosXi UAV (see Fig. 4) for a first analysis and Nimbus PLP6 (see Fig. 5) for an in-depth analysis and detailed information about the plant. Both of them can be classified in the *light UAS* segment. In fact, the use of UAVs can reduce the monitoring cost much more than the other methods. Inspection by this method will be fast and it can save monitoring time. Therefore, this method can be appropriate for small and large PV array fields to find out PV modules' degradation and other failures. However, the early recognition of defects can prevent extending PV modules' degradation and wasting energy. The key aspects of UAV application in PV module monitoring include flexibility, fast detection of a large PV array field, and cost-effectiveness.

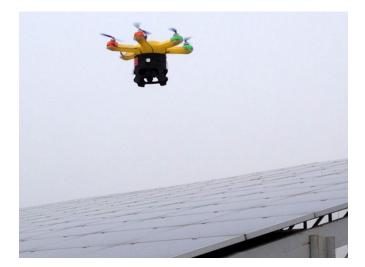
Fig. 5. Nimbus PLP6 during PV monitoring operation.

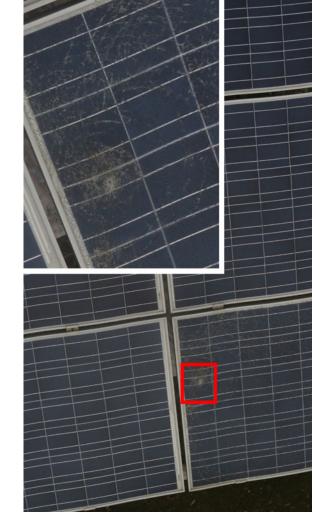
Fig. 9. Picture captured by a Nikon1-v1 camera with inlet detail of a particular shock-defect.

However, the distance between the PV array and the UAV in this case did not allow the accurate identification of additional information on the type of problem that was causing the overheating of some cells. The use of the second type of UAV allows us to get closer to the shelter and, consequently, to the modules. In this case, we performed a second analysis using a different sensor, namely a camera in the visible range. Figs. 9 and 10 show some of the results obtained. First picture shows that the defect detected by the thermal analysis is because of breaking of the glass (a mechanical shock). The second picture shows the snail trail phenomenon.

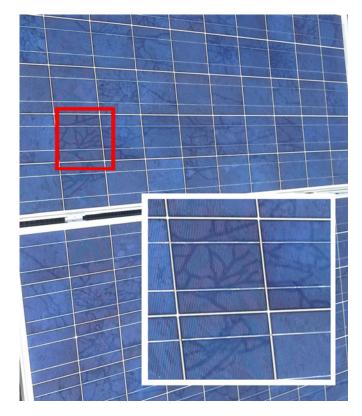
Fig. 10. Picture captured by a Nikon camera with a module affected by *snail trails*.
