## Condition monitoring of the rolling stock and infrastructure: results of a pilot project

### Abstract

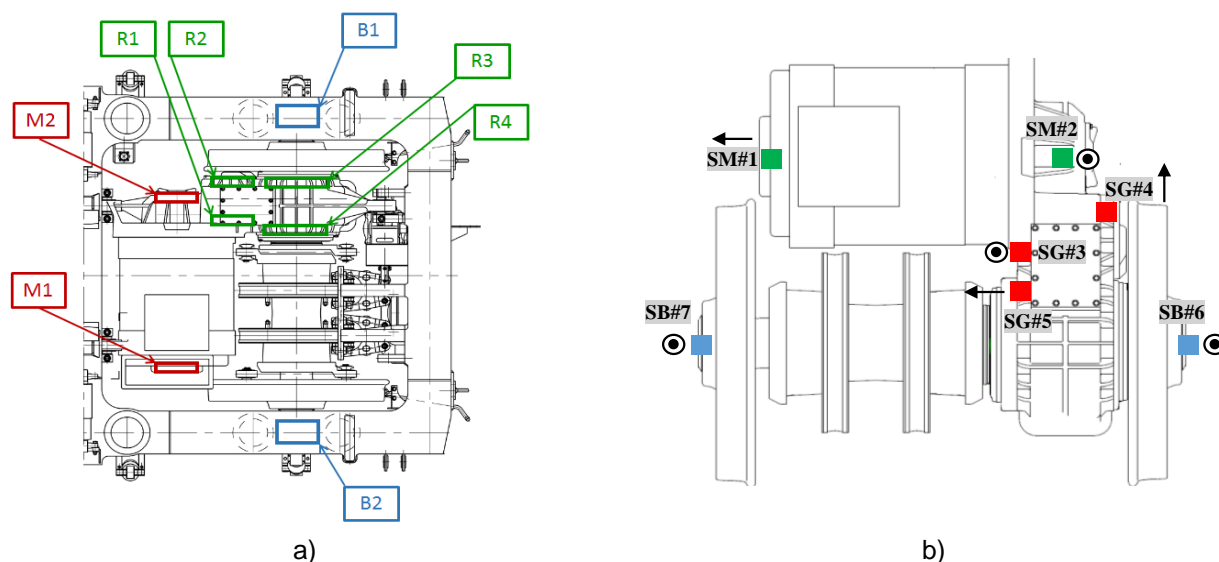
For the monitoring of the traction system, accelerometers and dual sensors (acceleration + temperature) are used. All four motors and gearboxes and all eight axle boxes are monitored. Figure 1 shows the bearing positions on the motor, gearbox and axle bearing.

**Figure 1.** a) bearings of the traction monitoring unit. b) position of the sensors

The vibrations of the bearings are measured by IEPE industrial accelerometers placed close to each bearing. A tachometer sensor is installed in correspondence of each motor and detects the number of revolutions. The accelerometers installed on the gearbox-motor assembly are PCB IMI-Sensors T0602D01 and PCB IMI-Sensors T0603C01 with sensitivity of 100mV/g and range up to 50g. On the bushings, Measurement Specialties 8021-01-0500 accelerometers with range up to 500g are installed, due to the higher level of acceleration expected on the axle. All the used sensors are dual-sensors measuring acceleration and temperature

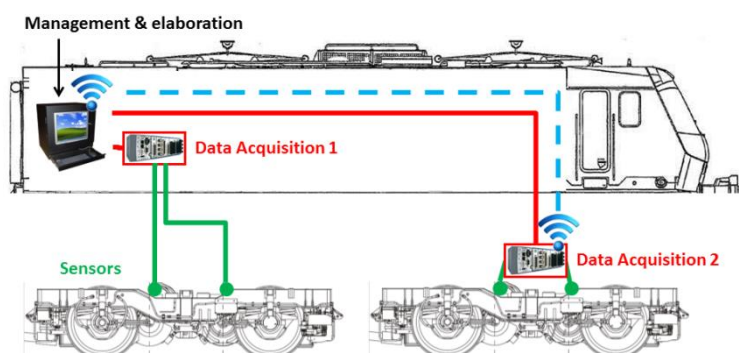
All signals are acquired by two data acquisition systems, one per bogie. The sampled data are sent for processing to a central system (industrial PC) that manages the entire apparatus. The data acquisition system for the leading bogie is positioned under the car-body and the one for the trailing bogie is located in the car-body. The connection between the PC and the on-board system is via Ethernet cable, while the connection to the leading bogie's acquisition system is performed by means of wireless transmission. In order to ensure redundancy in the communication between the leading bogie data acquisition system and the central unit, a physical connection via Ethernet cable is also implemented. The complete layout of the data acquisition and processing system is shown in Figure 2.

**Figure 2:** Schematics of the data acquisition and processing hardware.

Data acquisition is performed by two National Instruments CompactRIO devices. These are reconfigurable systems equipped with an FPGA module for real-time programming. The industrial PC is a MOXA-V2416 installed in a rack placed on board the car-body in the rear cargo area of the

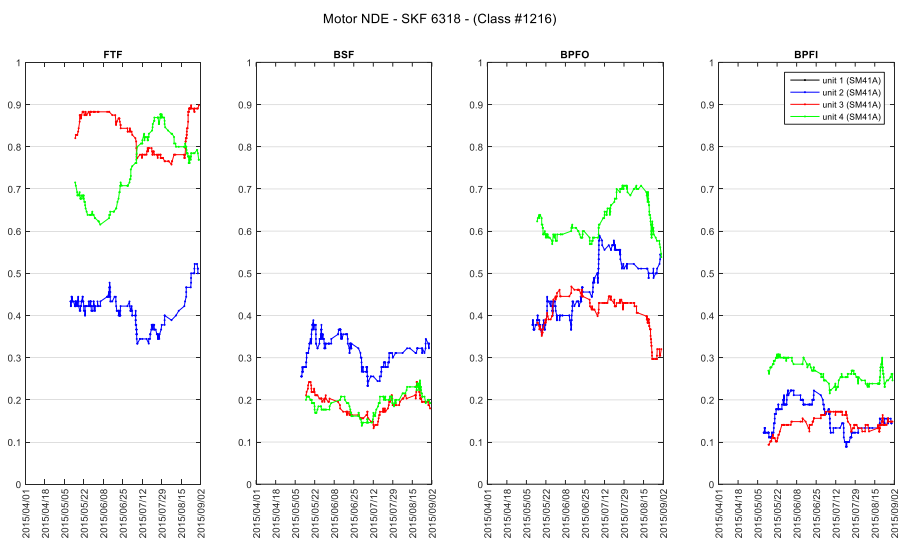
**Figure 3.** Trends of the damage indicators for the ball bearing in the NDE side of the motor.

The procedure has been repeated for all bearings of all four traction units. The trends of these indicators are shown in figure 3 for the ball bearing in the Non Driving End (NDE) side of the motor. It is possible to highlight high values of the indicator for a possible damage on the cage (FTF) and outer race (BPFO). The inspection of the bearing performed after the monitoring period has actually revealed the presence of cage and outer race defects on these bearings.

Vibration data for rolling element bearings have been acquired at high sampling frequency, namely 25600 Hz and collected in different operating conditions: train speed and direction, motor torque temperature. In particular, some rules have been defined in order to acquire data only in suitable operating conditions, mainly in constant speed, and with an average interval of about 5 minutes between two consecutive acquisitions. In the monitoring period, a total amount of about 25000 acquisitions have been collected. Data acquisitions have been classified depending on the operating condition. For each class the bearing health has been evaluated as function of the train mileage by means of suitable damage indicator. Fault identification has been performed mainly by means of envelope tools [7] due to the nature of the vibration signal for a damaged bearing. In particular peaks in correspondence of the bearing defect frequencies have been extracted from the envelope spectrum. BPFO, BPFI, FTF and BSF bearing defect frequencies, corresponding to a defect on outer race, inner race, cage and roller respectively, have been investigated. The final fault indicator  $\delta$  is then evaluated as the ratio between the number of acquisitions in which peaks in the envelope spectrum exceed a statistical threshold [8] and the total number of samples falling in a moving time window. The upper limit of the fault index is equal to one and indicates that in all acquisitions a bearing damage is clearly detectable, that is a probability of a defect is very high.

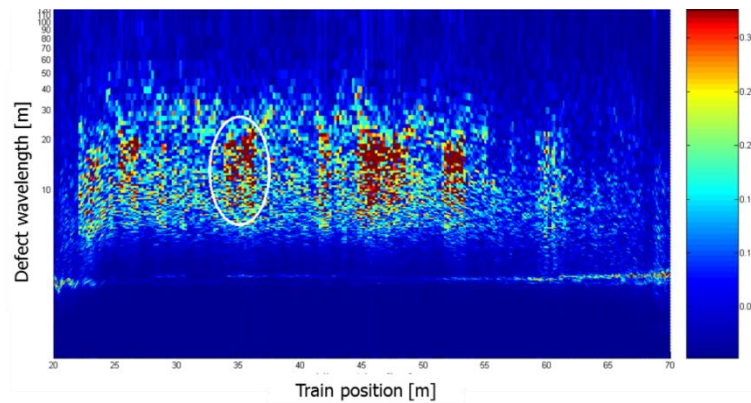
strong correlation between acceleration measurements and track condition, is obtained applying a Specgram technique to the signals. This 3-D graph (shown in Figure 4) reports on the horizontal axis the position along the line of the vehicle and on vertical axis the wavelength content of the signal, while the color map defines the amplitude of the R.M.S. of the acceleration signal. This representation points out clearly possible track defects, providing information on their location and wavelength, thereby providing an overall evaluation of the line condition. It can be concluded that the study of the track geometry seen from vehicle's dynamics point of view is of fundamental importance for the evaluation of the line condition and for the definition of track condition monitoring approaches: as a matter of fact traditional measurement methodologies (for instance 3 points based measurements) are able to identify only irregularity profile with wavelengths under 30 whereas the experimental set up adopted here can go beyond this limitation allowing the identification of higher wavelength irregularity, besides enabling the continuous monitoring of the track with a relatively low effort spent.

**Figure 4:** Example of Specgram of bogie lateral acceleration

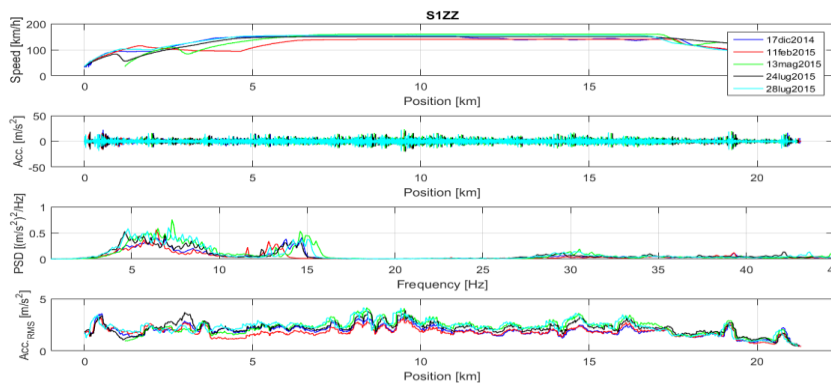
Owing to the confirmed correlation between track condition and train dynamic response, a step forward was done focusing the attention on the correlation between the frequency content in the acceleration signals and the track defect wavelength. Figure 5 shows an example of the results obtained. A track section on the conventional line Torino Porta Nuova – Genova Brignole is taken as a reference and the vertical bogie acceleration is analysed in different time periods covering seven months of service. In the first subplot the vehicle speed is reported as a function of train position for different vehicle runs. The second subplot shows the vertical acceleration signal pass-band filtered in the 3-40Hz frequency range. The third subplot reports the power spectral density (PSD) of the vertical bogie acceleration and finally the lower subplot shows the r.m.s. of the same signal computed over a 250m moving window.

**Figure 5:** Monitoring of track state for the Torino – Genova line from December 2014 to July 2015

From the vehicle speed diagram it can be observed that the speed profiles are subject to some variability which is reflected in a variation of the moving average r.m.s. recorded in different runs. Hence, it is important that the condition based monitoring methodology properly takes into account the effect of speed in order to distinguish between an evolution of the defect and the effect of speed variations. Moreover, from the trend of the moving window r.m.s. it is possible to identify track segments producing higher levels of vehicle vibration, which can be interpreted as produced by higher levels of track irregularity or other track defects. The evolution with time of these track segments can be monitored by proper interrogation of the track data-base being built based on the measurements collected.

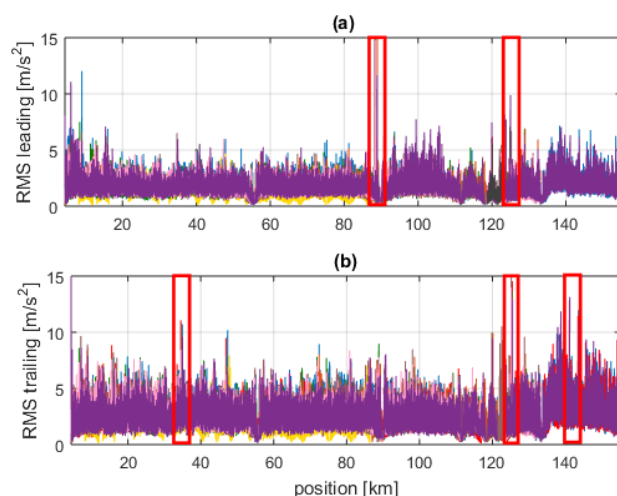
**Figure 6:** RMS values of pan-head accelerations. (a) Leading strip. (b) Trailing strip.

Figure 6 shows an example of the results obtained by RMS analysis, corresponding to the accelerometers placed to the leading (a) and trailing (b) contact strips (Frequency content 0.5-50 Hz). All the repetitions along a 150 km line are reported. The maximum commercial speed is 160 km/h, and some train stops can be identified in the figure where the RMS value gets to zero. Five remarkable peaks are detected, highlighted in the figure by a red square. The identification of hot-spots is made by disregarding the peaks that are not confirmed in several repetitions, such as the ones at km 6 and km 9 for the leading strip. It is possible to observe that most of peaks are only visible in one signal, confirming the necessity of two sensors. The final step of the work will be an evaluation of a threshold to identify which peaks are remarkable, and which is the level of priority for maintenance. This can be done by means of a field analysis aimed at identifying the correspondence between the detected defect and the status of the overhead line.

During the 6-month testing period, it has been possible to monitor all the 3 kV conventional overhead lines over a wide geographical area in North-West Italy. Several data acquisitions were performed on the same lines and at comparable speed, allowing to verify the repeatability of the diagnostic information obtained, which is essential for developing a reliable condition-based maintenance system. The analysis performed is aimed at identifying local defects of the overhead line, i.e. singular points which can affect the stability of current collection. These defects can be either the result of construction imperfections or infrastructure degradation. The root mean square value (RMS) of both accelerations is computed over a mobile window of short length (e.g. 0.2 s) with a high level of overlap (e.g. 90%), in order to highlight the power increase of collector accelerations at the location of local defects [9]. The main idea behind this technique is to identify the power associated with the acceleration peaks, so as to distinguish occasional peaks from those generated by a real defect. The data obtained with different train runs are then compared to verify the persistence of the main RMS peaks at the same positions, which indicates the presence of a relevant infrastructure defect. The use of accelerometers allows extending the measurement to the frequency band 0.5-250 Hz, which is larger than the 0-20 Hz usually allowed by contact force measurement. This enables the acquisition of useful information on the level of excitation of collector flexural modes, which are usually excited by contact line singularities. However, the analysis showed that the identification of RMS peaks with respect to the background level is easier when only the range 0.5-50 Hz is considered. This is due to the flexibility of the support holding the sensors in the pantograph adopted in the present work, and marks a difference with respect to the results obtained in [9].
