Stress corrosion cracking of additively manufactured alloy 625

Stress Corrosion Cracking of Additively Manufactured Alloy 625

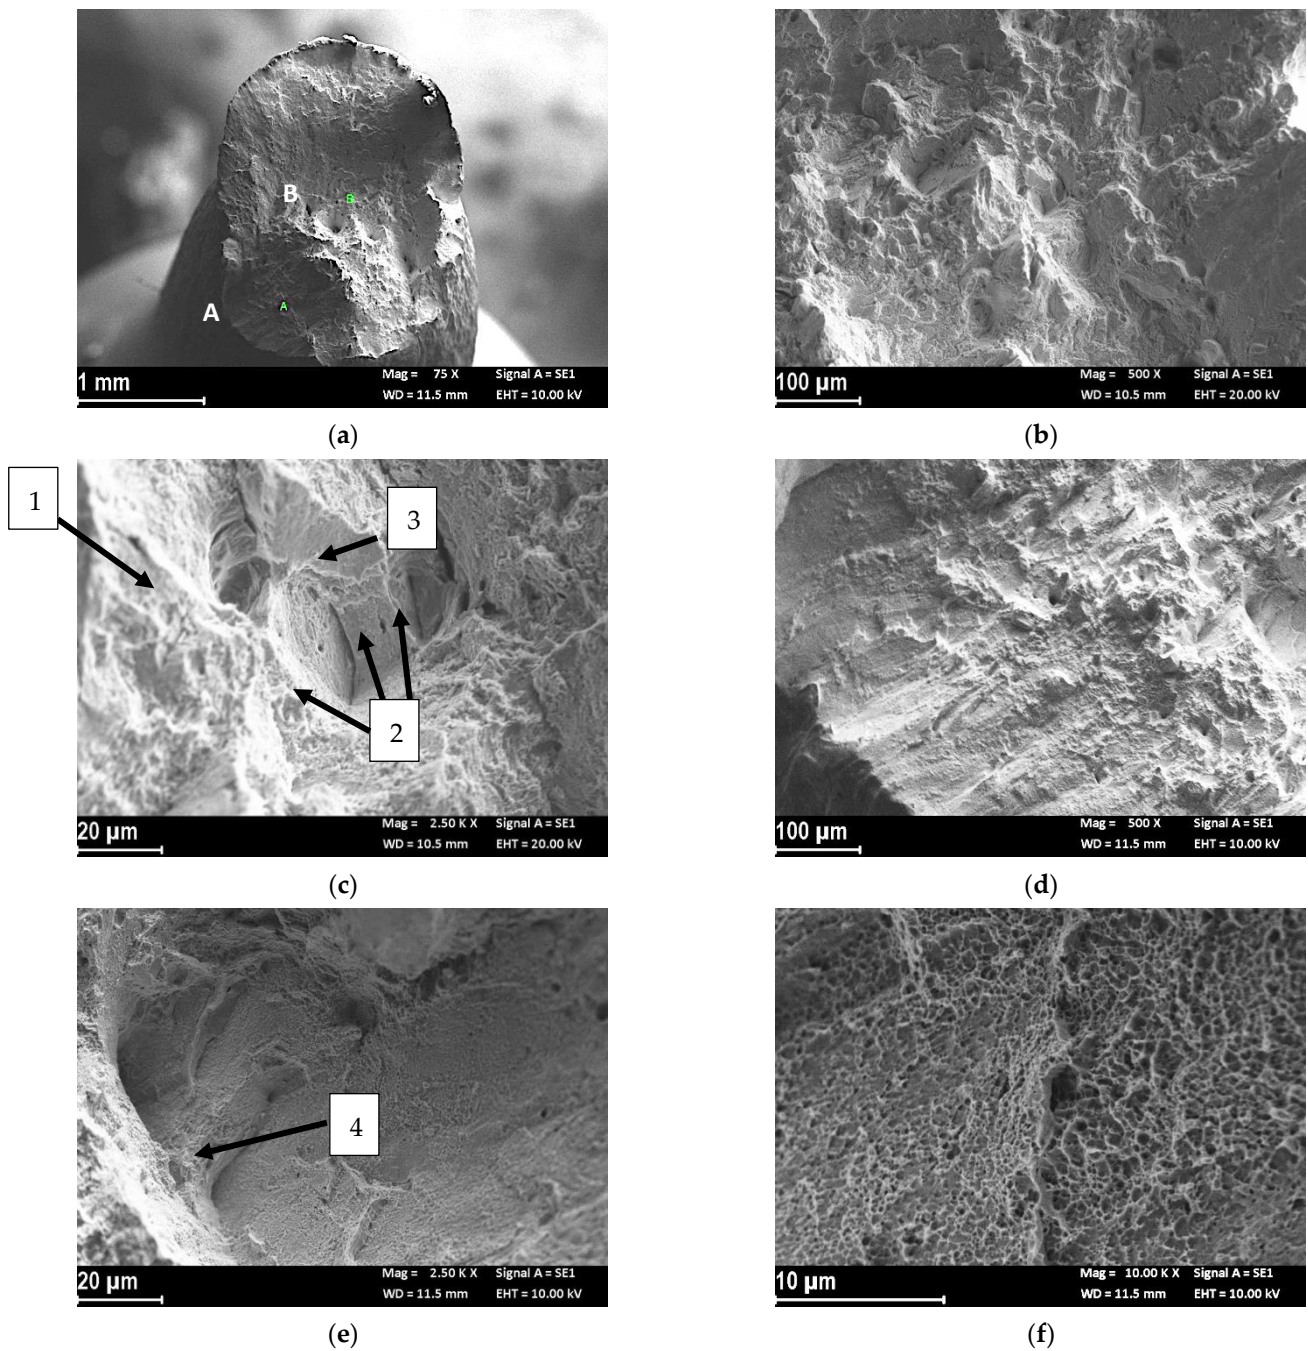
Figure 3. Secondary electron fractographic analysis of the UT-LPBF specimen after the SSRT test in air: (a) macro image; (b) close-up of the center of the specimen (zone B in (a)); (c) close-up at higher magnification of Figure 3b, the arrows indicate: (1) presence of large dimple associated to inclusion, (2) edge of the melt pool, and (3) low toughness zone; (d) close-up of zone A of (a) fracture zone of shearing; (e) close-up of (d) in which is evident the separation of the melt pools, (f) close-up of zone (4) in (e) in which are evident micro dimples in the separation of the melt pools.

Figure 3 shows the fracture morphology of the UT-LPBF specimen tested in air. The specimen did not have a perfectly regular cone/cup fracture surface (Figure 3a). In the center of the specimen, the fracture was characterized by irregular dimples of different sizes (zone B in Figure 3a and close up of Figure 3b,c) sometimes associated with inclusions (zone 1 in Figure 3c), or, more frequently to the border of the melt pools (zone 2 in Figure 3c). Analyzing the center of the specimen at high magnifications, areas of low toughness and points of cleavage almost appeared (zone 3 in Figure 3c). At the border of the specimen (zone A in Figure 3a) the fracture mode was due to shearing (Figure 3d). On the shearing zone there were micro-separations corresponding with either the edge of the melting pool (zone 4 in Figure 3e), or the dimples (Figure 3f). The different cracking behavior in different regions suggested that there were some zones more ductile than others in the specimen, as it was possible to observe by the sharp decrease in the stress vs. strain curves (Figure 2).

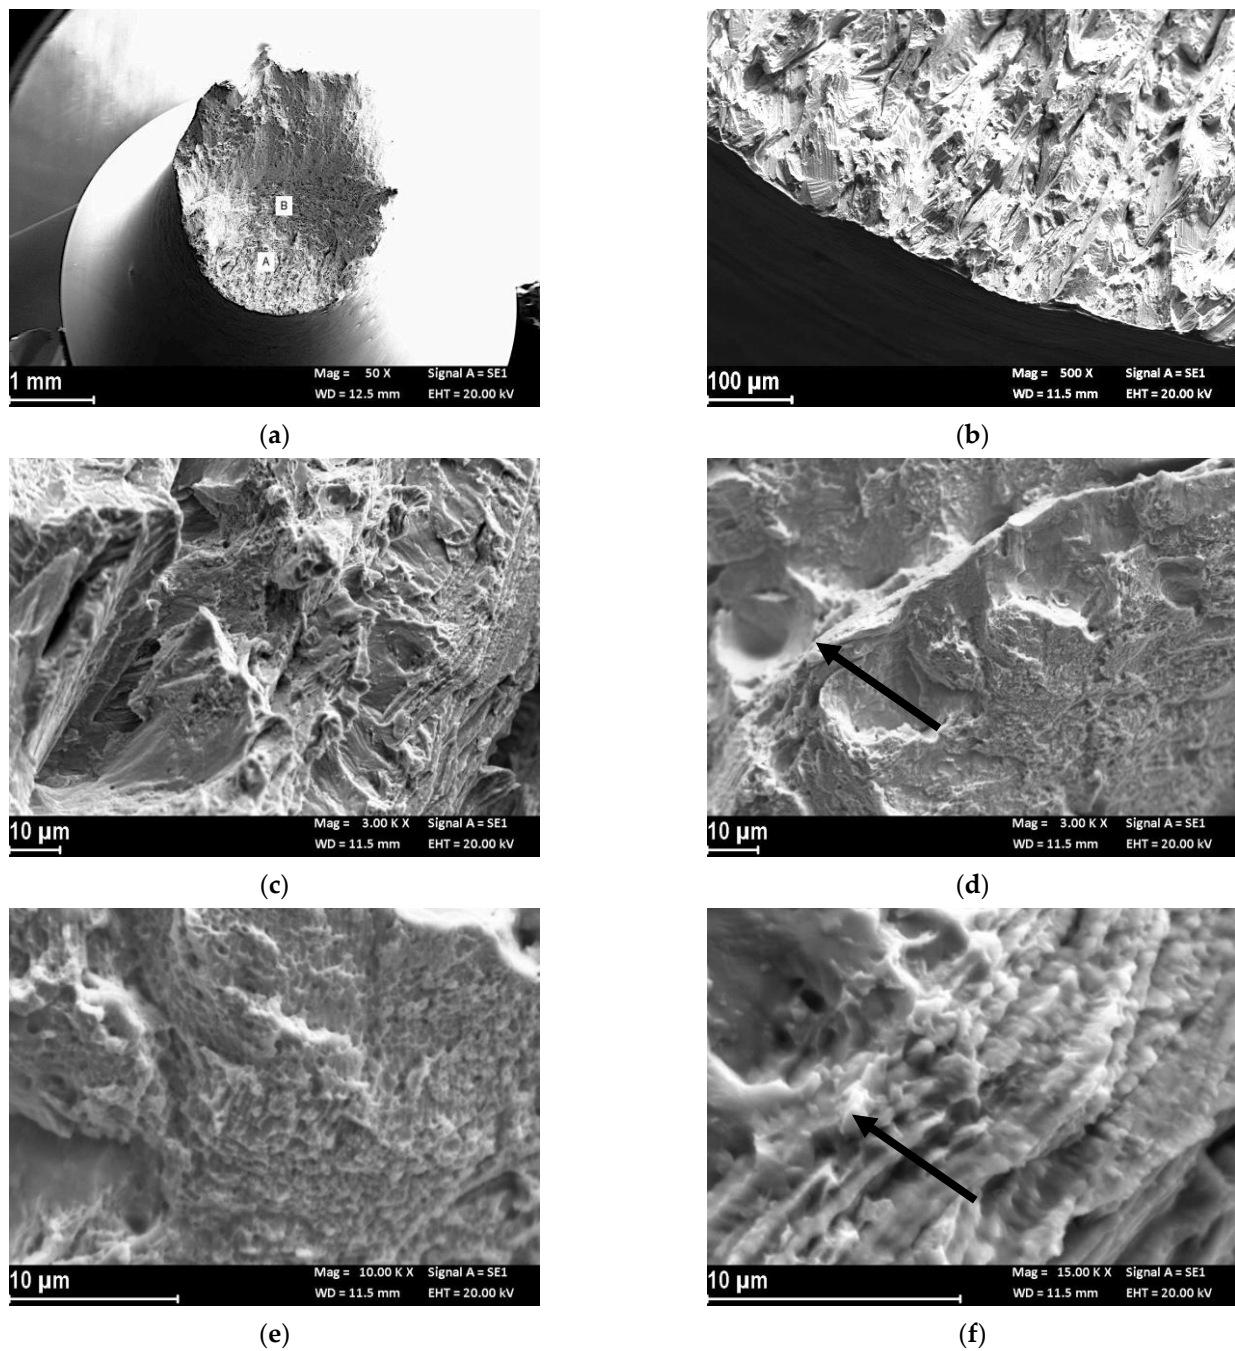
Figure 4. Secondary electron images of the fracture surface of UT-LPBF specimen after the SSRT test at strain rate $3.15 \times 10^{-6} \text{ s}^{-1}$ in SOW and cathodic polarization at -1.1 V vs. Ag/AgCl : (a) macro image; (b) close-up of the trigger zone (zone A in (a)) with brittle morphology; (c) close-up of (b) in which is evident a quasi-cleavage growth, (d) close-up of (b) in which is evident the separation of the melt pool (arrow) and presence of dimples in the upper melt pool; (e) close-up of the center of the specimen (zone B in (a)), presence of dimples and brittle zone; (f) close-up at higher magnification of (e) in which are evident the presence of intermetallic precipitates.

Figure 4a reports the macro image of the UT-LPBF specimen after the test in SOW and cathodic polarization of -1.1 V vs. Ag/AgCl. The specimen still showed plastic deformation, as can be seen from the reduction of area percentage shown in Table 3, but the fracture surface had a flat trigger area (zone A of Figure 4a), which extended to the center of the specimen (zone B of Figure 4a) and the final break was due to sliding by shearing. The trigger zone had a quasi-cleavage aspect (Figure 4b), which is typical of hydrogen embrittlement phenomena. The higher magnification details (Figure 4c) show the alternation of flat areas and small dimples. Microfractures were evident at the separations of the fusion wells, which changed the fracture propagation (Figure 4d). The fracture surface at the center of the specimen (zone B of Figure 4a) was mixed, with brittle area interspersed with small dimples (Figure 4e). The high-magnification image shows the presence of small intermetallic precipitates on the flat facets (Figure 4f).

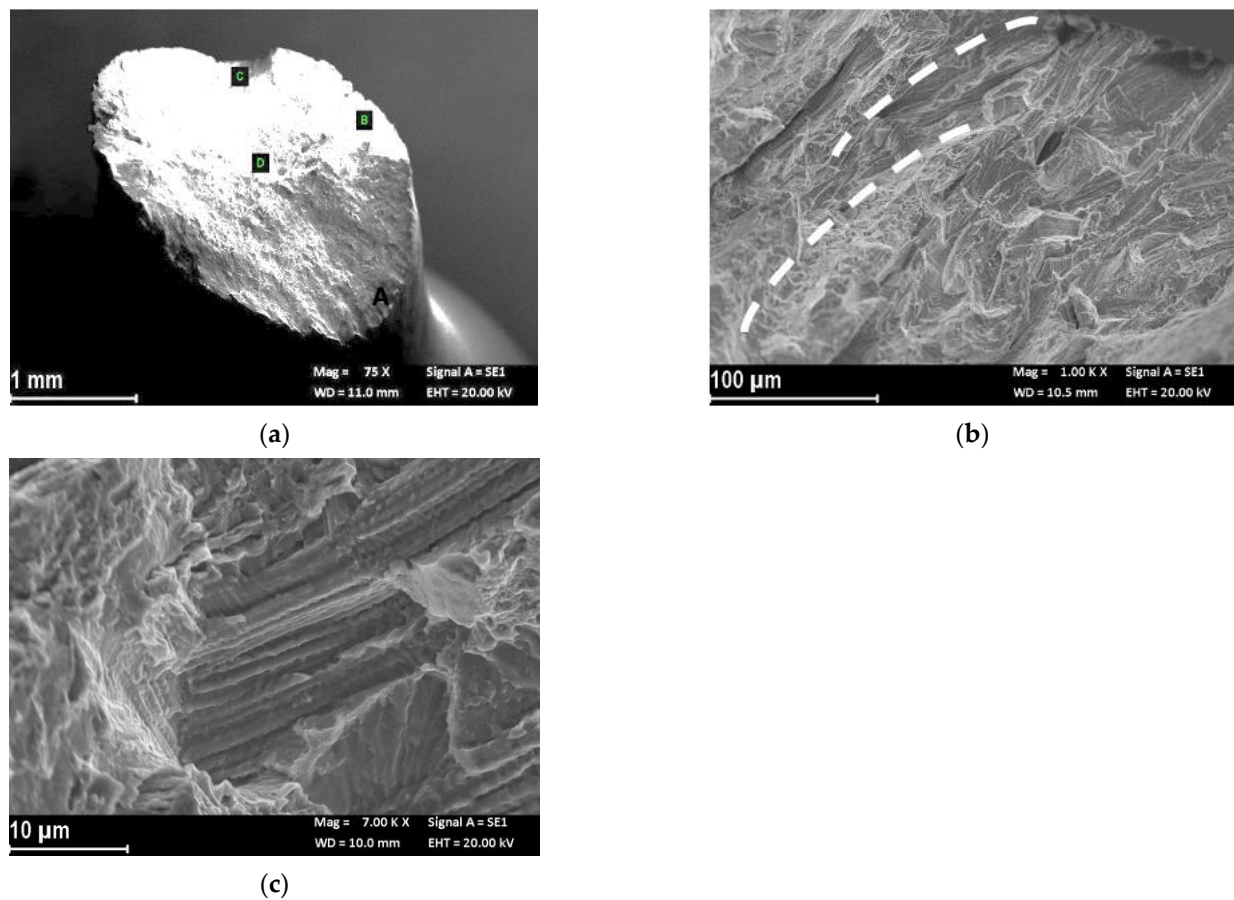
Figure 5. Fractographic analysis of the UT-LPBF specimen after the SSRT test at strain rate $3.15 \times 10^{-5} \text{ s}^{-1}$ in SOW and cathodic polarization at -1.1 V vs. Ag/AgCl after 16 h of hydrogen pre-charging: (a) macro image; (b) close-up of zone A, and (c) a similar morphology is observed in zone C; close-up of zone B; zone D in (a) is fully ductile.

Figure 5a shows the macro image of the fracture surface of the UT-LPBF specimen pre-charged with hydrogen for 16 h and then strained at $3.15 \times 10^{-5} \text{ s}^{-1}$. The fracture surface had some small trigger areas with a morphology typical of hydrogen embrittlement (zone A, B and C of Figure 5a; the close-up of zone A is shown in Figure 5b, the close-up of zone B is shown in Figure 5c), while the central area had a mixed fracture consisting of numerous dimples, small brittle facets and rare areas of quasi-cleavage. The final breakage of the specimen occurred by sharing. The value of the normalized reduction of area was very similar to that obtained in the previous case. At high magnification for areas A (Figure 5b), B (Figure 5c) and C of the specimen, a morphology similar to that observed in Figure 4 could be noted, with many brittle facets arranged perpendicularly to the direction of propagation of the fracture (along the dendritic growth) that occasionally jumped on a different plane, and a separation of the border of the melting pool (dotted line in Figure 5b).
