**TECHNICAL REPORT 0-7058-1**  
TXDOT PROJECT NUMBER 0-7058

# Development of a Performance-Related Test for Designing Seal Coats

August 2022  
Published January 2023

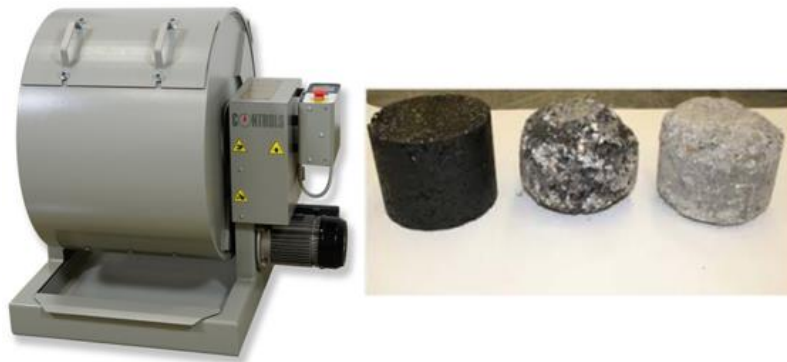
no charge (steel balls). The rotating action of the LA Abrasion drum abrades the specimen. The amount of specimen lost during this process can be measured and used as a metric for aggregate binder bond strength. This procedure requires the fabrication of a molded specimen using project specific aggregate and binder. Figure 2.1 shows a photograph of the LA abrasion device that is used for the Cantabro test.

**Figure 2.1. Cantabro Test Equipment (TEX-245-F, 2019)**

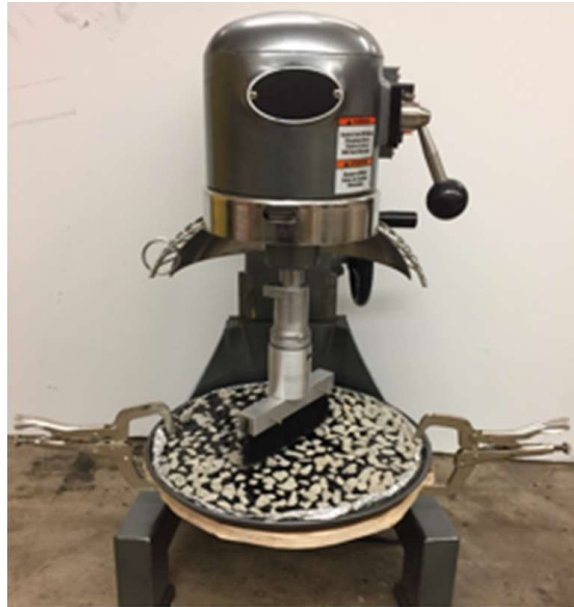
The ASTM D7000 Sweep Test (ASTM International, 2019) shown in Figure 2.2 was originally used to evaluate micro surfacing materials or slurry seals. This test can also be used to measure aggregate retention on a fabricated seal coat specimen. Two variations of Sweep tests are available and were used by other researchers in evaluating the performance of seal coats. The difference in the two variations is the type of fixture and material that is responsible for abrading the sample. Both variations measure aggregate retention but are intended to simulate different field conditions. The first type of Sweep test uses a brush accessory mounted on a planetary type mechanical mixer (eg: Hobart). The sample can be swept for a predetermined duration of time and temperature and measured for aggregate loss. In this case, the Sweep test is simulating the sweeping action of the broom that are used in the field immediately after seal coat construction and before opening to traffic. This sweeping practice is conducted to remove any excess aggregate from the surface of the seal coat. However, occasionally, this test not only sweeps excess particles but also dislodges particles that do not bond well with binder, which is referred to as short term raveling (Howard et al., 2011).

**Figure 2.2. A photograph of the Sweep test shown with the brush attachment (ASTM International)**

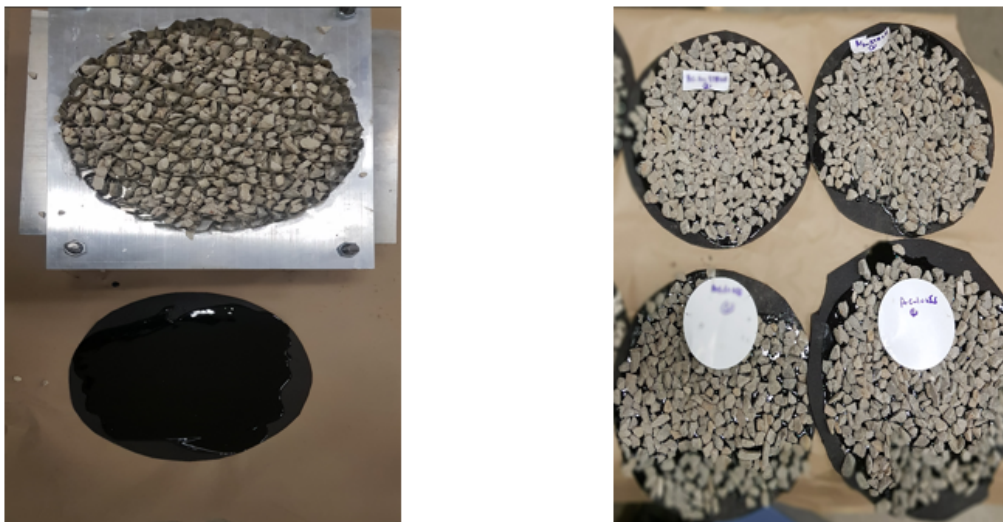
In Equation 3.1,  $A$  is the initial weight of the specimen,  $B$  is the final weight of the specimen, and  $C$  is the weight of the asphalt binder and the felt disk. Figure 3.2 and 3.3 shows a sample of specimen fabrication and the specimen attached to the Sweep test table using the tube variation, respectively.

**Figure 3.2. Specimen fabrication for the Sweep test (left: specimen before applying aggregates; right: after placing aggregates)**

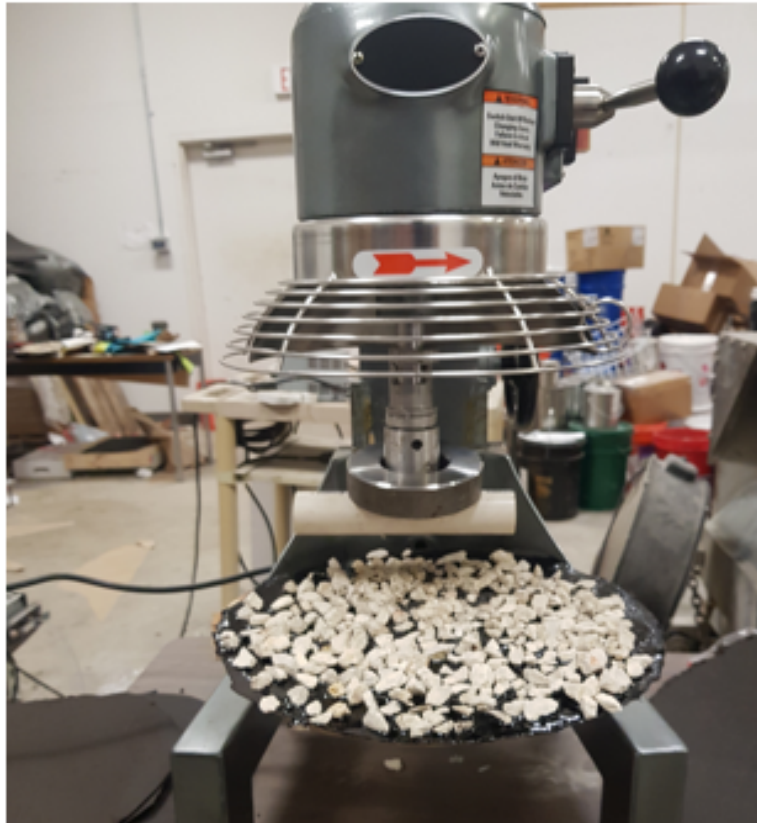
**Figure 3.3. Specimen in the Sweep test**

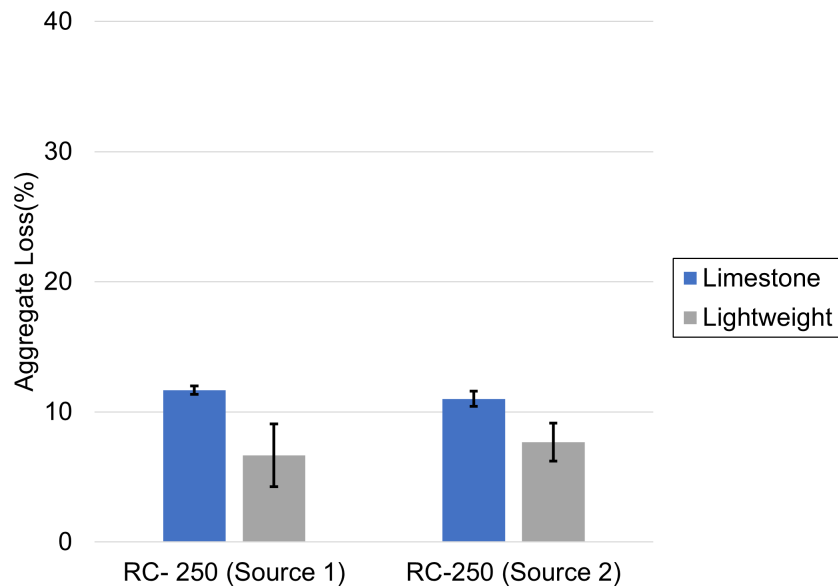
Figure 3.8 presents the results from this set. These results highlight that the RC-250 from the different producers performed similarly with each aggregate. Also, typically the limestone aggregate showed slightly lower adhesion compared to the sandstone for both cases. These results further speak to the sensitivity and repeatability of the test method.

**Figure 3.8. Vialit aggregate loss for RC-250 from two different sources with two different types of aggregates**

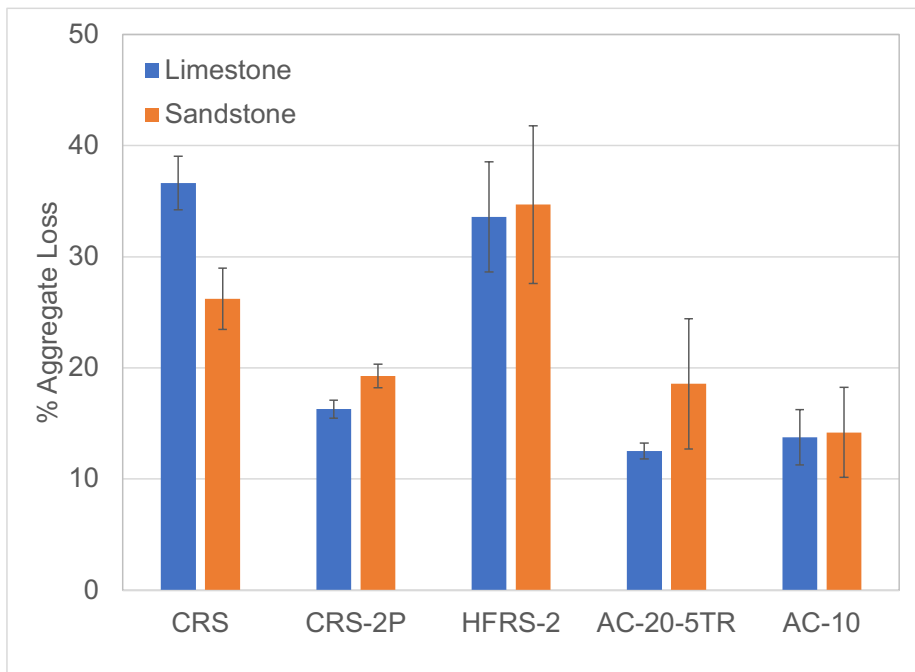
Results from Sweep test were different compared to the Vialit test. Based on the results from the Sweep test, overall CRS-2P and AC-20-5TR showed similar loss. To some extent, this is consistent with field experience.

**Figure 5.8. Results from the Sweep test showing the influence of five different base binder types on aggregate loss using two different aggregates.**

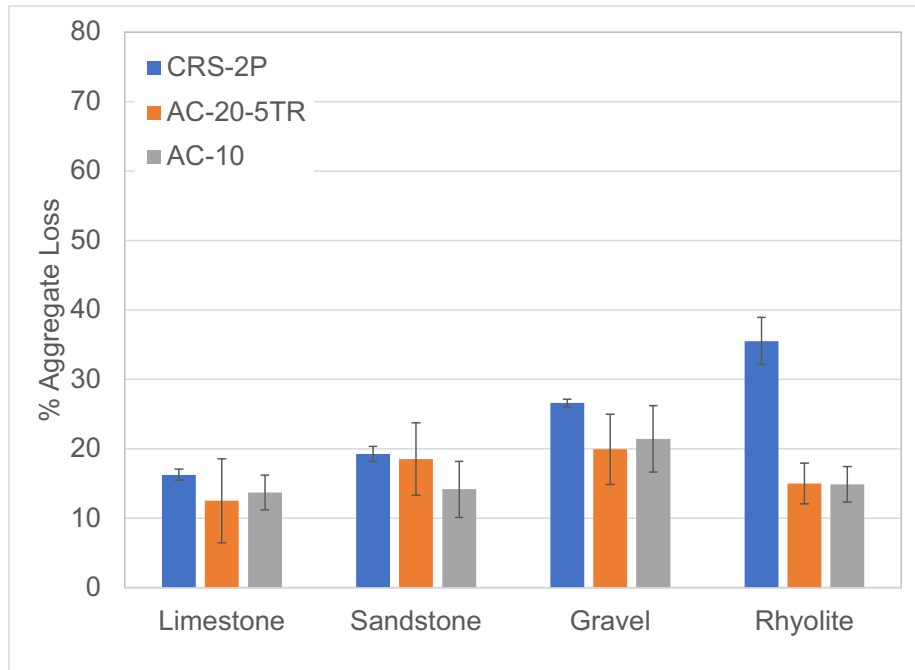
Results from Sweep test were different compared to the Vialit test. Based on the results from the Sweep test, Limestone and Sandstone showed statistically similar results with all three binders. Gravel and Rhyolite showed slightly higher loss with CRS-2P compared to hot applied binders. However, these aggregates were precoated at a higher than optimal percentage as determined from another study.

**Figure 5.10. Results from the Sweep test showing the influence of four different aggregate types on aggregate loss using three different base binders.**

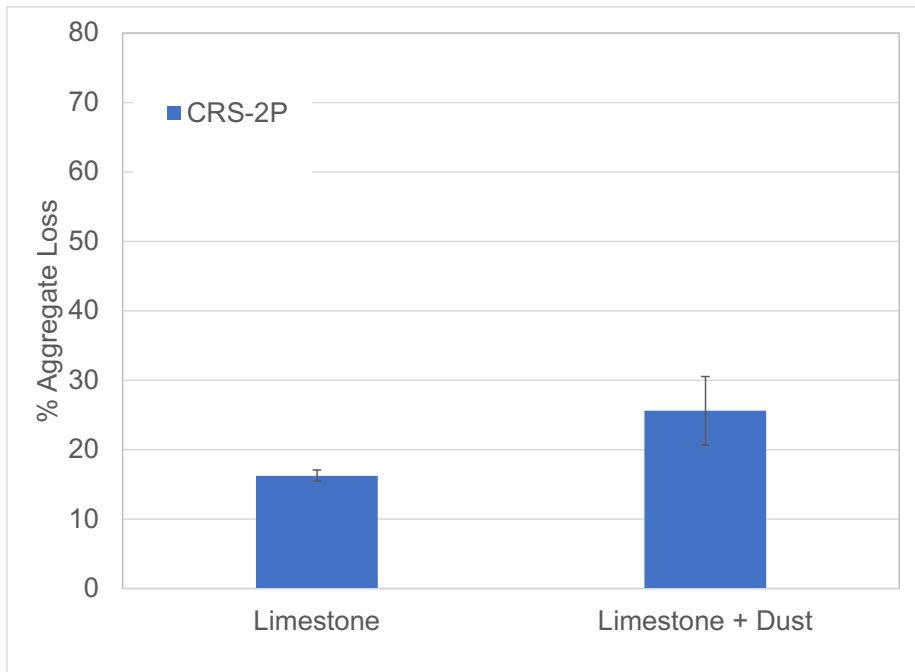
In order to evaluate the impact of dust on the quality of adhesion, limestone fines were sieved using the #200 sieve in the laboratory. These fines were added to the coarse aggregate (1% by weight of the aggregates) and thoroughly mixed to create “dusty aggregates”. The dusty aggregates were then used with the CRS-2P emulsion and the Sweep and Vialit tests. These tests were conducted as before. Figures 5.11 and 5.12 consistently show the adverse impact of dust.

**Figure 5.12. Results from the Sweep test showing the influence of dust on aggregate loss.**

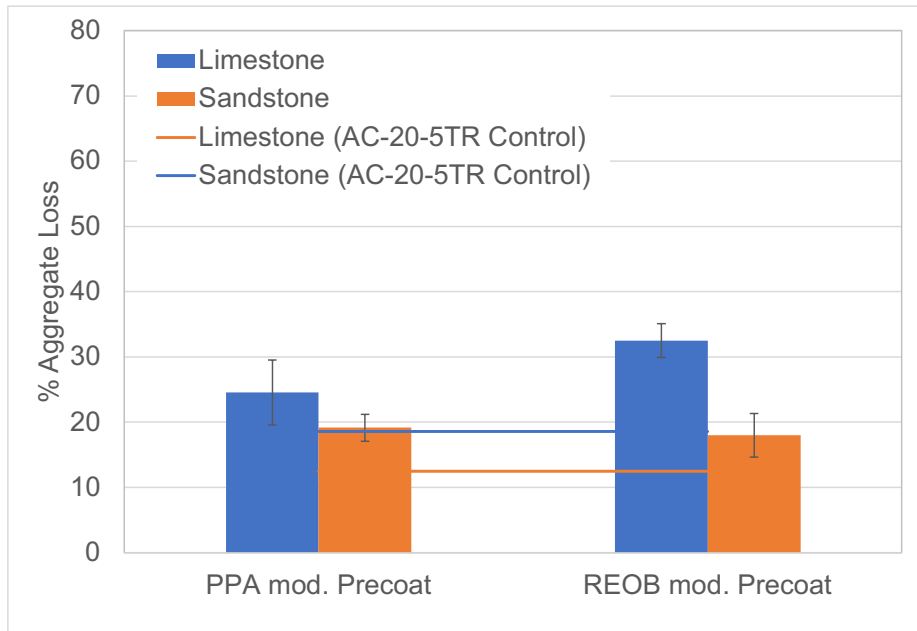
**Figure 5.16. Results from the Sweep test showing the influence of PPA and REOB modified binders used for precoating with AC-20XP base binder on aggregate loss.**

Aggregates precoated using PPA or REOB modified binders were evaluated using AC-20-5TR and AC-20XP as the base binder with the Vialit and the Sweep tests. Figures 5.13 through 5.16 show the results from these tests. These figures use the test results from the respective aggregates with PG 64-22 as the precoating binder and AC-20-5TR as the base binder as the baseline for comparison. The Vialit test results shows that the PPA and REOB modified binders used for precoating reduce the aggregate loss, although this reduction is not substantial. Interestingly, Sweep test results show that precoating with PPA and REOB modified binders had a negative impact on the adhesion quality with varying degrees depending on the type of binder and aggregate. However, when PPA or REOB modified binders were used as the base binders with aggregates precoated using a typical PG 64-22, both the Vialit and Sweep tests showed either no statistically significant change or an increase in the amount of aggregate loss (Figure 5.17 and Figure 5.18). All aforementioned results suggest a conservative position to disallow the use of PPA and REOB for either precoating or use as a base binder.

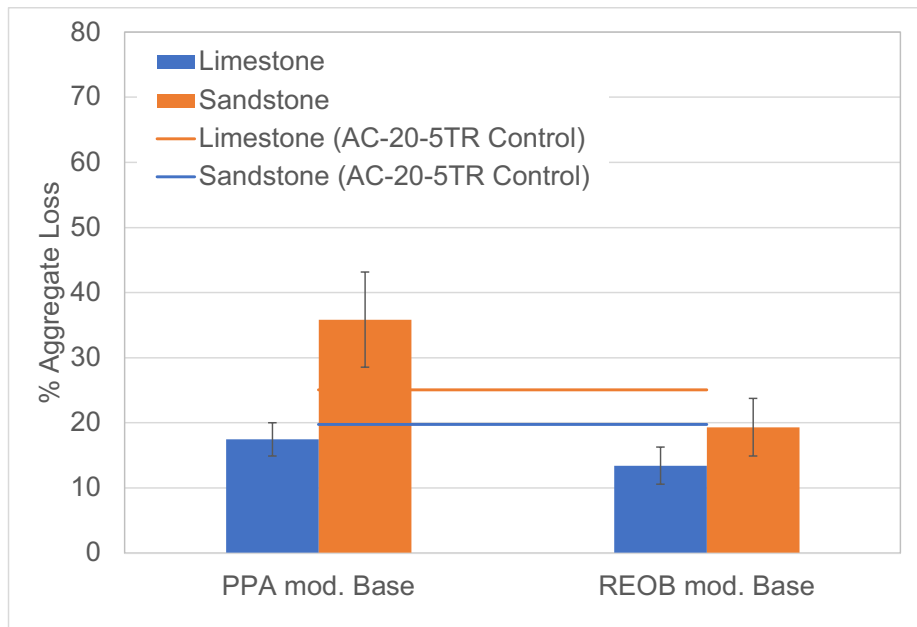
**Figure 5.17. Results from the Vialit test showing the influence of PPA and REOB modified binders used as the base binder on aggregate loss.**

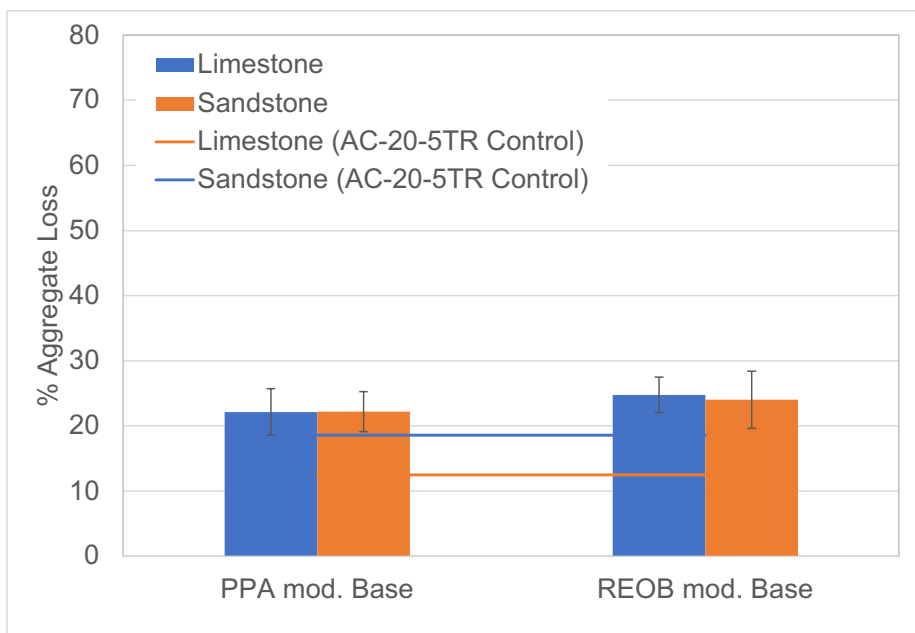
**Figure 5.18. Results from the Sweep test showing the influence of PPA and REOB modified binders used for as the base binder on aggregate loss.**

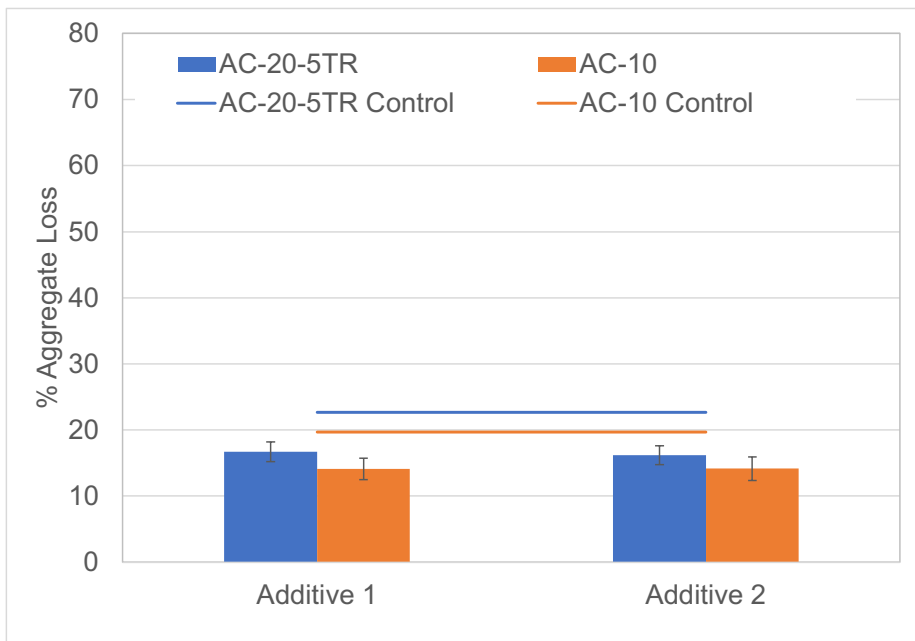
Figures 5.19 and 5.20 show the results from these tests. These results show that the use of these two liquid antistrip agents reduced aggregate loss based on the Sweep test. However, based on the Vialit test, only one of the liquid anti-strip agents showed some improvement with AC-20-5TR. In fact, with the Vialit test, the AC-10 binder showed similar or even worse performance with the liquid anti-strip additive. Another important point that must be noted here is that, although the Sweep test results show some improvement, the magnitude of this improvement may not be substantial to warrant the use of a liquid anti-strip agent. Nevertheless, these results show that the use of liquid anti-strip agents may be a potential solution when encountering problematic binder-aggregate pairs.

**Figure 5.20. Results from the Sweep test showing the influence of liquid anti-strip agents on aggregate loss with gravel and AC-20-5TR and AC-10 binders.**

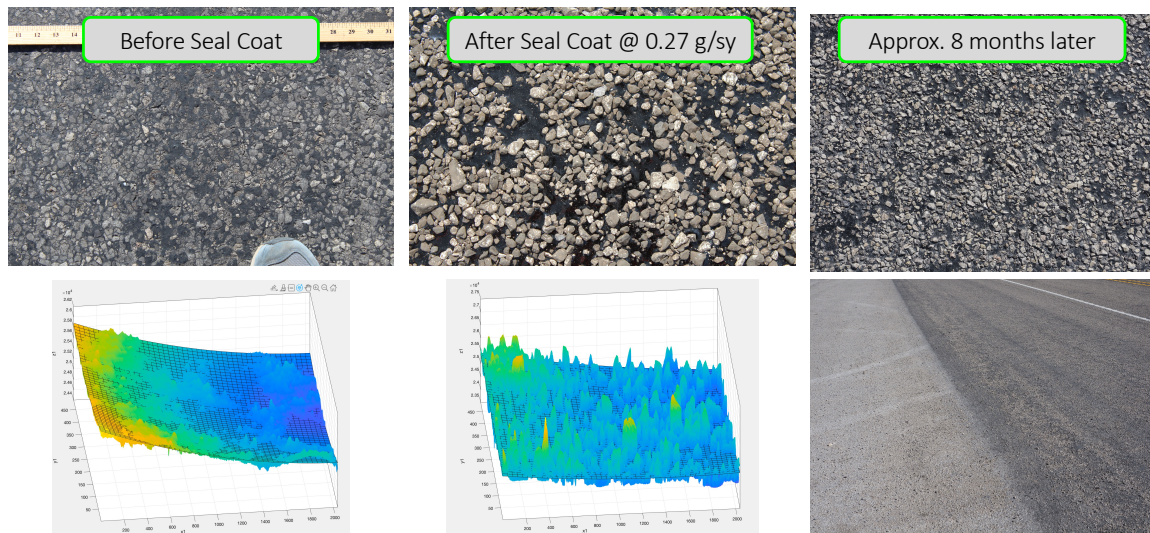
The 3D point cloud data was available for these sections immediately after construction as well as one to three years after construction. These data were used to quantify the texture of the pavement immediately after construction as well as after a performance period. The texture from these two points in time was used to estimate the loss in texture over time. Figure 6.2 shows a typical example of the 3D mesh (along with a plane fitting the profile) using the point cloud measured at a section from the 2020 construction season on US 87. The seal coat binder was AC-20-5TR and the aggregates were precoated Grade 4 SAC B.

**Figure 6.2. The 3D model generated using a point cloud (top left - image before seal coat, bottom left - 3D scanned image before seal coat, top middle - image after seal coat, bottom middle - 3D scanned image after seal coat, top and bottom right - images approximately 8 months later).**

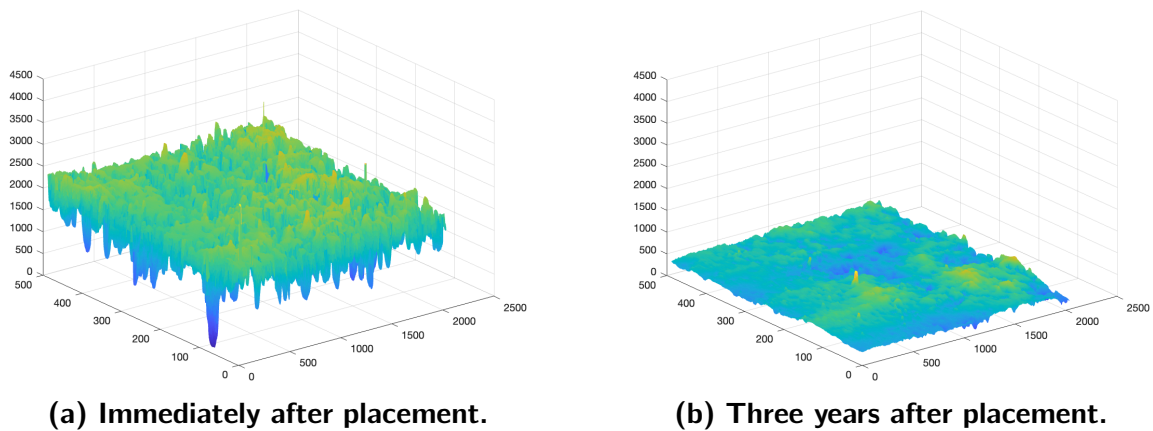
laser profiler was analyzed as follows. A second-degree polynomial surface was fit to the point cloud. Note that slight difference in pressure applied to scanner during measurement, geometry or camber of the pavement surface, and slight variations in the alignment of the profiler can cause the profile to drift from an ideal flat surface. However, the process of fitting a surface can compensate for these effects. The error from the actual points measured to the best fit surface was used as a quantitative measure of the texture. Simply put, higher error from the best fit surface indicates a coarser texture and vice-versa.

**Figure 6.3. Texture from a typical section that has shown substantial loss in texture over period of observation.**

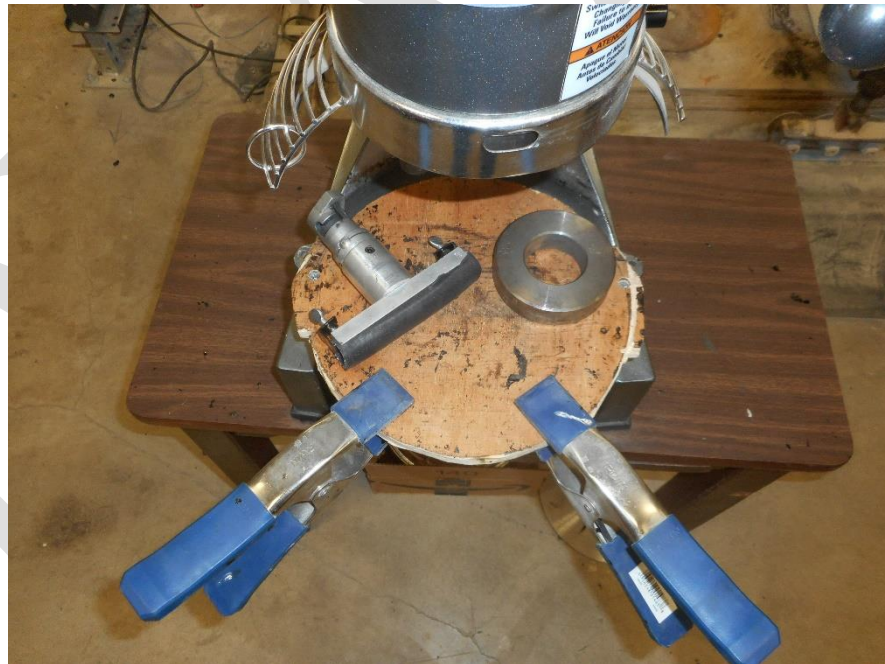
Figure 1. Sweep Test Apparatus Components.

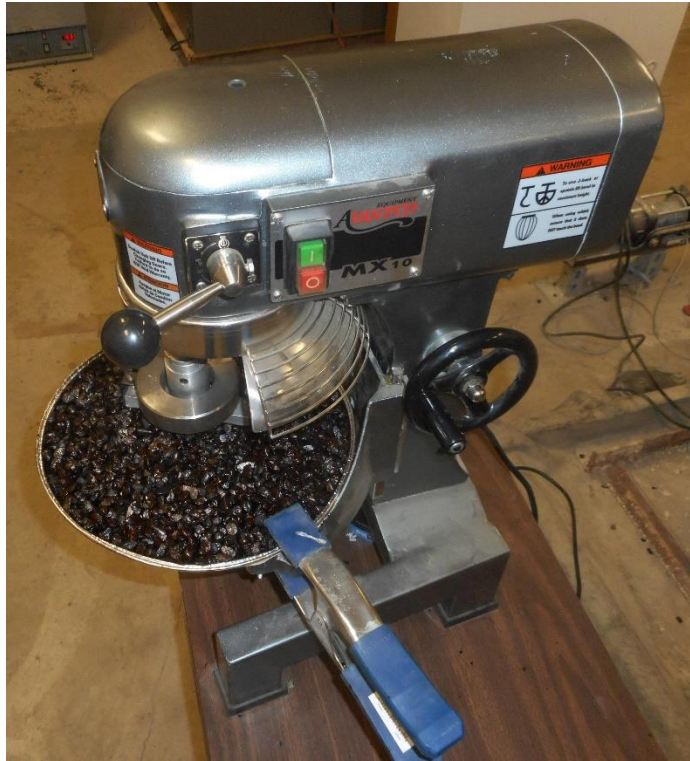
Figure 4. Assembled Apparatus with Sample Ready to Test.

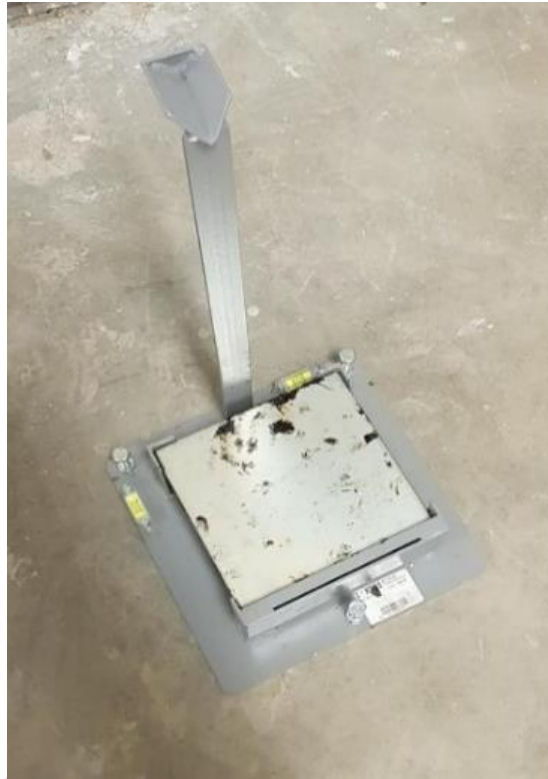
Figure 4 Vialit plate on the 3-point supports.

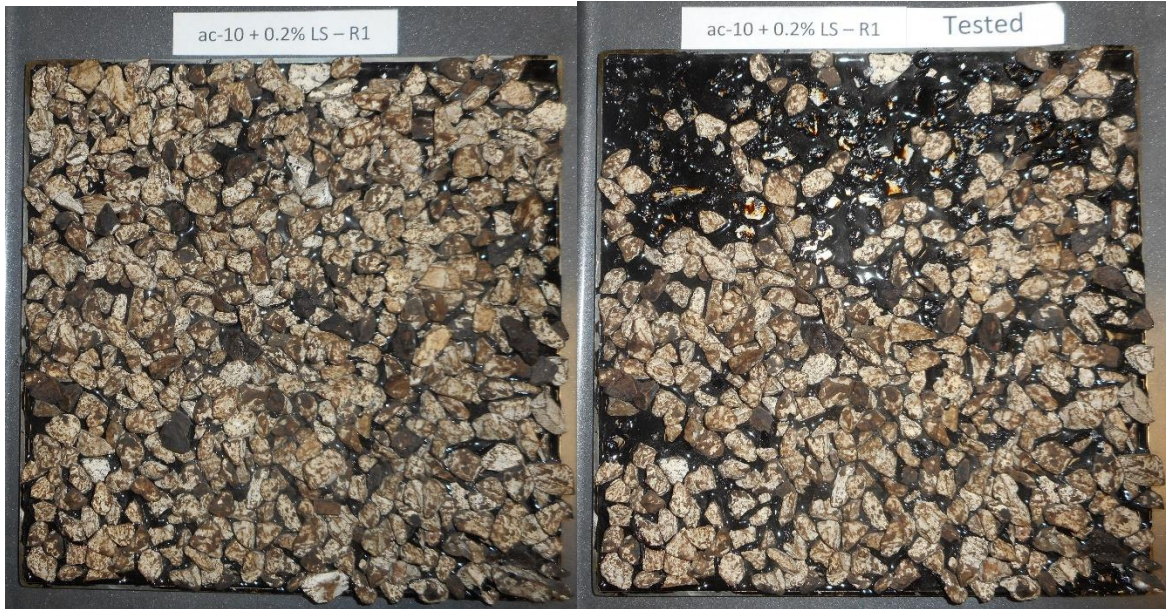
Figure 6. Vialit Plate Before and After Testing.
