Julie LIEGEY, William BRIAND, Marc REBILLAT, Mohamed EL MAY, Olivier DEVOS, Nazih MECHBAL - Detection, localization, and quantification of corrosion damage using Lamb Waves for the structural health monitoring of aluminum aeronautics structures - In: EWSHM2022 (European Workshop on Structural Health Monitoring) 4-7 July 2022, Italie, 2022-07-04 - EWSHM2022 - 2022

Detection, localization, and quantification of corrosion damage using Lamb Waves for the structural health monitoring of aluminum aeronautics structures

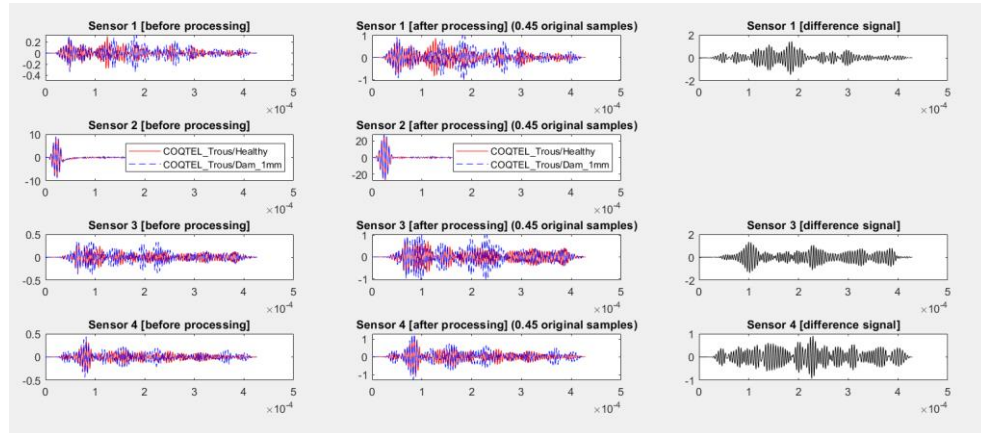
Figure 4 : Signals from plate with 1mm defect at 200kHz and with the piezoelectric element number 2 used as an actuator. On the left column, the signals are raw. In the middle one, the denoised and time aligned reference and current signals are presented. On the right one, the difference signals (*i.e.* the differences between the healthy and damaged signals) are shown.

To exploit the recorded Lamb wave data, signals from the damaged plate are compared to the healthy ones. For example, below are shown the signals received and processed from the plate with the 1mm damage and at 200kHz with the piezoelectric element number 2 being active. On the left column, the signals are raw. In the middle one, the denoised and time aligned reference and current signals are presented. On the right one, the difference signals (*i.e.* the differences between the healthy and damaged signals) are shown.

Given the received signals, a clear difference between the signal associated to corrosion damage and the healthy one can be seen. The hole of 1mm radius and 1mm of depth is thus clearly detectable using Lamb waves and this is also true for the smaller holes. The detection step is thus correctly achieved using Lamb waves.

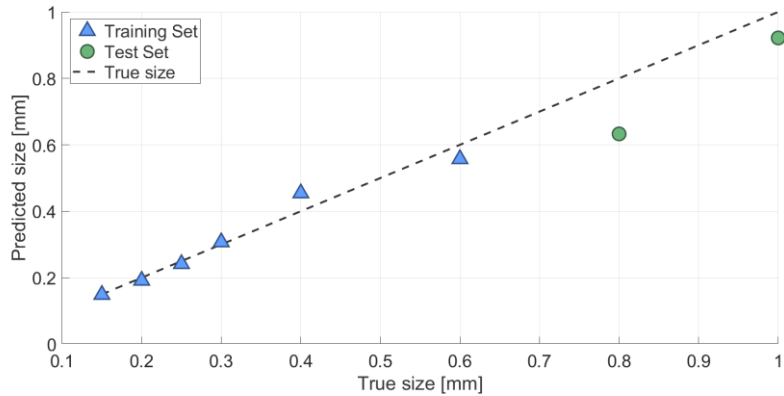
Figure 6 : Example of damage size quantification achieved by the IPP approach. The IPP algorithm has been trained on blue triangle and predicts sizes corresponding to green circles.

ability of the algorithm to extrapolate to larger damage sizes have been assessed. Points close to the diagonal line indicated correct damage size quantification. Learning points are shown in blue and prediction points in green. This example illustrates the fact that such algorithm is able to quantify correctly the size of corrosion-like damages.
