# Classification of barely visible impact damage in composite laminates using deep learning and pulsed thermographic inspection

Kailun Deng<sup>1</sup> · Haochen Liu<sup>1</sup> · Lichao Yang<sup>1</sup> · Sri Addepalli<sup>2</sup> · Yifan Zhao<sup>1</sup>

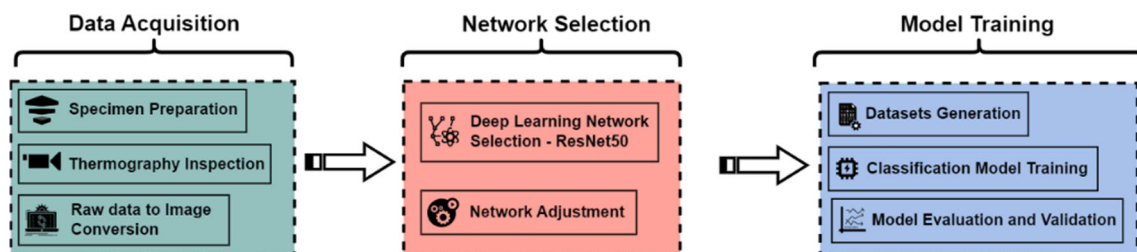
Fig. 1 Structure of the proposed methodology

The proposed methodology is illustrated in Fig. 1. The first step of the study is data acquisition, including impact damage specimen preparation and implementation of pulsed thermographic inspection. The 16-bit raw data were then calibrated to RGB-colormap image frames and saved as 8-bit PNG images. The second step is the deep learning network selection. ResNet was selected due to its superior capability in image classification, and some fine-tuning was made for the network to fit our learning assignment [27]. In the following stage, different datasets were generated using saved thermal images and fed into the selected deep learning network for model training. The performance of the trained classification network was compared and analysed in the last section. More details for each part of the method are discussed below.

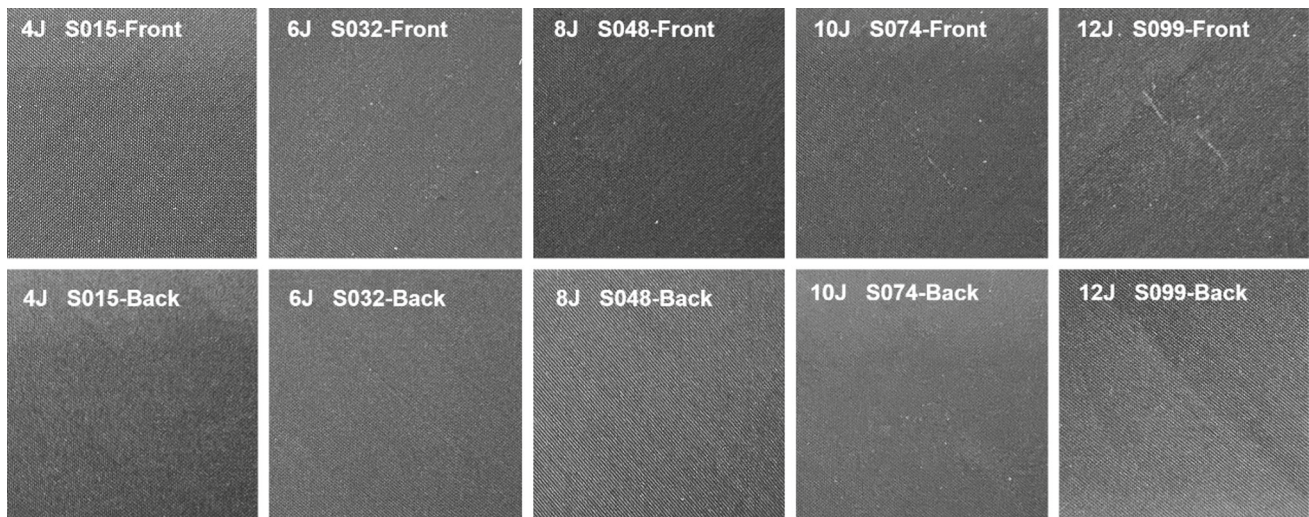
**Fig. 2** Digital images of both front and back sides of 5 specimens for 4 J, 6 J, 8 J, 10 J & 12 J impacts

One hundred specimens of CFRP samples with the size of  $150 \times 100 \times 3$  mm were manufactured in the laboratory before subjecting to drop-impact test. The samples were cut from 4 larger plates ( $750 \times 750 \times 3$  mm) marked with P1, P2, P3 and P4, manufactured with the same CFRP material specified in Table 1 in Appendix. Then, the drop-impact experiment was conducted on each sample with pre-set impact energy levels of 4 J, 6 J, 8 J, 10 J and 12 J. The impact was performed by the free fall of a hemispherical indenter with an exact weight of 2.281 kg. The precise impact energies was achieved by subtly setting the free fall distance and the force of impact from a force transducer. The 100 prepared samples were equally divided into five groups, and each group was exposed to one particular level of impact energy. Thus 100 specimens (from S001 to S100) were produced. Figure 2 displays the front and back sides (only the Region of Interest) of five specimens with different corresponding impact energy levels. The drop-impact was applied on the front side of each sample (see the first row of Fig. 2), and no impact damage can be detected by visual inspection from either of the sample surfaces ranging from no visible features to barely visible features (Fig. 2). In this investigation, pulsed thermographic inspection was conducted on the back side of each specimen to reveal the subsurface impact damage.

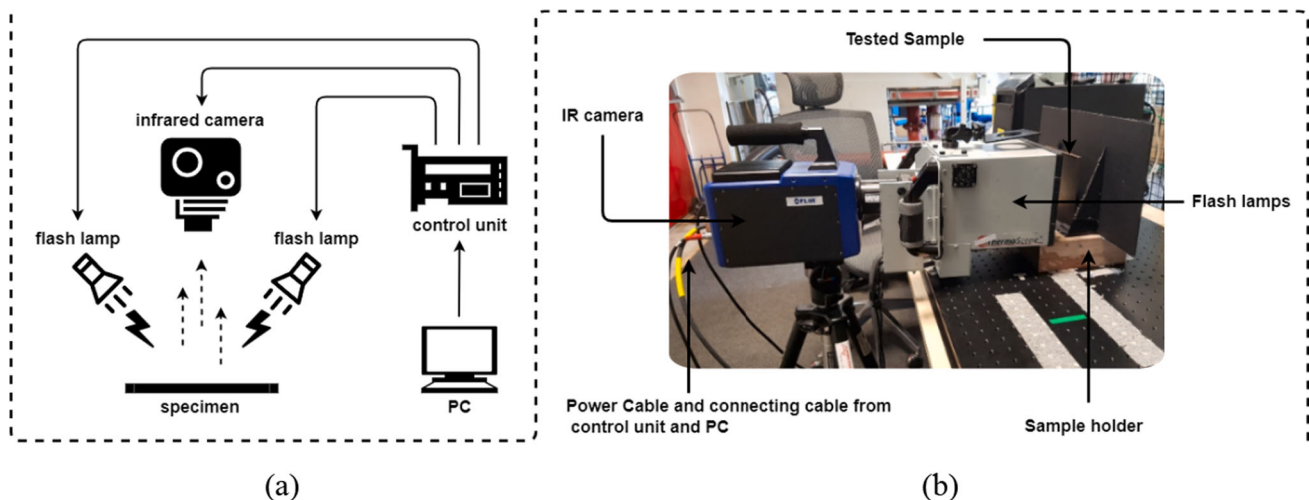
**Fig. 3** **a** Illustration of Pulsed Thermography set-up; **b** A photo of the experimental set-up

The principle of pulsed thermography inspection is illustrated in Fig. 3a. In this case, an artificial temperature gradient was induced by a high-energy heat pulse produced by flash lamps. With time elapsing, the heat propagates within the specimen and displays unusual heat conduction behaviour when getting through damaged areas compared to sound regions [28]. The thermal camera records the whole process at an appointed frame rate, and these abnormalities can be detected and recorded in a sequence of frames which can be eventually interpreted into damage patterns.

pulse. The thermal camera utilised in this study is a cooled FLIR SC7000 series IR radiometer (see Fig. 3b) with a spatial resolution of  $640 \times 512$  pixels. During each inspection, the specimen was placed in front of the IR camera at a distance of around 250 mm, and the surface of the specimen was kept perpendicular to the camera lens. The energy provided by the heat pulse in this inspection was around 2 kJ, and its effective area is  $200 \times 250$  mm, which can cover the inspected specimen in full. The sampling rate of the camera was set to 50 Hz, which was determined after taking into account CFRPSs low thermal diffusivity property and the specimens' thickness into account.

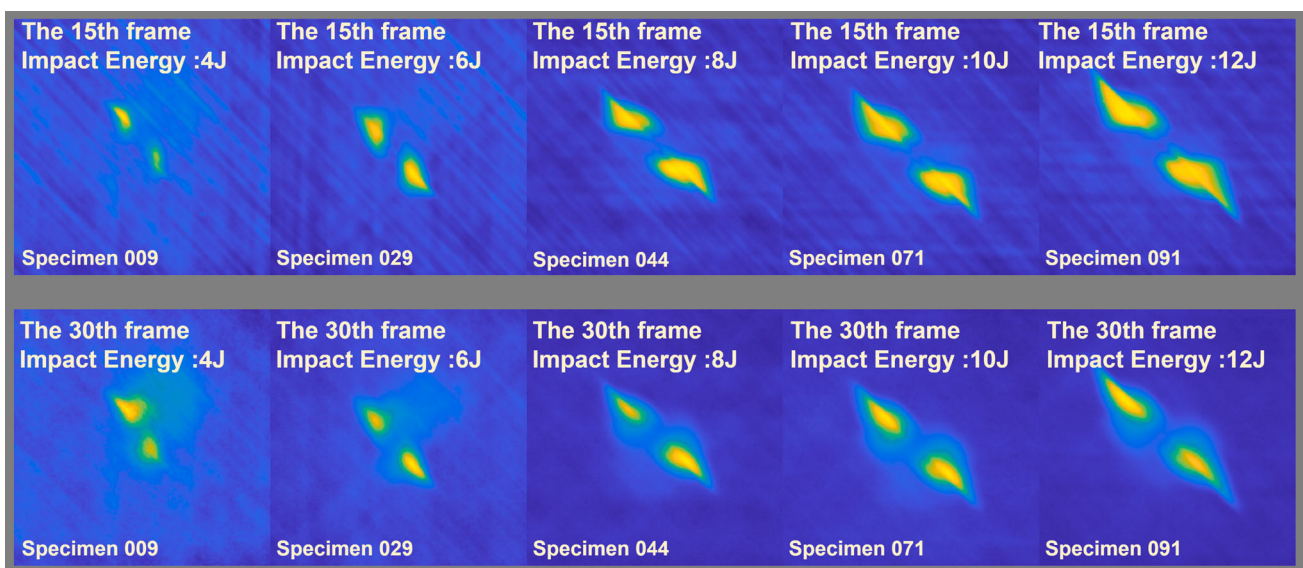
**Fig. 4** Reconstructed thermal images of different specimens with the regulated size of  $150 \times 150$  pixels

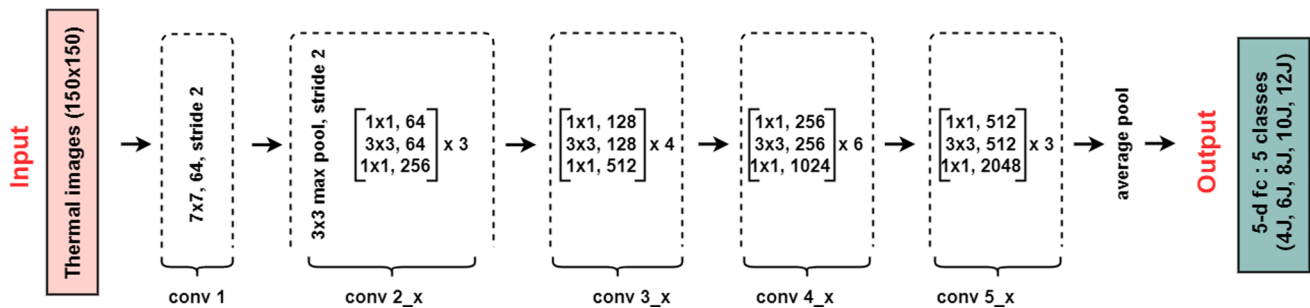
Fig. 5 Architecture of ResNet50 with customised input and output

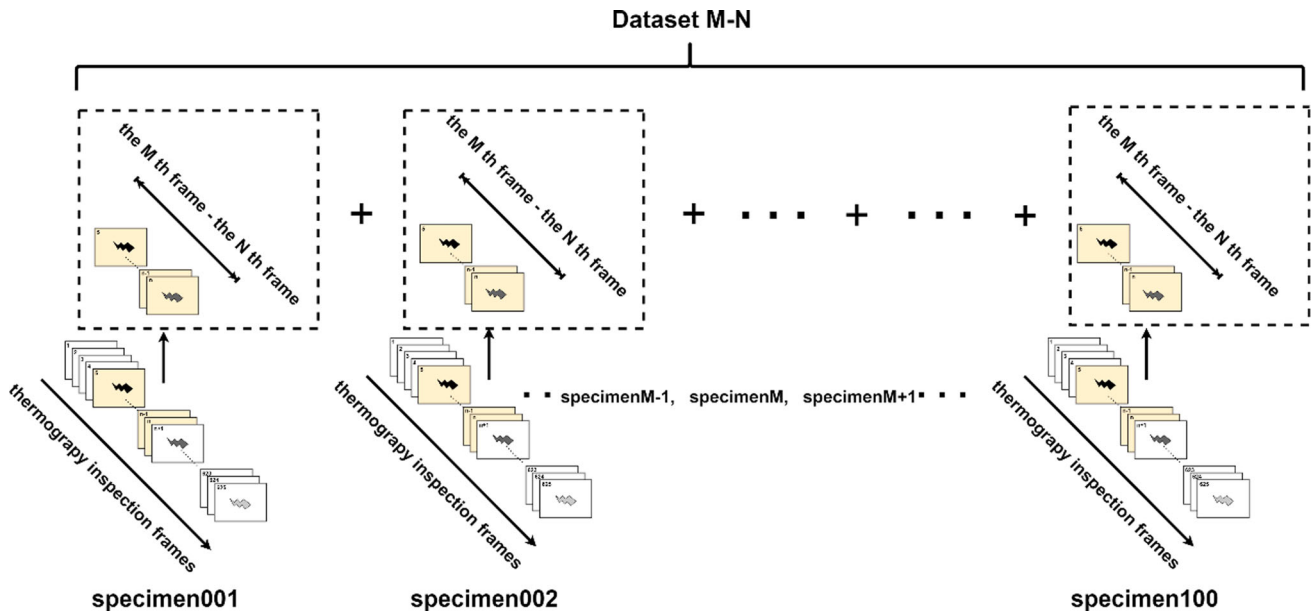
Fig. 6 Illustration of the generation of Dataset M-N

The same strategy was applied to 10-frame windows, 20-frame windows and even 60-frame windows to study the correlation between the classification accuracy and the frame number constituting the dataset. The corresponding datasets are Dataset14-23, ....., Dataset614-623, Dataset14-33, ....., Dataset594-613 and Dataset14-73, ....., Dataset554-613. Figure 6 illustrates the dataset generation process in this research.

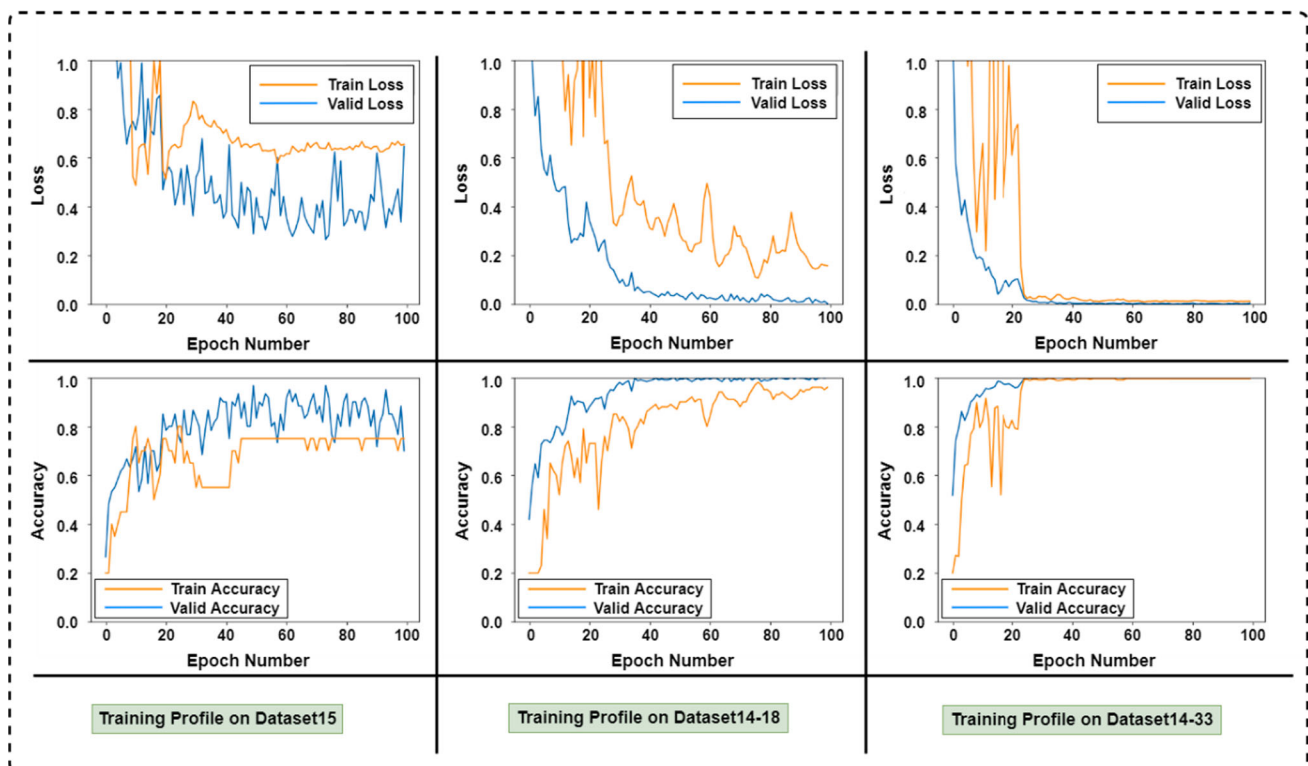
Fig. 7 Training loss and accuracy profiles of 3 different datasets

Figure 7 shows the loss and accuracy curves throughout the training process on three different datasets. The training loss and validation loss from each graph have a similar tendency that decreases from the beginning and level off as

the training epoch increases. Meanwhile, both accuracies from each training process share the opposite pattern from losses, which rise to the peak at the early stage and then converge around a specific value. Observed from the loss and accuracy charts, it is clear that models trained on various datasets all have quick convergence at around the 40th epoch (the total epochs are 100). Both the training accuracy and validation accuracy reached a relatively high level, with more than 70% on Dataset15 and over 90% on Dataset14-18 and Dataset14-33. In addition, similar accuracies were noticed between training and validation in each epoch, especially after the model achieved convergence, which suggests a high consistency between training and validation indicating that the trained models have neither underfitting nor overfitting problems. In brief, the loss and accuracy curves suggest that ResNet50 is suitable for our research task, and the network parameters for the model training are appropriate.

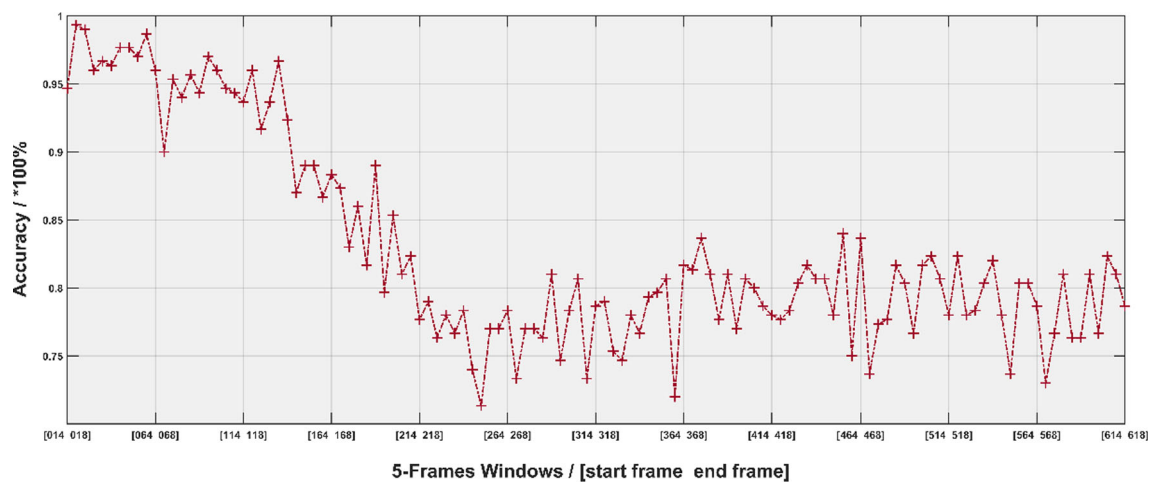
Fig. 8 The curve of classification accuracy with a temporal-shifting window of 5-frame datasets

In order to identify the 5-frame window for generating a dataset on which the best classification accuracy can be achieved, the deep learning training was conducted on a series of temporal-shifting window datasets through the whole thermal sequence (Dataset14-18, Dataset19-23, Dataset24-28, ..., Dataset619-623). The classification accuracies of different time-window datasets are shown in Fig. 8. It can be observed that the average test accuracy keeps declining from more than 95% (with a peak of 99.33%) and converges around 78%. The turning point of the curve from declining emerges at the frame window around Dataset214-218, which suggests that the crucial features that can contribute most to the classification accuracy can only be found on the images before this turning point. There are some impact energy-related features for those images after the turning point, but the network cannot build high-performance models only based on these images. The best accuracy (99.33%) can be observed on the frame window from 19th to 23rd (on Dataset19-23), which indicates that the thermal images within this period in inspection sequences contain the most prominent defect features and representation of damage severity.

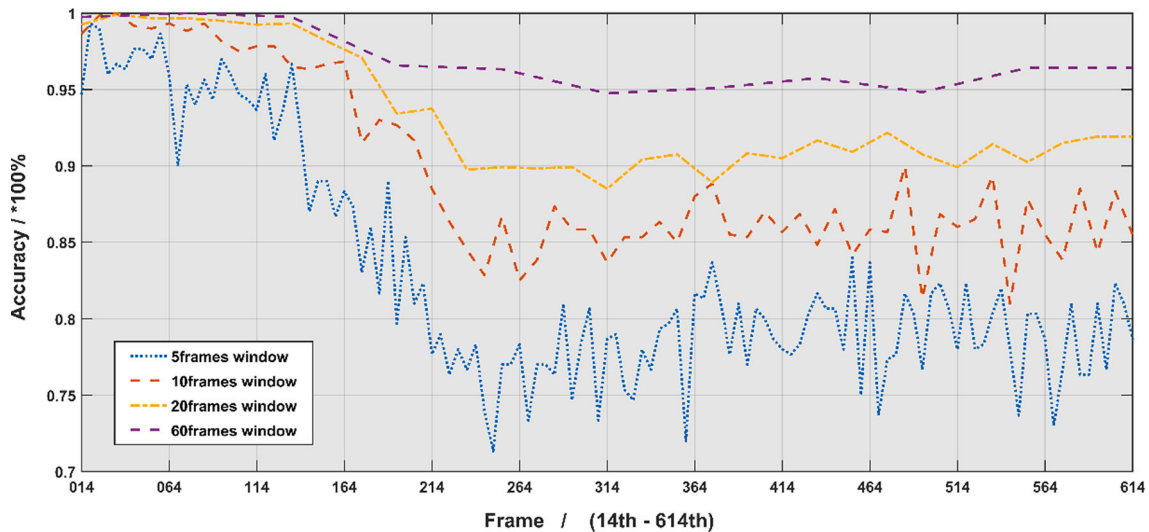
Fig. 9 The curves of classification accuracy with a temporal-shifting window of datasets with different frame numbers

Then, to figure out the most appropriate duration of the time-window abovementioned, the same training program was implemented for a 10-frame dataset, a 20-frame dataset and a 60-frame dataset. The accuracy shifting curve for each of them can be found in Figs. 13, 14, 15 in Appendix. Figure 9 is a joint illustration of these shifting curves of accuracy. If the length of the frame window for generating the dataset is fixed, the window starting from the 14th frame would be the best one for sourcing training data. Moreover, a dataset using images from earlier frame

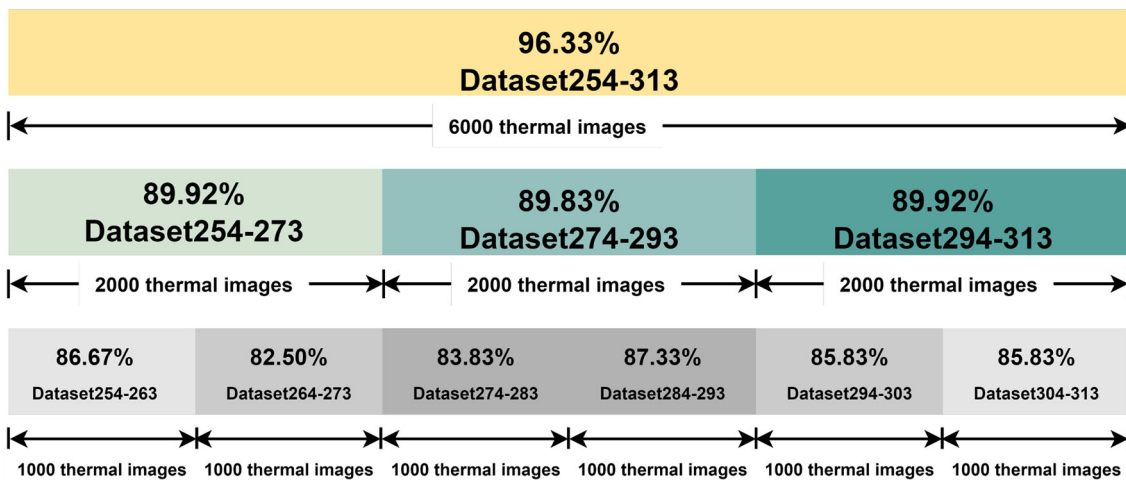
Fig. 10 Classification accuracy comparison of different datasets generated using thermal images on the window from 254 to 313th frame

Apart from the similar variation trend of each curve, another significant pattern was observed. In any specific frame window, such as 164th to 264th, the accuracy of the model trained from the 60-frame dataset ranked at the top, followed by the model trained from the 20-frame datasets. The models trained from the 10-frame dataset took the third position, outperforming the models trained from the 5-frame dataset. The observed ranking indicates that within a specific frame window of a thermographic inspection, more successive frames of thermal images are employed to constitute the dataset, and better classification accuracy will be achieved. This conclusion is confirmed by analysing the results on different datasets. Figure 10 lists the test accuracies of trained models on ten different datasets. On the top row, an accuracy of 96.33% is displayed, which is achieved on the 60-frame dataset Dataset254-313. Another three model accuracies are placed on the middle row, which is gained by the models trained on three 20-frame datasets (Dataset254-273, Dataset274-293 and Dataset294-313). The test accuracies based on the 10-frame datasets from Dataset254-263 to Dataset304-313 occupied the bottom line. Essentially, all the images from Dataset254-273, Dataset274-293 and Dataset294-313 are identical to all the images from Dataset254-313. The average model accuracy trained on Dataset254-273 is 89.92%, while 89.83% for Dataset274-293 and 89.92% for Dataset294-313. These three accuracies are much lower than the accuracy of 96.33% achieved on Dataset254-313. This phenomenon can also be interpreted as the model accuracy will increase if thermal images from successive frames are added to either Dataset254-273, Dataset274-293 or

Dataset294-313. The same conclusion can be drawn by comparing the data between the figure’s middle and bottom rows. Since the deep learning model training is only conducted on datasets sourcing from no more than 60 successive frames in this study, this inference can only be valid within this scope.

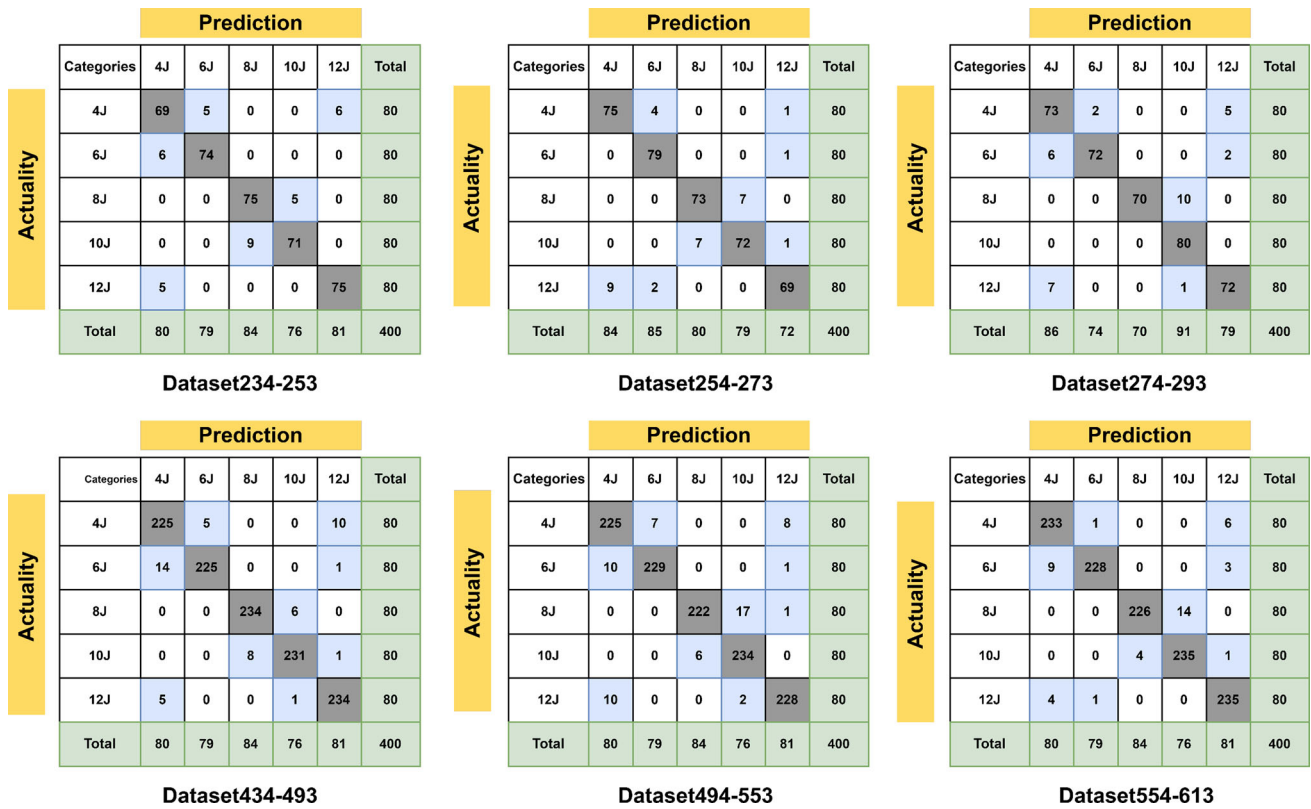
Fig. 11 Confusion Matrixes of testing results on six different datasets

Apart from the overall test accuracy, the Confusion Matrix from the test process was also provided to reveal the models’ classification performance for each class/impact energy. Six confusion matrixes are displayed in Fig. 11, in which the results of the first row are generated from the 20-frame datasets, and the results of the second row are obtained from the 60-frame datasets. Except for individual

test accuracy for each class of impact damage with different impact energy levels, some other interesting characteristics can also be found in the confusion matrixes. Impact damage generated with 4 J’s impact energy are inclined to confuse with damage from 6 J, and the same phenomenon is also observed between 8 and 10 J. For example, four elements in the first column which should belong to class 6 J, are classified into class 4 J, which results in the most significant proportion of misprediction for class 4 J. In the third and fourth columns, seven elements from class 8 J are classified as class 10 J, and another seven elements from class 10 J are classified as class 8 J, almost occupying all the wrong predictions in these two categories. Similar behaviours have been observed in the other five confusion matrixes in Fig. 11. The observed confusion tendency between damage patterns

caused by adjacent impacts energy levels such as 4 J and 6 J, 8 J and 10 J may be explained by the minor impact energy differences leading to similar damage patterns.

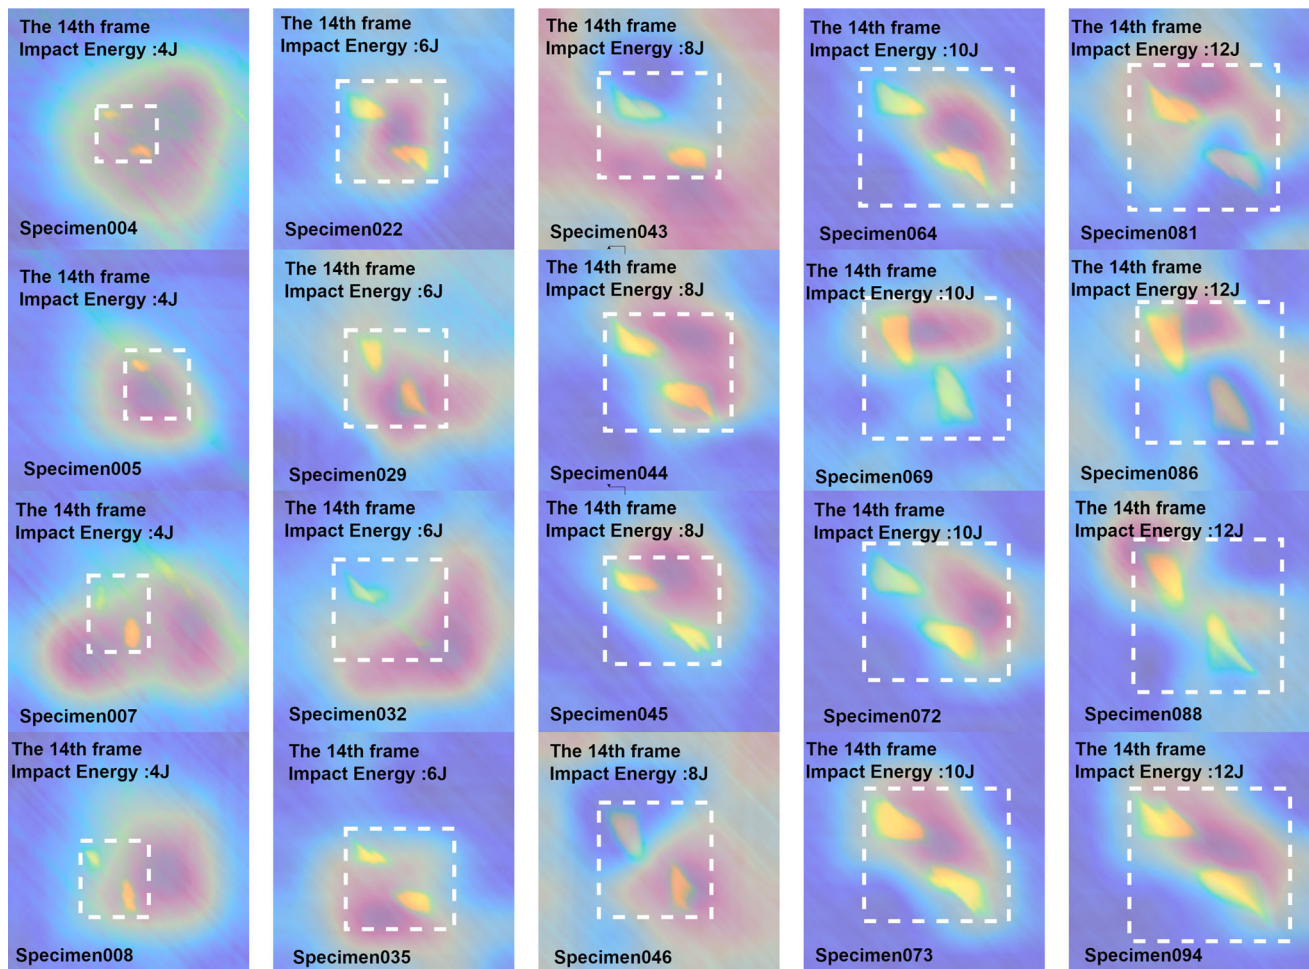
Fig. 12 Class Activation Maps of 20 testing images of different impact energies on Dataset14-33

This study employed Class Activation Map (CAM) to better understand how the trained models work. This technique can visualise the model’s learning process on one specific image. More specifically, a class activation map can reveal the critical areas of the tested image from where the model learns discriminative features that contribute to the classification. Figure 12 shows class activation maps based on 24 tested thermal images from Dataset14-33. A translucent heat map is generated by CAM and overlaps with the original image. In the map, the regions in red play more critical roles than those in blue regions in identifying a specific class of the original image. Looking into each picture in Fig. 12, almost all the red areas are centred on or around the impact damage areas enclosed with the dotted line. This observation suggests that the models learned features from damage patterns instead of other parts of the images. The classification was

based on features closely related to impact damage patterns.

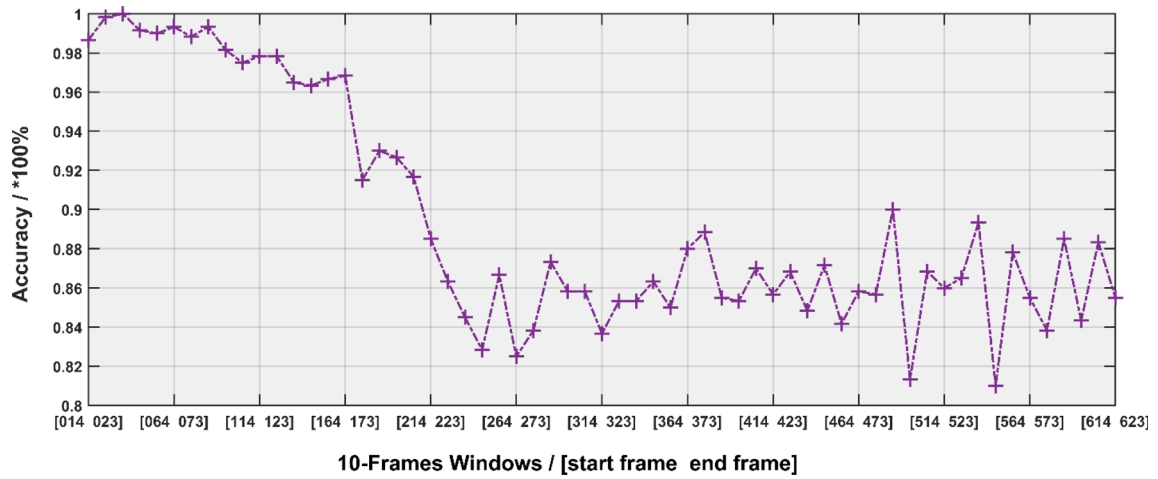
Fig. 13 The classification accuracy shifting curves with temporal-shifting window of 10-frame datasets

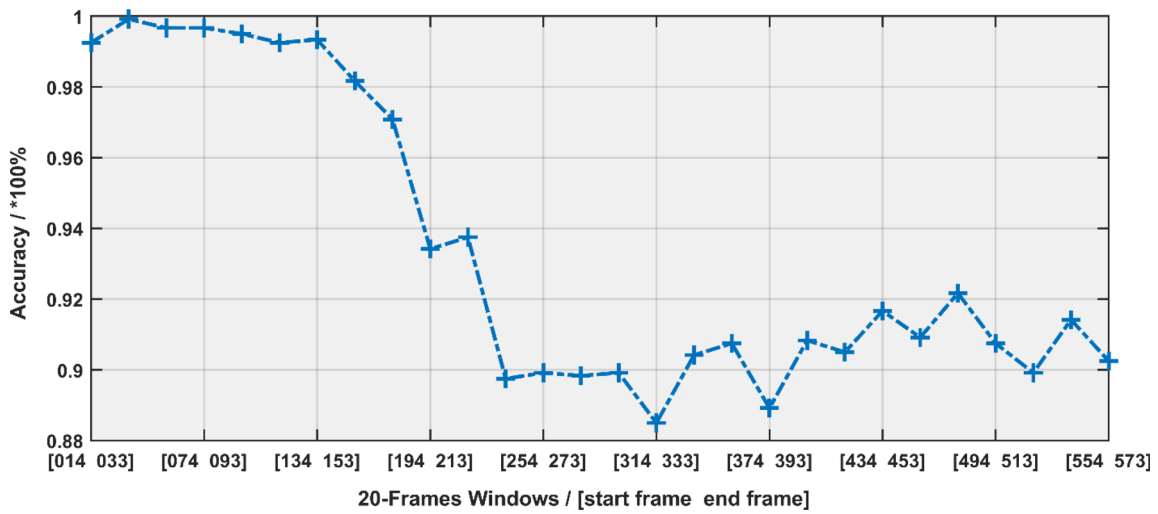
Fig. 14 The classification accuracy shifting curves with temporal-shifting window of 20-frame datasets

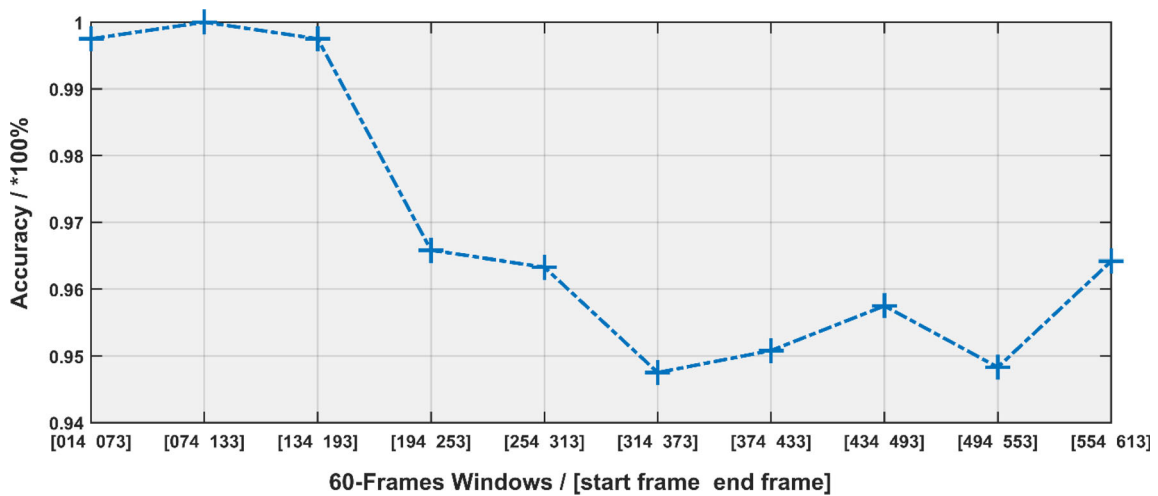
Fig. 15 The classification accuracy shifting curves with temporal-shifting window of 60-frame datasets
