Giving a future to a part of Roman Maastricht: the Hotel Derlon museum cellar

GIVING A FUTURE TO A PART OF ROMAN MAASTRICHT :
THE HOTEL DERLON MUSEUM CELLAR

BY TITUS PANHUYSEN

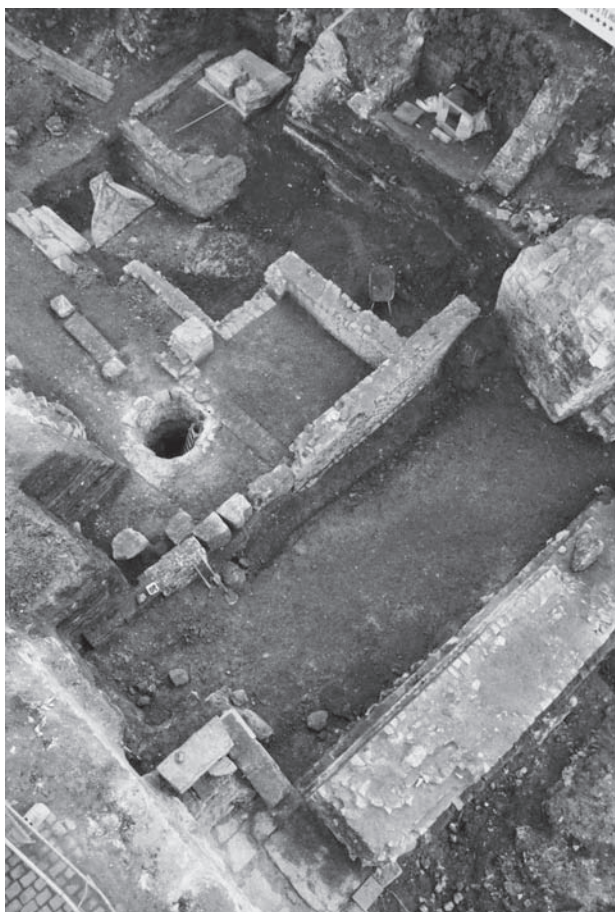
Fig. 1. View across the excavations at the Hotel Derlon site in the summer of 1983 (seen from the north west). At the bottom is the wall and (part of) the west gate of the late-Roman fortress. At the top is the Roman sanctuary with the base of the monumental Jupiter Pillar to the left of centre.

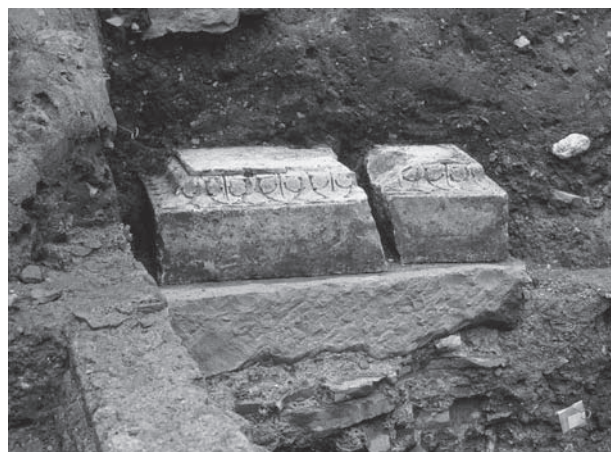
Fig. 2. The sculptured base of the Jupiter Pillar from the second century AD, which rested on a massive foundation block, photographed shortly after its discovery in the south section of the excavation trench at Hotel Derlon.

a number of sculptured stone blocks and fragments which belonged to an unique monumental votive pillar in honor of Jupiter and the Roman gods, dating from the middle of the second century AD (Fig. 2). This find made it quite clear that the excavation was investigating one of the central estates of the former Roman vicus.

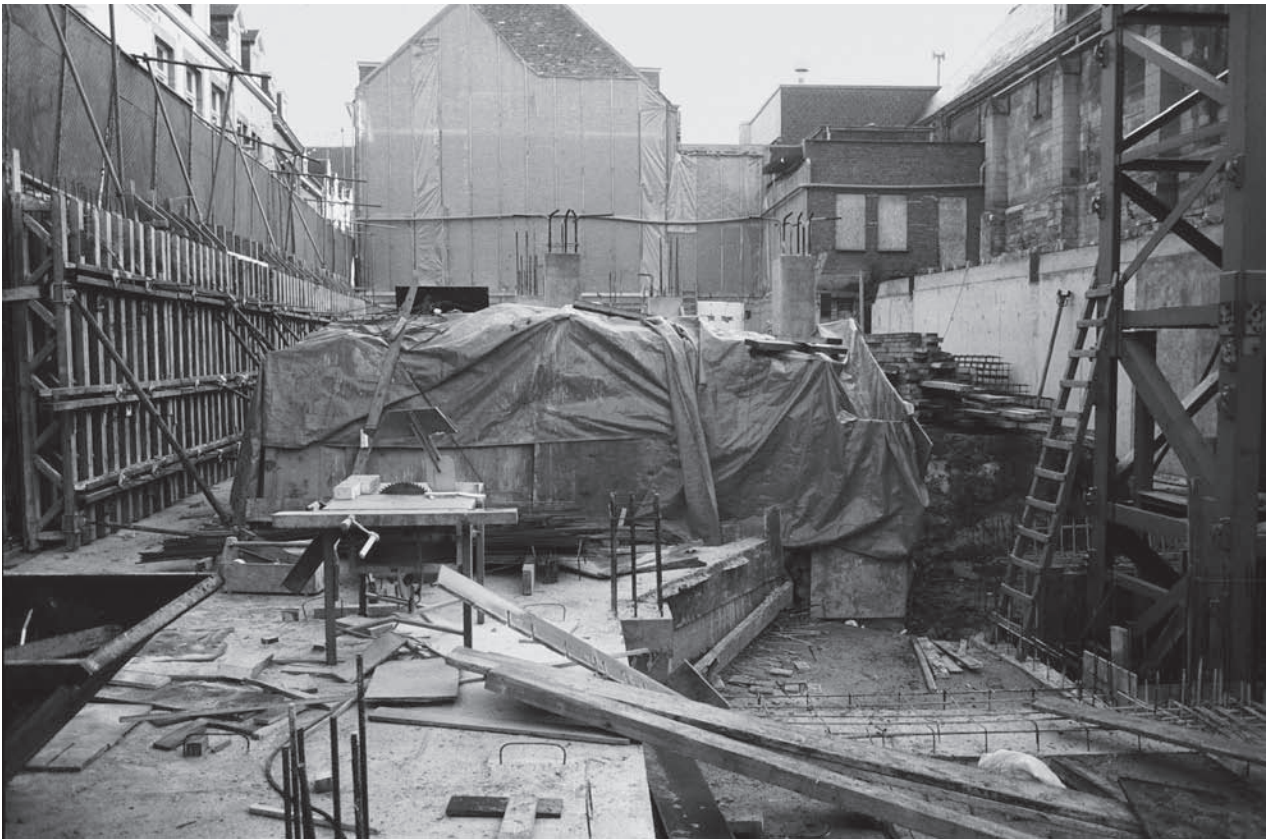
Fig. 3. The Hotel Derlon site during building activities in the winter of 1983–84. In the centre, the fortress wall has been protected by wooden boarding and plastic tarpaulin.

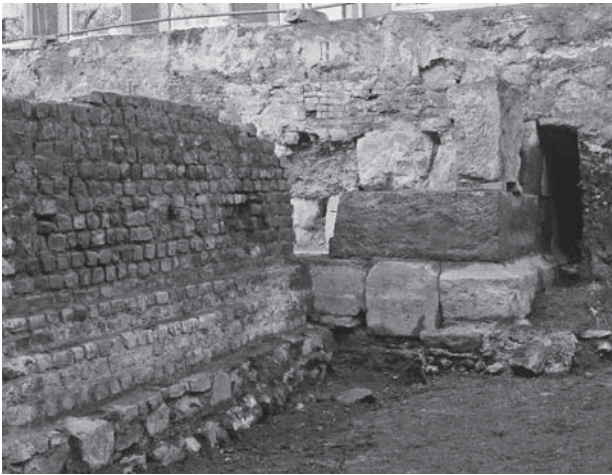
Fig. 4. The inner side of the west wall and ruined gate of the late-Roman fortress (including the upper part of the foundations) during the 1983 excavation.

Half way through October, while the excavation was still continuing, the development company itself took the initiative to reposition the planned pile foundations, at their own account and risk, so as to keep them away from the Roman walls and monuments. This allowed an extra four months before the definitive decisions had to be made. This readjustment raised the costs by € 32.000, but meant that the work of preparing the site for building could start as planned during the next winter. Meanwhile, the complete excavation was protected with filling it with sand and packaging the stone walls and monuments with an extra protection of wooden boarding (Fig. 3). Inconvenient components of the site such as the town gate, which stood in the way of the building activities, were dismantled and put into store for the time being (Fig. 4).

7. Using discreet architectural tricks to reinforce the properties of an archaeological excavation site in the presentation, such as cut-aways along the borders of original Roman walls marking their outline (Figs. 4–7), the floor of the basement corbelling the excavation trench (Fig. 13), leaving an opening or cut-away in the basement ceiling just above the excavation site (Fig. 13), and the applying of (dark grey) paint on the basement walls to indicate missing Roman walls (Fig. 6).

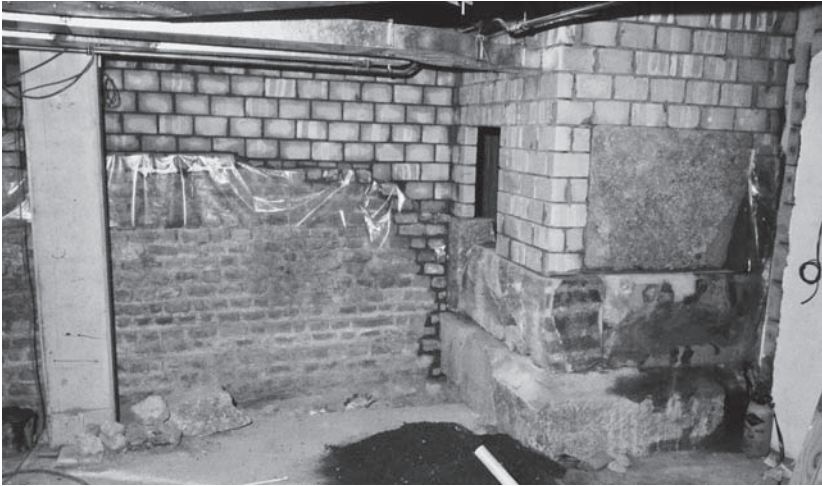
Fig. 5. The inner side of the west wall and gate of the late-Roman fortress during the restoration and reconstruction activities in 1987.

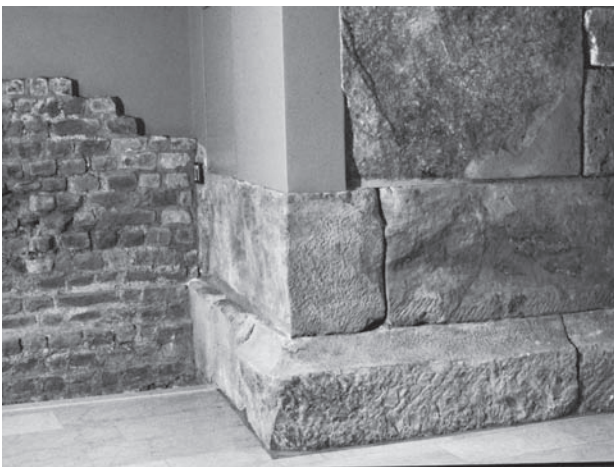
Fig. 6. Detail of the inner side of the west wall and west gate of the late-Roman fortress shortly after the opening of the Hotel Derlon Museum Cellar in March 1988. The west wall was reconstructed in modern materials to the ceiling of the basement (see fig. 5) and was painted dark grey. The flooring was laid at the ground level of the fourth century AD.

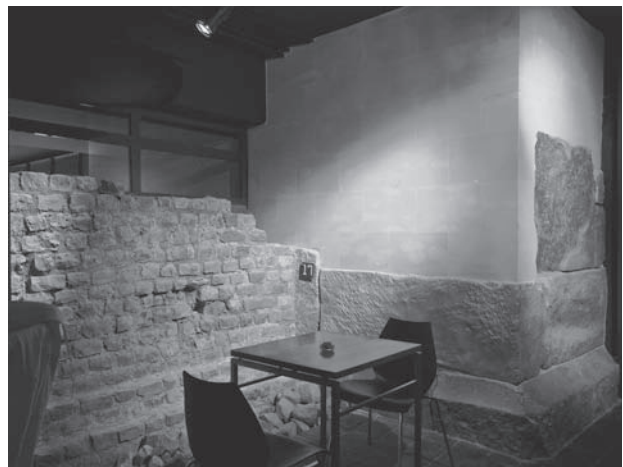
Fig. 7. The inner side of the west wall and west gate of the late-Roman fortress after the renovation of the Hotel Derlon Museum Cellar in 2007. The reconstructed section of the west wall of the fortress has been removed to give access to the new hotel bar.

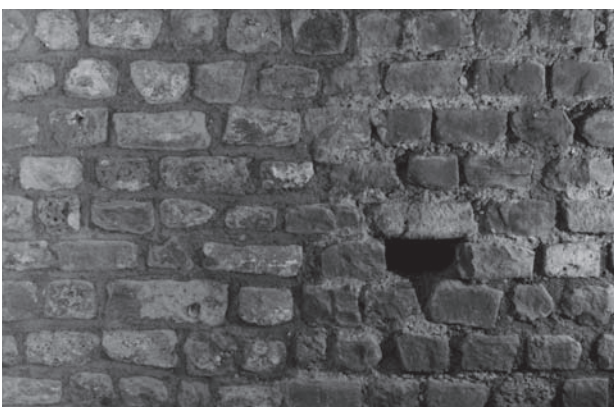
Fig. 8. Detail of the masonry of the late-Roman west wall at the inner side: on the right can be seen the consolidated original joints, on the left the renewed joints where the mortar has been pushed back a little bit.

4. Reuse of ancient building material or similar quarry stone, and adapted lime mortar (Fig. 15);
5. Making a restraint contrast between the original joint, the renewed joint (pushed or pointed backwards), and the new masonry (joint flat) (Figs. 8–9); adding the top of the ruined walls strengthened but not filled up with mortar (Fig. 10);

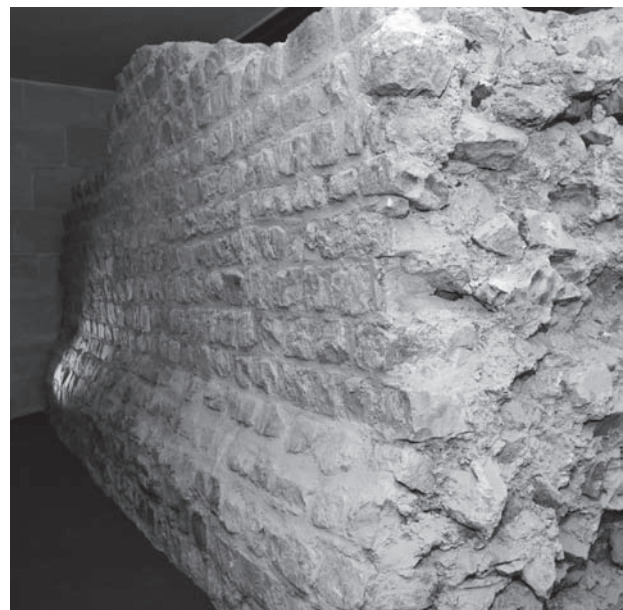
Fig. 9. The exterior of the west wall (land side) was only displayed after the 2007 renovations. Most of the joints have been renewed.

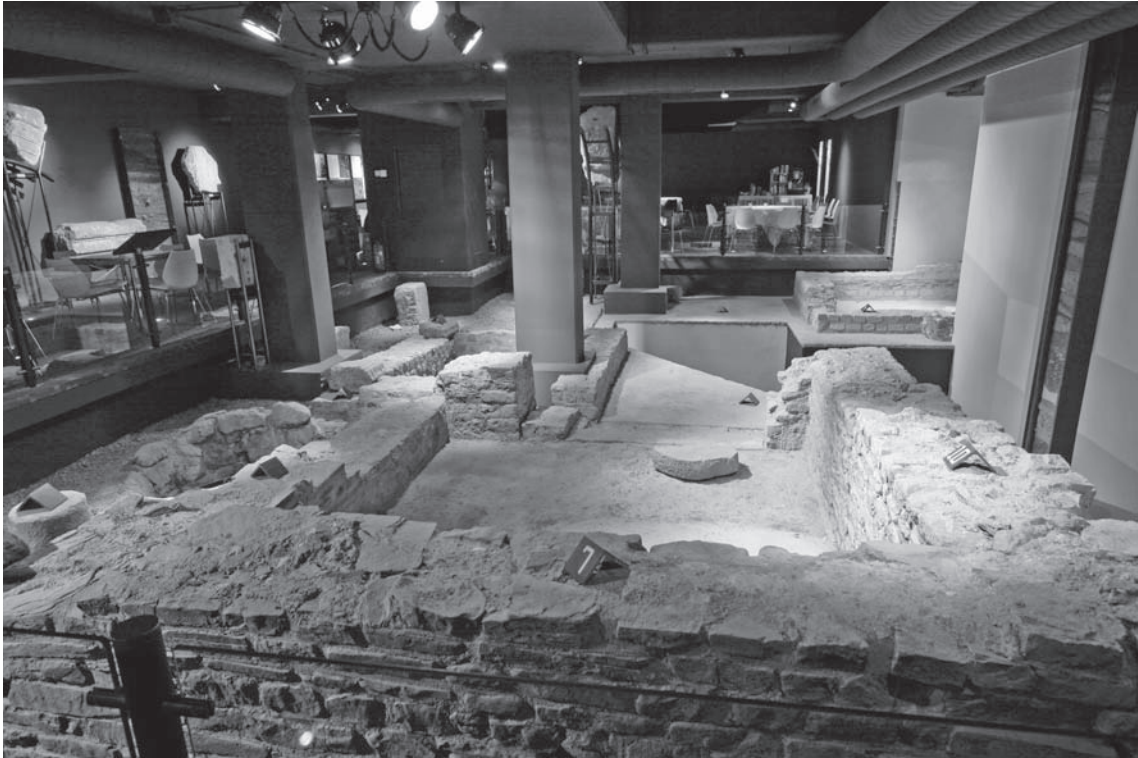
Fig. 10. View from the west across the consolidated and partly reconstructed excavation in 2007. Nearest to the viewer is the west wall of the sanctuary enclosure with renewed joints in the masonry.

3. The flat joints used on new masonry were moved down enough that the joint did not become too wide and as much of the stone was visible as possible (Fig. 10).
4. The paved road at the bottom of the excavation trench was not been impregnated with any silicon esters. The loose cobblestones were simply covered in clean river clay. Afterwards the whole bottom surface was treated with a quaternary ammoniate or ammine against cellar mildew.

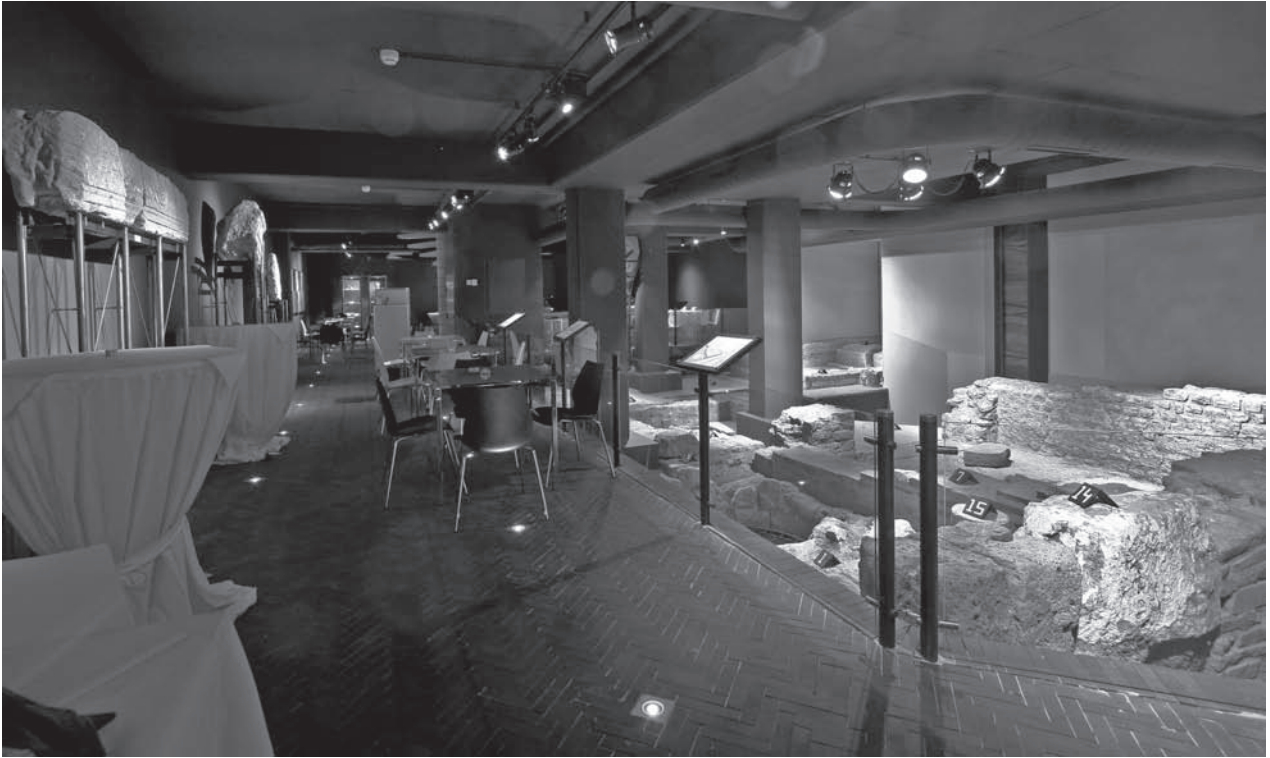
Fig. 11. View from the west over the dining platform to the north of the site (in 2007). The original lighting and the cut-away in the ceiling just above the excavation site had been removed for the renovation (see Figs. 13–14).

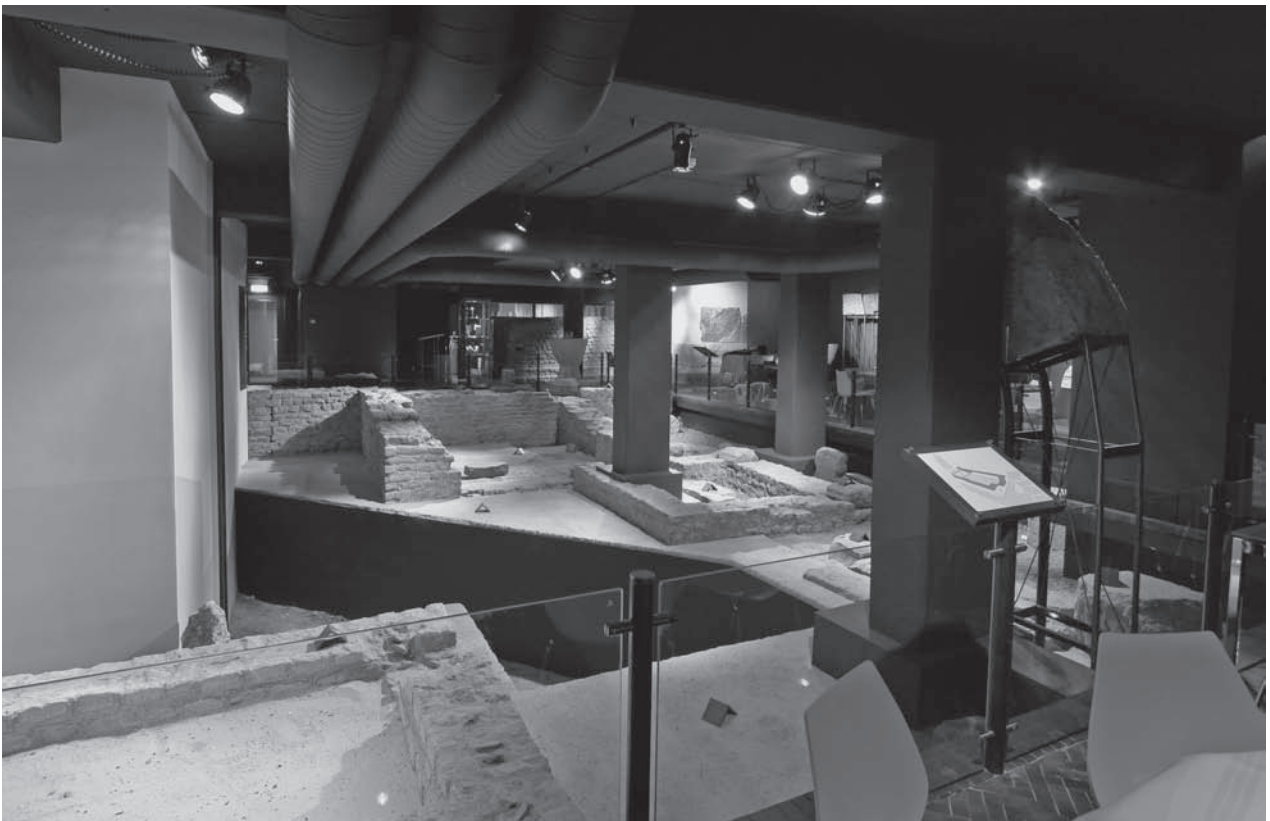
Fig. 12. View from the east across the site in 2007. Nearest is the reconstructed enclosure of the Jupiter Pillar; in the centre is the hole in the floor of the sanctuary left open to display the cobblestone road in the deepest layer of the excavation and beyond that can be seen a room in the north west corner of the sanctuary (see Fig. 14).

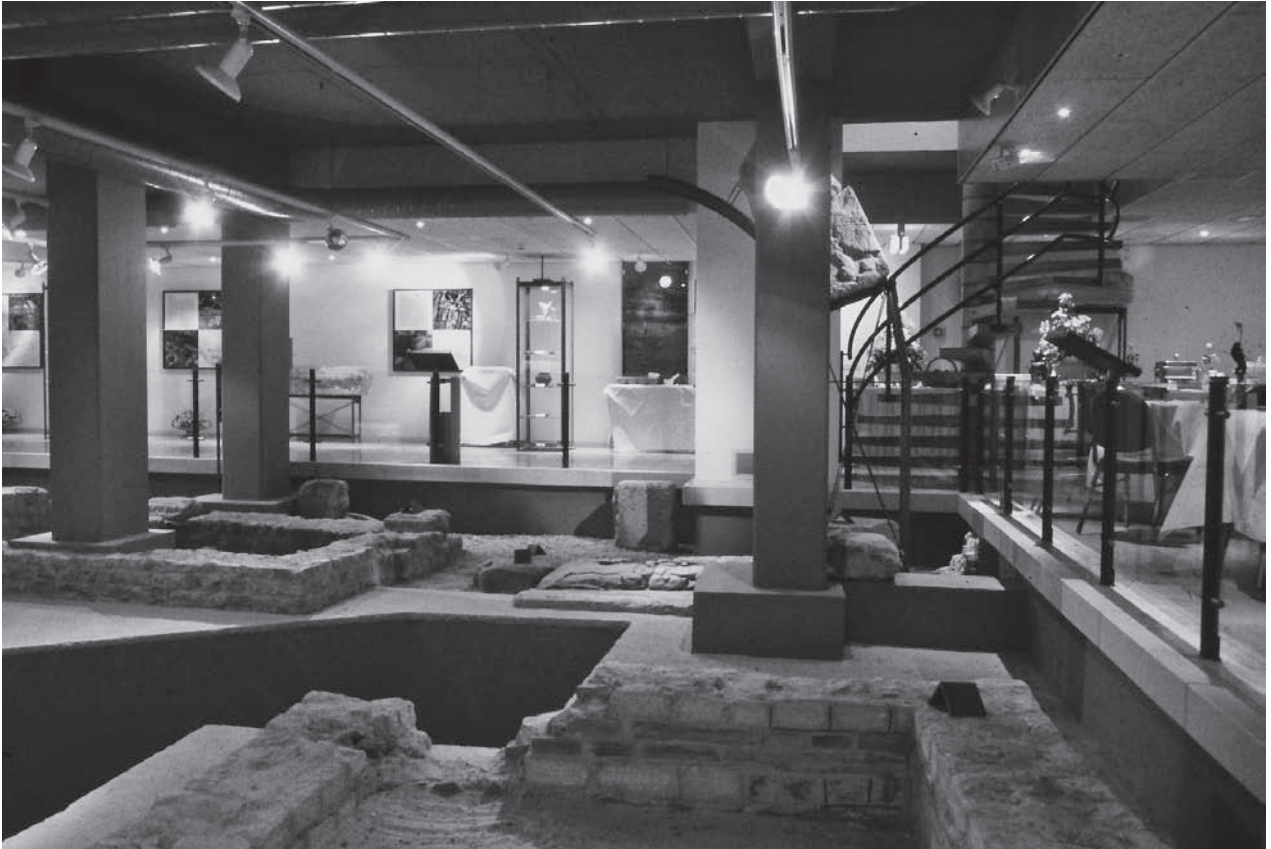
Fig. 13. Looking north across the site in 1988: nearest is the reconstructed enclosure of the Jupiter Pillar; on the left is the hole in the sanctuary floor to display the cobblestone road.

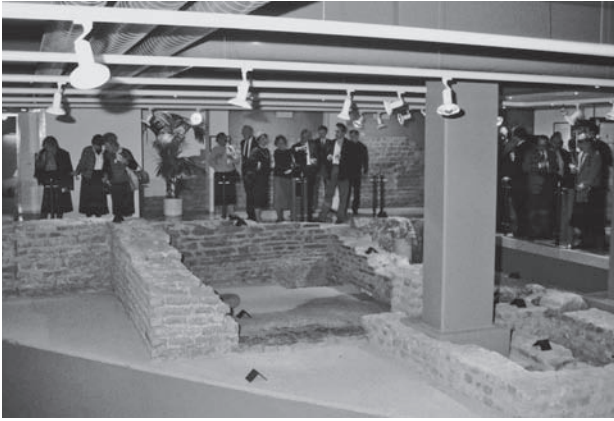
Fig. 14. Looking west across the west section of the site in 1988: in the centre is the entrance to a small room in the corner of the enclosed sanctuary.

6. Modest information by means of lighting techniques (Fig. 14), evocative arrangement of original and casted sculptures (Fig. 15), restricted educational restoration, creation of an evocative work of art as scenery background for the excavation, limited opening of the museum, a proper and sober architectural setting;

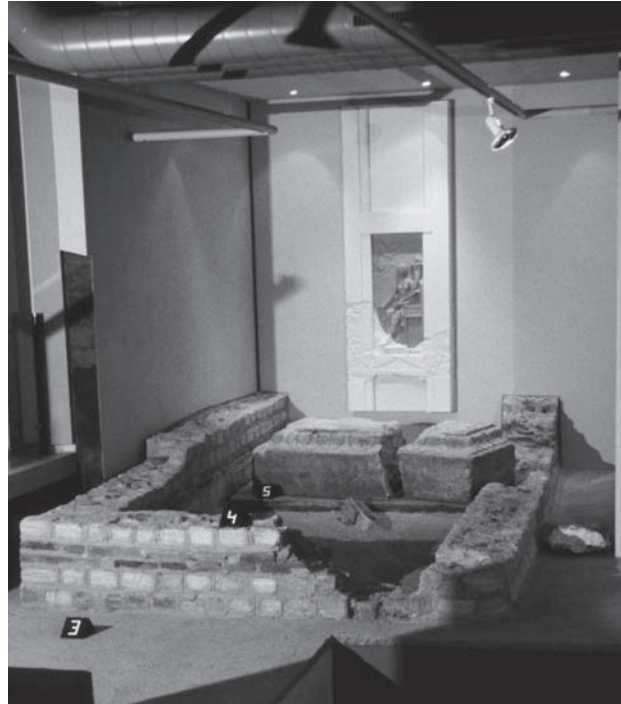
Fig. 15. Looking towards the new-made niche in the south wall of the basement in 1988: the broken sculptured base of the Jupiter Pillar is in situ and is accompanied by an evocative arrangement of original and casted sculptures.

For the rest, as much as possible Roman building material was reused which had been found during the excavation, but which had been broken as a consequence of the building of the previous hotel. Some scrap and rubble from the Church of St. Servatius (then under excavation and restoration), was reused, especially from the Carolingian terrazzo flooring of red concrete. This was crushed and mixed with hydraulic powdered lime for the flooring of the Roman sanctuary (Fig. 12). Original Roman *tegulae* were sourced from a villa excavation in the vicinity of Namur for the complete reconstruction of the low enclosure of the Jupiter Pillar (Fig. 15).
