## BRAIDED FIBRE REINFORCED COMPOSITE RODS FOR CONCRETE REINFORCEMENT

R. Fangueiro<sup>1</sup>, G. Sousa<sup>1</sup>, F. Soutinho<sup>1</sup>, S. Jalali<sup>2</sup> and M. de Araújo<sup>1</sup>

<sup>1</sup>Department of Textile Engineering, University of Minho

<sup>2</sup>Department of Civil Engineering, University of Minho

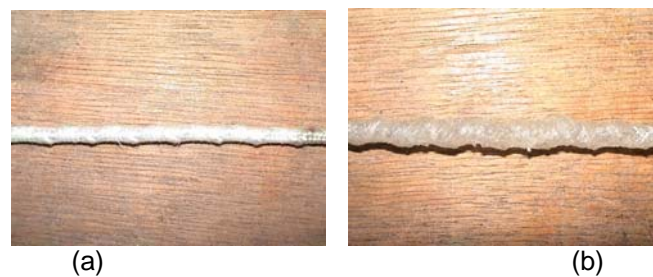
Figure 2 – Ribbed structure  
(a) braided fabric (b) braided reinforced composite rod

The samples have been produced on a conventional braiding machine specially adapted to impregnate simultaneously the braided fabrics. In order to increase roughness of the braided reinforced composite material rods, and then its adhesion to the concrete, braided fabrics have been produced as a ribbed structure, as shown in Figure 2. This ribbed structure is provided by thicker yarns that are used in the braiding machine in a combination of 7 standard to 1 thicker yarn. For a stronger effect on roughness the number of thicker yarns could be increased during braiding the process.

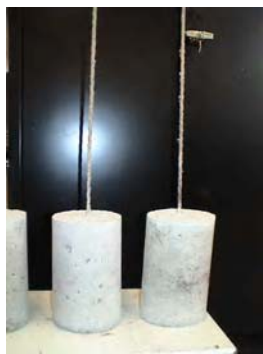
Figure 4 – Samples for adherence test

In order to evaluate the adherence between the braided composite rods and the concrete, 8 samples have been prepared, as shown in Figure 4. The samples have been tested (Figure 5) on an universal tensile tester, at a cross-head speed of 0.1 mm/s, according to standard NP EN 10002-1 usually used for steel. The braided composite rods have completely adhered to the concrete up to the breaking point.

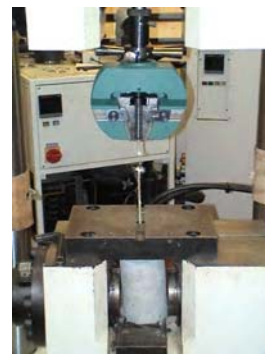
Figure 5 – Adherence test

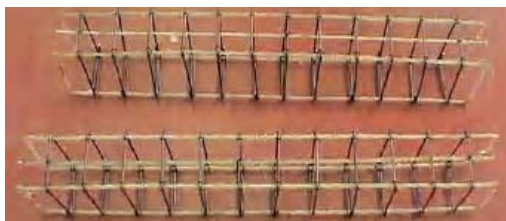
Figure 6 - Composite rods reinforcements used

Three concrete beams reinforced by an armour of braided composite rods (Figure 6) and three concrete beams reinforced by an armour of steel were prepared. The dimensions of the beams are presented in Figure 7.

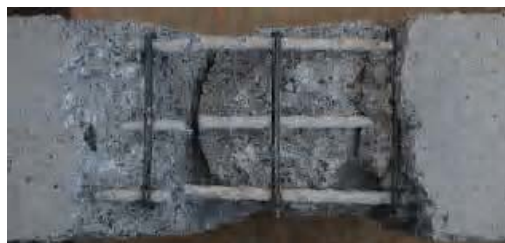
Figure 10 – Beam produced with braided reinforced composite rods after testing

Figure 10 presents a beam after testing. The broken braided reinforced composite rods are shown.

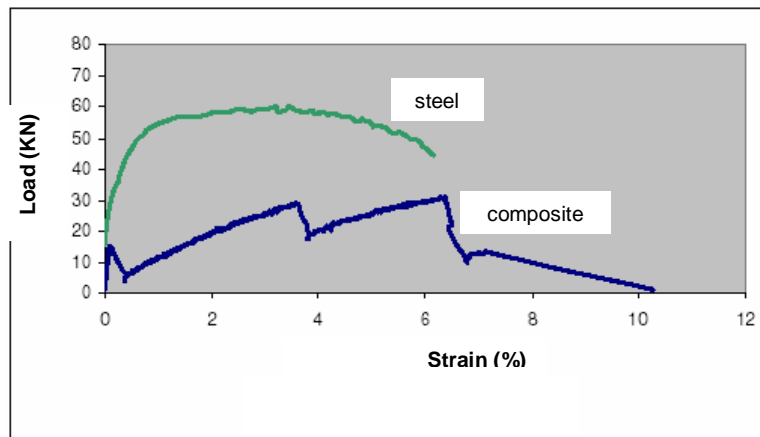
Figure 11 – Load-strain curves for concrete beams reinforced by composite rods and steel

Figure 11 presents the load-deformation curves for each type of beam tested.

Analysing the results obtained and the correspondent load-extension curves it is possible to detect different performances between both types of beams tested. The steel reinforced beams carry twice as much load compared to composite reinforced beams. Moreover, strain values of the steel reinforced beams are lower than those obtained for beams reinforced by the composite rods. In the load-strain curves obtained for the composite reinforced beams, three peaks are visible that correspond to the breaking point of each of the composite rods used. These peaks show that the rods in the reinforcement are not stressed simultaneously. Moreover, the first peak indicates that the reinforcement is not bearing the full load at the initial stage of testing. This behaviour is probably due to the rather loose state of the composite rods that are tensioned only after some considerable deformation of the beam. Another problem encountered is the fact that composite rods have a lower modulus of elasticity when compared to that of the steel rods used, i.e. 18 GPa compared to 210 GPa.
