Concrete Reinforced by Braided Fibre Composite Rods

Abstract — This paper describes the work that is being done at the University of Minho concerning the development of braided rods for concrete reinforcement.

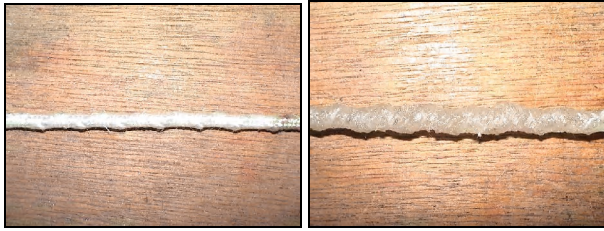
Fig. 2. Ribbed structure

(a) braided fabric (b) braided reinforced composite rod

fabrics have been produced as a ribbed structure, as shown in Figure 2. This ribbed structure is provided by thicker yarns that are used in the braiding machine in a combination of 7 standard to 1 thicker yarn. For a stronger effect on roughness the number of thicker yarns could be increased during braiding the process.

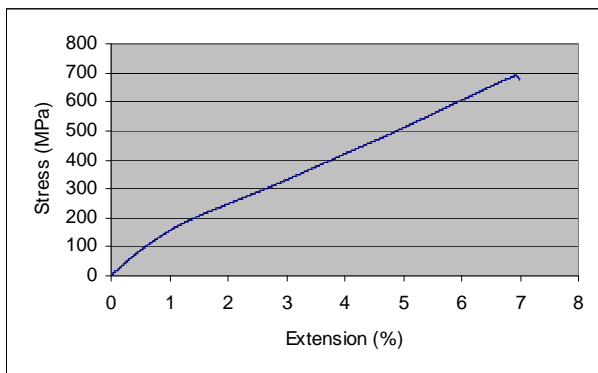
Fig. 3. Typical stress-strain curve for braided reinforced composite rods

For the evaluation of the tensile properties of the braided reinforced composite rods produced, experimental work has been undertaken using a HOUNSFIELD universal tensile tester, according to ASTM D638 standard, at a cross-head speed of 1 mm/min. The results obtained are shown in Table 2 while Figure 3 shows the typical load-extension curve.

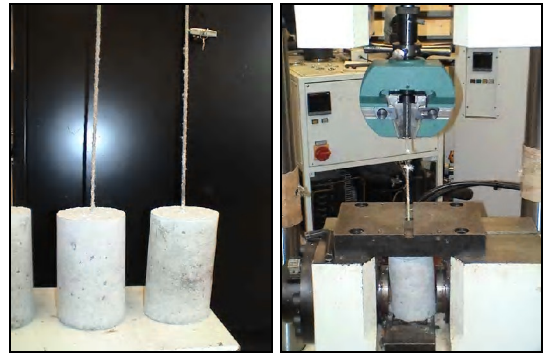
Fig. 4. Samples for adherence test

In order to evaluate the adherence between the braided composite rods and the concrete, 8 samples have been prepared, as shown in Figure 4. The samples have been tested (Figure 5) on a universal tensile tester, at a cross-head speed of 0.1 mm/s, according to standard NP EN 10002-1 usually used for steel. The braided composite rods have completely adhered to the concrete up to the breaking point

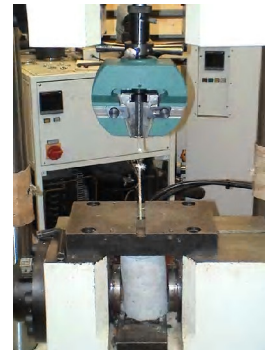
Fig. 5. Adherence test

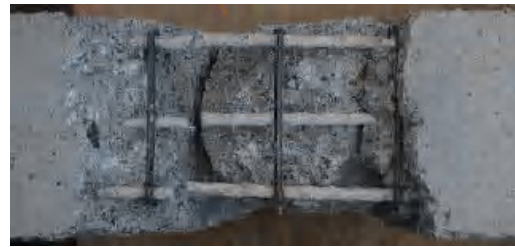
Fig. 10. Beam produced with braided reinforced composite rods after testing

Figure 10 presents a beam after testing. The broken braided reinforced composite rods are shown.

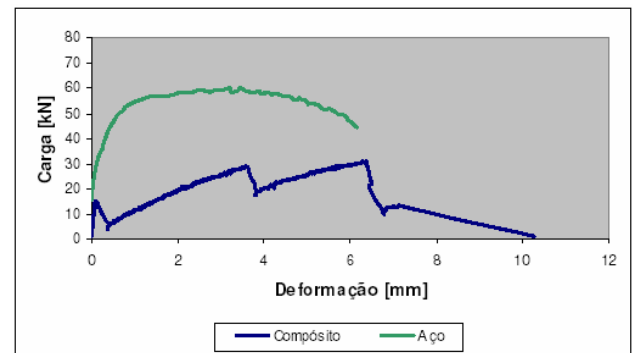
Fig. 11. Load-strain curves for concrete beams reinforced by composite rods and steel

Figure 11 presents the load-deformation curves for each type of beam tested.

Analysing the results obtained and the correspondent load-extension curves it is possible to detect different performances between both types of beams tested. The steel reinforced beams carry twice as much load compared to composite reinforced beams. Moreover, strain values of the steel reinforced beams are lower than those obtained for beams reinforced by the composite rods. In the load-strain curves obtained for the composite reinforced beams, three peaks are visible that correspond to the breaking point of each of the composite rods used. These peaks show that the rods in the reinforcement are not stressed simultaneously. Moreover, the first peak indicates that the reinforcement is not bearing the full load at the initial stage of testing. This behaviour is probably due to the rather loose state of the composite

rods that are tensioned only after some considerable deformation of the beam. Another problem encountered is the fact that composite rods have a lower modulus of elasticity when compared to that of the steel rods used, i.e. 18 GPa compared to 210 GPa.
