## 6 Earthquakes and robustness

J. Branco and L. Neves

## 6.2 Timber structures under seismic loads

## 6.5 Examples

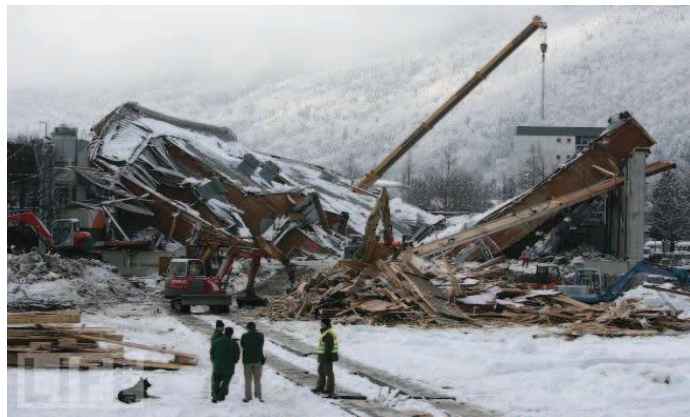
**Figure 18.** Bad Reichenhall ice-arena collapse

At the beginning of the year 2006, 2<sup>nd</sup> January, the ice-arena roof in Bad Reichenhall collapsed under the actual snow load (Figure 18). Fifteen people died, thirty were partly heavily injured. The main reasons for the collapse are: (i) use of urea-formaldehyde glue under moist conditions; (ii) mistakes in the static calculation; (iii) non robust construction; and, (iv) lack of maintenance.

According to the findings of experts (Winter and Kreuzinger 2008), one of the three main box-girders on the east side failed first. Due to the stiff cross girders, the loads were shifted from the box-girder that failed first to the neighbouring girders. These box-girders, which were already pre-damaged were also overloaded due to which the entire roof collapsed

like a zipper. This transversal stiffness is, however, a desirable property under seismic design, and no real advantage could have been obtained from considering earthquake as a load. In fact, as shown in Figure 18 an increase in stiffness of transversal elements can, in fact, led to an increased risk associated with damage.

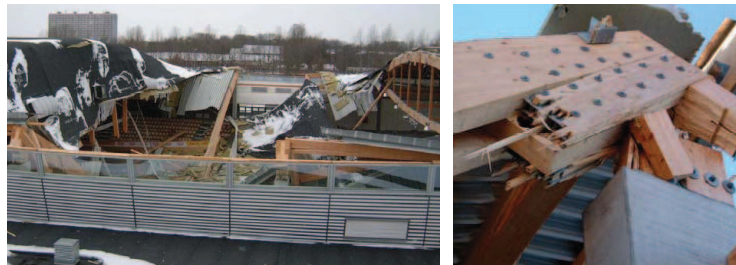
**Figure 19.** Siemens Arena roof after the collapse of two trusses (Munch-Andersen 2009).

In the case of the Siemens Arena failure (figure 19), the first consequence of a seismic design would have been the increase of transversal stiffness. This could have caused progressive failure, following the collapse of one truss, leading to large increases in indirect consequences of damage. In fact, the 12 m long purlins between the trusses were only moderately fastened, so that a failure of one truss should not initiate progressive collapse. As all trusses had much lower strength than required by the failure of a neighbour element, it might be fair to conclude that the extent of the collapse was not disproportionate to the cause, as analyzed by (Munch-Andersen 2009). The result of a seismic design could have been an increase in transversal stiffness, which could have caused progressive collapse of the structure.

a) An intact truss is seen to the right      b) Rupture at the critical cross section in the corner connection

In these last two cases, the only possible advantage of seismic design would have been the closer attention paid to the detailing of connections, required for the definition of the dissipation zones defined in EN 1998-1 (CEN 2004). In fact, connections played a major role in both incidents, and a more careful design could have avoided the errors.
