International Institute for FRP in Construction

BEHAVIOUR OF CONCRETE ELEMENTS STRENGTHENED WITH NEAR SURFACE MOUNTED CFRP STRIPS UNDER THERMAL CYCLES

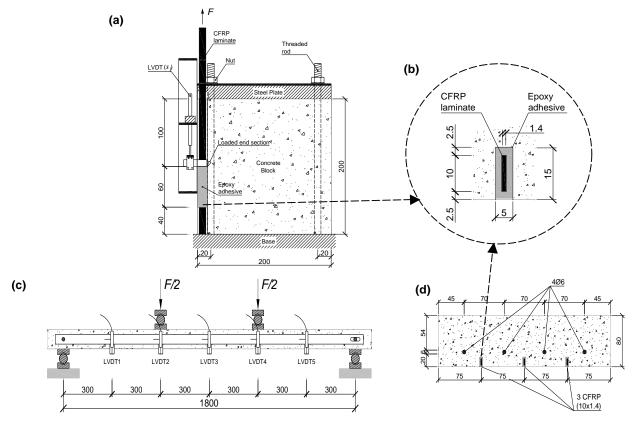
Fig. 2 (a) and (b) show the geometry and test configuration of the direct pullout tests. The specimens' geometry consisted of concrete cubic blocks of 200 mm edge, into which a CFRP ($10x1.4 \text{ mm}^2$) was embedded. The bond length started 100 mm far from the top of the block to prevent the premature splitting failure in the concrete ahead the loaded end. To guarantee negligible vertical displacement at the top of the concrete specimen during pullout test, a steel plate with 20 mm thickness was applied at the top of the concrete block. This plate was fixed to the base through four M10 steel threaded rods. A torque of 30 N×m was applied to fasten these rods, inducing an initial compression in concrete of about 2.0 MPa. The instrumentation of the specimens consisted of one displacement transducer (LVDT) and a load cell. The LVDT records the slip at the loaded end, s_i . The tests were controlled by another LVDT placed between the actuator and the grip, at rate of 2 µm/s. The applied force, *F*, was registered by a load cell placed between the grip and the actuator.

Fig. 2 (c) and (d) depict the geometry and test configuration/instrumentation of the slabs. The slabs are 2000 mm long, 300 mm wide and 80 mm thick. The longitudinal reinforcement is composed by 4Ø6, which corresponds to a longitudinal reinforcement ratio, ρ_{l} , equal to 0.47%. The flexural strengthening solution is composed by 3 NSM CFRP (10×1.4 mm²) laminate strips, in correspondence to an equivalent longitudinal reinforcement ratio, $\rho_{s,eq}$, of 0.68%. In this experimental study, a four-point bending test configuration was adopted. The internal displacement transducer of the servo-control equipment is used to control the test at 20 µm/s. The instrumentation of the slab in the tests includes 5 LVDTs, a load cell and strain gauges (SG). Five SG were glued on the lateral surface of the intermediate CFRP to measure the strains at distinct sections. Two additional SG are also used to record the strains in the longitudinal reinforcement and concrete at the top fiber of the cross-section mid-span. Additionally, a K-type thermocouple was installed in the groove for temperature measurement. All the information related to the preparation of the strengthened specimens (SL and DPT) is available elsewhere (Sena-Cruz *et al.*, 2013). The strengthening was performed in the laboratory with a temperature of about 25°C and 42% of RH.

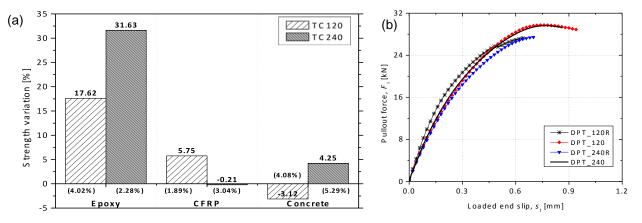
Fig. 3 – (a) Strength variation of the materials; (b) Pullout force *versus* loaded end slip.

Fig. 3 (a) presents the strength variation observed in the materials (concrete, epoxy adhesive and laminate) in regard to reference specimens. The strength variation is defined as the ratio (TC - REF) / REF, with TC and REF corresponding to the strength of a generic material/series submitted to thermal cycles and the corresponding reference series at the same age, respectively. From these results it is clear that the aging action neither damaged the CFRP laminate nor the concrete. For the epoxy adhesive, the results show that the tensile strength increased of about 18% and 32% when the specimens were submitted to 120 and 240 thermal cycles, respectively. In the technical and safety data sheet of the product (epoxy) provided by the supplier, there is no information available about the curing and post-curing process. However, based on literature review about this topic it is possible to conclude that depending on the type of epoxy resins is common a post-curing process happens when the material is submitted to a temperature higher than of the first cure.

Fig. 3 (b) depicts the average pullout force *versus* loaded end slip (F_{l} - s_{l}) relationship of all the bond test series, whereas Table 2 includes the corresponding results. In this table, F_{fmax} is the maximum pullout force; s_{Imax} is the loaded end slip at F_{fmax} , $\tau_{max,av1} = F_{fmax}/(P_f L_b)$ is the average bond strength at the CFRP-epoxy interface, being P_f the perimeter of the CFRP cross-section and L_b is the bond length.

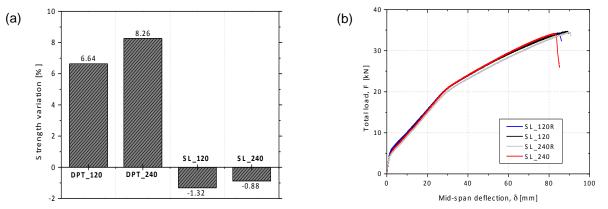
The variation of maximum pullout force obtained from the experimental program is plotted in Fig. 4 (a). From these results it is clear that the thermal cycles improved the bond behavior, yielding to higher values of F_{fmax} , $\tau_{\text{max,av1}}$ and s_{imax} , when compared with the reference specimens, although the high value of CoV obtained from loaded end slip of the reference specimens (DPT_120R). Two failure modes were observed in this experimental program (see Table 2): concrete splitting (C) and debonding at adhesive/laminate interface (D). Concrete splitting was characterized by a large area of detached concrete surrounding the bonded region. The occurred failure modes (mainly D) and the behavior observed for the epoxy under the thermal cycles (see section 3.1) justify the obtained bond performance.

After being submitted to the thermal cycles during four and eight months, the slabs were tested monotonically up to the failure. Fig. 4(b) shows the obtained relationship between total load and mid-span deflection of the reference and aged slabs. When compared with the reference slabs, a negligible strength variation is observed (see Fig. 4(a)) for the aged specimens. This result was expected once mechanical properties of concrete and CFRP were not affected, whereas the ones of the epoxy adhesive were improved. Despite of the epoxy adhesive properties have improved, this benefit did not affect the structural member response, since the failure mode was controlled by the concrete properties.
