# MORTAR-BASED SYSTEMS FOR EXTERNALLY BONDED STRENGTHENING OF MASONRY

## ABSTRACT

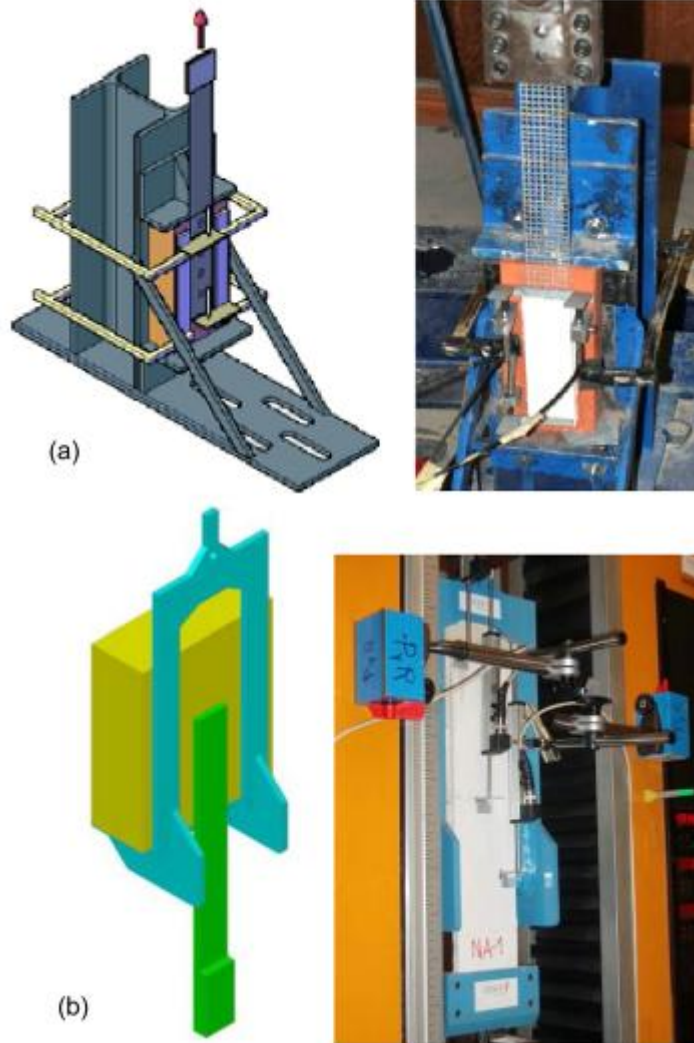
Fig. 4 Single-lap (SL) setup for bond shear tests carried out at UMINHO (a) and TECNALIA (b)

Drawing on previous experience on FRP (Valluzzi et al., 2012), four different shear bond testing setups were used: two single-lap (SL) and two double-lap (DL1 and DL2), as shown by Figs. 4 and 5. Very similar single-lap test schemes were used by UMINHO and TECNALIA, consisting of stiffened steel plates welded so as to form an angle of 90° (Fig. 4). At UMINHO, the specimens were supported appropriately to avoid misalignments in the load application and were loaded from above (Fig 4a). Tests were carried out under displacement control at a rate of 0.005 mm/s. The load was measured by a load cell while the relative displacement between the reinforcement and the brick was measured by means of two LVDTs mounted at the loaded end. At TECNALIA, the specimens rested on the bottom of the steel frame and the reinforcement sheet was loaded from below (Fig. 4b). Tests were performed using a 5 kN Lloyds Universal Testing machine under displacement control at 0.008 mm/s rate. Displacements were recorded by LVDTs fixed at the main frame of the testing machine and measuring the relative displacement between aluminium squares stuck to the mortar on bonded and unbonded areas.

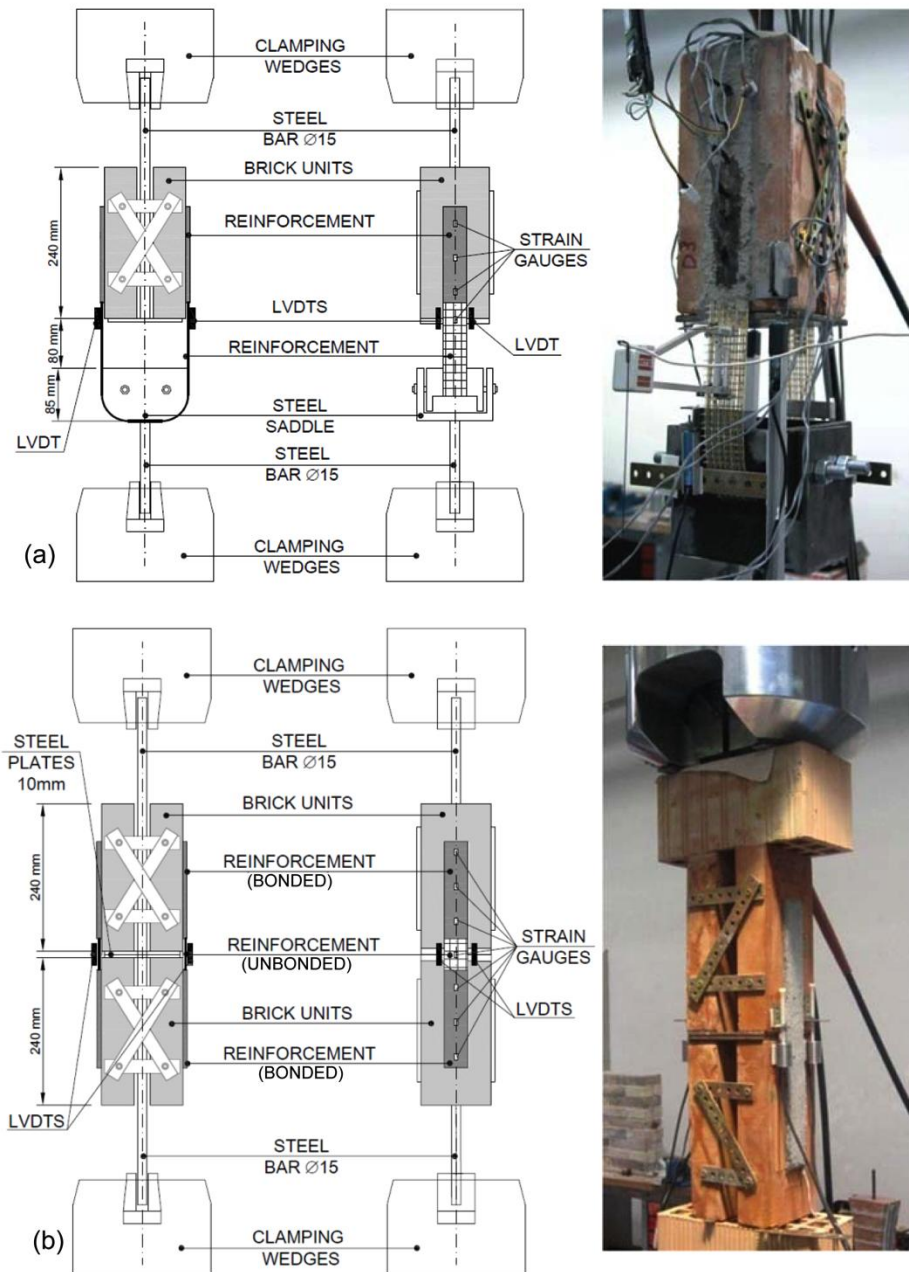
Fig. 5 Double lap setup for shear bond tests: type 1 (DL1, a) and type 2 (DL2, b)

UNIRM3 used double lap setups (DL). Specimens were built by joining together two bricks, placed parallel to each other; the reinforcement was then applied on both external faces. Setup DL1 (Fig. 5a) consisted of two or four bricks (depending on the anchorage length) pulled by the testing machine in one direction (upwards in the present case) through a steel bar welded to a steel plate (on which the bricks rested), while a continuous U-shaped reinforcement strip was pulled in the other direction (downwards) by means of a semi-circular steel saddle, having a diameter equal to the specimen width to apply pure shear stresses on the brick-reinforcement interface. In test setup DL2 (Fig. 5b) specimens were made out of four bricks. Two bricks were pulled upwards while the other two were pulled downwards. Two separate strengthening strips were applied on the external faces so as to connect two bricks by crossing strips the gap between them. In UNIRM3 tests were performed by using a 500 kN MTS Universal Testing

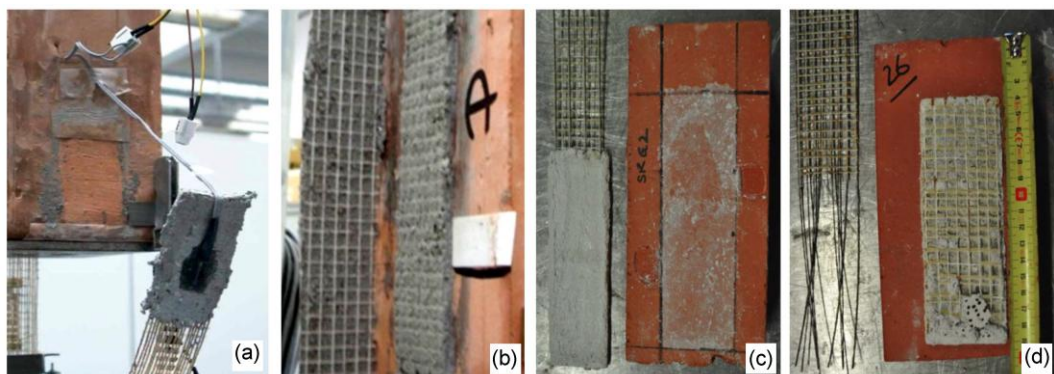
Fig. 7 Failure modes in SRG specimens. Effect of anchorage length: debonding at the substrate-matrix interface in specimens with anchorage length of 55 mm (a) and at the textile-matrix interface in specimens with anchorage length of 220 mm (b) (all specimens received minimal surface preparation prior to SRG application). Effect of surface preparations: specimens with minimal preparation (c) and with sand-blasted surface (d)

Moreover the effective length of Mode I is much less than that of Mode II and therefore a short joint is very sensitive to Mode I. A cohesive failure by debonding at the textile-matrix interface (mode b) was observed with the longest anchorage lengths (220 mm and 440 mm), as shown in Fig. 7b. The results of the tests performed on SRG showed that the surface preparation may significantly affect the failure mode. In the brick specimens with minimal surface preparation, the mortar detached from the brick surface (failure mode (a), Fig. 7c), while steel cord slipping with mortar cover separation was observed in the sand-blasted specimens (combined failure mode (b-c), Fig. 7d).

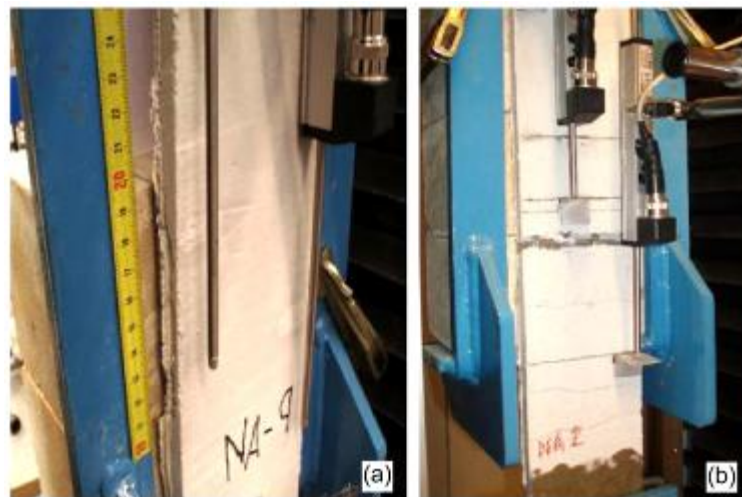
Fig. 8 Failure modes in BTRM specimens: debonding at the substrate-matrix interface in specimens with anchorage length of 85 mm (a) and slipping of the fibre rovings from the matrix in specimens with anchorage length of 220 mm (b)

In the case of BTRM, debonding at the substrate-mortar interface was observed for the shortest anchorage length (85 mm, Fig. 8a), while failure by slipping of the textile within the matrix (mode c) occurred for the longest anchorage lengths (150mm and 220 mm, Fig. 8b).
