OUT-OF-PLANE BEHAVIOR OF MASONRY INFILL WALLS

In order to investigate the out-of-plane behaviour of masonry infill walls, quasi-static testing was performed on a masonry infill walls built inside a reinforced concrete frame by means of an airbag system to apply the uniform out-of-plane load to each component of the infill. The main advantage of this testing setup is that the out-of-plane loading can be applied more uniformly in the walls, contrarily to point load configuration. The test was performed under displacement control by selecting the mid-point of the infill as control point. Input and output air in the airbag was controlled by using a software to apply a specific displacement in the control point of the infill wall. The effect of the distance between the reaction frame of the airbag and the masonry infill on the effective contact area was previously analysed. Four load cells were attached to the reaction frame to measure the out-of-plane force. The effective contact area of the airbag was calculated by dividing the load measured in load cells by the pressure inside the airbag. When the distance between the reaction walls and the masonry infill wall is smaller, the effect

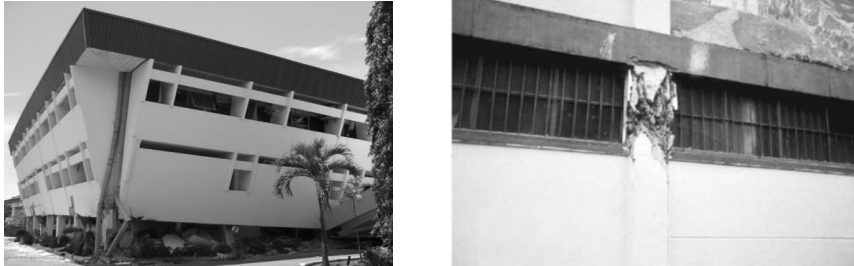
Figure 1 Negative effects of infill within structure; soft storey mechanism, (Kusumastuti 2010)(left), short column mechanism (Guevara and García)(right)

the structure or when the masonry infills leave a short portion of the column clear, leading to the shear collapse of the columns, see Figure 1.

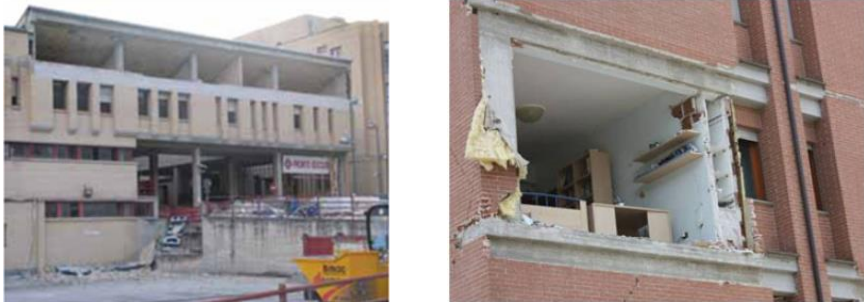
Figure 2 Damage in non-structural elements (Braga, Manfredi et al. 2011)

Out-of-plane collapse of masonry infills within concrete frames has been observed in most of the earthquakes. Although the infill panels are assumed as non-structural elements, their damage or collapse is not desirable, given the consequences in terms of human life losses and repair or reconstruction costs. In addition, this type of damage can limit the immediate occupancy after the earthquake event. The earthquakes such as Mexico City earthquake on 19th of September 1985 (Miranda and Bertero 1989), Bhuj earthquake on 26th of January 2001 (Jain, Lettis et al. 2002) and L’Aquila earthquake on 6th April 2009 (Braga, Manfredi et al. 2011), highlights the damages developed in the infill walls in relation to the minor cracks observed in the structure. In these cases, it was observed that no immediate occupancy was possible due to the generalized damage in the masonry infills. As it is observed in the Figure 2 the ground motion was not strong enough to cause structural damage but due to improper anchorage and interaction of the infill walls and surrounding frame, the exterior walls tore away and the concrete beam and columns were exposed.

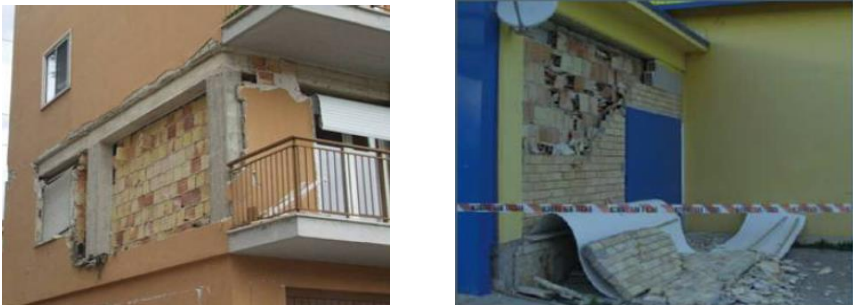
Figure 3 Detachment of the leaves in multi leaf walls (Braga, Manfredi et al. 2011)

Out-of-plane failure of the infills can be observed in dividing walls and also in multi-leaf walls when there is no proper transversal connection between the leaves as it is shown in Figure 3.
