Capsules changing in brittleness due to leaching of plasticizing agents

K. Van Tittelboom¹, E. Gruyaert¹, J. Sucaet¹, B. De Geest², J.P. Remon² and N. De Belie¹

¹ *Magnel Laboratory for Concrete Research, Faculty of engineering and architecture, Ghent University, Technologiepark-Zwijnaarde 904, 9052 Ghent, Belgium – e-mail: kim.vantittelboom@ugent.be, elke.gruyaert@ugent.be, nele.debelie@ugent.be*

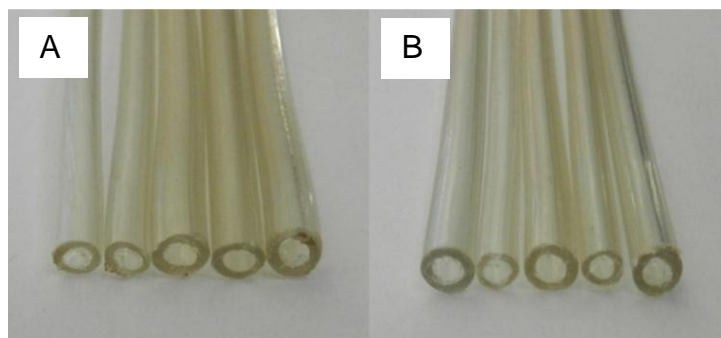
The polymer ethyl cellulose (EC) was selected to extrude capsules. Prior to hot-melt extrusion of the hollow tubes, EC was manually mixed with a plasticizer. Four different plasticizers were applied, i.e. triacetin (TAC), triethyl citrate (TEC), polyethylene oxide (PEO) and dibutyl sebacate (DBS). At the beginning of the experiment TAC, TEC and DBS were added to EC in a concentration of 25% w/w. Considering the first results obtained, it was decided to extrude also EC-capsules containing respectively 10% TAC and 10% PEO (w/w). The hot-melt extruded EC-capsules had an inner diameter of approximately 3 mm and an outer diameter of about 5 mm (Figure 1).

Figure 1: EC-capsules with 25% TEC (A) and EC-capsules with 25% DBS (B).
