DURABILITY AND SERVICE LIFE OF CONCRETE REPAIRS IN THE PRESENCE OF CRACKS

Jian Zhou (1), Guang Ye (1,2) and Klaas van Breugel (1)

(1) Microlab, Faculty of Civil Engineering and Geosciences, Delft University of Technology, Delft, the Netherlands

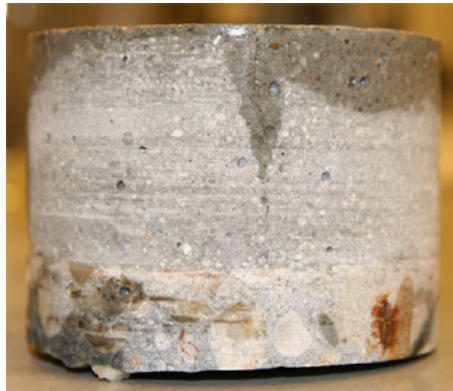
Figure 1: Specimen for RCM tests

Before placing the repair materials, the concrete substrate was grit-blasted and saturated. ECC and FRPM mortar were cast on the concrete substrates, and the thickness of the repair layer was 50 mm. After demolding, the composite beams were moved into a room with ambient conditions of 20°C and 50% RH. The differential shrinkage caused cracking in the repair materials. After 90 days, three cylinders with a diameter of 100 mm were cored out of each composite beam at the locations with cracks. As shown in Figure 1, the specimens consist of a layer of repair material with a thickness of 50 mm and a layer of concrete substrate with a thickness of 20 mm. More than 4 cracks were observed in each ECC specimen and only one crack in each FRPM mortar specimen. The surface crack width was measured using a portable microscope. The specimens were then saturated with $\text{Ca}(\text{OH})_2$ solution for 24 hours.

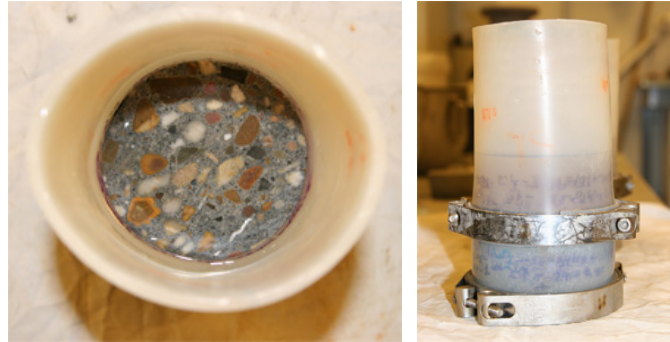
Figure 2: Specimen sealed with rubber sleeve and stainless steel clamps

The RCM test was carried out according to the Nordic standard NT BUILD 492 [6]. After $\text{Ca}(\text{OH})_2$ solution saturation, the specimens were put in a rubber sleeve and fastened with two stainless steel clamps to ensure that no water goes along the edge of the specimens, as shown in Figure 2. The RCM test set-up is illustrated in Figure 3. The substrate surface was immersed in the anolyte solution of 0.3 M NaOH and the cracked repair surface was immersed in the catholyte solution of 10% NaCl. A voltage of 60 V was then applied on the anolyte solution and catholyte solution for 3 days. The room temperature during testing was $24.6 \pm 0.2^\circ\text{C}$.

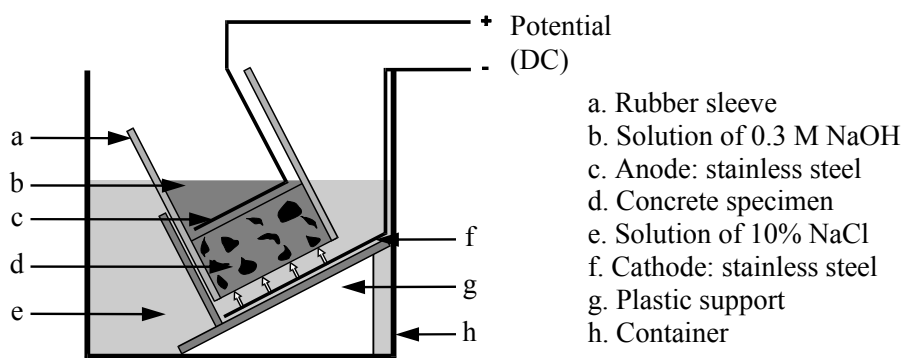
Figure 3: RCM test set-up

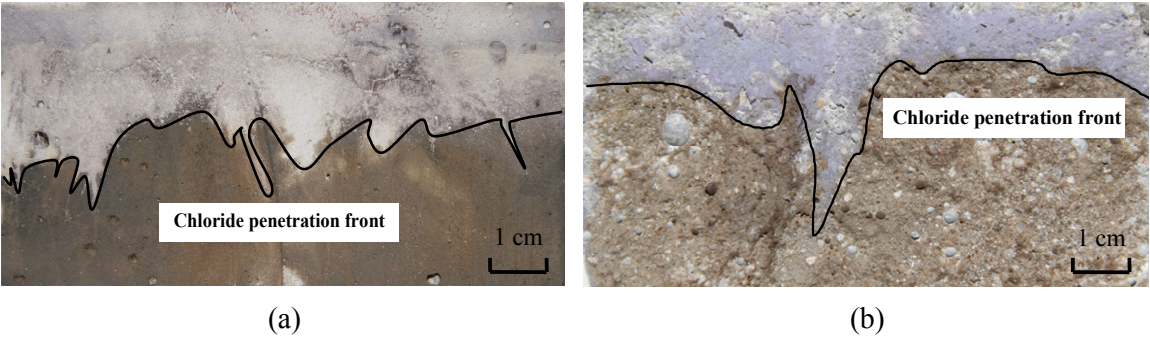
Figure 4: Chloride penetration profile in (a) ECC and (b) FRPM mortar at the age of 90 days

As observed using a portable microscope, the differential shrinkage resulted in averaged crack widths of 39 μm and 112 μm in ECC and FRPM mortar, respectively. As shown in Figure 4, surface cracking facilitates chloride penetration in the repair materials and the cracks are all accompanied by a peak in the chloride penetration front (or all peaks in chloride penetration front were observed in cracks). Due to the presence of more than 4 cracks, the chloride penetration front in ECC shows several peaks. While, there is one major peak in the chloride penetration front in FRPM mortar and this peak is more pronounced than those in ECC. The chloride penetration depth in cracks shows a good linear relationship with its crack width as shown in Figure 5. In both repair materials, as the crack width increases, the chloride penetration depth in this crack increases.

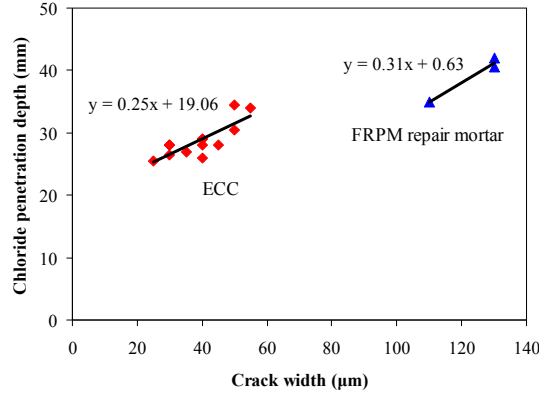
Figure 5: Relationship between the maximum chloride penetration depth in cracks and the crack width

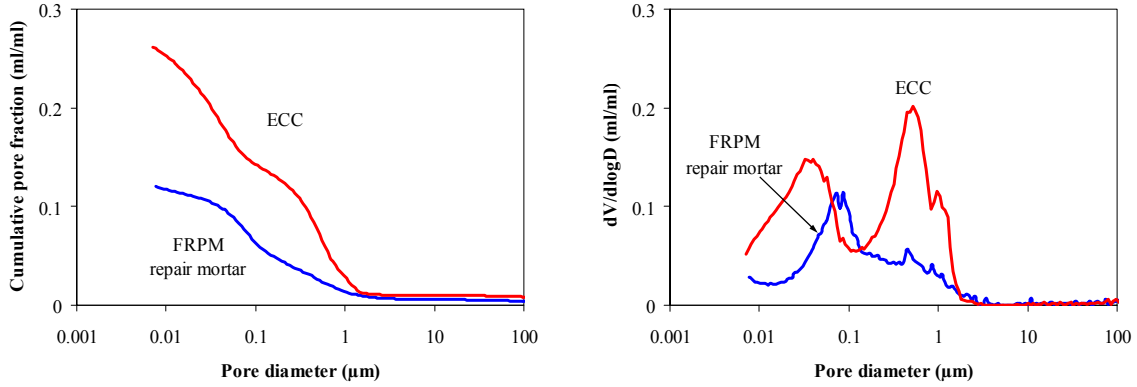
Figure 6: Pore size distributions of the repair materials at the age of 90 days

In order to explain the chloride transport in the repair materials, the pore structures of the repair materials were investigated by MIP. The MIP results of the two repair materials are shown in Figure 6. The experimental results show that ECC is much more porous than FRPM mortar. The total porosities of ECC and FRPM mortar are 26.2% and 12.1%, respectively. The differential curve of ECC shows two major peaks located at the pore diameters of 0.52 μm and 0.04 μm . The differential curve of FRPM mortar shows only one major peak located

at the pore diameter of 0.07 μm . Since the addition of fibers induces porous fiber-matrix interface, the porosity is increased. The presence of the peaks corresponding to larger pore diameter might be attributed to the addition of high volume of fibers in ECC.
