Full-scale Laboratory Validation of a MEMS-based Technology for Post-earthquake Damage Assessment

SUMMARY:

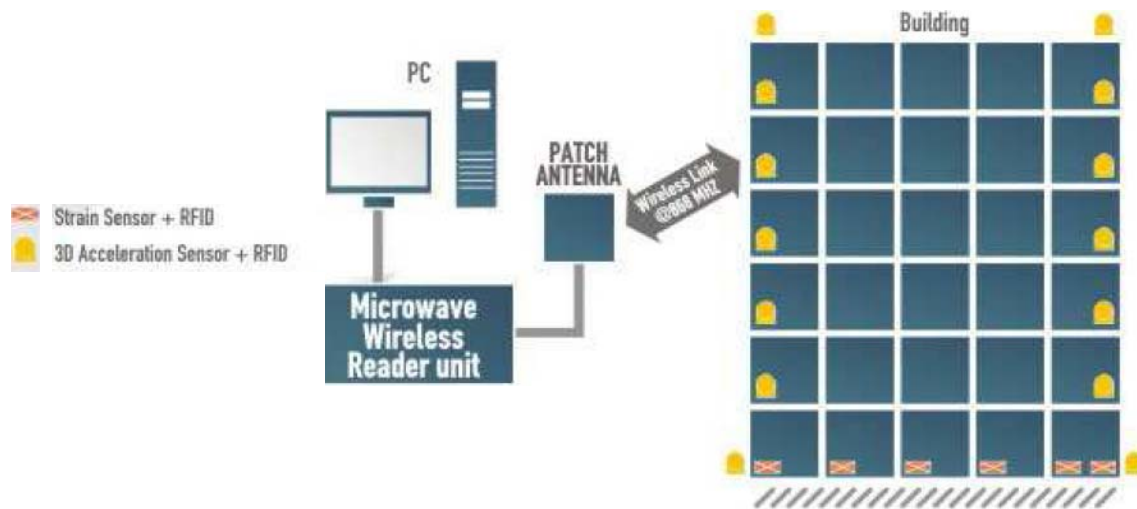
Figure 1. Memscon layout

In the Memscon system the accelerometers are installed in pairs at every floor of the building, measuring the response of the structure to the ground motions in terms of acceleration. Acceleration measures are used in order to perform a damage assessment analysis, estimating the displacements by the double integration of accelerations and imposing them to a finite element model of the structure; the output for the user are the information about the structural safety.

event occurs or when it is scheduled by the user. The sensors (Santana J. et. al., 2011, Torfs T. et. al., 2011) transmit data wirelessly to a remote acquisition unit where data are stored, processed and interpreted using the developed software. This software consists of a damage assessment module and a decision support module, providing respectively an estimation of the level of damage inside the building and an insight of the rehabilitation methodologies and costs.

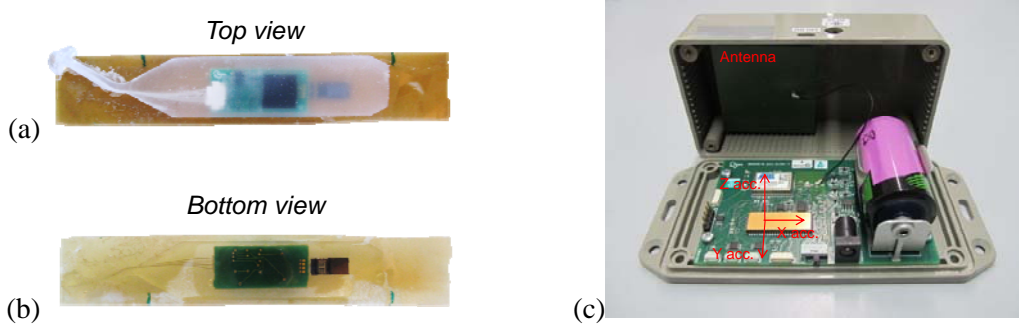
Figure 2. Memsccon strain sensor top view (a) and bottom view (b); Memsccon accelerometer (c)

The designed accelerometers (Figure 2c) are three-dimensional capacitive MEMS accelerometers based on different technologies: while for the in plane accelerations (X and Y channels) the sensor has a interdigitated-comb structure, for the out of plane acceleration (Z channel) a pendulum system is used. These MEMS devices are packaged inside a plastic housing together with a lithium battery, an ASIC, an ADC, a Zigbit module and an antenna. Features of the device are 200 Hz sampling rate, a 54 seconds maximum acquisition period, 16 bit resolution, 2,5V range of the ADC. Moreover, the Memscon acceleration sensor is characterized by a reduced energy consumption, due to the fact that it remains in the idle state until a seismic event particularly relevant occurs.

The Memscon strain sensors (Figures 2a and 2b) are designed to be directly bonded to the reinforcing bars embedded in the RC columns at the ground level, namely at the interface between foundation and column. The strain measures, recorded in correspondence of three reinforcing bars inside the element, are used to indirectly estimate the stress inside the whole building, recognizing any stress changes due to unforecasted settlement or overloads. Besides this, strain sensors provide the deformed shape of the structure from which the structure undergoes damage due to the earthquake, and the strain field inside the building after the seismic event. The Memscon strain sensor consists of two parts: the front-end sensor embedded into the RC element and the mote to be attached externally. The front-end sensor is a capacitive MEMS strain sensor connected to an ASIC, both embedded in a PDMS substrate 4 cm long and 5 mm thick. The whole package is bonded to a polyimide carrier 8 cm long and 1 cm wide, to be bonded in turn to the reinforcing bars, by using a cyanoacrylate glue. The external mote is instead a plastic housing (externally identical to the housing of the accelerometer) inside which there are a lithium battery, a Zigbit module and an antenna. The mote allows for connection up to three strain sensors at a time, in order to reduce to one the required number of devices per columns.

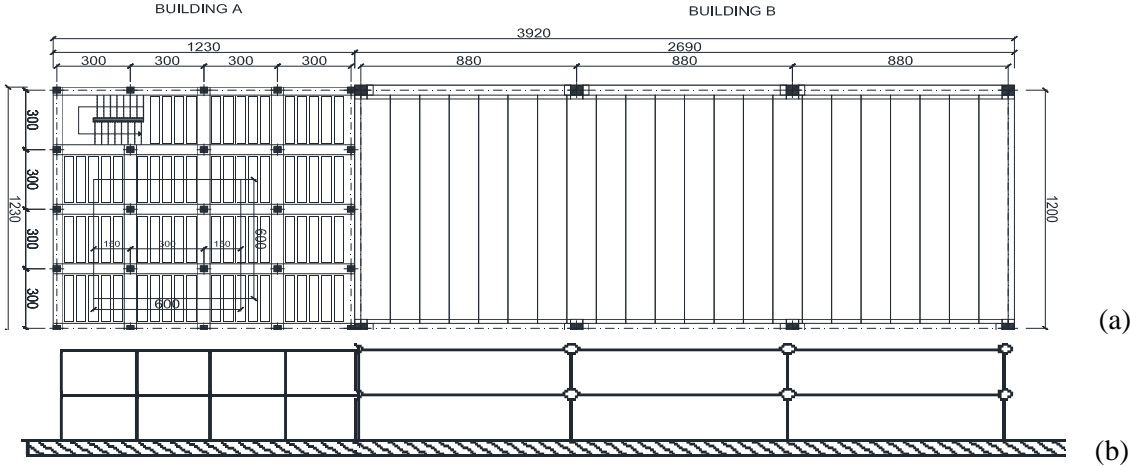
Figure 3. Plane view (a) and front view (b) of the prototype building

The Memsccon technology was preliminary validated performing static and dynamic tests on small-scale reinforced concrete specimens (Pozzi M. et. al., 2011, Zonta D. et. al., 2011). In this work, both Memsccon strain sensors and accelerometers, as well as Memsccon damage assessment methodology and software, were instead validated installing the system into a three-dimensional RC frame specimen, tested under laboratory conditions inducing to it different seismic events of increasing amplitude. The frame had been extracted from a two floors prototype building sited in a seismic zone, showed in Figure 3, in order to reproduce in laboratory the dynamic response of such a building when undergoing an earthquake. The frame realized in laboratory consisted of four foundation beams anchored to the ground, with the aim to reproduce the full restraint, four columns, four beams along orthogonal directions and a concrete slab. The prototype building from which the frame was extracted had been selected as a commercial building, consisting of two different parts, named simply part A and part B: part A was assumed to be in concrete, with plane dimensions 12.3x12.3 meters, while part B was assumed to be in precast concrete, with plane dimensions 26.9x12.5 meters. The lateral stiffness of part B was assumed equal to zero in both directions, hence the total lateral stiffness of the building was considered as offered by part A of the building only. The 25 300x300 mm columns of part A were pitched in plan at 3x3 meters and were parts of frames connected by beams section 300x500 mm along the length and 300x500 along the width. The vertical floor pitch was 3.20 meters so the columns had a net height of 2.80 meters. The total load of each floor was estimated at 1368+1022 kN. The seismic mass of Part B of the prototype building was instead estimated as equal to 3305 + 2485 kN. The vertical loads applied to both parts of the prototype building were used to estimate the vertical load applied to the columns during an earthquake; considering the columns pitch, the load applied to each column in seismic combination was 150 kN. In order to study the whole structure, we adopted a two degrees of freedom system, characterized by a stiffness equal to the stiffness of the part A of the building and the two seismic masses equal to those of both A and B parts. We obtained, assuming the structure behaviour as the behaviour of a shear type structure and the column stiffness as the stiffness near to bars yielding, bending stiffness $K = 25k$ where $k = 3650$ kN/m is the bending stiffness of the single column, and seismic masses m_1 and m_2 equal to 4685 kN and 3515 kN respectively. The natural frequencies of such a system can be expressed as:

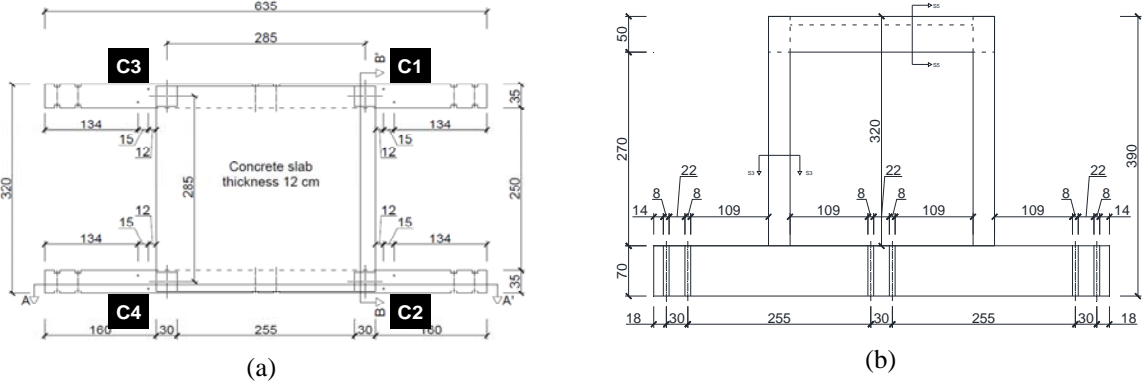
Figure 4. Plane view (a) and front view (b) of the three-dimensional RC frame

As stated in the previous section the three-dimensional frame constructed in laboratory was extracted from the part A of the prototype building. The materials selected to construct the specimen were B450C steel reinforcing bars and C25/30 concrete. The dimensions of the frame were 3.20x6.35 meters in plane and 3.90 meters in elevation. The columns, named C1, C2, C3 and C4, were designed with section 300x300 mm, reinforced longitudinally with 4 ribbed 20mm steel bars type B450C and transversally with 8 mm diameter B450C stirrups, at 100 mm pitch, to avoid fragile failure due to shear. The longitudinal foundations were designed to avoid cracking during the experimental campaign. To obtain this, in addition to the massive cross section of dimensions 350x700 mm reinforced with 4+4 bars 16 mm diameter, the foundations were post-tensioned with a force of 1400 kN, increasing the first crack bending moment. The longitudinal top beams had section 300x500 mm and were reinforced with 2+2 bars 16 mm diameter, in addition to the 20 mm diameter bars connecting to the columns. The resisting bending moment was 1.5 times the one of the column. The concrete slab, 120 mm thick and reinforced with crossed 10 mm diameter bars spaced at 200x200mm, was designed to ensure the diaphragm behaviour of the deck. No loads were foreseen directly on the slab excluding its self-weight. The plane and the front views of the frame are showed in the following figure.

Each of the four bars inside each frame column were instrumented using the Memscon strain sensors and two reference strain sensors (LY41-3/700 strain gauges produced by HBM GmbH) with the aim to validate Memscon devices' response. The Memscon strain sensors were connected via cable to the motes, placed externally the columns and transmitting recorded data wirelessly to the Memscon receiver placed near the frame. The reference sensors were instead acquired using a wired acquisition system (National Instruments Field Point system, consisting of one FP2000 and 3 FPSG140). Both the systems were on during the construction of the frame, in order to monitor strains induced by the loads, creep and shrinkage. The strains have been recorded also during earthquake simulation, in order to know the deformed shape of the structure at the moment of the simulated earthquake.

Above the slab four Memscon accelerometers were installed, fastening them to the concrete surface using a set of screws. Back to back to them we mounted also a pair of reference accelerometers (piezoelectric accelerometers model PCB 393C produced by PCB Piezotronics), acquired by an acquisition unit NI PXI 4472B produced by National Instruments, in order to assess the accuracy of the Memscon devices compared with commercial available devices specifically intended for seismic measurements. Finally, during the dynamic tests we recorded also displacements. Besides the data acquired by the load application system (specifically by the horizontal actuator described below) a set of Linear variable differential transformer (LVDT) displacement transducers (Gefran LT-F-0500-S) were mounted along the columns at different heights and acquired every 0.1 seconds.

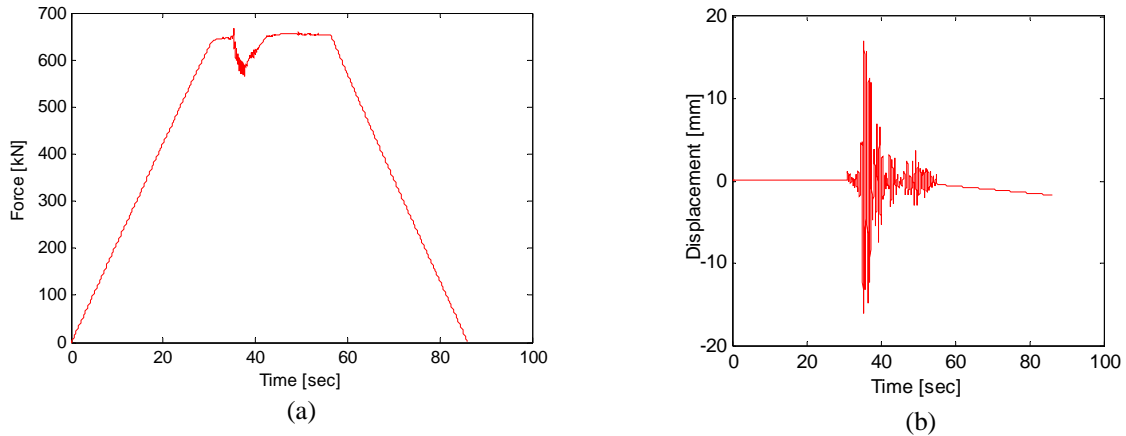
Figure 5. Time history of the vertical load (a) and of the horizontal displacement (b)

The selected load protocol, showed in Figure 5, consisted of a vertical load, which was produced by a vertical actuator, MTS model 243.60, placed inside the frame, kept as constant during the application of the horizontal displacement time history (actually a reduction of the vertical force transmitted from the vertical actuator was detected in the central part of the tests), which was produced by an horizontal actuator, MTS model 244.51, reproducing the displacements at the first floor of the prototype building during the target earthquake. The load application system was designed in such a way that the vertical load was directly applied to the columns and not to the slab, which was not designed to resist to vertical loads. Moreover, the horizontal load was applied always pushing the slab and never pulling it, this achieved realizing a system consisting of a set of threaded bars in tension connected to a pair of steel plates external to the transversal beams, as showed in Figure 6. The test sequence was selected in order to induce cracking of the concrete at the interface between columns and foundations during the first earthquake simulation (maximum displacement equal to Δ_{crack}). Next, maximum displacements multiple of 25% the displacement expected at steel yielding (Δ_y) were produced up to yielding (25-50-75-100 Δ_y). Finally, the frame underwent maximum displacements multiple of 100% Δ_y (200-300-400-500-600 Δ_y).

A spectrum compatible earthquake was founded into the database attached to the Rexel software (Iervolino I. et. al., 2009): it is the earthquake occurred in Chenoua, Algeria, in 1989, characterized by a 0.22g PGA (Bounif A. et. al., 2003). The ground acceleration time history of this target earthquake was applied to the model discussed above and the displacement response at the first floor of the building was estimated using the Newmark's method, applied to a two-degrees-of-freedom model. This response was used as reference in designing the tests load protocol. Indeed, scaling the maximum displacement to different amplitudes had been possible to reproduce various damage scenarios in the prototype building, including cracking, steel reinforcement yielding and concrete spalling. A cantilever scheme for the columns were selected to obtain the different displacements, corresponding to the different levels of damage: it was obtained for example that the displacement at first cracking of the concrete (Δ_{crack}) was 1.5 mm to which a lateral force of 110 kN corresponded, while the displacement at yielding was 17.0 mm to which a lateral force of 304 kN corresponded.

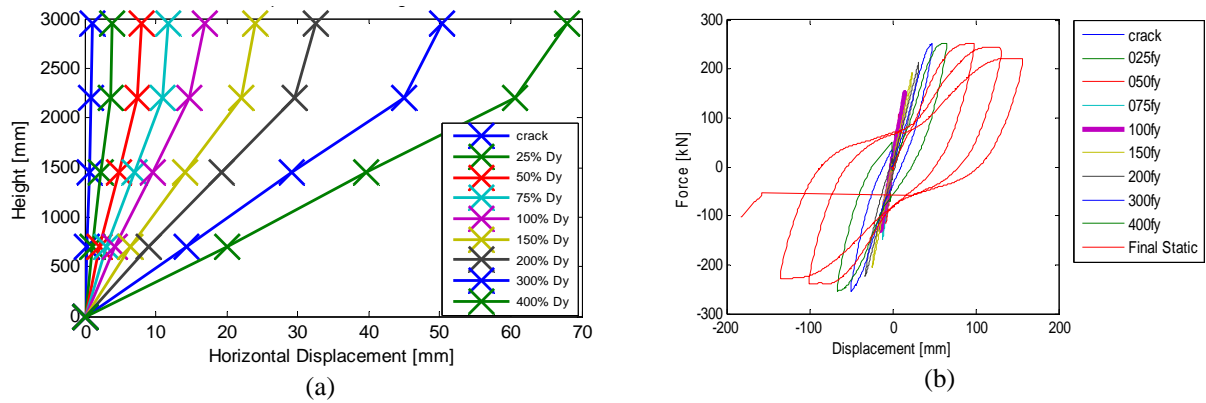
Figure 7. Displacements along column C3 during different tests (a), force-displacement plot (b)

Each dynamic test was characterized by a maximum displacement of the time history of displacement. This displacement was also statically applied to the frame after each dynamic test. The static tests allowed us to evaluate the evolution of damage in terms of stiffness loss due to the increasing earthquake intensity, and to record the force-displacement relationships of the RC frame. The displacements were recorded during the tests using the displacement transducers presented in the previous section, while the load was recorded by the load cell of the horizontal actuator. The displacements along the columns are shown in Figure 7a for different maximum displacements induced to the frame. Analysing the plot we hypothesize that a plastic hinge developed at the base of each of the columns during tests at 75% Δ_y or 100% Δ_y . Increasing damage was then observed also at the top of the columns: for example, the plot related to the 400% Δ_y test indicates a plastic hinge also at the interface between column and beam. Figure 7b shows instead the force-displacement plot, where energy dissipation by hysteresis is appreciable.

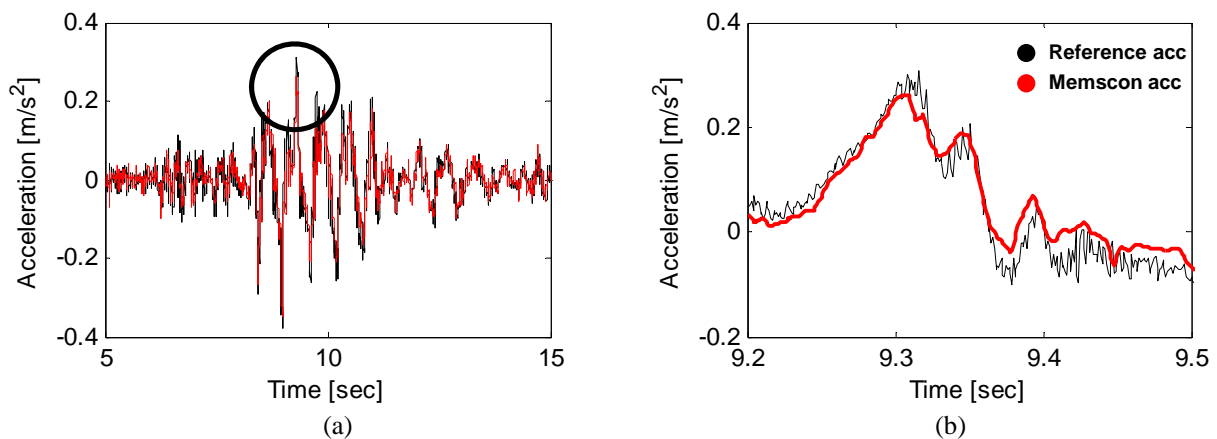
Figure 8. Comparison between Memscon accelerometer and reference accelerometer responses

Indeed, discrepancies less than 20 mg, evaluated in terms of RMS, were observed between the two monitoring systems, as it can be seen in Figure 8 below. Moreover, it is not clear if these discrepancy were due to the Memscon system or to the reference one. Even if the value of the background noise of the Memscon accelerometers is about 10-15 mg, the signals from the Memscon devices appears smoother than the signals from reference system. Reference signals are probably affected by some noise component, lacking from Memscon signals.

Each Memscon accelerometer was validated by comparing it with a couple of reference piezoelectric accelerometers, acquired using a NI PXI 4472B acquisition unit sampling 32768 measures at 1000Hz, mounted in two orthogonal directions in order to validate both the sensing directions of the Memscon device. We selected to measure acceleration in two points above the slab, one at the top of column C2 (sensors 103, 104) and the other at the top of column C3 (sensors 102, 106). All the devices were fastened to the concrete slab, recording in this way its actual acceleration. The comparison between the signals recorded during the induced shaking motion highlighted that no critical deviation in the response of the Memscon accelerometers occurred during the tests, in comparison with the wired reference sensors.

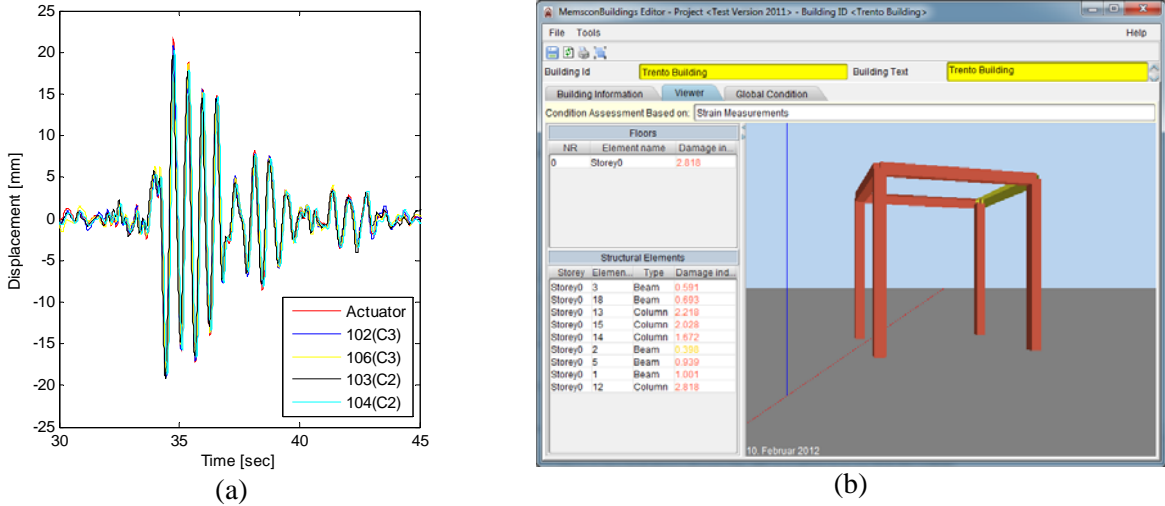
Figure 9. Comparison between displacements actually induced by the actuator and displacements estimated by double integrating the acceleration measures recorded by the four Memscon accelerometers (a), output of the Memscon software (b)

The acceleration data recorded by the Memscon sensors were used to estimate the displacement time history induced in the frame by the horizontal actuator, double integrating the time histories. To do this, an high-pass filter was implemented during post-processing analysis, this characterized by 0.2 Hz stop band frequency, 1.2 Hz pass band frequency, 0.0001 stop band attenuation, 0.0575 pass band ripple and 20 density factor. The so estimated displacement time histories were compared to those recorded by the MTS system, which provided the displacement actually produced by the horizontal actuator. We observed that performing the double integration of the filtered signal it was possible to evaluate the displacement time history without inducing a drift to the response. For example the comparison between the displacement time history obtained by double integration of the accelerations recorded during tests 100 Δ y and the one actually produced during the same test, showed in the plot in Figure 9a, indicates a discrepancy of the order of 0.5 mm.

The acceleration measures were subsequently imported into the Memscon software in order to assess if it was able to provide the user with a reliable estimation of the maximum displacements induced to the frame during the tests. The software includes an high-pass filter, similar to the filter briefly presented above, which cuts low frequencies from the acceleration signals. The filtered signals are double-integrated and the maximum displacement is estimated. This target displacement value is

imposed to a finite element model of the structure, within an ETABS/SAP2000 environment, and a non-linear analysis is performed. For each element a damage index is calculated, comparing the force induced by the earthquake and the design forces. The output of the analysis is based on this damage index and is supplied in the form of a “traffic light”: the element is showed in red if severe damage occurred, in yellow if visual inspections are needed, in green if no damage occurred. The occurred damage is then expressed by a damage index. Figure 9b shows the output of the test $200\Delta_y$, during which a displacement two times the displacement expected at column reinforcement’s yielding: almost all elements are red, being this consistent with the severe damage occurred at the base of the columns.
