The Origin of Fault Scarps & Fissures on Moorland Plateaux & in the Vicinity of Landslides, in the South Wales Coalfield, UK

ABSTRACT: Fault scarps and fissures occur on moorland plateaux and in the vicinity of deep-seated landslides in the South Wales Coalfield, UK. These scarps may reach about 4 m in height and 3-4 km in length. The ages of the fault scarps and fissures are difficult to determine. Their relatively fresh and unweathered appearance would seem to suggest they were generated during subsidence as a result of coal mining which has taken place for some 150 years. However, their large magnitude, which make them dramatic features of the landscape, sets them apart from the much lesser features generated during coal mining subsidence in other UK coalfields. Some fault scarps seem to pre-date Ordnance Survey and British Geological Survey maps from the late 1800s-early 1900s. As total extraction (longwall) methods associated with fault reactivation had yet to develop widely at that time it is probable that mining subsidence alone could not have generated such distinct topographic features. The paper reviews the evidence of analogous non-mining fault steps and fissuring, mine

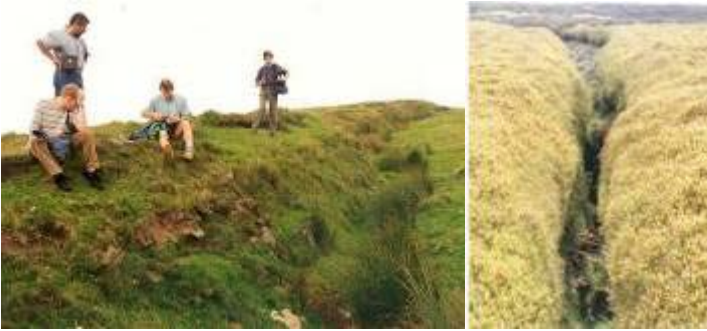
Figure 1. (Left). The 4m high Tableland fault scarp that can be traced for several kilometers. (Right) A typical fissure, approximately 1 to 2 m wide, tens of metres long and of unknown depth (photograph Laurance Donnelly).

north-west to south-east. The latter is associated with the principal orientation of faults across the coalfield (Figure 1).

The fault scarps and fissures occur as distinct, dramatic and extensive landscape features that influence significantly the morphology of entire slopes. The reactivated faults appear as relatively unweathered, steep-sided, fault-scarp walls up to 4 m high and up to several kilometres long. They are most pronounced on the escarpments, formed from the strong, ‘Pennant’ sandstones. Some dissipate towards the centre of the plateaux and virtually all peter out where weaker shales and mudstones crop out on the upper and middle valley sides. They also occur in multiple sets with both uphill and downhill facing sub-scarps. Where the fault scarps have opposing directions of displacements they form graben. Usually these are oriented north-west to south-east parallel to the principal joint trends, slightly oblique to the north to south trending valleys. The graben channel

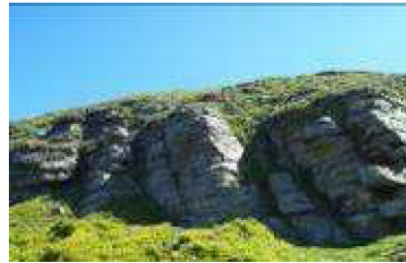
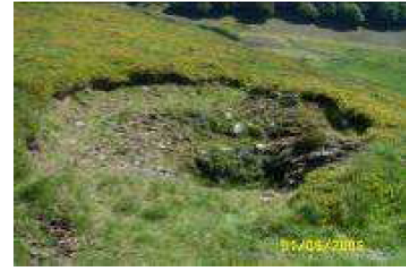
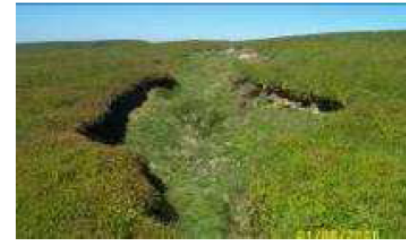
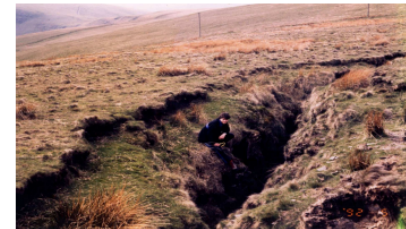
A. Pre dilation of joint or fault

B. Initiation of joint dilation

C. Youthful fissuring

D. Advanced fissuring

E Mature fissuring

Figure 2. Schematic diagram to illustrate the evolution of fissures. Dilation of fissures in direction of arrows may be strongly influenced by glacial stress relief and/or mining-induced movements as shown in Figure 3. (A) Pre-fissuring, head and weathered sandstone forming a soil cover, above strong, well-jointed, Pennant sandstone. (B) Initial dilation of a high-angled joint causing the development of a circular subsidence depression, 1 to 5 m in diameter. (C) Youthful fissuring, subsidence depressions begin to coalesce caused by increased joint dilation. (D) Advanced fissuring, linear fissures develop, some bridged by superficial deposits that later collapse. (E) Mature fissuring, several fissures may coalesce, some may become filled with debris washed in, or fallen from the fissure walls (based on Donnelly 1994, photographs Laurance Donnelly).

Fissure walls often display horizontal and/or vertical slickensides and most contain an accumulation of debris on their floors which has fallen from the roof and/or side walls. Further information on South Wales fault scarps and fissures may be found in Donnelly 1994, 2005, 2006, Donnelly et al., 2000a, 2000b, 2002. The fissures are envisaged to develop over time by the processes summarized in Figure 2.
