Temperature Profiles of Railroad Tapered Roller Bearings With Defective Inner and Outer Rings

JRC2016-5816

TEMPERATURE PROFILES OF RAILROAD TAPERED ROLLER BEARINGS WITH DEFECTIVE INNER AND OUTER RINGS

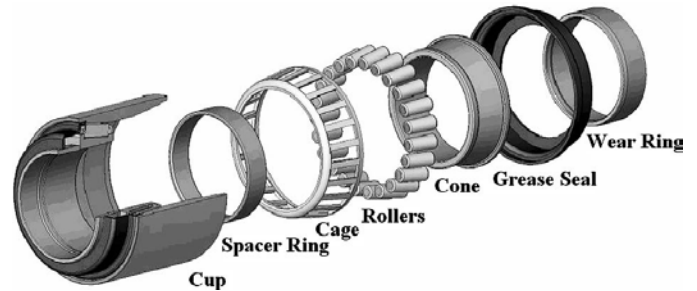
Figure 1. A detailed component view of a typical railroad tapered roller bearing assembly.

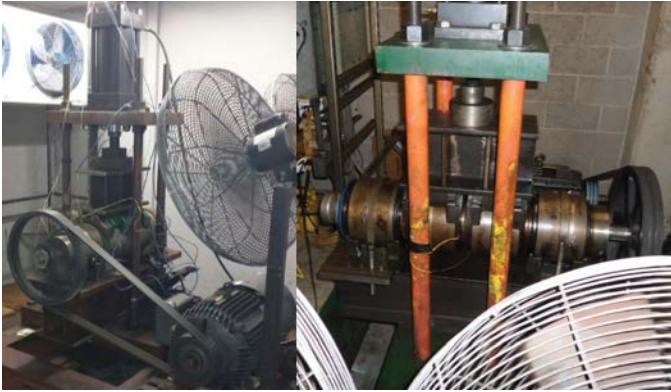
Figure 2. Photographs of the dynamic bearing testers used to conduct the experiments for this study.

All the experiments were performed using the dynamic bearing testers at The University of Texas Rio Grande Valley (UTRGV), pictured in Figure 2. The dynamic test rig can accommodate four Class K (6 ½ × 9") or Class F (6 ½ × 12") tapered-roller bearings. Tests were performed at several different velocities, as listed in Table 1. Convective cooling was achieved with three fans that produced an air stream traveling at an average speed of 5 m/s (11.2 mph) across the bearings. The dynamic bearing testers are equipped with a hydraulic cylinder capable of applying loads ranging from 0 to 175% of full load. The data provided in this paper were acquired utilizing a 17% load setting, which simulates an empty railcar, and a 100% load setting, which simulates a fully-loaded railcar and corresponds to a load of 153,000 N (34,400 lb) per bearing.

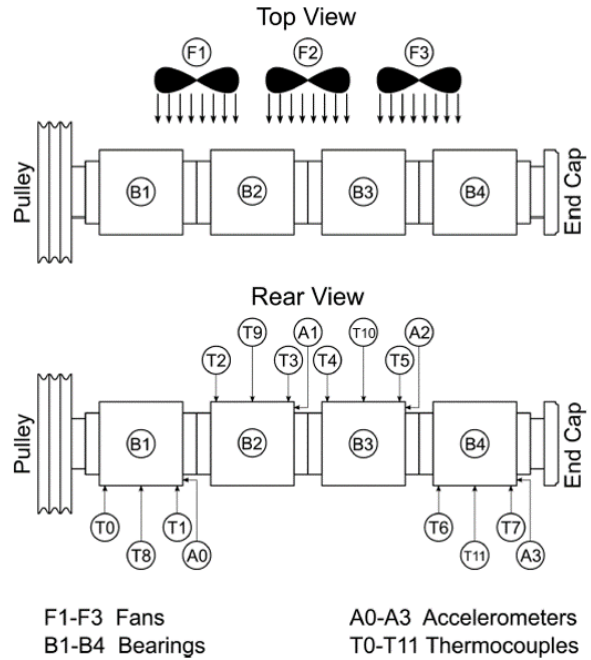
Figure 3. Schematic showing the top and rear view of the dynamic bearing tester, including sensor locations.

The instrumentation setup is illustrated in Figure 3. Four bearing adapters were specially machined to accept a 500g accelerometer and two K-type bayonet thermocouples, one inboard and one outboard. To ensure the accuracy of the bayonet thermocouples, one K-type thermocouple was fixed to the middle of each bearing using a hose clamp and was aligned level with the two bayonet thermocouples. Additionally, two K-type thermocouples were used to monitor and record the ambient temperature surrounding the tester; one was positioned at the front of the tester and the other at the rear of the test rig. Data collected from fourteen thermocouples and four accelerometers were recorded utilizing a National Instruments

(refer to Figure 3). The statistical mean and corresponding uncertainty of the two thermocouples was calculated for every speed and load combination. The uncertainty in the temperature data was within 3°C (5°F). Finally, the data obtained was evaluated according to the defect severity as determined by its area. The approximate area of the spalls was obtained by treating the spall as a rectangle, and measuring the spall's length and width. The area of the spall was measured at the beginning and end of each experiment. The test plan was developed to populate bearing temperature profiles at speeds and loads typical of field service conditions.

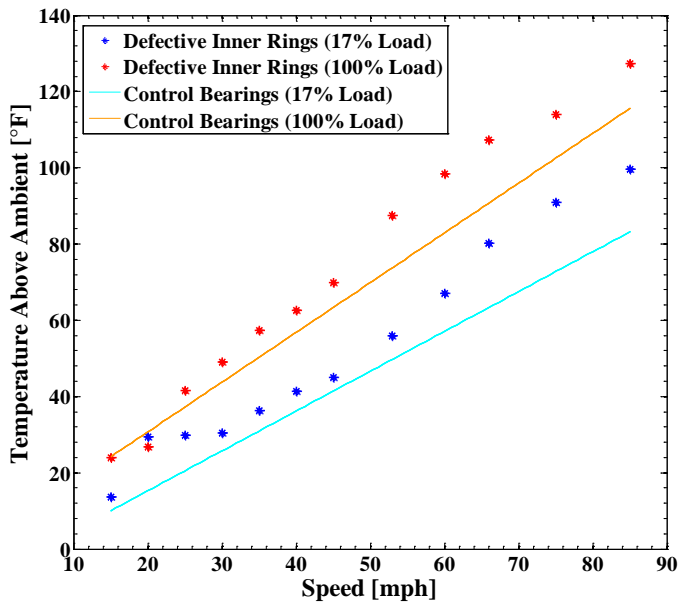
Figure 4. Average operating temperatures above ambient (78°F) of bearings with inner ring defects as compared to healthy (control) bearings at various speeds under 17% (empty railcar) and 100% (full railcar) load conditions.

From Figure 4 and Figure 5, it is evident that there is an almost linear increase in bearing operating temperature with speed. Moreover, speed seems to play a more important role on the bearing operating temperature than load. For example, going from 17% to 100% load will result in an average temperature increase of about 23°F (13°C) in a healthy bearing, whereas, going from 25 to 66 mph results in an average temperature increase of about 48°F (27°C) in a healthy bearing. Note that changes in speed will be more common in field service operation than changes in load.

In Figure 4, the average operating temperatures of the bearings with inner ring defects are mostly above the control bearings average temperature (linear fit). As speed increases, the average temperature of the bearings with inner ring defects appears to diverge from the linear fit of the control bearings; a behavior that is more pronounced in the 17% (empty railcar) load condition. On the other hand, the average operating temperatures of bearings with outer ring defects are consistently at or below the average operating temperatures of the control (healthy) bearings (linear fit) for both loading conditions, as seen in Figure 5. This difference in temperature behavior with respect to the defective bearing component can be explained by referring to the findings in the literature. It was stated earlier that the highest contact pressure during bearing operation occurs between the rollers and the inner ring (cone), and that the higher temperatures within the bearing assembly are seen at the rib – roller contact [8]. It is then expected that if a defect is present on the inner ring (cone) race, it will experience more contact with the rollers, thus, increasing the frictional heating. Moreover, the inner ring is in constant

rotational motion, hence, the likelihood of roller misalignment due to contact with the defect is much higher. If roller misalignment occurs, frictional heating is further exacerbated. The combination of the aforementioned effects tends to raise the overall bearing operating temperature which in turn decreases the viscosity of the lubricant leading to more metal-to-metal contact and added frictional heating. The latter becomes even more evident at higher operating speeds (≥ 60 mph), as demonstrated in Figure 4, where the average operating temperature of bearings with inner ring defects is about 15°F (8°C) above that of healthy bearings. One explanation as to why the behavior seen in bearings with inner ring (cone) defects is not observed in bearings with defects present on the outer ring (cup) raceways is that spalls present on the cup raceways may favor the formation of pockets of lubricant which in turn enhances lubrication and maintains the operating temperature at or below the average operating temperature of healthy bearings.

Figure 4 and Figure 5 at 30 and 60 mph for the unloaded (17% load) and loaded (100% load) conditions represent an average of all the data points seen in Figure 6 through Figure 9 for bearings with inner and outer defects of various sizes (as measured by the defect area).

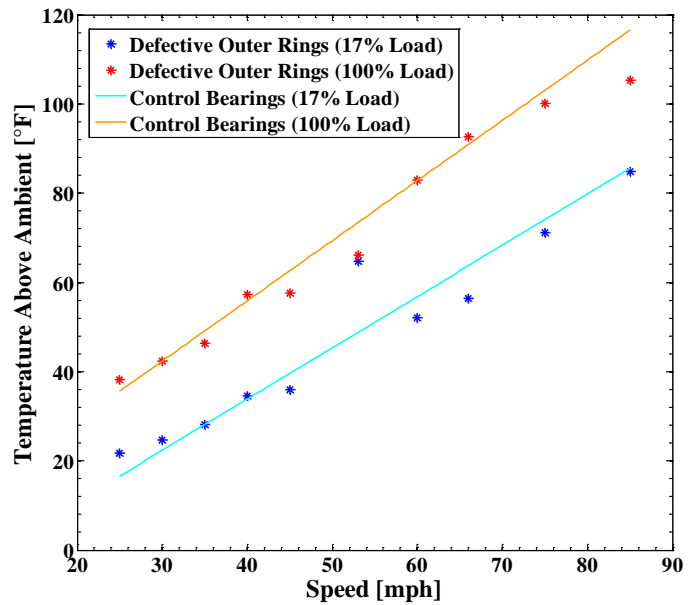
Figure 5. Average operating temperatures above ambient (78°F) of bearings with outer ring defects as compared to healthy (control) bearings at various speeds under 17% (empty railcar) and 100% (full railcar) load conditions.

Examining Table 3, it can be observed that the bearing operating temperatures rise almost linearly with the speed, as exhibited in Figure 5. For bearings with outer ring (cup) defects, in most cases, the operating bearing temperature tends to increase with defect size. Furthermore, note that most of the operating temperatures for bearings with inner and outer ring defects do not greatly differ from the average operating temperatures of healthy (control) bearings at the same load and speed conditions. More importantly, none of these temperatures are high enough to trigger the HBD alarm threshold of 94.4°C (170°F) above ambient conditions set by the Association of American Railroads (AAR).

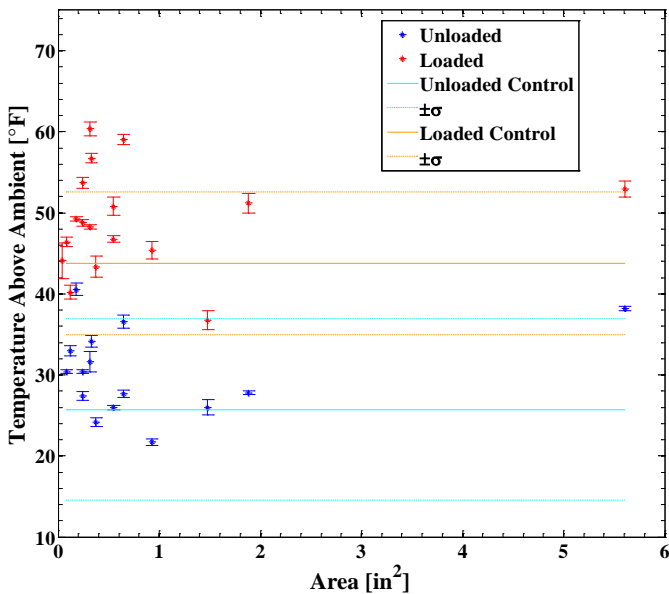
Figure 6. Temperature data of bearings with inner ring defects of various sizes (as measured by defect area) compared against the range of operating temperatures for healthy (control) bearings for unloaded (17% load) and loaded (100% load) conditions at a speed of 30 mph.

For a more detailed analysis, the temperatures obtained for bearings with different size inner and outer ring defects (as measured by the defect area) at two common operating speeds (30 and 60 mph) were plotted and compared against the range of healthy (control) bearing temperatures subjected to the same load and speed conditions. The temperature data for bearings with inner ring defects at operating speeds of 30 and 60 mph are given in Figure 6 and Figure 7, respectively, whereas, the temperature data for bearings with outer ring defects at operating speeds of 30 and 60 mph are provided in Figure 8 and Figure 9, respectively. Note that the data points plotted in

By looking at Figure 6 through Figure 9, it becomes apparent that there is no distinct correlation between defect severity and the corresponding bearing operating temperature. While a few bearings with defective inner and outer rings were found to be operating at temperatures above the control (healthy) bearing temperature range for the given speeds and loads, a significant number of bearings with defective inner and outer rings were running at temperatures within or below the healthy bearing temperature range. Therefore, temperature alone does not seem to be a good indicator of the presence of a defect within a bearing, much less of defect severity. The aforementioned statement can be validated by looking at the two data points circled in green in Figure 7. One data point belongs to a bearing with an inner ring defect size of 1.48 in^2 (955 mm^2), whereas, the other data point belongs to a bearing with an inner ring defect size of 1.88 in^2 (1213 mm^2). These two defects are pictured in Figure 10. While the bearing with larger defect size has an operating temperature that is relatively higher than the healthy bearing operating temperature range, the bearing with the slightly smaller defect has an operating temperature that is markedly lower than the operating temperature range for healthy bearings. In fact, the bearing with the inner ring defect size of 1.48 in^2 has an operating temperature that is significantly lower than that of other

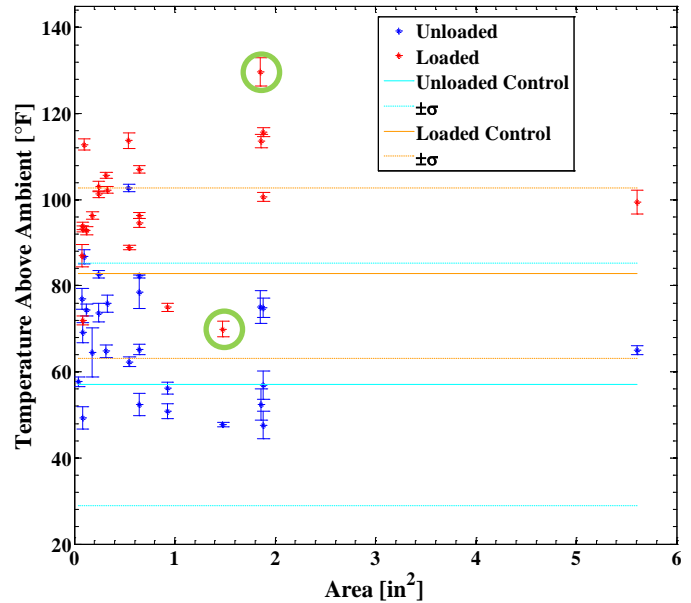
Figure 7. Temperature data of bearings with inner ring defects of various sizes (as measured by defect area) compared against the range of operating temperatures for healthy (control) bearings for unloaded (17% load) and loaded (100% load) conditions at a speed of 60 mph.

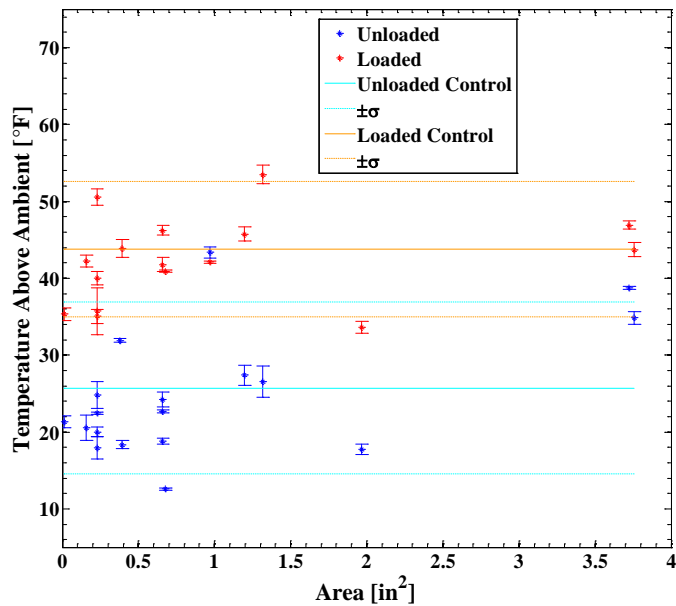
Figure 8. Temperature data of bearings with outer ring defects of various sizes (as measured by defect area) compared against the range of operating temperatures for healthy (control) bearings for unloaded (17% load) and loaded (100% load) conditions at a speed of 30 mph.

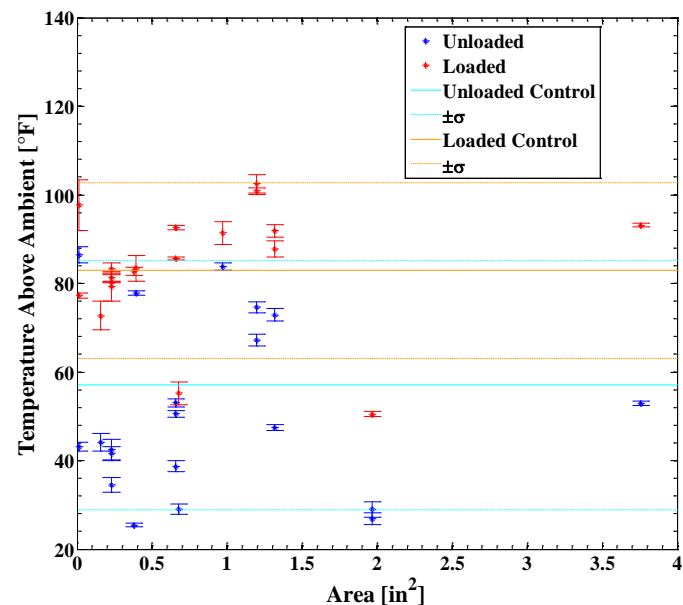
Figure 9. Temperature data of bearings with outer ring defects of various sizes (as measured by defect area) compared against the range of operating temperatures for healthy (control) bearings for unloaded (17% load) and loaded (100% load) conditions at a speed of 60 mph.

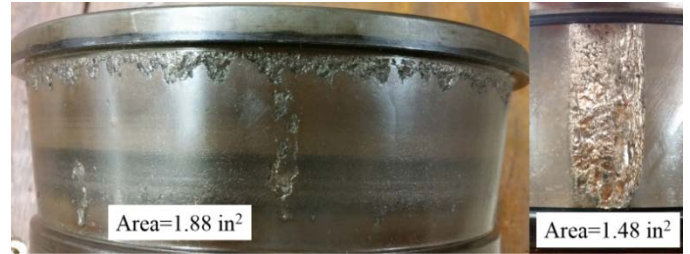
Figure 10. Photographs depicting large defects (spalls) present on bearing inner ring (cone) raceways.

Examining Figure 10, the reason for the large difference in operating temperature of the two defective inner rings becomes apparent. The defect on the left side of Figure 10 is spread across a narrow zone of the raceway closest to the upper cone rib, whereas, the defect on the right side of Figure 10 forms a rectangular spall that stretches across the width of the raceway. As mentioned earlier, the highest temperature within the bearing assembly is expected to occur along the roller – rib contact zone. Thus, the presence of a spall in this zone will exacerbate the frictional heating, degrade the lubricant, and significantly increase the likelihood of roller misalignment, which will result in higher bearing operating temperatures. On the other hand, it seems like when the defect (spall) stretches across the width of the raceway, such as in Figure 10 (right), the spall cavity fills with lubricant which tends to reduce the likelihood of rollers misaligning. Hence, the presence of a defect as severe as the one depicted in Figure 10 (right) will go undetected by conventional wayside HBDs because the bearing operating temperature is below that of the healthy bearing operating range, as can be seen in Figure 7. In this case, the bearing with the inner ring defect size of 1.88 in², depicted in Figure 10 (left), had an operating temperature of about 130°F (72°C) above ambient, whereas, the bearing with the inner ring defect size of 1.48 in², pictured in Figure 10 (right), had an operating temperature of about 70°F (39°C) above ambient. In comparison, the average operating temperature of a healthy

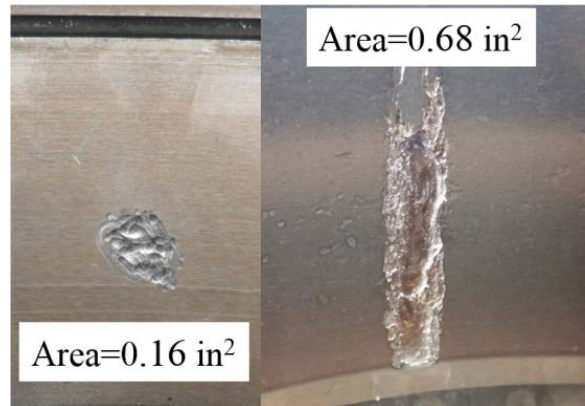
Figure 11. Photographs depicting small (left) and medium (right) size defects (spalls) present on bearing outer ring (cup) raceways.
