Article

A Simplified Framework for Historic Cities to Define Strategies Aimed at Implementing Resilience Skills: The Case of Lisbon Downtown

Keywords: historic cities; seismic resilience; urban vulnerability

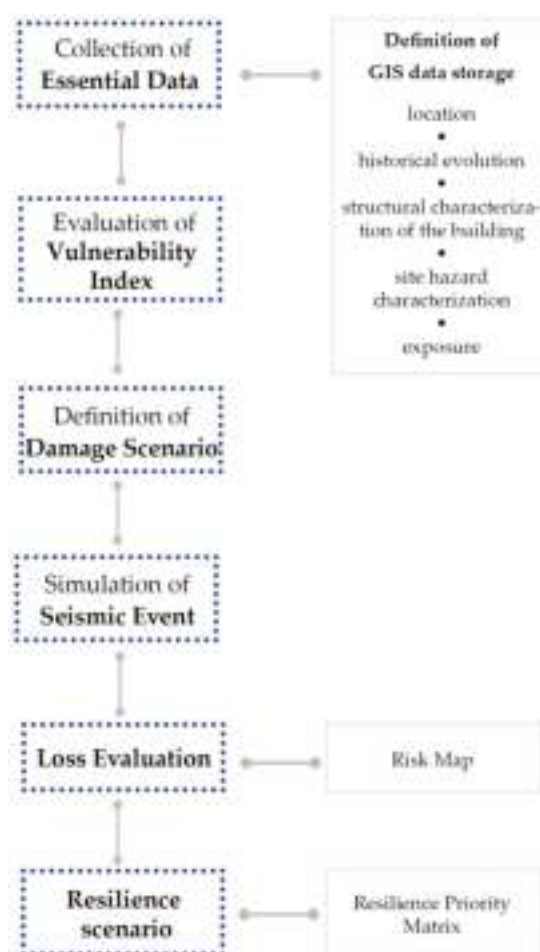
Figure 1. Proposed framework.

The proposed framework is mainly based on six operational phases (Figure 1):

1. The collection of essential data
2. The evaluation of vulnerability index
3. The definition of damage scenario
4. The simulation of the seismic event
5. Loss evaluation
6. Resilience scenario

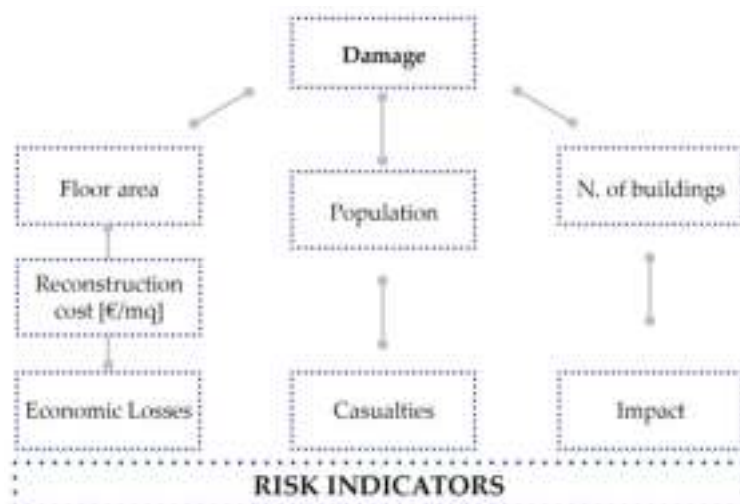
Figure 2. Framework for risk assessment.

an impact or loss: in order to estimate losses, the research employed default percentages from the IRMA Platform [19]. The steps for risk assessment are shown in Figure 2. The percentage of damaged structures matching to the selected impact is provided by matrix 1 (Table 4). Matrices 2 and 3 provide the values to evaluate economic and human losses (Tables 5 and 6).

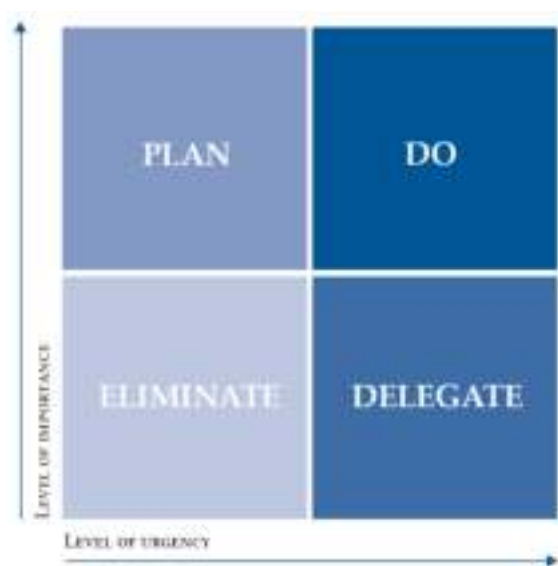
Figure 3. Eisenhower priority matrix.

The values thus obtained on the one hand of the damage and expected losses, and on the other hand, the basic value of the cultural assets was then normalized to a scale of 10 on the totals for each building’s “urgency” and “importance” in the historic city under consideration, defining a pair of input values (x,y) for each building’s priority matrix (Figure 3).

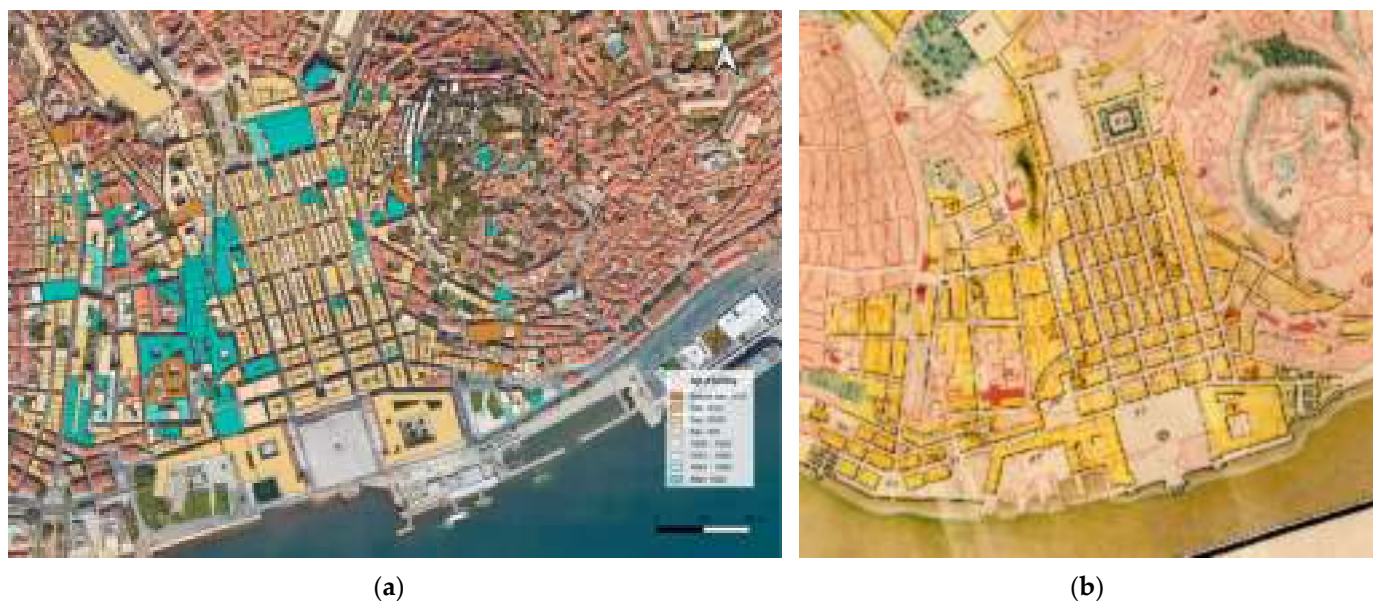
Figure 5. Current cartography of the Baixa of Lisbon with the dating of the individual buildings (a); historical cartography of the post-earthquake reconstruction of 1755 (b).

Based on the observation of the available cartography and iconography (Figure 5) regarding Lisbon before the earthquake of 1755, the urban structure of the central part of the city has remained unchanged since the 16th century.

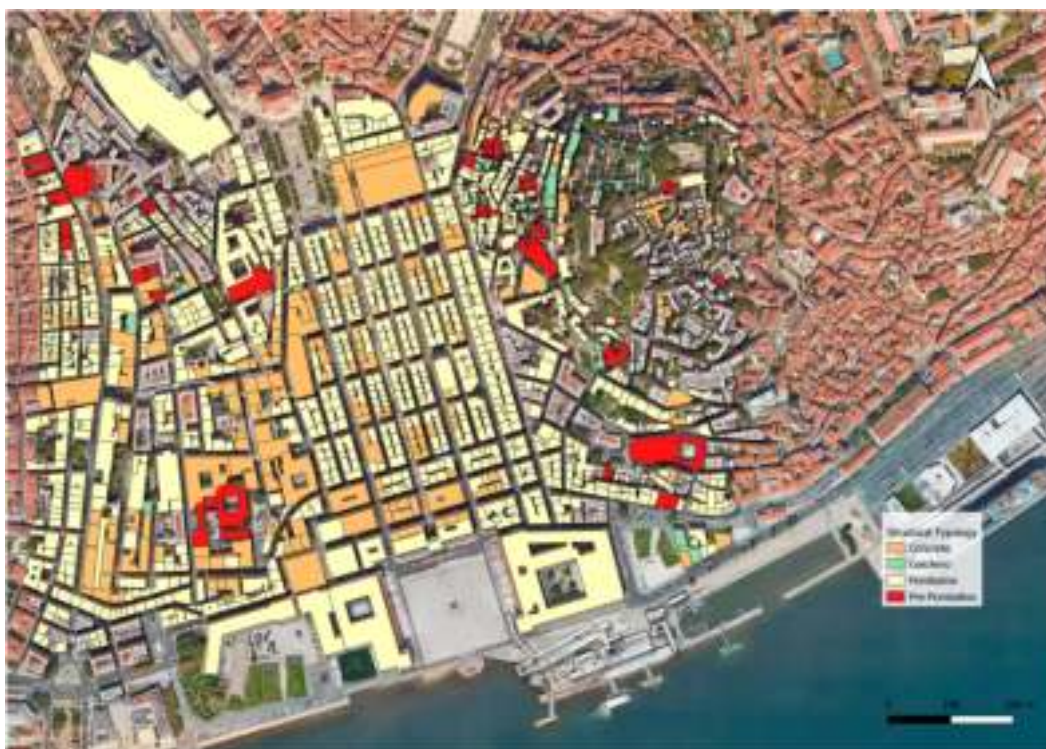
Figure 6. Construction typology of the buildings under study.

To establish a clear and concise evolution of building typologies, it can be said that masonry buildings constitute an important percentage of the building heritage of the city. Given the evolution over time of construction practices in masonry buildings, it is possible to detect variations in terms of architecture and construction types and structural design [41]. These differences determine significant variations in the seismic resistance of the different building types identified. Among the types of masonry buildings built after 1755, three phases can be distinguished: “Pombalino”, “Gaioleiro” and “Placa” buildings. The differentiation between the building types mentioned is based not only on the time of construction but essentially on the presence or less of wooden structural elements [42]. It is, therefore, possible to establish a subdivision in terms of building types based on their structural characteristics directly related to the time of construction and the construction technologies used (Figure 6).

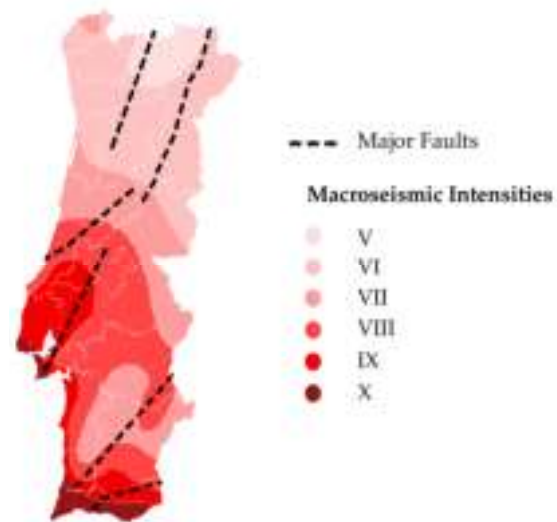
Figure 7. Map of macroseismic intensities and major faults in Portugal. Adapted from [45].

The Lisbon region and the Algarve region are located in the area with the highest seismic risk on the Portuguese continent; noteworthy are the regions of Tagus Lezíria and the Setúbal peninsula, located in the “Lower Tagus Valley Fault”, which also have a high seismic vulnerability. In addition, the coastal region of Alentejo has a medium-high impact index, along with a significant frequency of seismic events (Figure 7).

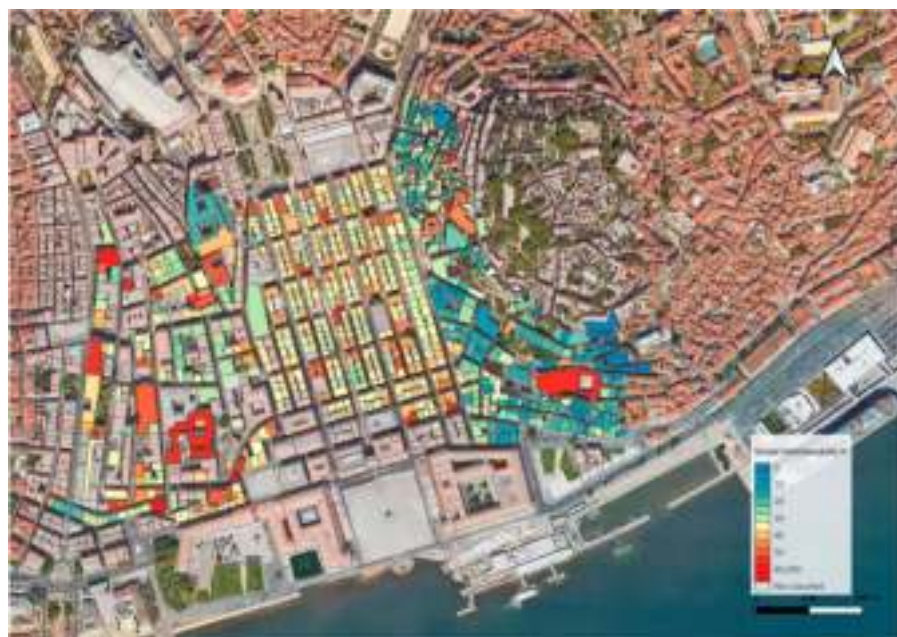
Figure 10. Vulnerability index calculated according to the Vicente method (2011).

From all the information obtained from the research data implemented above, it was possible to obtain all the information necessary to assess the seismic vulnerability of the buildings in the historic center of Lisbon. Two simplified assessments were performed: the first takes up the study done by Catulo [32] on the *Baixa* area, which is based on the Vicente method (2011) based on vulnerability index (VI). Figure 10 shows the mapping of the vulnerability index VI obtained.

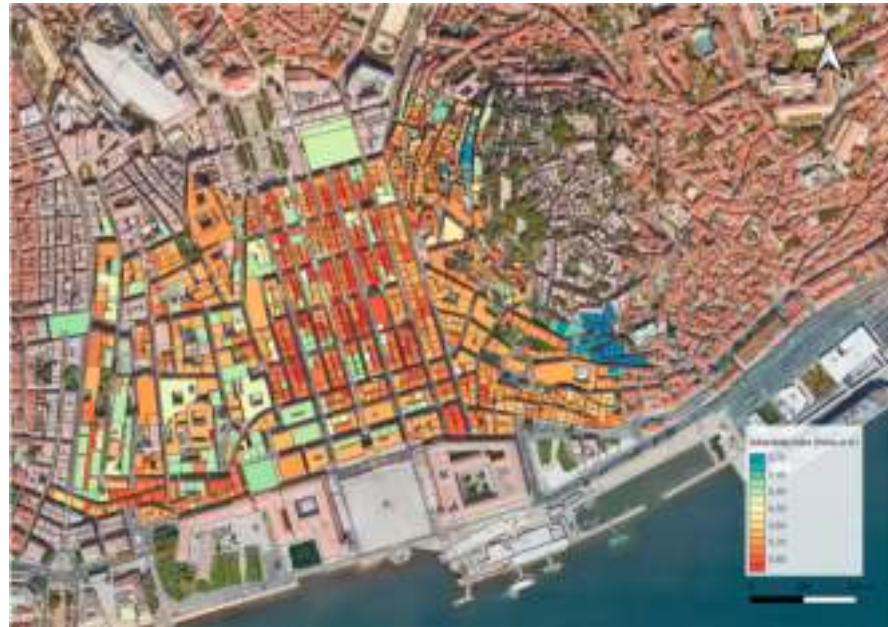
Figure 11. Vulnerability calculated based on the Polese et al. method (2011).

The second method applied for the definition of vulnerability V is the one proposed by Polese et al. [35] (Figure 11), which adapted the method applied by Lagomarsino and Giovinazzi [8] based on the damage probability matrix (DPM). This method needs less data than the previous one.

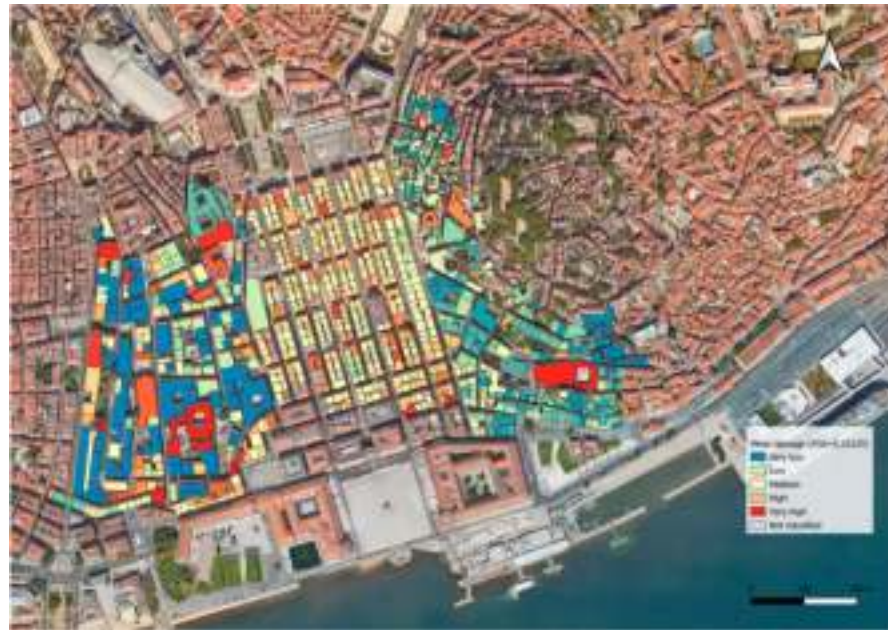
Figure 12. Mean damage (Vicente).

The mean damage based on the Vicente method (VI) is shown in Figure 12.

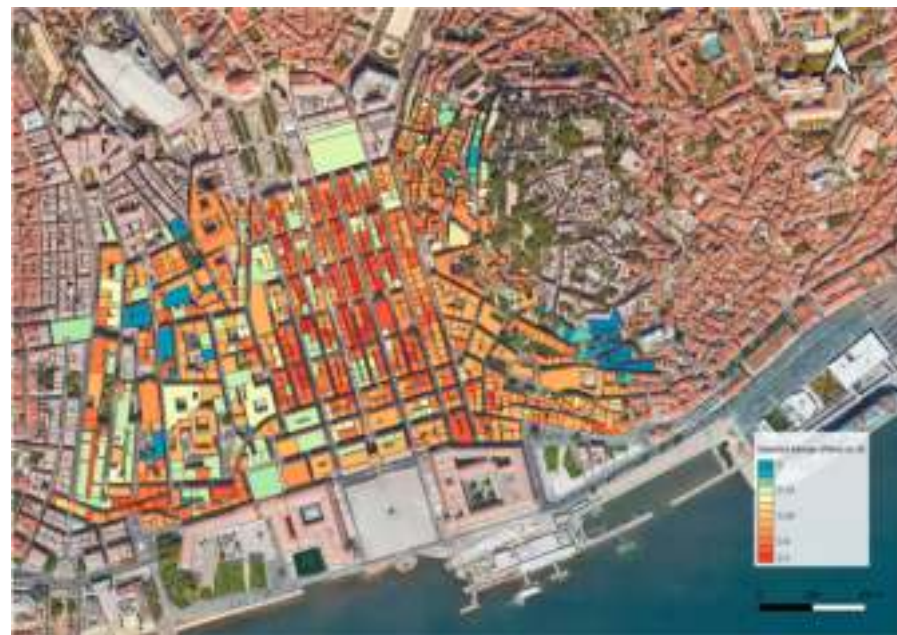
Figure 13. Mean damage (Polese et al. method).

The mean expected damage calculated based on the Polese et al. method is also reported (Figure 13).

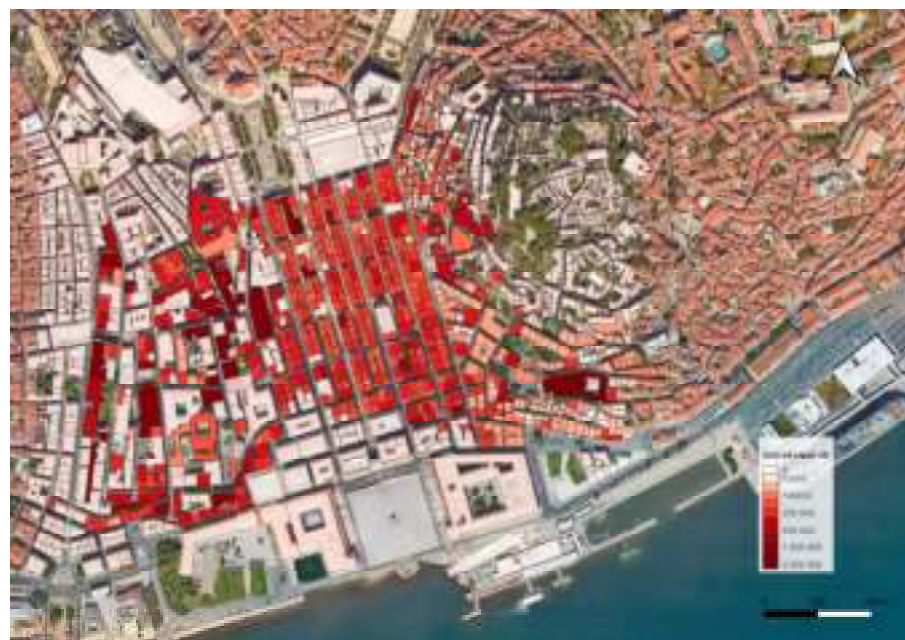
Figure 14. Cost of repair of Lisbon downtown (€).

To calculate the economic losses, with reference to the procedure previously described, in the case of Lisbon, a reconstruction cost of EUR 5000/sqm was considered. By multiplying this cost by the floor area and the number of stories, the total cost of the considered building can be found. This value is then multiplied by the percentage referring to the level of damage based on Vicente et al. (Table 5) to obtain an estimation of economic losses. The same technique can also be used to determine casualties, multiplying the proportion of fatalities and injuries by the total number of individuals and the impact, which is determined

The results of the calculations carried out using the Qgis software [48] in terms of repair costs are shown below since it is the most relevant result in terms of losses to be reported on the map (Figure 14).

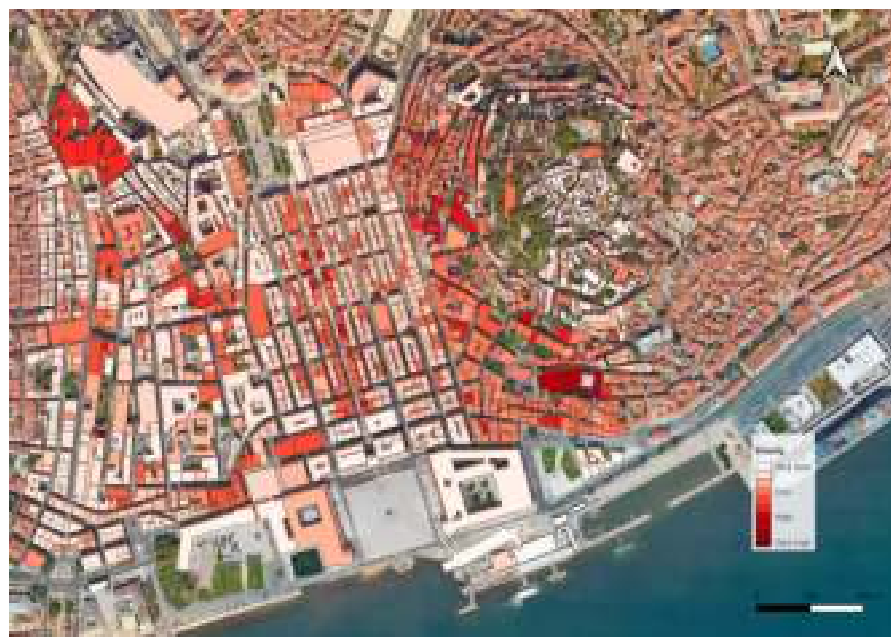
Figure 15. Map outlining the priorities for intervention in the historic center of Lisbon.

The result of this processing is shown in the map in Figure 15 which indicates the priorities for action on the built heritage in ascending order.
