Trinity Restoration Inc. Theater Design

393 Broad Street | Providence | RI
Community Partner: Trinity Restoration Inc.

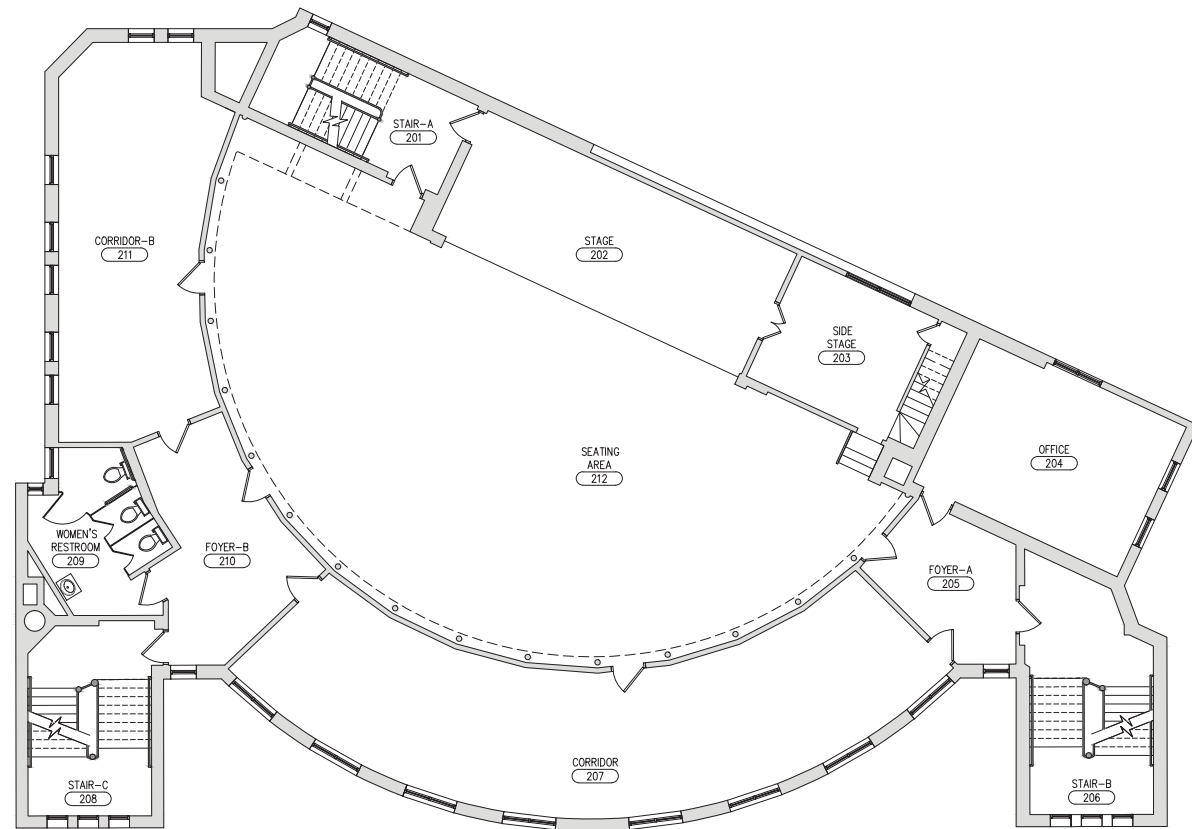
Second Floor

Existing Floor Plans

Site Investigation: The student team visited the site on several occasions to sketch and measure the interior layout of the theater space. The results of the investigation were used to create scaled floor plans in Auto-CAD.

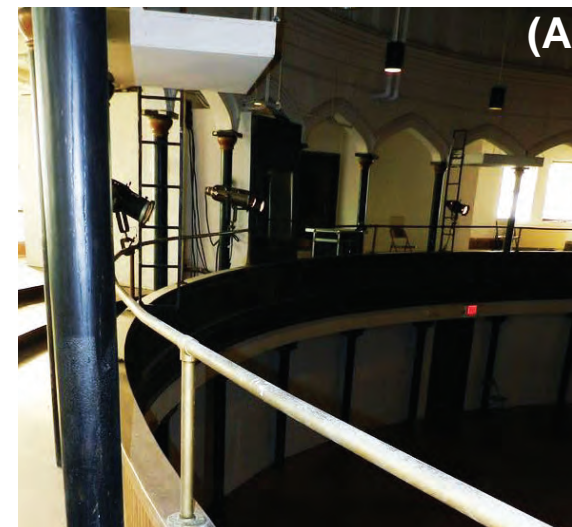
(A) Mezzanine hand rail

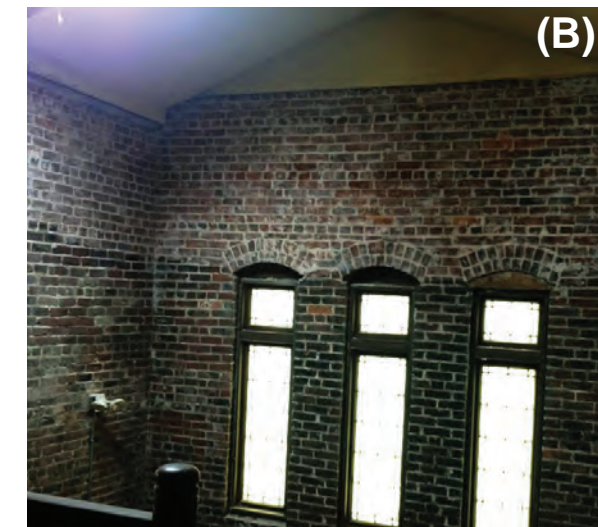
(B) View from stairwell

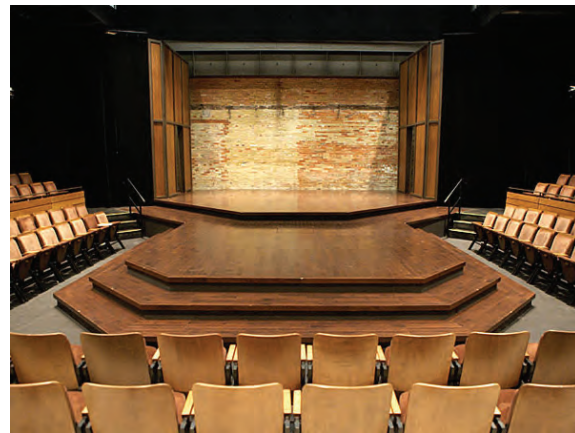
The Marilyn and Charles Baillie Theatre

Located at the Young Centre for the Performing Arts in Ontario, Canada, this building holds approximately 315 seats. The theater is a multi-configurable space with orchestra and balcony seating. It is set up with a proscenium configuration but can be rearranged for other functions.

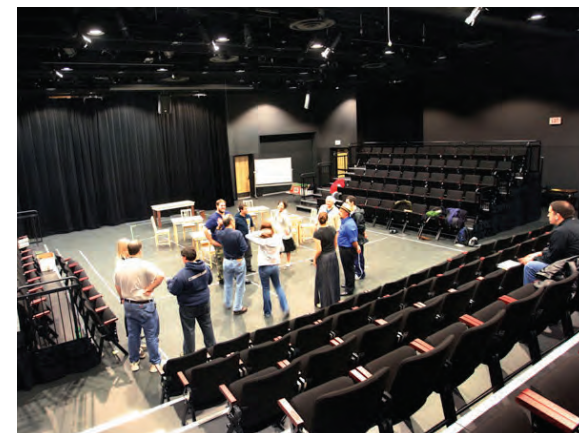
Edmonds C.C. Black Box Theater

Located in Edmonds, Washington, this “Black Box” theater implements a design that accommodates flexibility for seating, stage layout and AV device locations. This approach allows scheduling to become easier since different uses can be set up quickly.

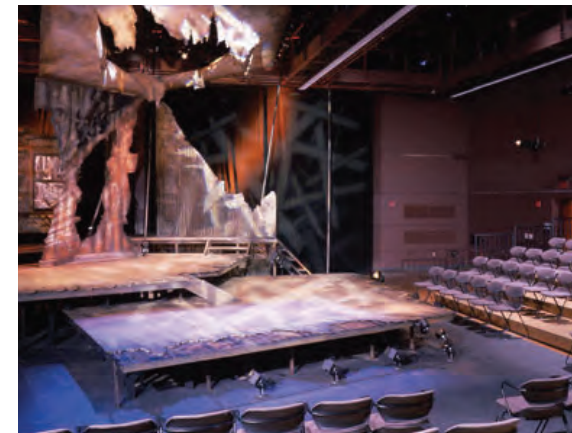
Kogod Theatre

Located at the University of Maryland, this multi-purpose, flexible theater can accommodate various seating configurations for a maximum capacity of 156 people. In addition, a modular stage can be manipulated to suit the needs of individual performances.

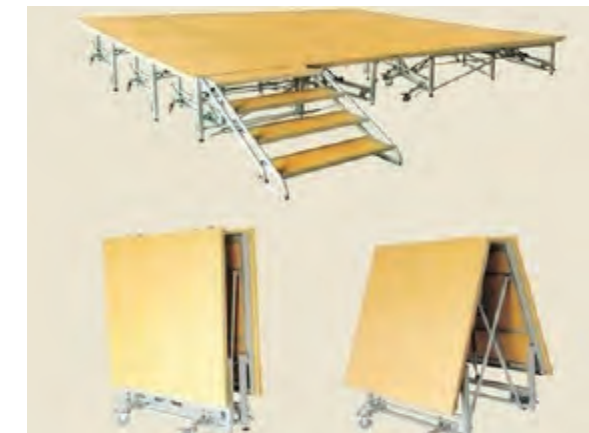
Portable and Modular Stages

There are many stages that can be moved into place using mobile techniques such as wheeled systems. These lightweight systems allow for easy storage. The above system is able to be folded up and rolled to the desired destination. Some lower budget theaters use them as permanent stages.

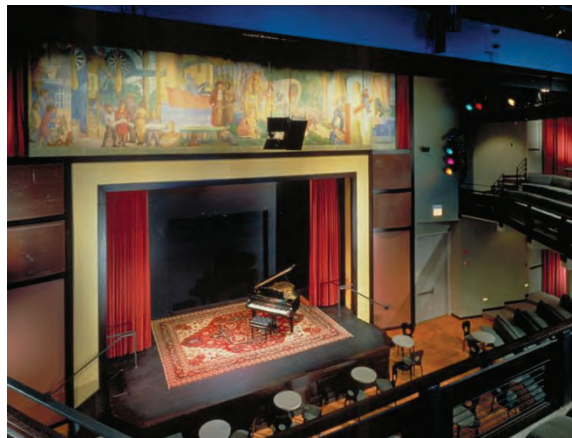
Old Town School of Folk Music

Located in Chicago, Illinois, this renovated library was turned into a 400-seat concert hall with an upper balcony. There is fixed seating on the balcony as well as fixed “bench” seating on the main level. In addition, moveable table and chair sets are placed along the front of the stage to allow for flexibility from performance to performance. During the day, the theater entry doors are opened which allows the space to be used for café seating.

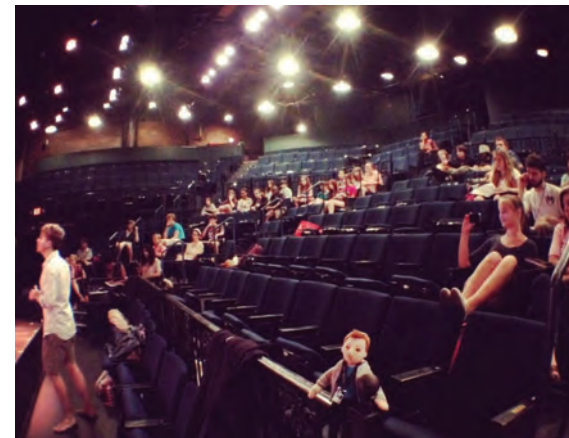
Trinity Repertory Company

Located in the Providence, Rhode Island this historic building houses two performance spaces. The lower level theater houses 286 seats, while the upper performing space holds over 500 seats. The large performance hall offers an assisted listening system so the hearing impaired are not restricted to up-front seating.

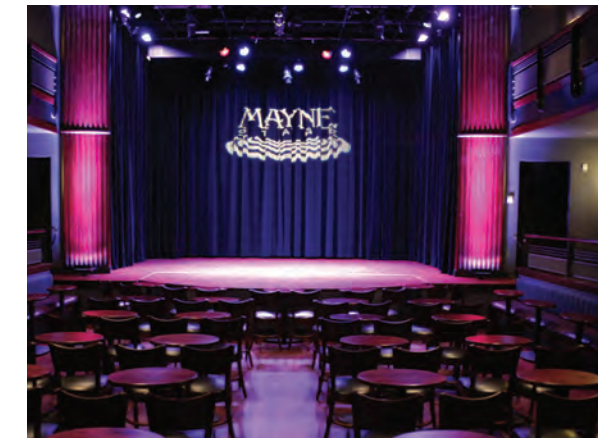
Mayne Stage

Located in Chicago, Illinois, the former Morse Theater, is able to be utilized as two different venue options. The theater can hold a capacity of 220 people when the space is filled with tables. When an event calls for mixed audience seating, 400 people can fit with a mix of standing spaces and additional seating.

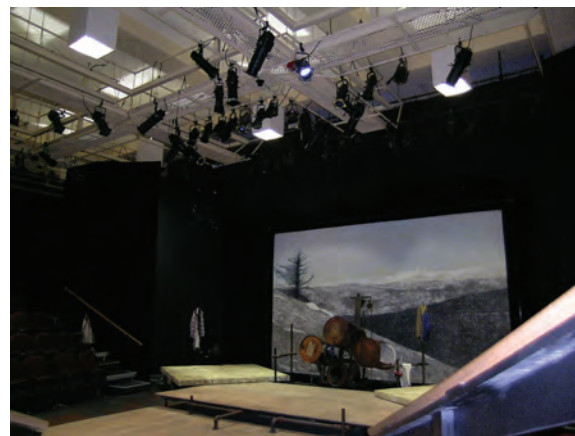
Lost Nation Theater

Located in, Montpelier, Vermont, this hall is known for its versatility. Theater lighting is often laid out in the form of grids. This theater decided to use catwalks for their grid format. To avoid distraction, the catwalks were painted the same color as the ceiling. This approach makes it easy for lights to be altered for different performance types.

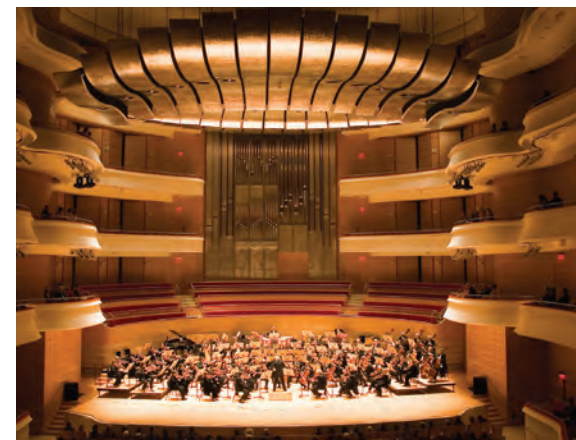
The Renee & Henry Segerstrom Hall

Located in Costa Mesa, California, this building implements a wide variety of LED Lights to achieve dazzling effects. In 2008, this space won an award of excellence for the International Illumination Design Awards. The LED lights wash down the 4' high fronts of the curved balcony. Accent lights, and fiber optics are also used in the lobby before entering the performance space.

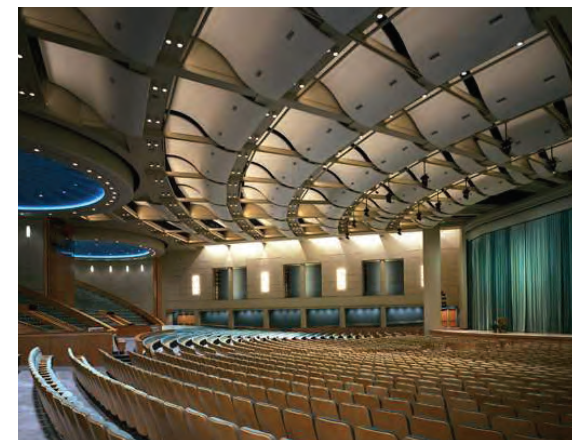
Minneapolis Convention Center

Located in Minneapolis, Minnesota, this large venue is often broken down to accommodate smaller events. The xenon fixtures are secured and accessible from catwalks to allow for quick changes. This lighting is supplemented by 400W quartz (incandescent) down lighting. There large bays are indirectly lighted with surface mounted strip-lights that are concealed behind columns.

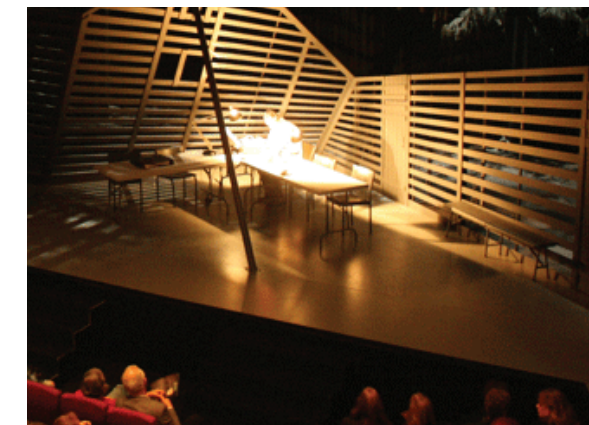
The Queensland Performing Arts Centre in Brisbane, Australia recently completed a major renovation of its 1800-seat concert hall. Since the installation of energy efficient lighting, energy consumption and cost have decreased. The stage lighting, which was once the top energy user, has fallen well behind other common theater units, such as air-conditioning.

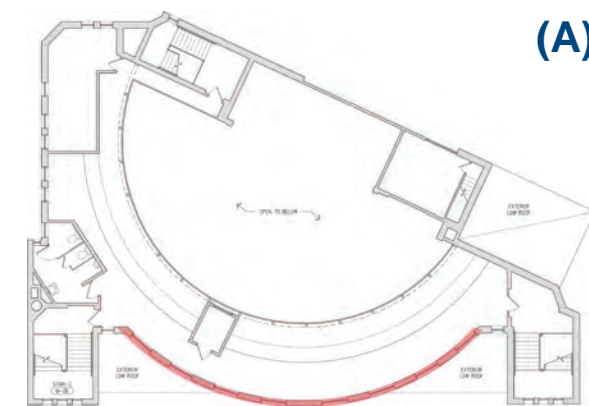
(A) Mezzanine Floor Plan

(A) Circular Form: The two walls identified in Diagram (A) and (B) are problem points for the acoustical quality of this theater. The exterior wall on the mezzanine has been built in a circular pattern and the gypsum wall on the second floor is made up of flat sections set up along a circular arc. These concave rear walls create a unique set of problems.

Problems: (1) Sound travels very quick around the curve of the wall creating a disproportional

amount of sound on the opposite ends of the arc. (2) Sounds that start in front of the curve gets reflected back to a focal point. The location of that focal point moves depending on where the sound is located. As a result, loud refocused echoes are created at the focal point. When heard, the sounds seem to come from a mysterious place. The effects of the curved walls are extremely strong and need to be addressed. One common mistake is over applying absorptive material to the walls. This solves the focal point problem but creates a “dead wall” problem.

Solutions: (1) Apply some acoustic absorptive material at the surface of the curved wall. This will pull the sound to the back of the room. (2) Apply reflective material in a scattered pattern where absorptive material is not implemented. The remaining sounds need to be scattered and reflected in directions away from the focal point. The typical sound scattering device implemented is a curved acoustical panel. This panel is essentially a thin flat plane that is bent to have a reversed curvature to the curve of the wall. This panel will scatter mid and high range sounds. In addition, the panel must also be a bass trap so that the reflecting low frequencies do not focus. (3) An alternative would be to increase the angles and depth of the rear walls. By adding irregular forms and voids, sounds can be

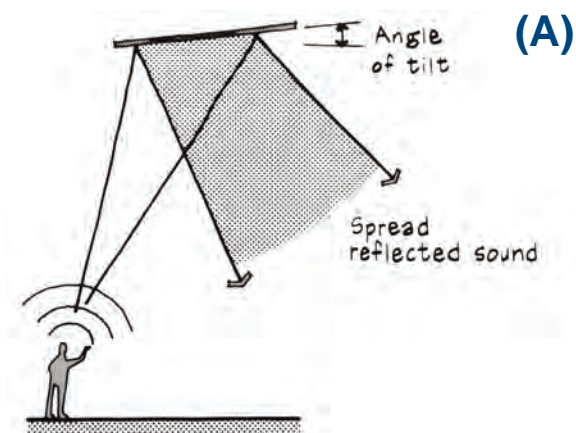
(A) A typical reflector spreads sound. The angle of tilt can be changed depending on the performance or occupancy.

Solutions: (1) Create a reflective shell for the interior of the stage to reflect sounds. The proscenium opening can lead to poor acoustic coupling between the stage and seating area. By lowering the ceiling height of the stage and angling the shell towards the audience, sounds will travel outwards instead of above, behind or adjacent to the stage. (2) Construct a platform that can be set up in front of proscenium stage for specific performances. This can greatly minimize the problems associated with the coupling between the stage and auditorium. Unfortunately, the trade-off is in the elimination of seating. (3) Install acoustical panels in front of the stage from the ceiling. The suspended acoustical panels should be adjustable. Different performances call for different panel heights. By making them adjustable the performer can test the heights before the show. (4) Avoid using the foyer space for seating. Overhanging mezzanines are great for creating extra seating but the space below often has poor acoustical qualities. The sound is usually dull and muffled. By following these measures the large size and ceiling heights can become a strength for Trinity Restoration instead of a weakness.

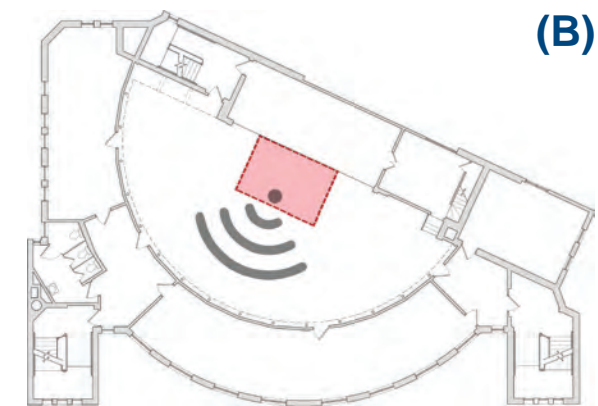
(C) If you can see the source you can hear the source. This is a good rule of thumb for seating layouts.

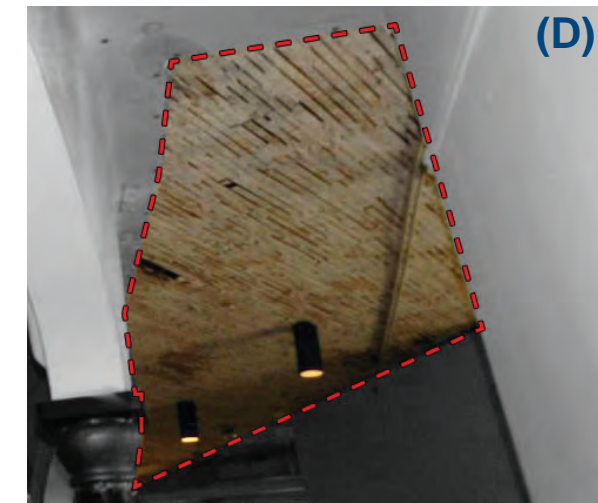
(D) Sufficient mass is necessary to keep desired sound in and unwanted noise out. All penetrations must be properly repaired.

Problems: To provide effective sound isolation the doors, walls, and roof need to be solidly built with sufficient mass. In addition, any penetrations in these variables or through windows must be sealed to keep the desired sound in and the unwanted noise out.

Solutions: (1) Consult a acoustician about replacing your current windows and doors with sound-rated products. (2) Consult a licensed contractor about repairing the building and sealing all voids that could allow leaks to the exterior of the space. Without eliminating sounds leakage, any efforts to improve the acoustics of this space will be under minded.

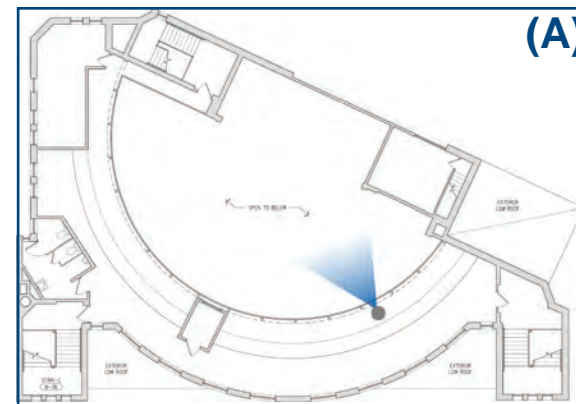
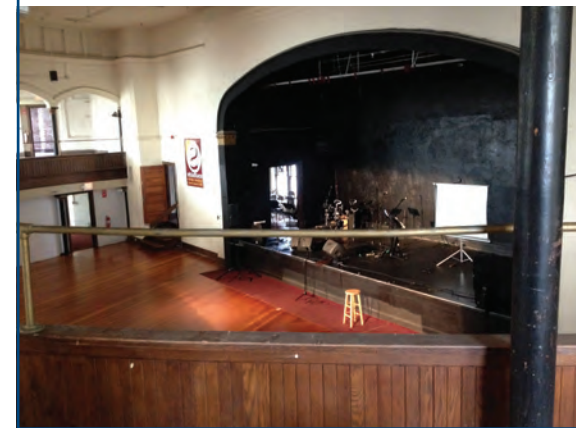
(A) Mezzanine Floor Plan with visual icon indicating view of stage.

Mezzanine Investigation: Visual connection is vital for theater design. Site lines are important design factors that must be kept in mind during the design process. The final design must create a built environment and a circulation that does not obstruct any views. The column arrangement and handrail position on the mezzanine will force a rigorous design approach to create seating with desired site lines. The current condition of the mezzanine has two levels but there may be a possibility to increase higher seating capacity by adding another seating section.

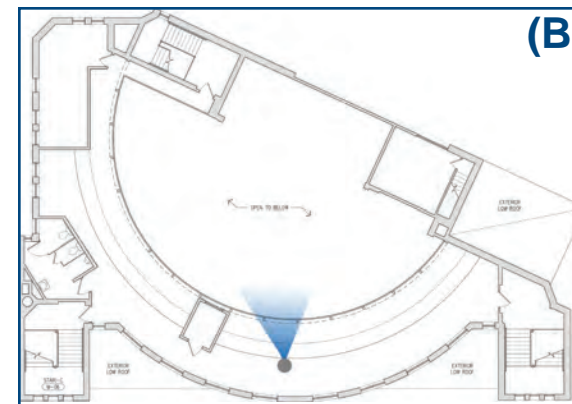
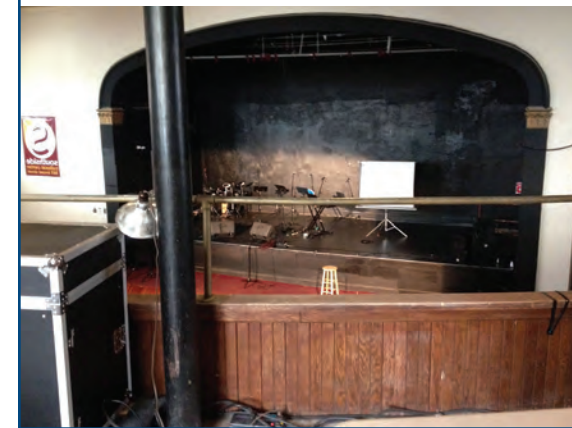
(B) Mezzanine Floor Plan with visual icon indicating view of stage.

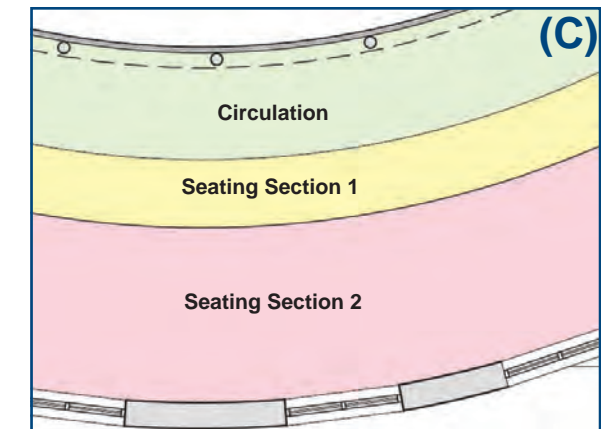
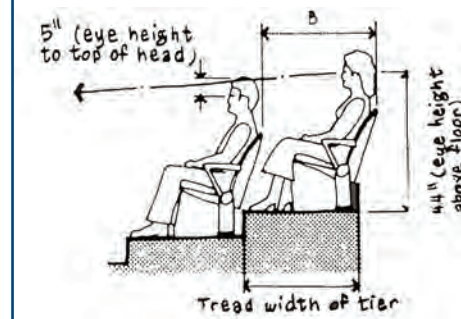
(C) Diagram showing current seating arrangement and the a typical stadium seating section.

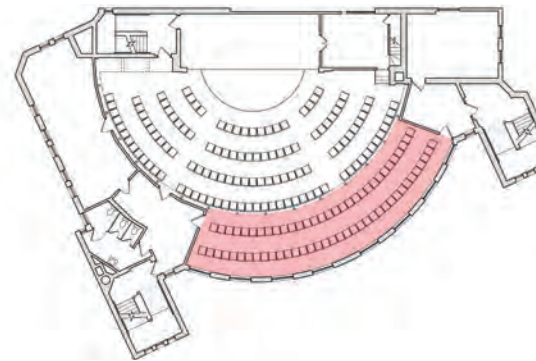
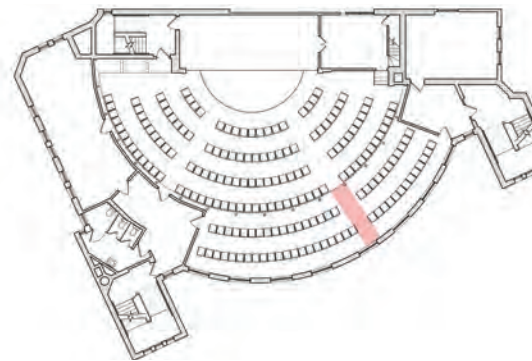
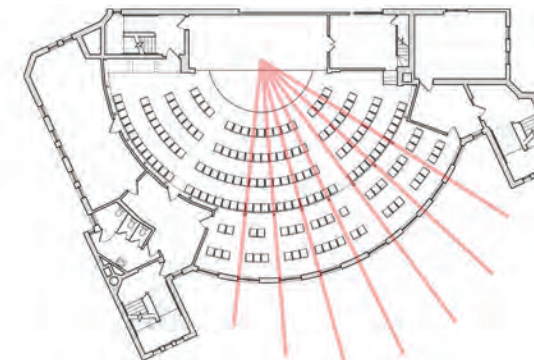
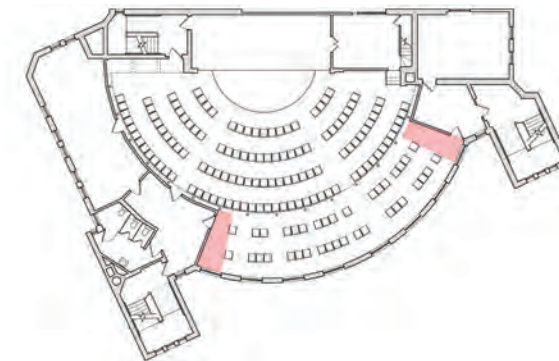
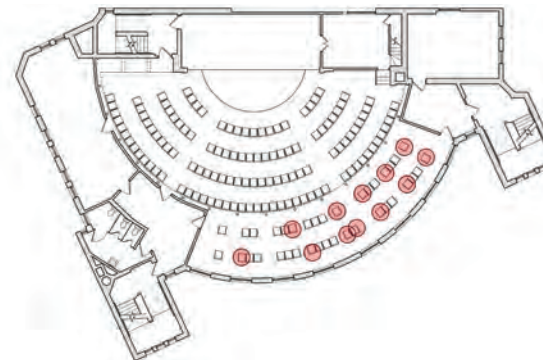
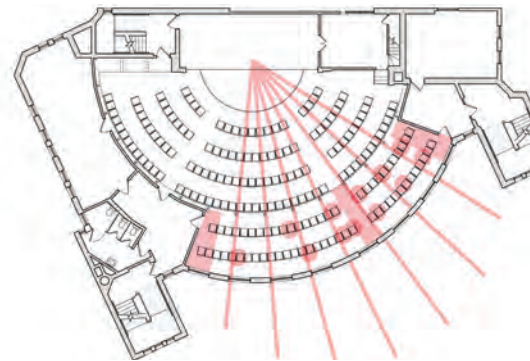
1 - Select space

2 - Remove seats for main aisle

3 - Remove seats due to columns

4 - Remove seats for side aisles

5 - Remove seats due to poor site lines

6 - Check results against project objection

Corridor Investigation: The space below the mezzanine has the possibility to hold many programs. One possibility is to open the space up as an extension to the theater seating. The CPC investigated the site lines in the space and concluded that the seating would not be able to hold a large amount of seats with high quality views. If TRI does pursue connecting the two spaces, the CPC recommends utilizing the space for unconcentrated seating. This style would allow for group seating options.

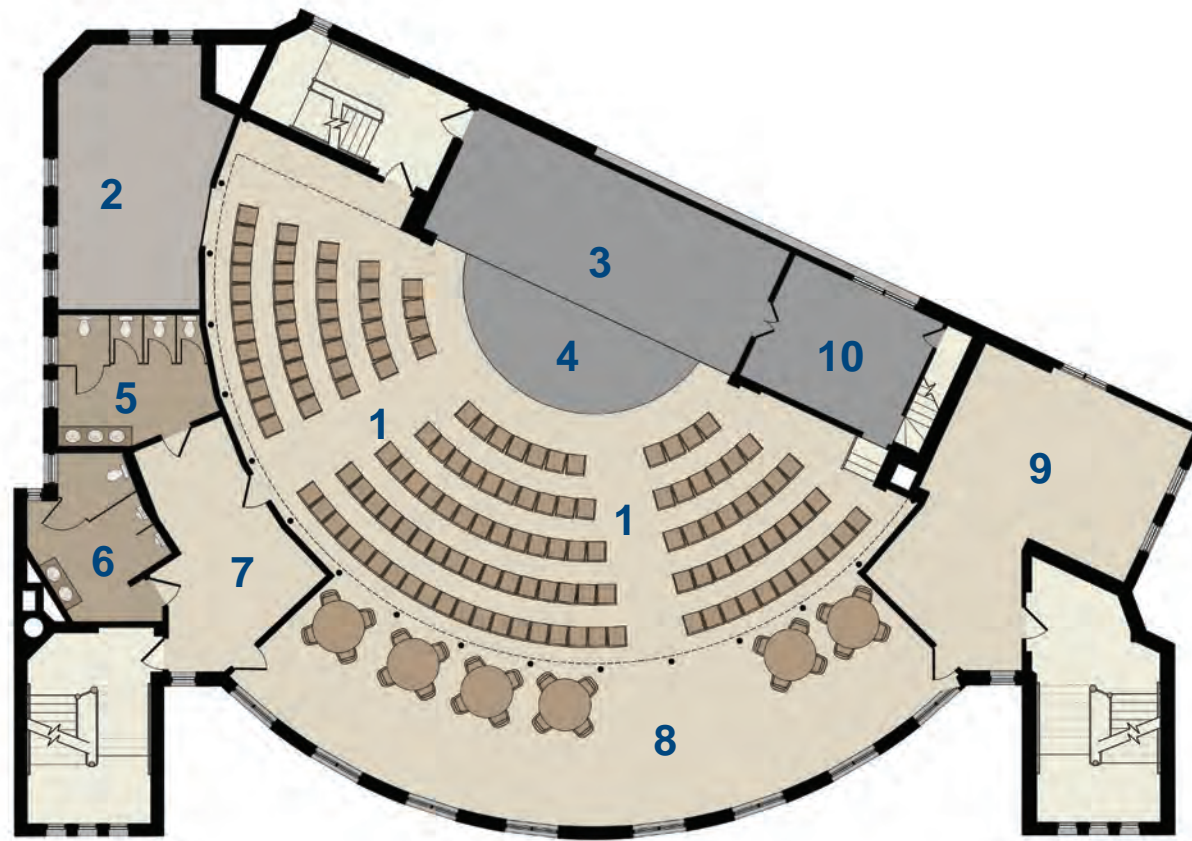
Second Floor

| 1 - Seating Area | 6 - Men's Bathroom | 11 - Unisex Bathroom |
| 2 - Storage | 7 - Foyer | 12 - Control Room |
| 3 - Stage | 8 - Flexible Space | 13 - Seating Area |
| 4 - Stage Extension | 9 - Sales | 14 - Storage |
| 5 - Women's Bathroom | 10 - Side Stage | 15 - Changing Room |

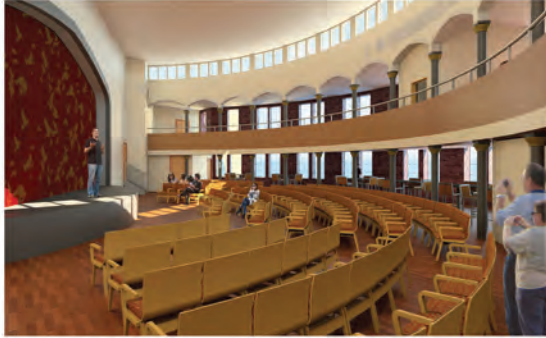
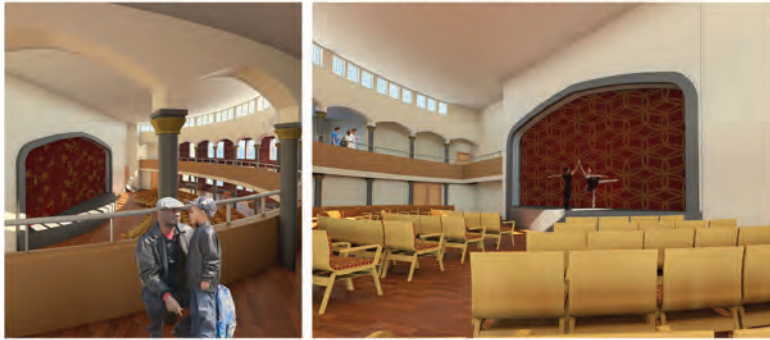
Curtain Design:

The material, ZEZ® fabric, being proposed for the Trinity Restoration Theater has been developed by Providence based designer Wanda Miglus. ZEZ® fabric is an optically interactive textile whose visual effect functions much like a hologram or lenticular graphic, where images/patterns change depending on the viewer's visual relationship to the fabric. This woven fabric is produced through commercially existing weaving technology and fibers.

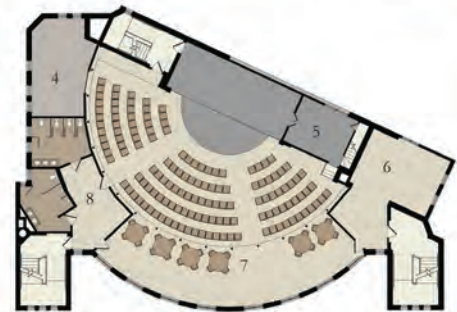
Second Floor:

Program:
1: Changing Room 2: Storage 3: Control Room 4: Storage 5: Side Stage 6: Foyer 7: Flexible Space 8: Foyer
