Detection of diesel engine valve clearance by acoustic emission.

## DETECTION OF DIESEL ENGINE VALVE CLEARANCE BY ACOUSTIC EMISSION

Fathi-Elamin, Y.Fan, F.Gu and A. Ball

<sup>1</sup> University of Huddersfield, Queensgate, Huddersfield HD1 3DH, UK

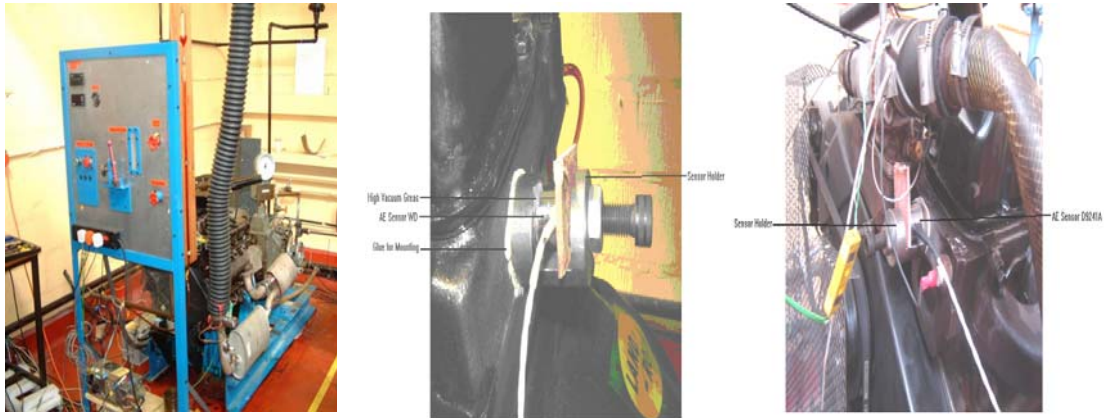
This paper used a 2.5-litre, Ford FSD 425, four-cylinder, four-stroke in-line OHV, direct injection compression ignition diesel engine as the source of acoustic emission data as seen in Fig. 3.

**Fig. 3** Photograph of test rig in situ. **Fig. 4** WD AE Sensor (Sensor1) **Fig. 5** D9241A AE Sensor (Sensor2)

Two types of AE sensors are mounted on the sensor holder which fixed on the engine cylinder by glue as shown in Figs. 4 and 5 and these are made by Physical Acoustics Corporation. One wideband sensor, WD, with an operating frequency range from 100kHz to 1MHz was connected to channel one as seen in Fig. 4 This type of sensor has a differential output to decrease the influence of noise. The second sensor is a differential sensor D9241 A, with operating frequency range from 20kHz to 180kHz, and this sensor was connected to channel two as seen in Fig. 5. These two sensors, with overlapping frequency ranges, were chosen for this study to determine the most suitable AE frequency for the condition monitoring of diesel engines.

High vacuum grease was applied between the sensor and the holder surface to get good signal conductivity. The two sensors were mounted in an appropriate places (both on the cylinder head of the engine) to collect the signals from all possible sources. The preamplifiers connected with these sensors are 2/4/6 preamplifiers and from the same company as made the sensors.

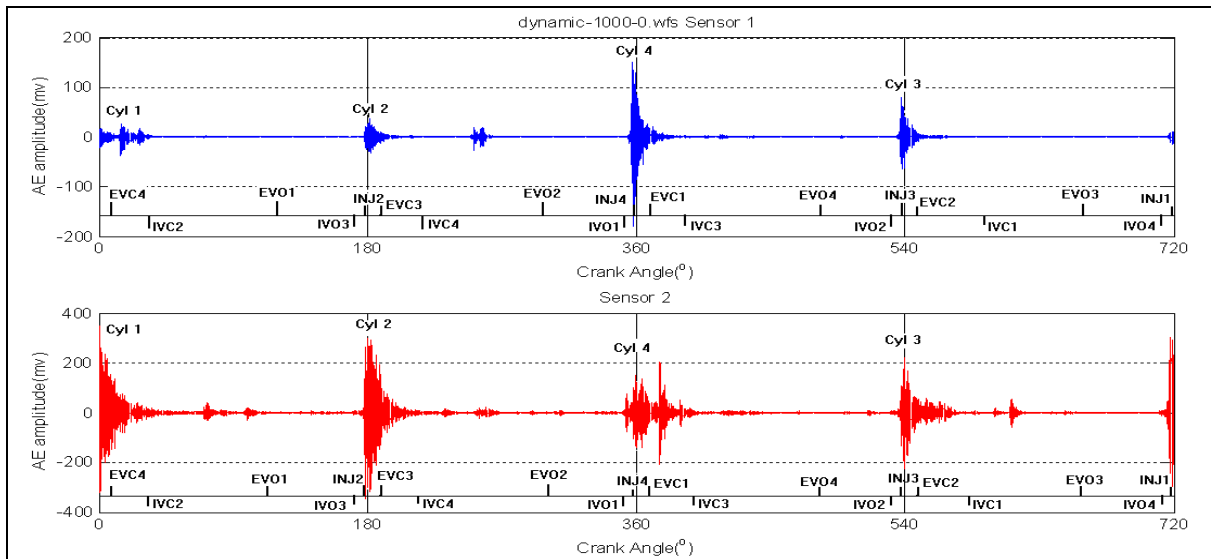
Fig. 7 shows the raw AE waveform recorded from a healthy engine running at 1000 rpm and zero load in a laboratory environment without any special consideration or precautions. It presents the AE signal acquired from one working cycle of the running engine versus crank angle from the two sensors mounted on the cylinder head of the engine (see Figs. 4 and 5). The mechanical events corresponding

to crank angle are shown along the bottom of Fig. 7. The main feature extracted from the AE waveform shown in Fig. 7 is that it exhibits four peaks equivalent to the engine firing sequences and each peak is caused by combustion in one of the cylinders of the engine, from left to right, cylinders 1, 2, 4, and 3. There is obvious difference in amplitude between sensors one and two, because of the different frequency ranges of each sensor, and the different sensor's mounting positions.

Thin vertical lines indicate TDC for each cylinder in their fire order: 1/ 2/ 4/ 3. On the figure, INJ is injector; EVO is exhaust valve opening; EVC is exhaust valve closing; IVO is intake valve opening; IVC is intake valve closing; and the numbers 1 to 4 represent the number of the cylinder.

As can be seen from Fig. 7, the largest AE signals, observed at both sensor positions are associated with injection events and occur around TDC for each cylinder. The highest AE amplitudes are, as would be expected, observed at the sensor close to the source, since the magnitude of the signal will decrease with distance from source. Smaller amplitude events are also associated with exhaust valves opening.

**Fig. 7** Raw AE signal from a running engine at zero Nm with 1000 rpm

The major mechanical events in the engine cylinder head are injection, fluid excitation, exhaust valve opening and mechanical impacts. It can be seen from the AE waveform shown in Fig. 7 that there were four large AE events equivalent to the engine firing sequences and each event was caused by the combustion in one of the cylinders of the engine.

The AE peaks, observed from both AE sensors were associated with injection events and occurred around TDC for each cylinder. Smaller AE events associated with exhaust valves opening can also be observed. The highest amplitude signal detected by sensor one was due to the events occurring in cylinder four. This is because sensor one was mounted closest to cylinder four. The highest amplitude at sensor two is due to events occurring in cylinder one. Numerous authors have confirmed that the highest amplitude AE signals are detected by those sensors placed closest to the source [7].

For a given sensor the figures show that the dominant event follows the fuel injection; that exhaust valve opening is the most significant of valve events that events associated with the engine exhaust valve differ from those associated with the intake valves. The intake valve movement involves lower kinetic energies and the pressure differences across it might be expected to show lower inherent signal energy, and this almost certainly explains the non-appearance of clear exhaust valve closing events.

The injector events for each cylinder occur at crank angles of around  $0^{\circ}$ ,  $180^{\circ}$ ,  $360^{\circ}$  and  $540^{\circ}$  after TDC for cylinder-1, consistent with the firing order of 1, 2, 4, 3. However, it is possible that the valves events include a number of related events associated with impacts of the rocker arm with the push rod or valve stem. This is also evident in the AE data that the actual timing of the events can be slightly different. The difference in energy between cycles - e.g. as the kinetic energy between the two potential impact points at push rod and valve stem - is relatively random, depending on exactly the position of the rocker from the previous cycle. There are apparent inconsistencies between cycles, e.g. the exhaust valve opening events show differences between the various running conditions. This is due to the exhaust valve opening energy changing with the force the hot products of combustion exert on the face of the valve, an effect whose magnitude will depend on running conditions.

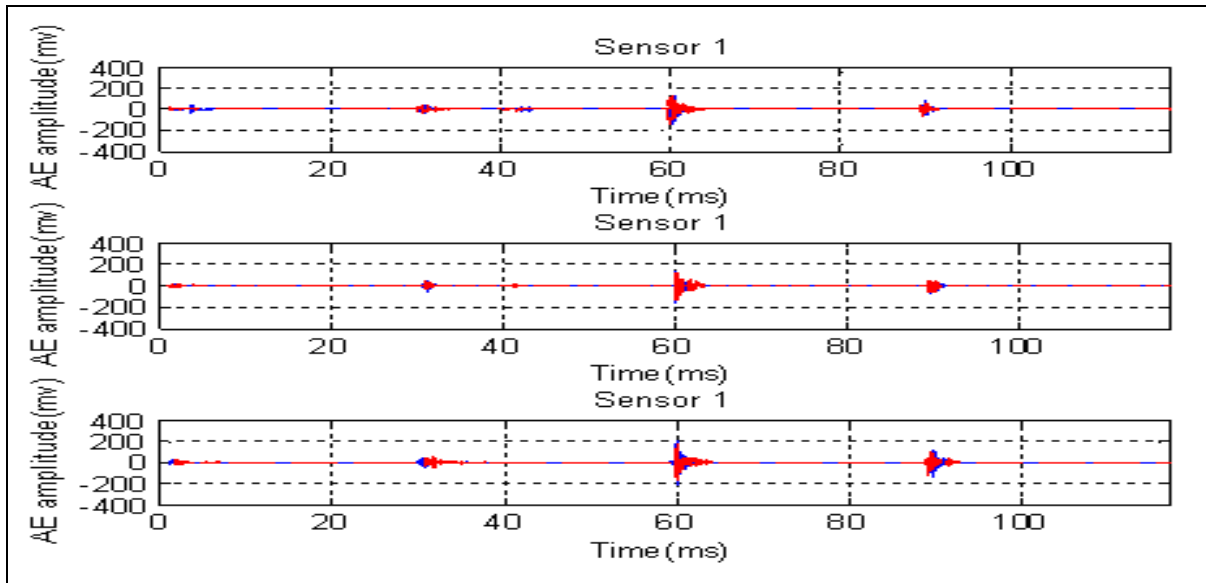
**Fig. 8 Time domain AE signal from sensor one for healthy (blue) and faulty (red) exhaust valve, speed 1000 rpm and different loads**

After investigated the AE activities from healthy engine, fault was introduced to the exhaust valve of cylinder 1 to see the response of AE. Fig. 8 shows the AE waveforms from sensor 1 when the engine ran at 1000 rpm with three different loads (0 Nm, 30 Nm and 60 Nm) under the healthy and faulty conditions. No significant change can be seen because sensor one had a higher frequency response and it was positioned relatively far from the faulty cylinder. There is obvious difference in amplitude between sensors one and two. This is mainly because of the different frequency ranges of the sensors. The different mounting positions also contributed to the variance of measurement. Furthermore, this seeded fault has no influence on the other healthy cylinders

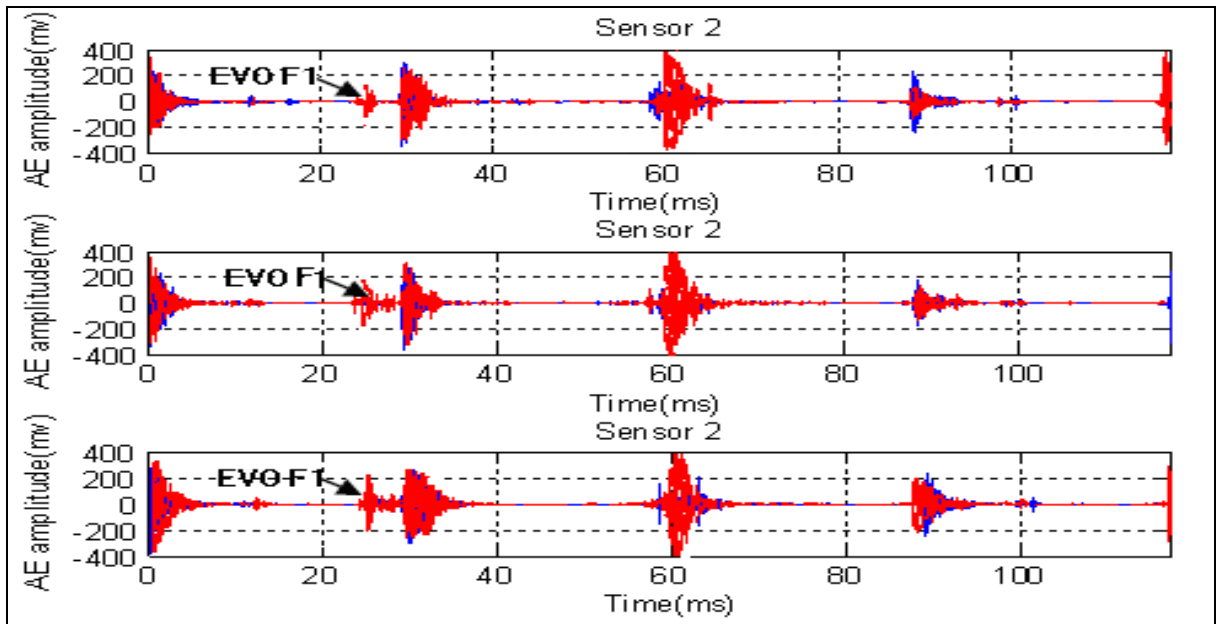
**Fig. 9** Time domain AE signal from sensor two for healthy (blue) and faulty (red) exhaust valve, speed 1000 rpm and different loads

Fig. 9 shows that there is no significant difference in the AE signals around TDC for the faulty condition compared with the healthy one. The introduction of the fault appears to have no significant influence on the AE signal from the other cylinders. However, if the AE amplitudes are examined more closely, a relative decrease of amplitude for the faulty condition can be seen. This is because of the AE wave propagation through the engine cylinder head will attenuate a little whilst passing along a transmission path from the AE sources to the position of the sensor and this small increase of attenuation originates from the increase in valve clearance.

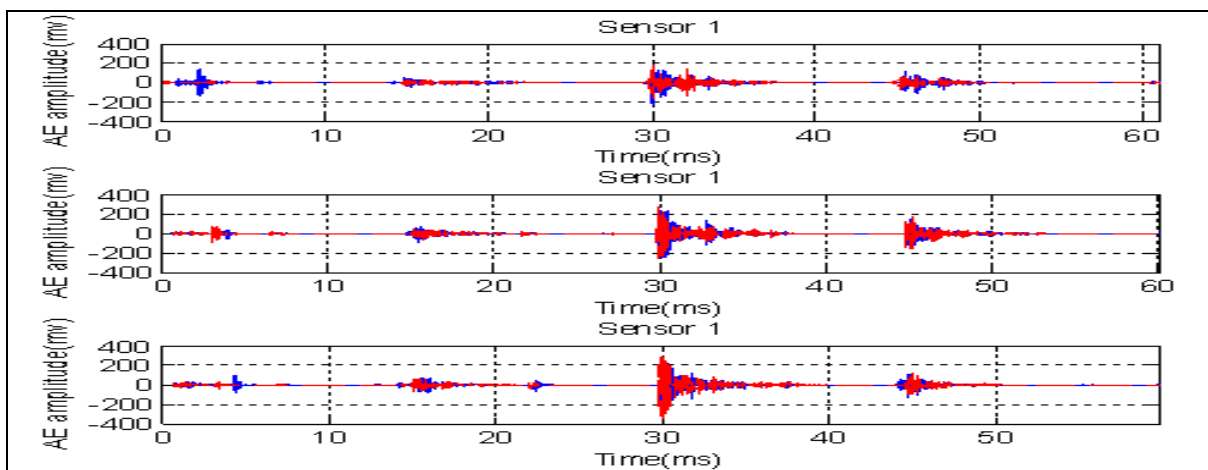
The change of AE signal from health to fault was more obvious when the engine speed was increased from 1000 rpm to 2000 rpm with different loads. It can be observed from the response of sensor one, shown in Fig.10, that the AE level under the faulty condition was lower than that under the healthy condition although the AE events were more or less the same.

**Fig. 10** Time domain AE signal from sensor one for healthy (blue) and faulty (red) exhaust valve, speed 2000 rpm and different loads

In Fig. 11 if the AE amplitudes are examined closely the decrease in amplitude in the faulty condition in comparison with the healthy condition, is more distinct than in Fig. 10. This means that the power output of the engine is reduced, especially in the faulty cylinder, and the other cylinders will try to compensate for this power reduction by increasing their power output because the engine is working as one system; for this reason the AE signal is slightly decreased under faulty conditions.

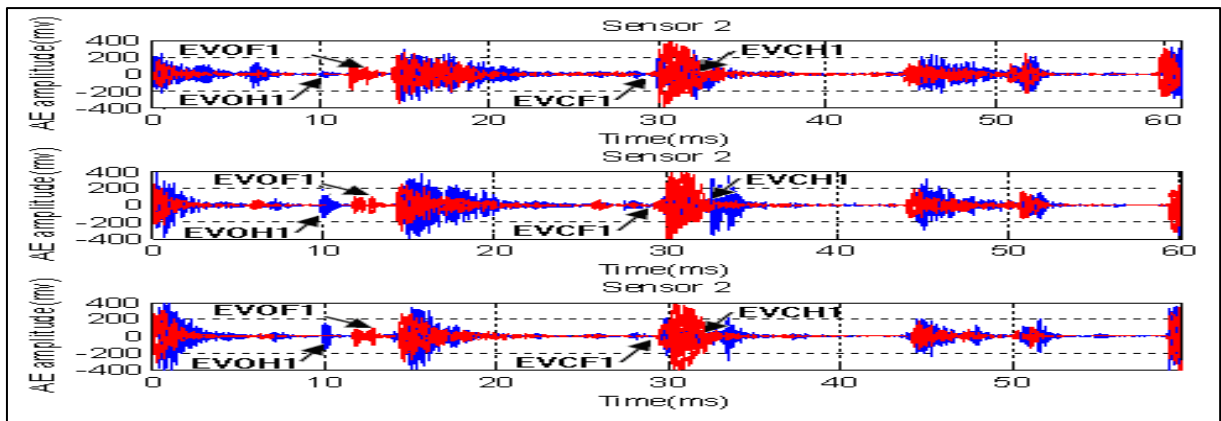
In Fig. 11 the AE signal for sensor two shows a significant difference in the peak levels for the healthy and faulty conditions. This is because the position of sensor two is close to the faulty first cylinder, and the exhaust valve opening event is clear for both healthy and faulty conditions. The figure shows a difference in the AE signal amplitudes for the exhaust valve opening event with and without the fault, it also shows a clear difference in the time of occurrence at which the exhaust valve opens due to exhaust valve timing differences. Opening occurs later, and closing occurs earlier, for the faulty exhaust valve. The faulty valve opens at  $5^\circ$  before BDC ( $46^\circ$  later than for the healthy condition) and closes at  $12^\circ$  before TDC ( $25^\circ$  earlier than for healthy condition),

**Fig. 11** Time domain AE signal from sensor two for healthy (blue) and faulty (red)

exhaust valve, speed 2000 rpm and different loads

A later open of exhaust valve reduces power output because of the increased volume of exhaust gases that must be discharged from the cylinder. This means that there are greater pumping losses while evacuating the exhaust gases from the cylinder. These pumping losses occur before the piston reverses at the end of exhaust stroke.

Early close of exhaust valve leads to a shorter valve overlap period and also reduces the engine volumetric efficiency significantly because the exhaust gas occupies the space that could be used for fresh mixture. Again this results in reduced engine power output. This is why the cylinder pressure with a faulty exhaust valve is higher than that with a healthy valve.
