# National Scale Landslide Susceptibility Assessment for Dominica

Technical Report · May 2016

# **National Scale Landslide Susceptibility Assessment for Dominica**

**May 2016**

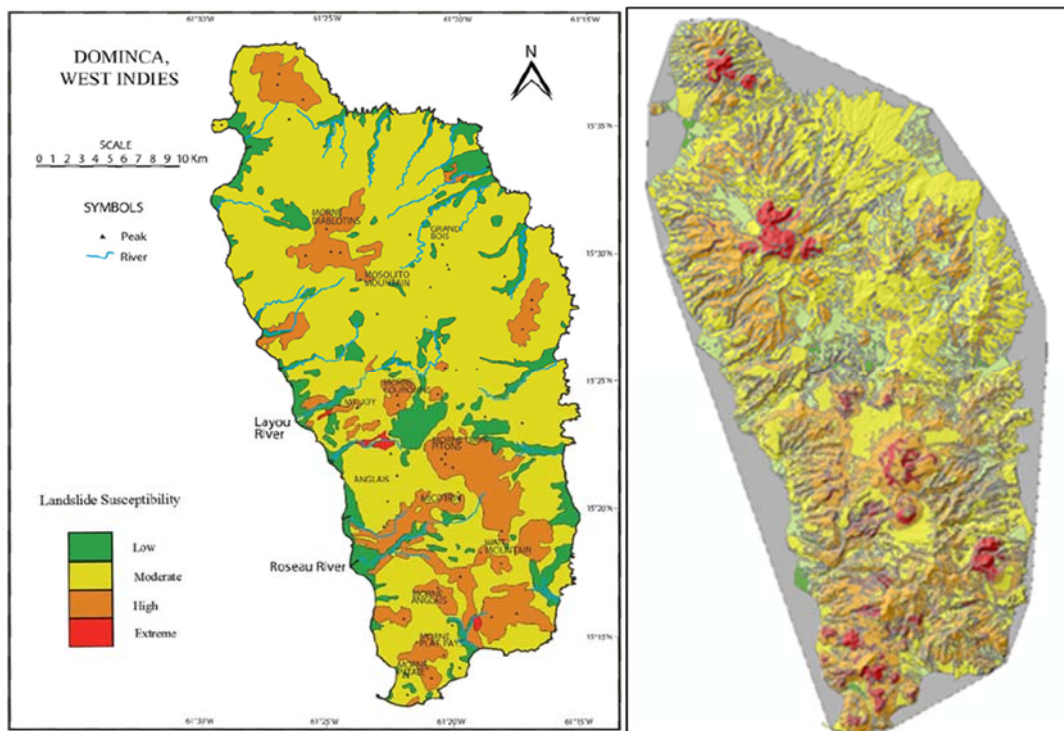
Figure 1-1. Previous landslide susceptibility maps for Dominica: Left: study carried out by DeGraff (1987, 1990) Right: study carried out by CIPA for USAID in 2006, as part of a multi-hazard mapping project.

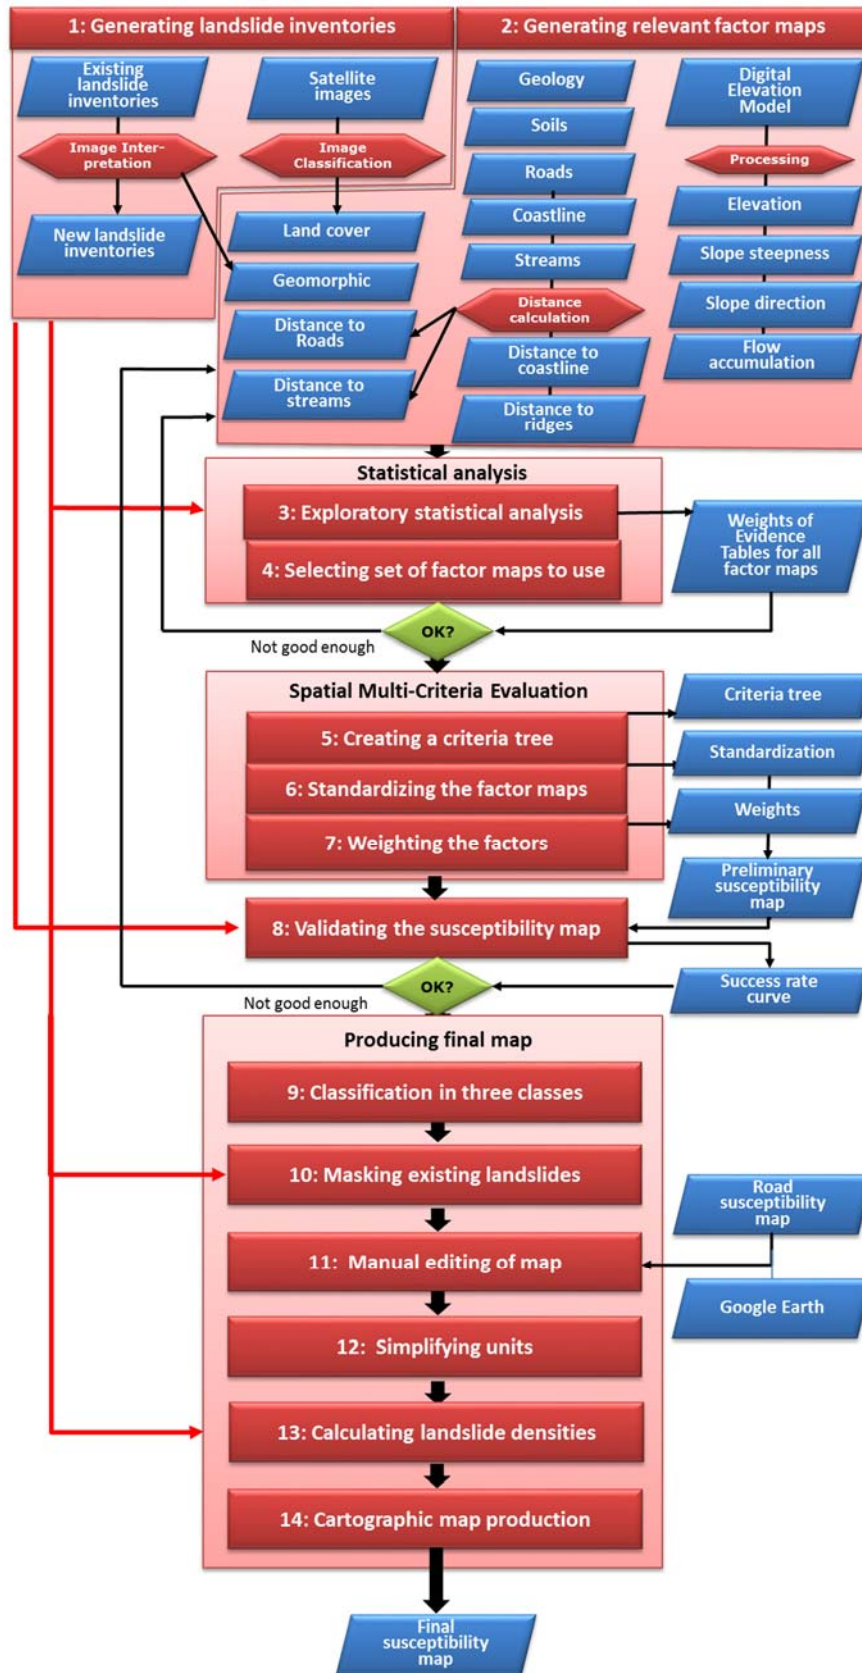
Figure 2-1: Flowchart of the method used for the generation of the national scale landslide susceptibility maps.  
See text for explanation. See also : <http://www.charim.net/use/83>

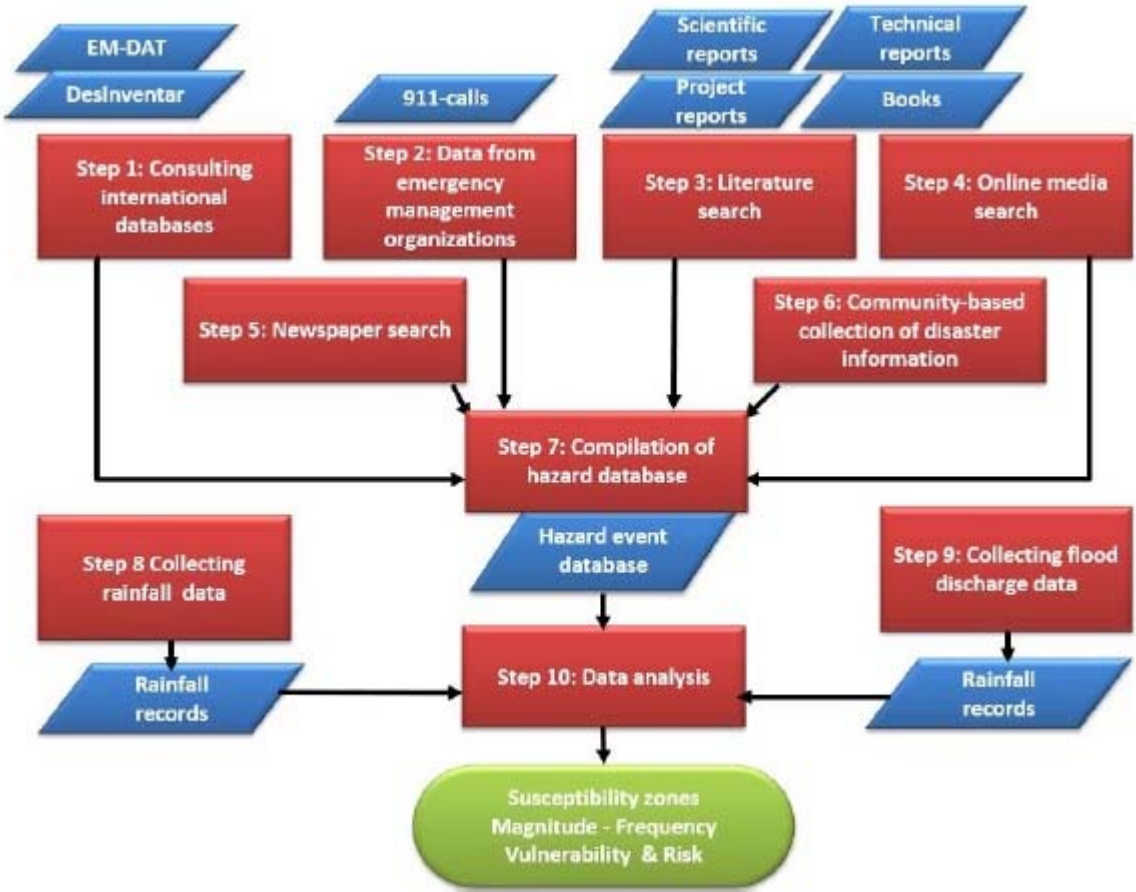
Figure 3-1: Overview of method for collecting information of past events.

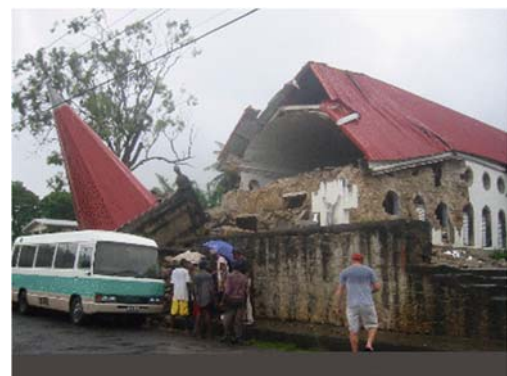
*Figure 3-2: Collapsed church tower in Portsmouth caused by the 2004 earthquake.*

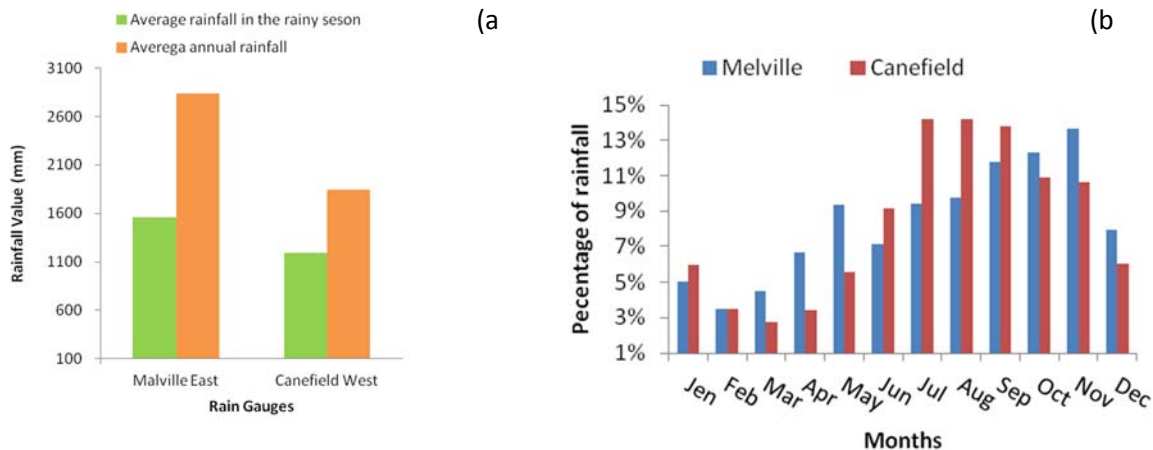
Figure 3-3: Distribution of rainfall, annually and monthly (A: average total annual rainfall and average rainfall in the rainy season b) percentage of rainfall per month in relation to annual rainfall from 1982 to 2013 for the two rain gauges considered: Melville on the East side and Canefield on the West side.

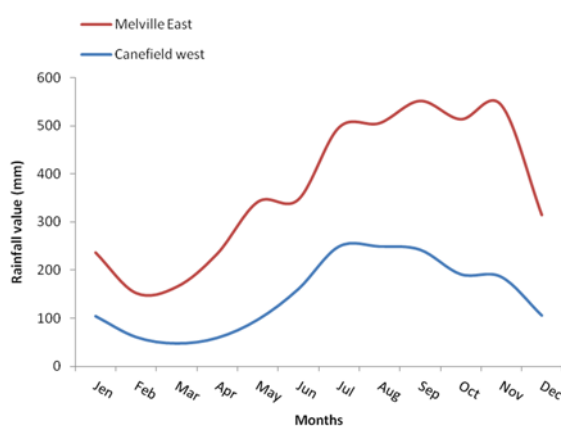
Figure 3-4: Mean Monthly rainfall for 32 years from 1982 to 2013 for two rain gauges.

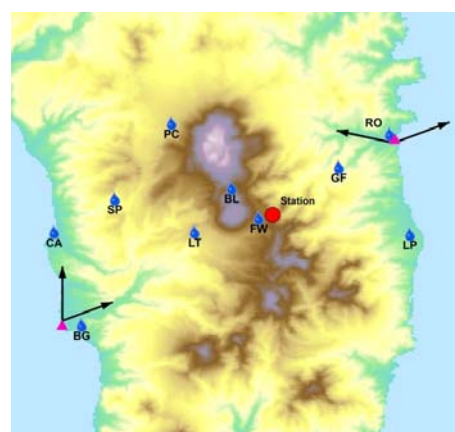
Figure 3-5: Location of 10 rain gauges installed for the DOMEX project at different altitudes and sides of the island in Dominica (Source: <http://www.domex2011.com/rain-gauge-network>)

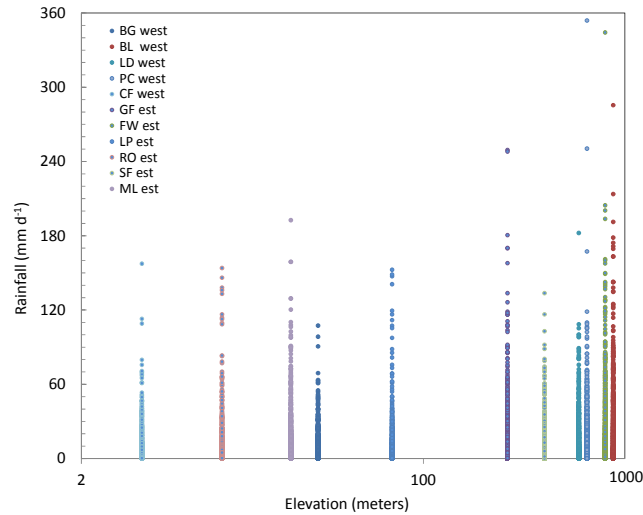
Figure 3-6: Relation between rainfall and elevation on Dominica for different rain gauges.

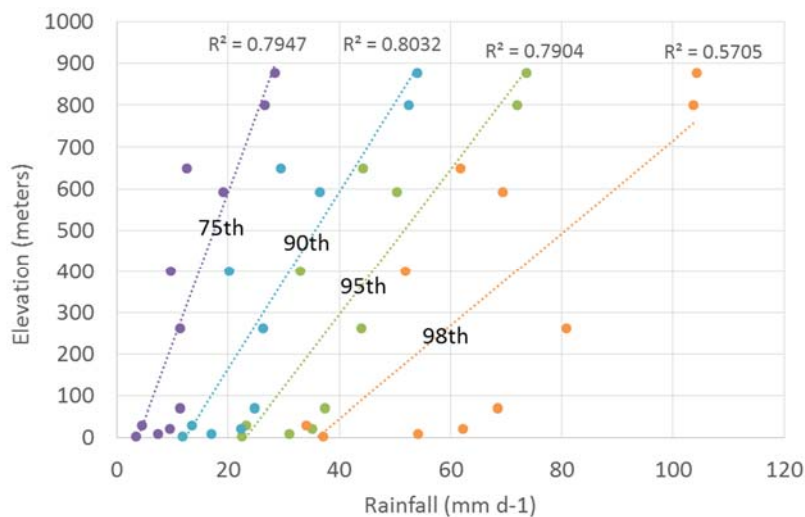
Figure 3-7: Percentiles distribution (from 75th to 98th) of rainfall-elevation relationship with related interpolation line

From Figure 3-7 it is interesting to note that there is good correlation between the elevation and rainfall. Only the 98<sup>th</sup> percentiles presents a lower correlation, perhaps this is due to a more chaotic pattern of rainfall during extreme precipitation. It is noted also a more pluviometrical gradient as the percentile distribution increases.

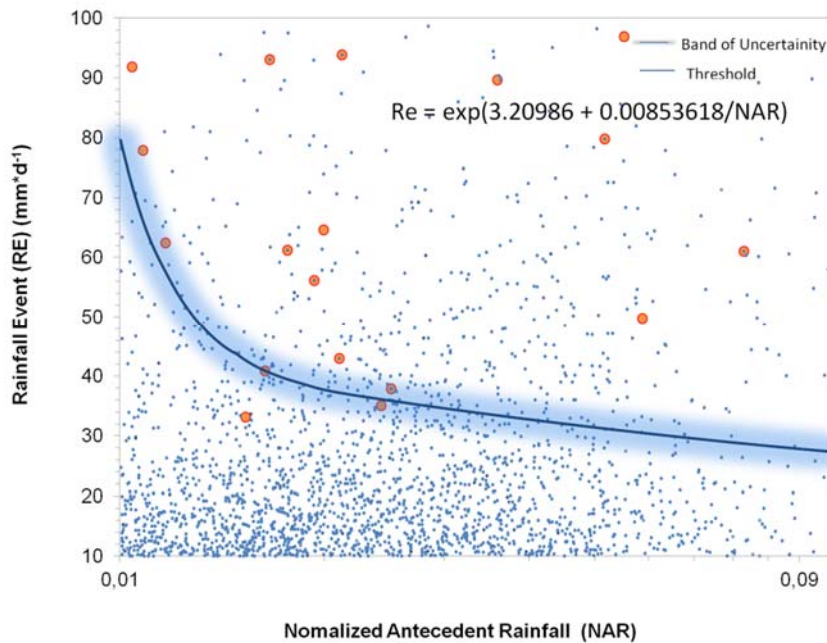
Figure 3-8: Landslide rainfall threshold for Dominica. RE is the threshold rainfall, and NAR is the 5-day antecedent rainfall; the orange points are the reported landslide events; blue points are the rainfall days without landslides, the blue line is the estimated rainfall threshold; the blurred blue area is the band of uncertainty which was visually identified.

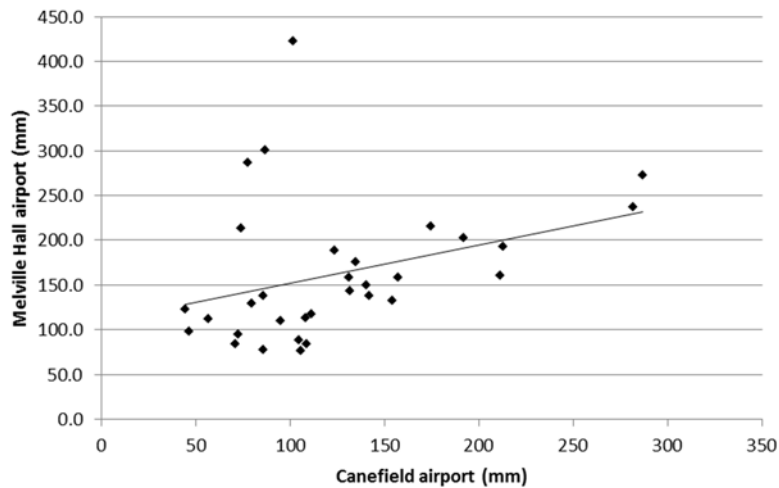
Figure 3-9. Comparison of the annual maxima of the two stations (common subset 1982-2013). There is a general agreement but the windward station (Melville Hall) has much higher values on a few occasions than the Leeward side station of Canefield.

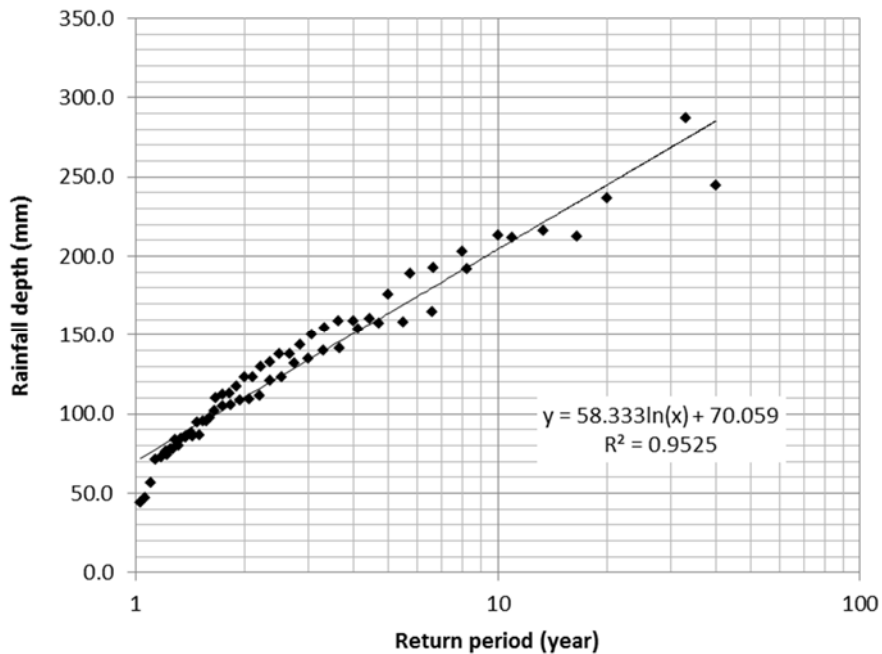
Figure 3-10. Gumbel analysis of the two stations on Dominica (Melville Hall and Canefield). The average return periods are derived from the log linear fit.

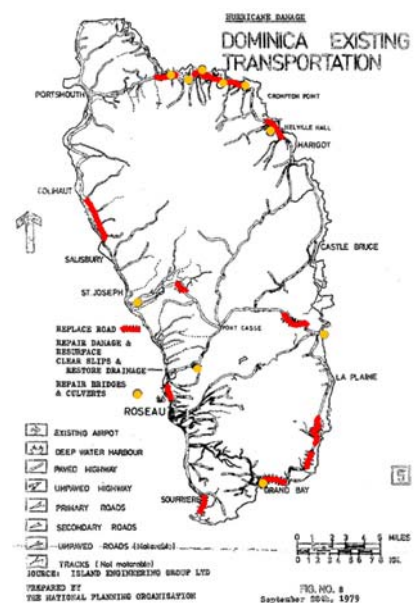
Figure 4-1: Map of damage to road infrastructure by

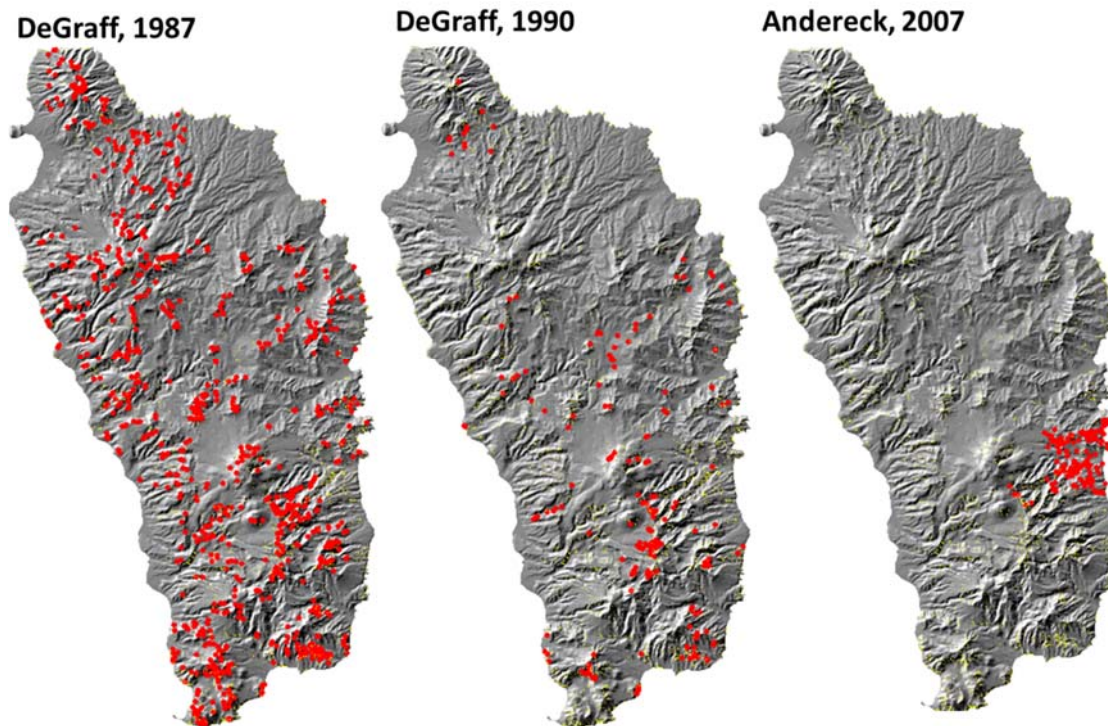
Figure 4-2: Landslide inventories that are available for Dominica. Above: Landslide inventory made by DeGraff in 1987, and DeGraff in 1990, and Andereck, 2007. Road related inventories will be shown in Chapter 7.

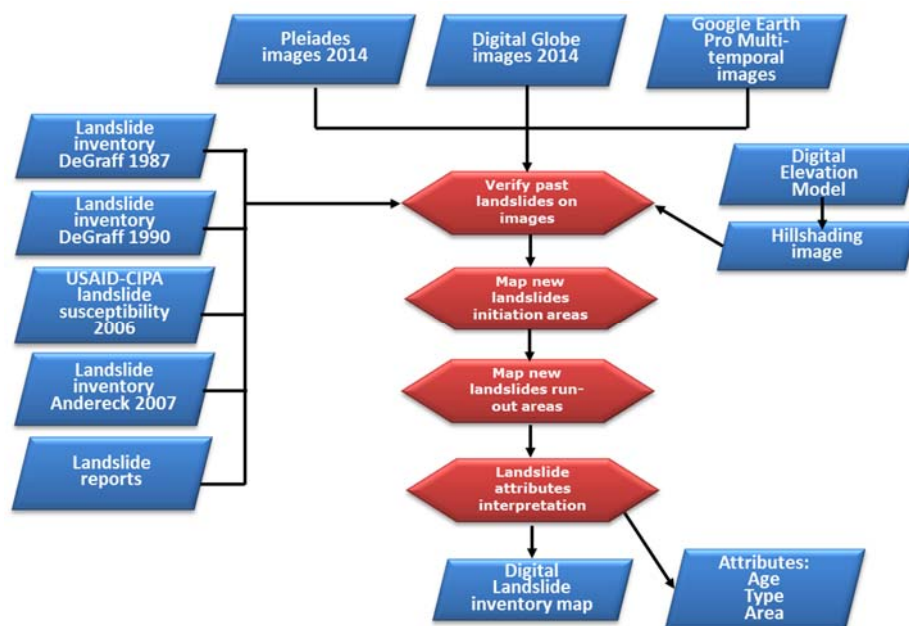
Figure 4-3: Method used for the generation of a landslide inventory map for Dominica

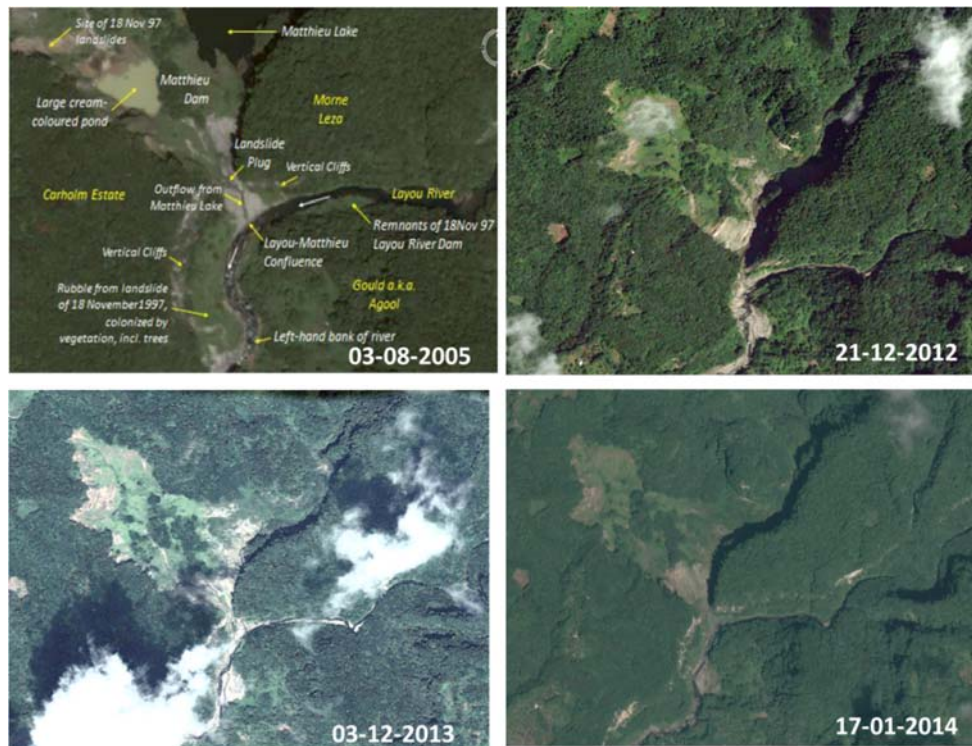
Figure 4-4: Example of multi-temporal images for the Matthieu landslide. The upper left image is from Arlington (2014), the upper right and lower left are from Google Earth, and the lower right is a Pleiades image.

Arlington (2014). It is possible to see the situation in 2005, 8 years after the damming in 1997, and the situation after the breaking of the landslide dam in 2011.

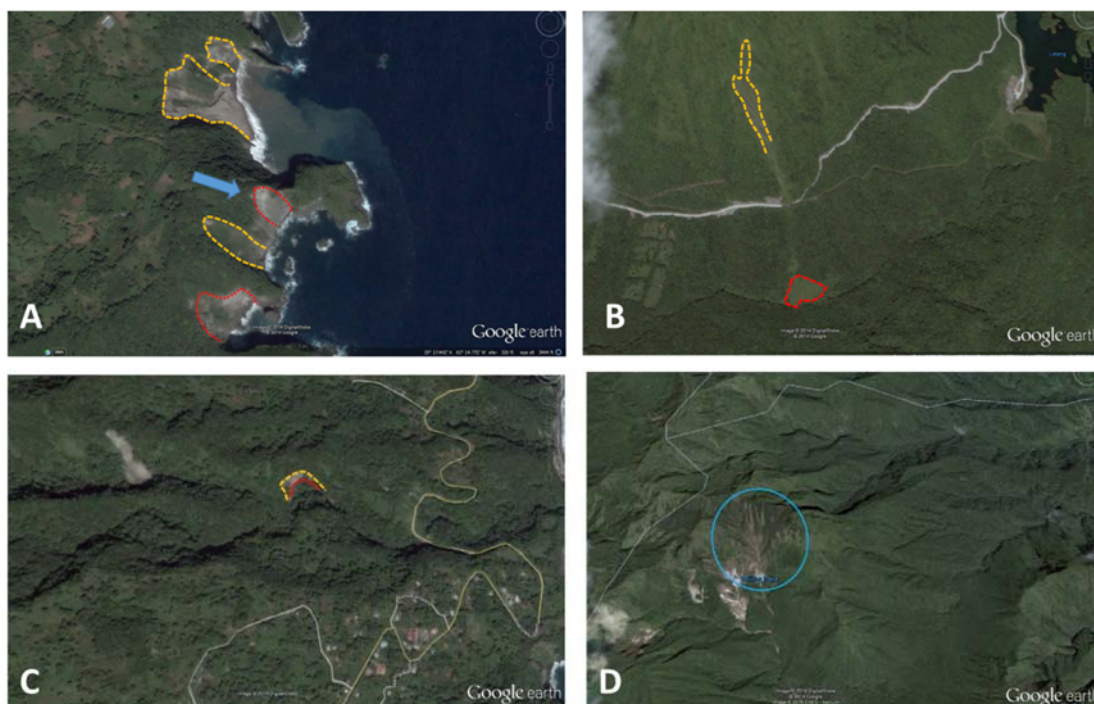
Figure 4-5: Example of interpreted landslides for different areas in Dominica. The explanation is given above.

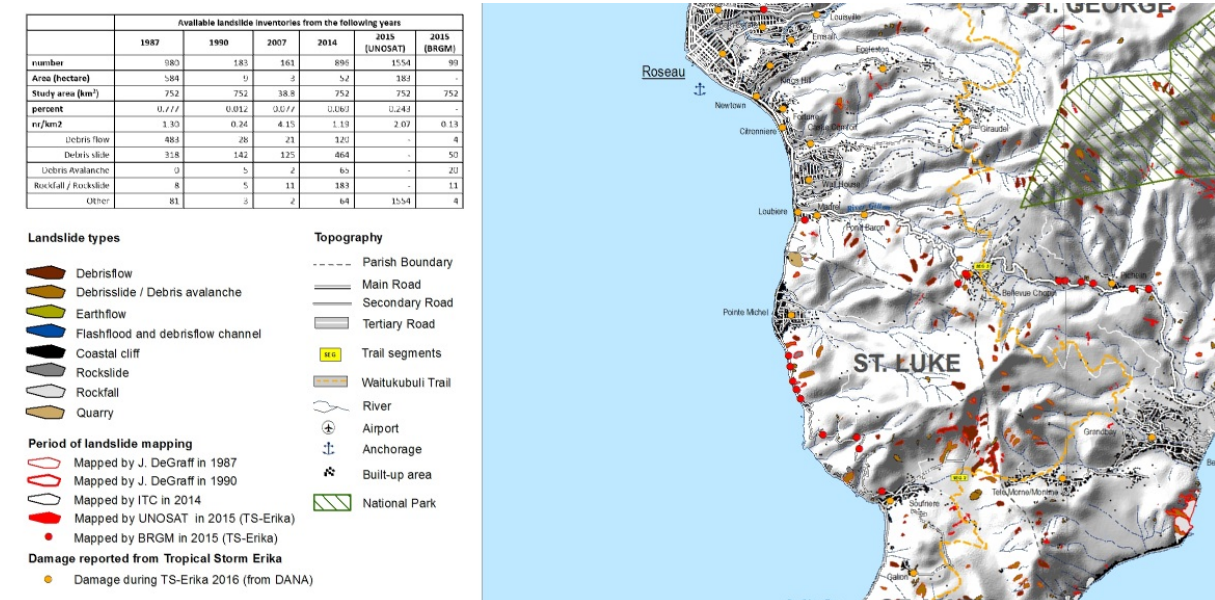
Figure 4-6: Legend of the final landslide inventory map for Dominica. The full map can be downloaded as pdf from the following website: <http://www.charim.net/dominica/maps>

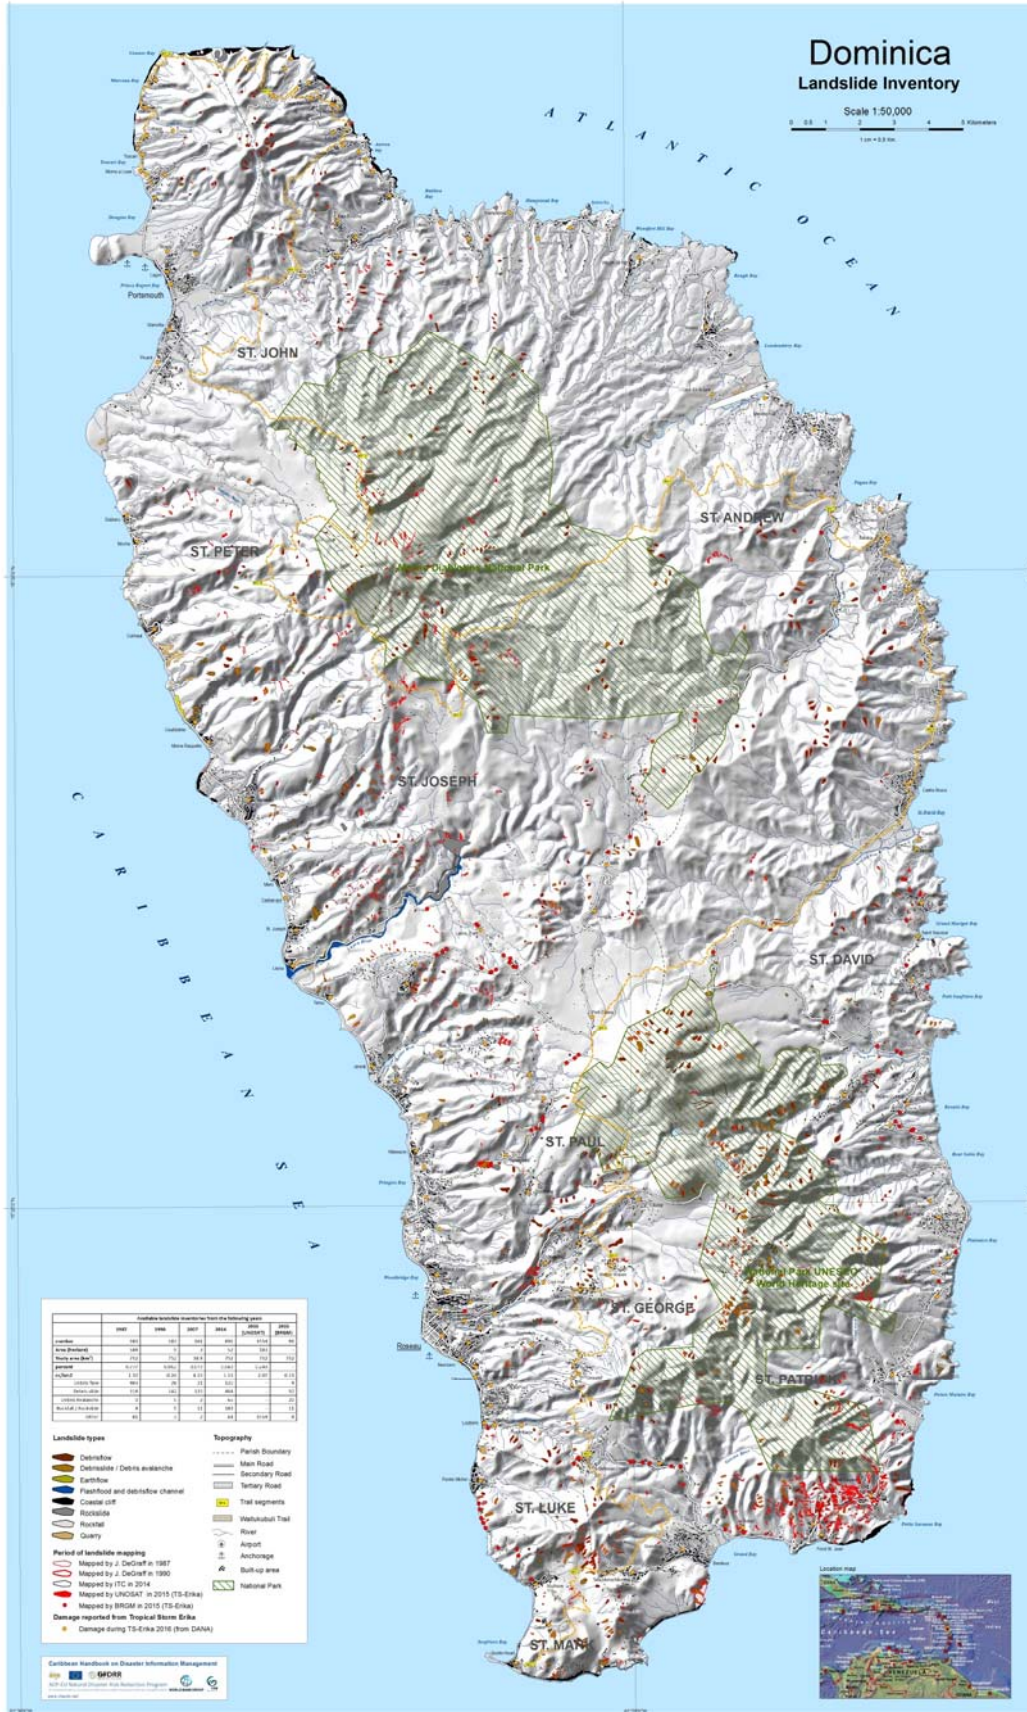
Figure 4-7: Final landslide inventory map for Dominica. The full map can be downloaded as pdf from the following website: <http://www.charim.net/dominica/maps>

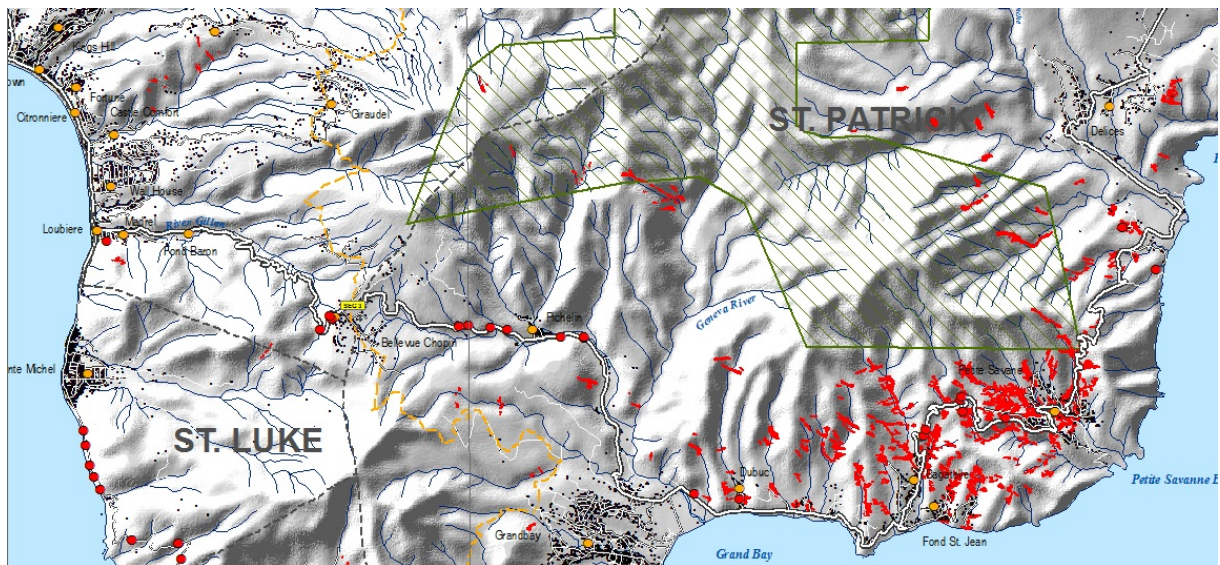
Figure 4-8: Landslides caused by tropical storm Erika in August 2015. The red polygons are the ones mapped by UNITAR-UNOSAT, the red dots by BRGM, and the orange dots are damage points mapped by the damage and loss estimation survey. The full map can be downloaded as pdf from the following website: <http://www.charim.net/dominica/maps>

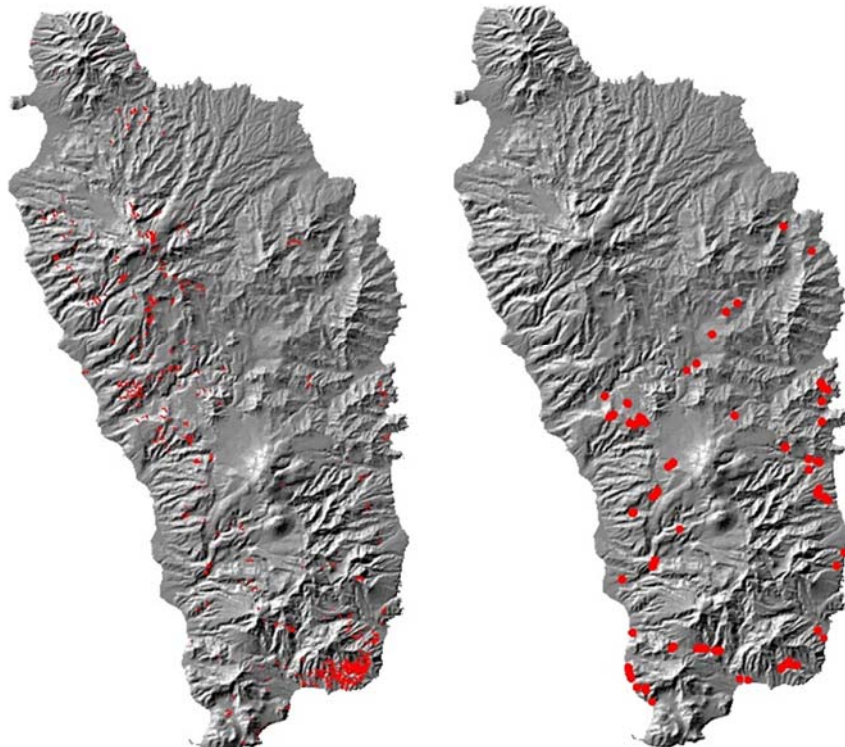
Figure 4-9: Landslides caused by tropical storm Erika in August 2015. Left: polygons mapped by UNITAR-UNOSAT. Right: Points mapped by BRGM

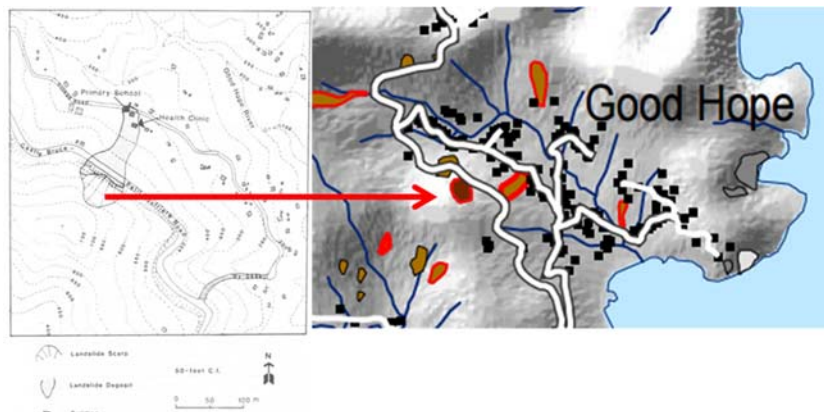
Figure 4-10: the Good Hope landslide as mapped by DeGraff et al (1989) (left) and how it appears in the landslide inventory map.

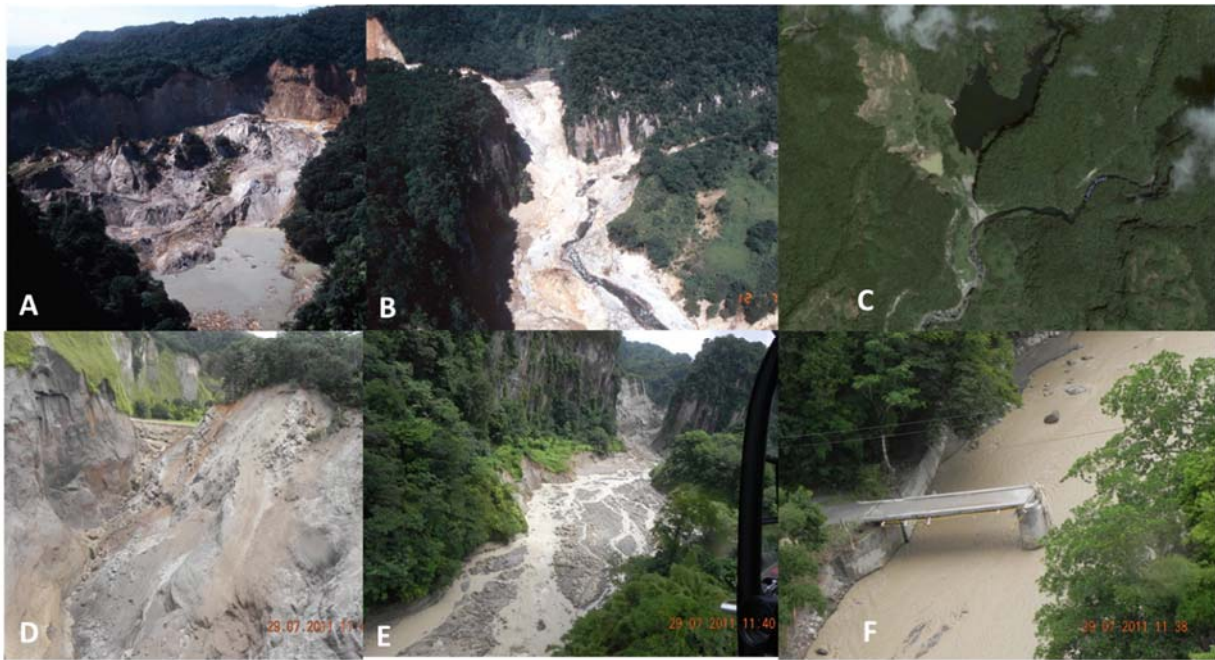
Figure 4-11: Mathieu landslide dam development. A: Carholm landslide blocking the Mathieu River and forming a lake in 1997 (Photo: J. DeGraff), B: View from downstream along the Layou valley towards the confluence of Layou and Mathieu river, with landslide dam location in 1997 (Photo: DeGraff, 1997); C: Google Earth image 3/8/2005 showing dammed lake. D: landslide dam washed out after dam break in May 2010; E: View from downstream towards former landslide dam, note the large area affected by dam break flooding; F: Bridge destroyed by dam break flood.

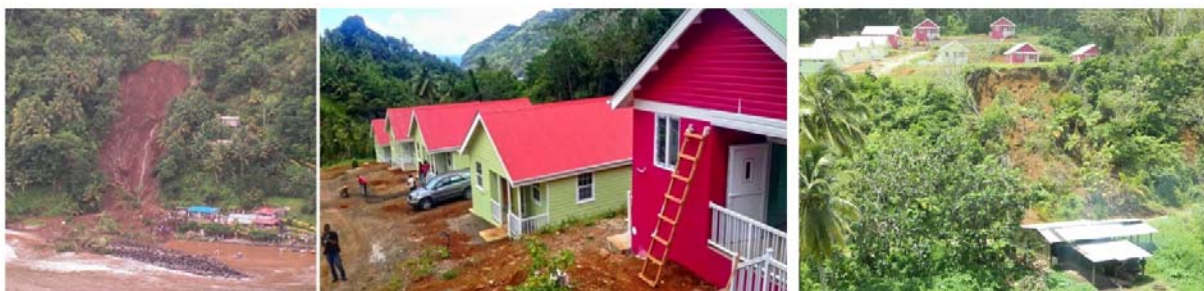
Figure 4-12: San Sauveur landslide which occurred on 24/05/2010 and which killed three people. The government decided to relocate 10 families and with a donation from the Chinese government a resettlement was carried out which was completed in 2015. The area was affected again in August 2015 during tropical storm Erika (right Figure from Garner et al, (2015))

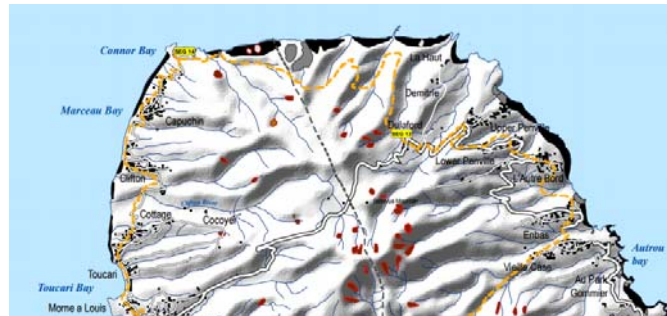
Figure 4-13: Large rockslides along the northern coast of Dominica. The slopes around these, according to Teeuw et al (2009, might have the potential to produce large landslides that could trigger a tsunami.

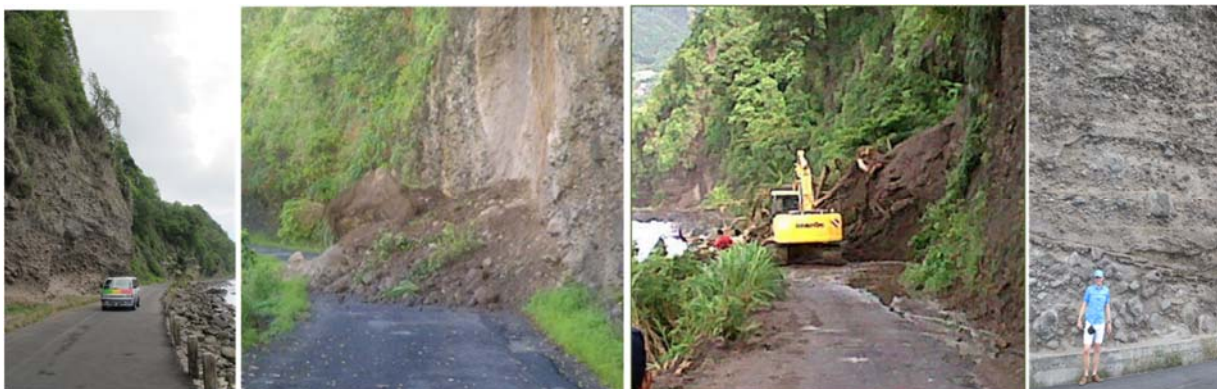
Figure 4-14: Landslide and rockfall problems in the Stowe-Dubuc area in the SE of Dominica.

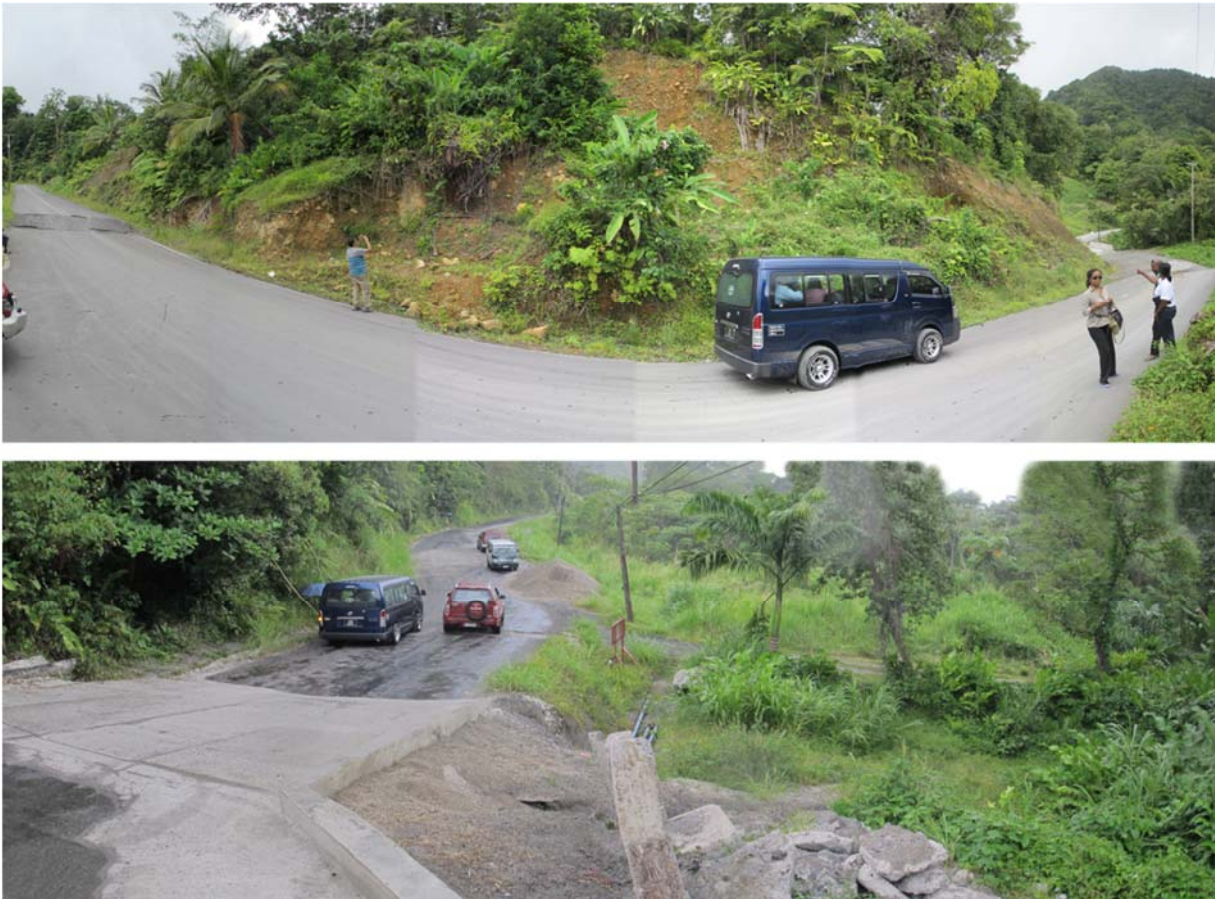
Figure 4-15: Landslide subsidence along two problem areas along the road from Canefield to Melville hall.

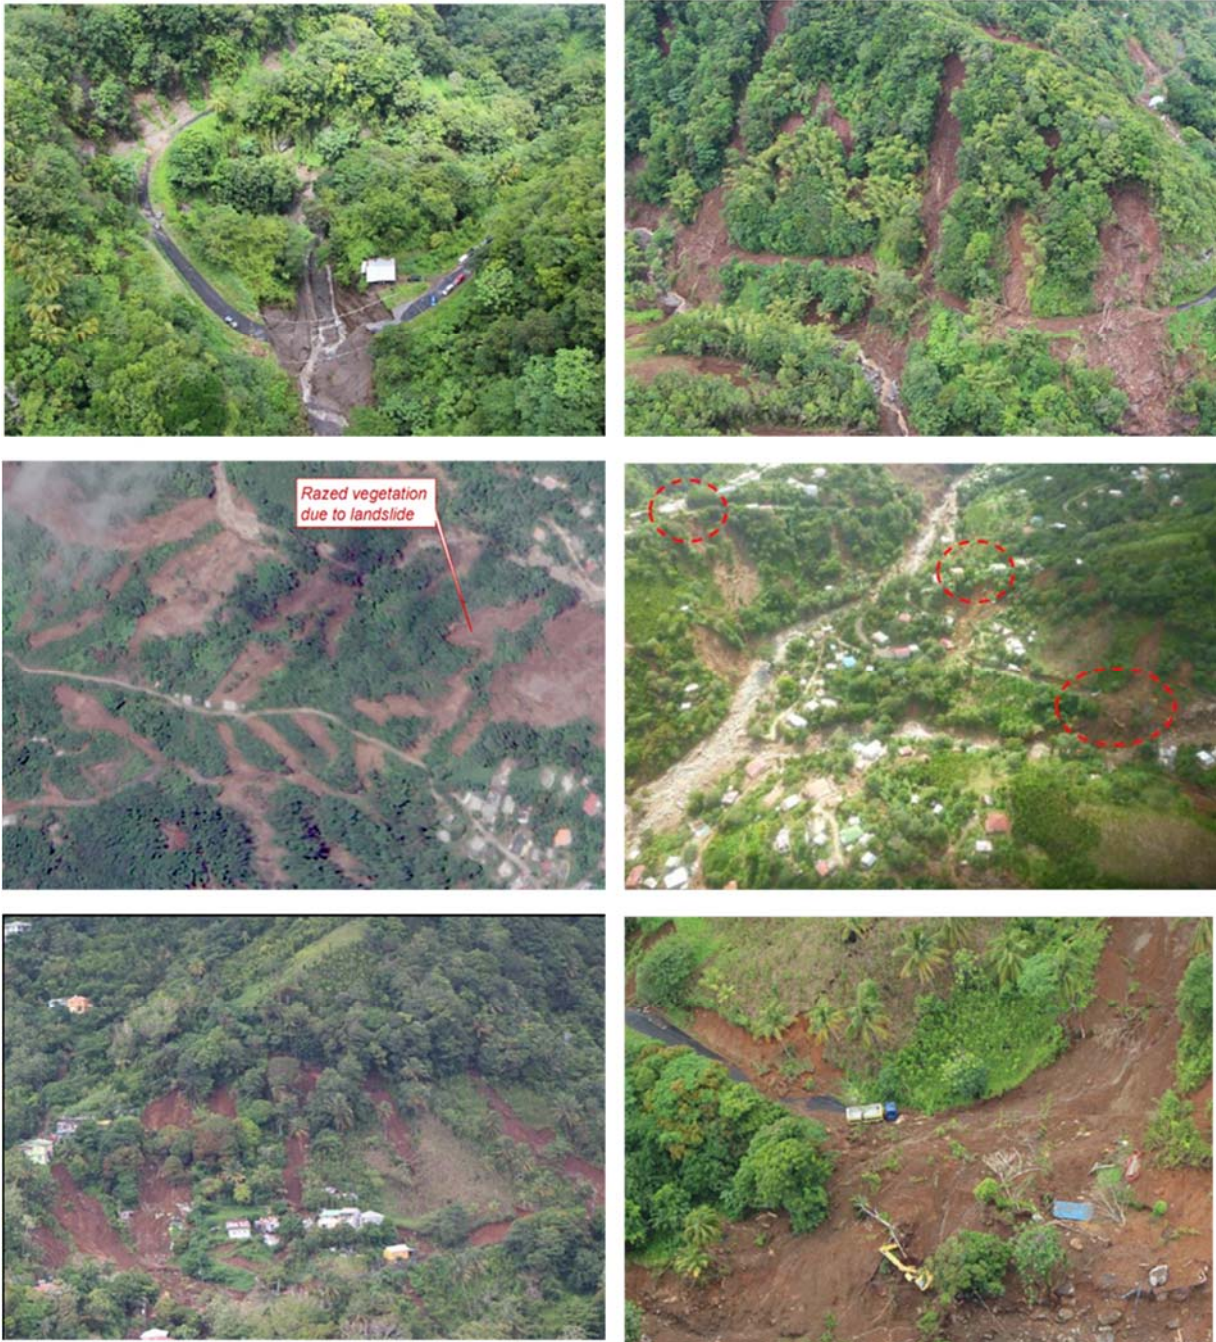
Figure 4-16: Landslides triggered by tropical storm Erika in the south-eastern part of Dominica. Upper left: road washed out to the north of Boetica; Upper right: access from the south to Petite Savanne – section of the road located after the washed-out bridge; Middle left: section of a satellite image showing the destruction near Petite Savanne; Middle right and lower: landslides in Petite Savanne. Sources: Garnier et al. (2015) and UNITAR-UNOSAT (2015).

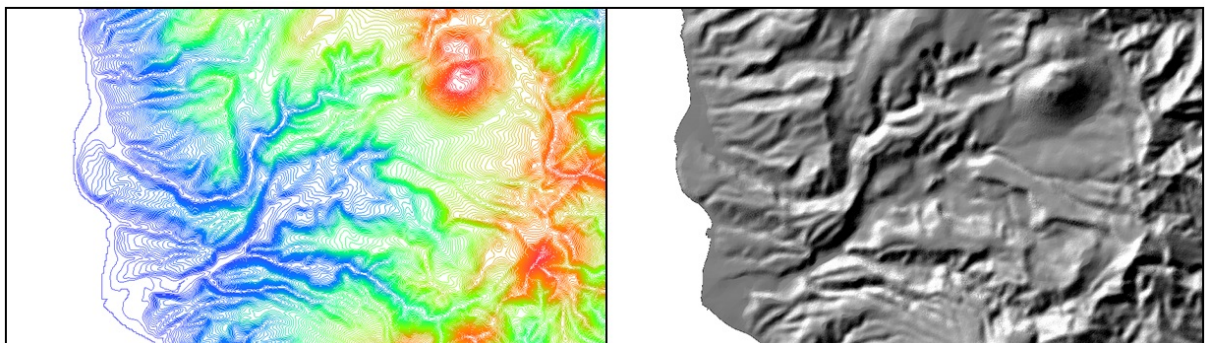
Figure 5-1: The Digital Elevation Model for Dominica is of poor quality. The figure shows a detail of the hill shading image that clearly shows the rounded and generalized topography.

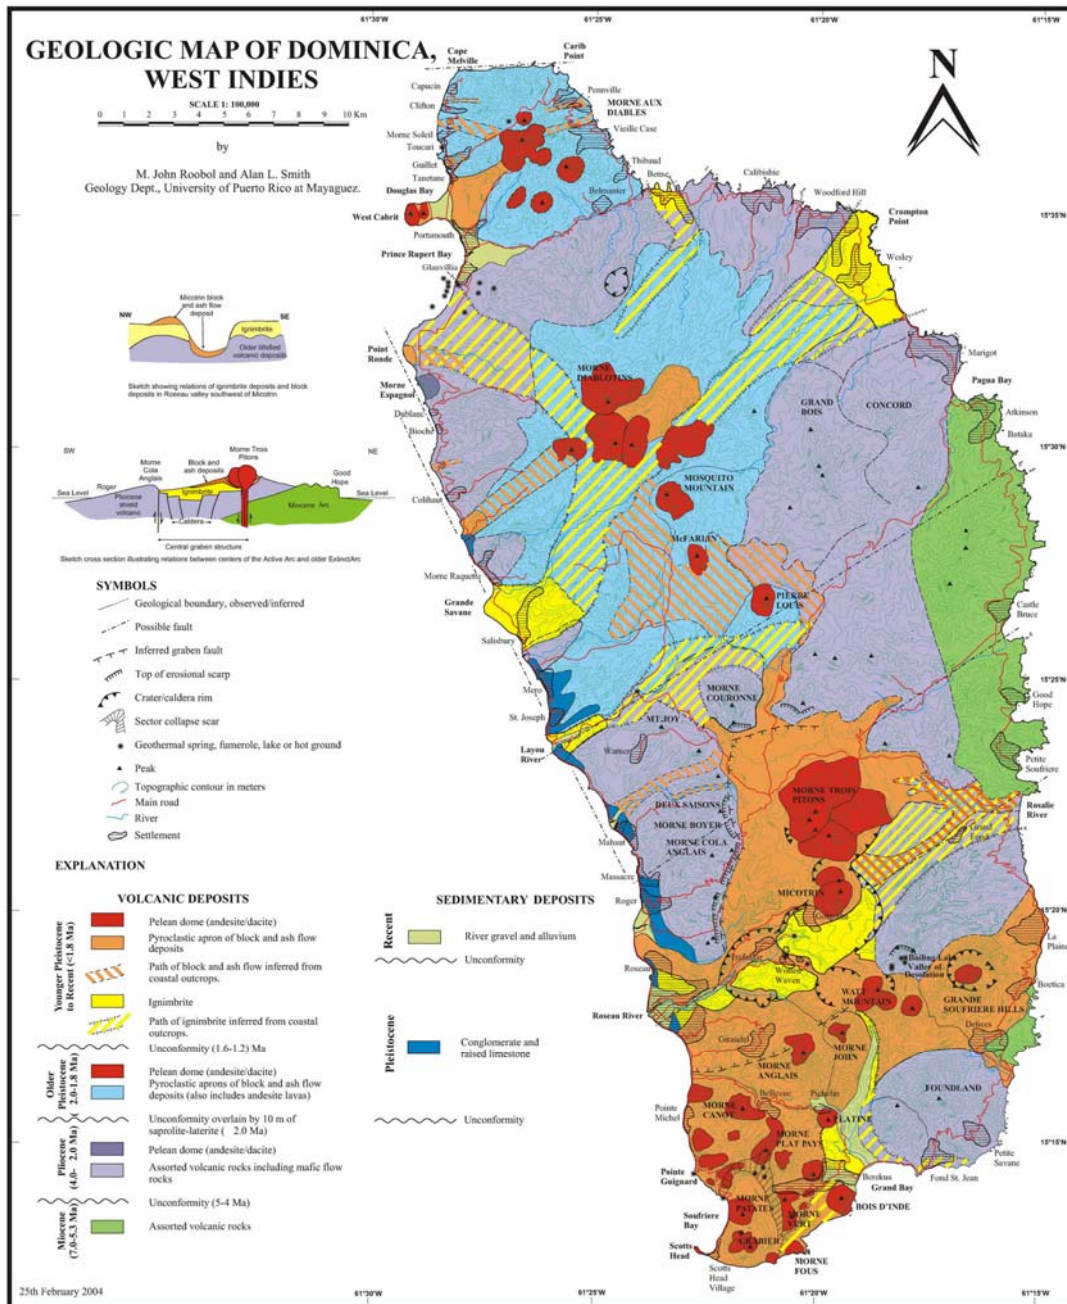
Figure 5-2: Geological map of Dominica (Roobol and Smith, 2004)

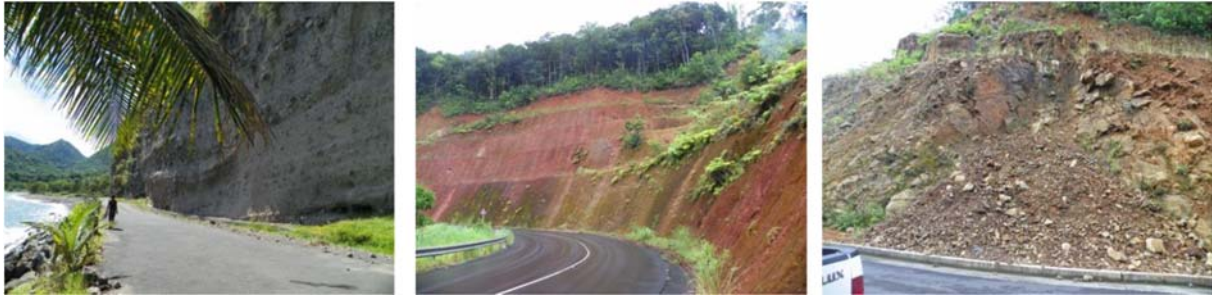
Figure 5-3. Examples of outcrops in volcanic deposits in Dominica. Note the high degree of weathering in the middle photo.
