# National Scale Landslide Susceptibility Assessment for Dominica

Technical Report · May 2016

# **National Scale Landslide Susceptibility Assessment for Dominica**

**May 2016**

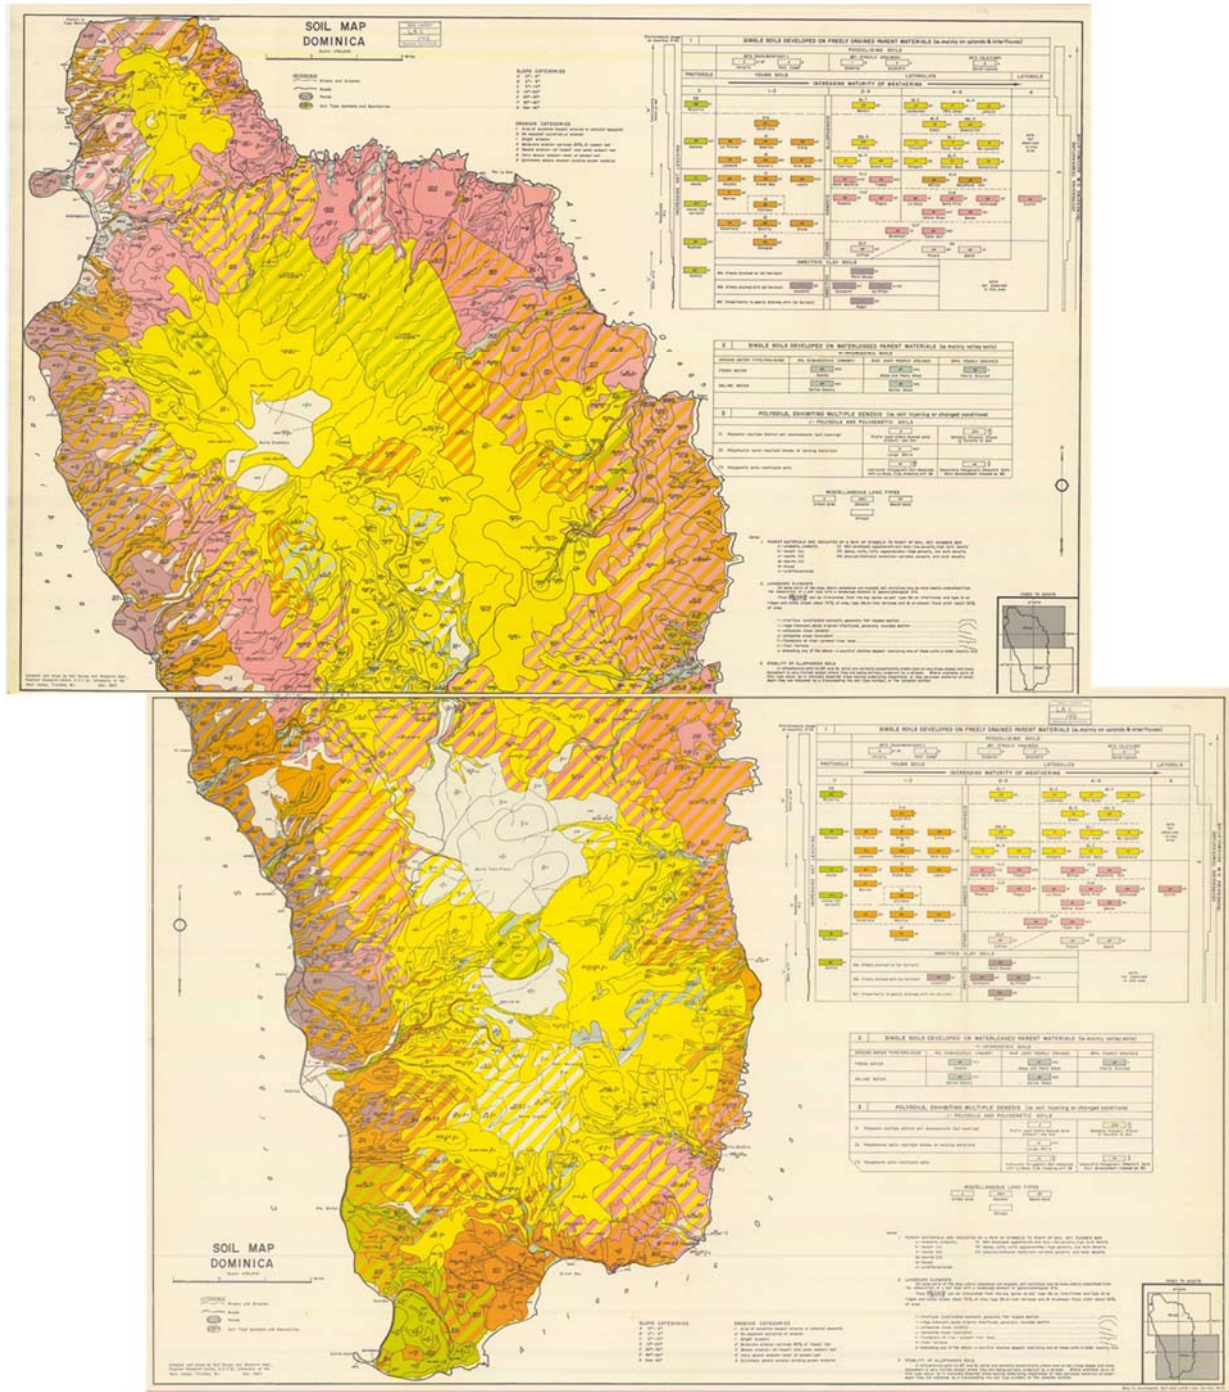
Figure 5-4: Soil map of Dominica (Lang, 1967)

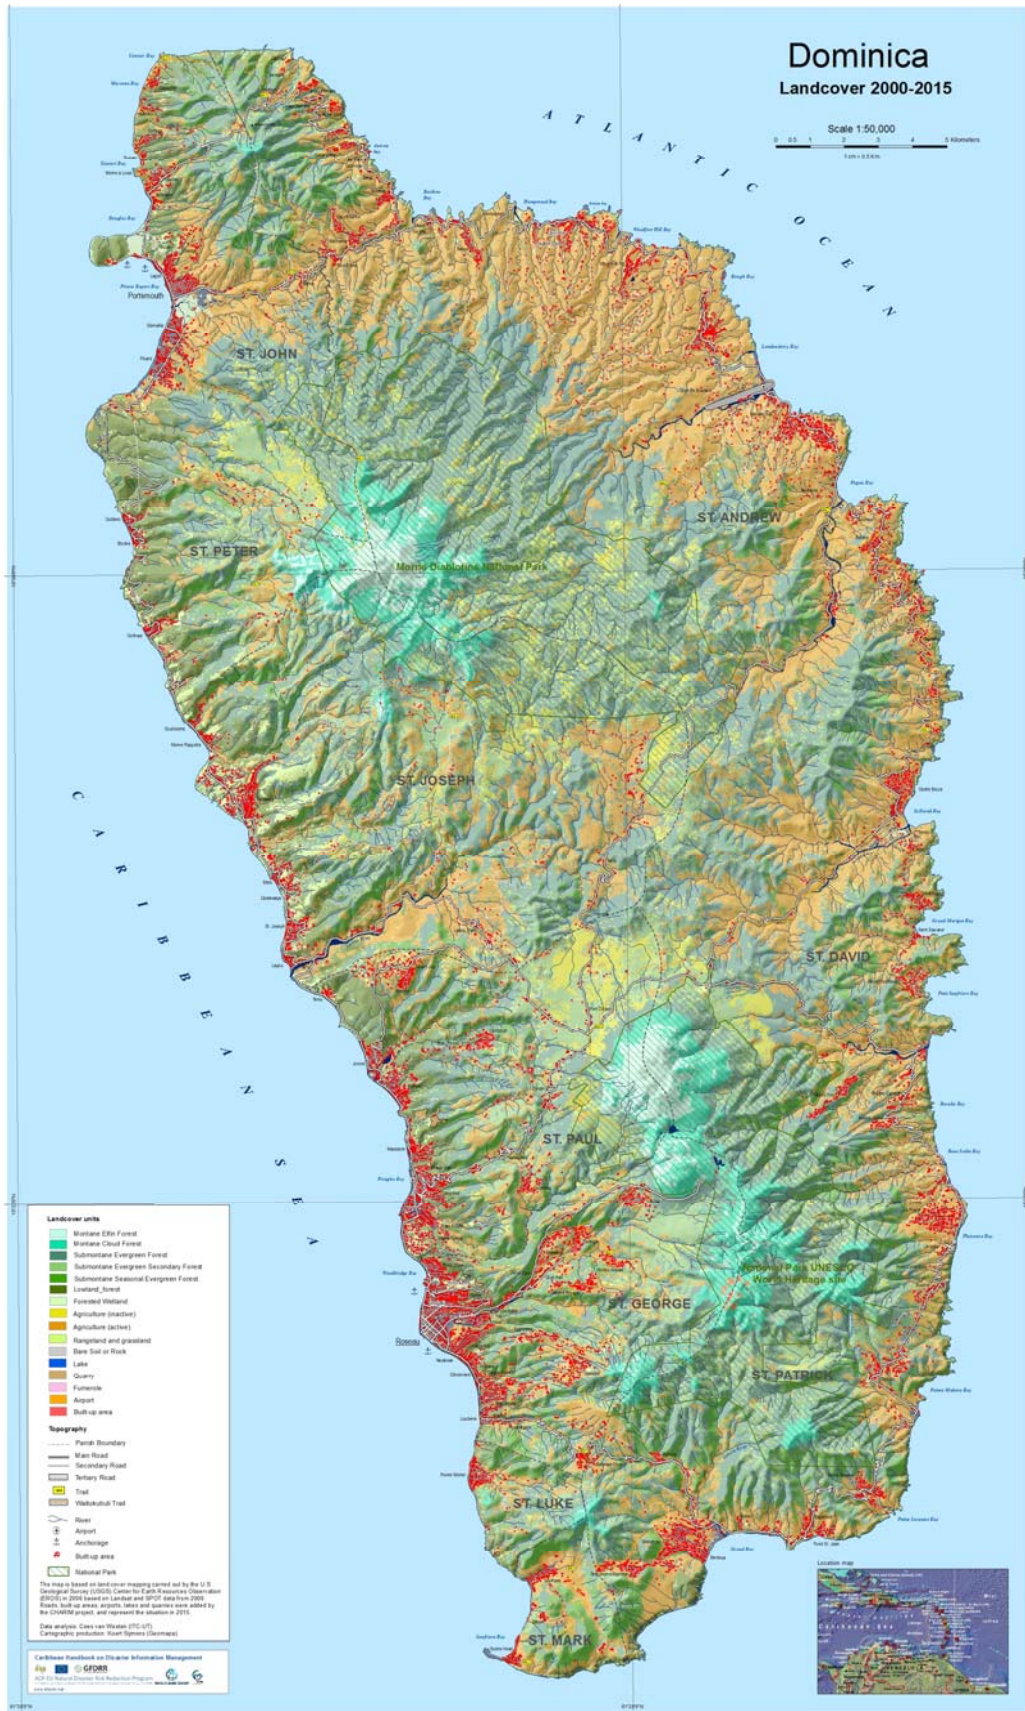
Figure 5-5: Detail and legend of the Land cover map of Dominica. The map can be downloaded from: <http://www.charim.net/dominica/maps>

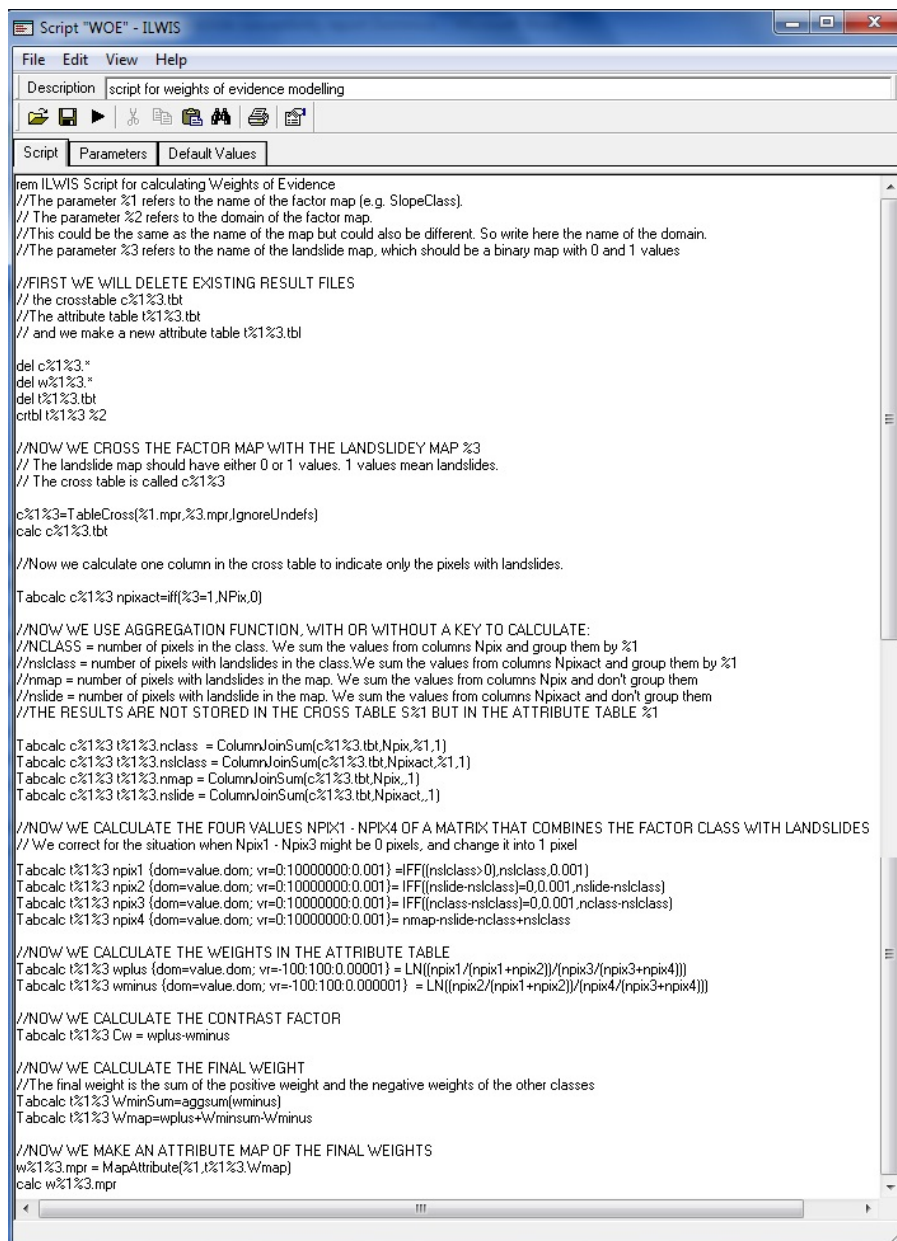
Script "WOE" - ILWIS
File Edit View Help
Description script for weights of evidence modelling
Script Parameters Default Values
Item ILWIS Script for calculating Weights of Evidence
//The parameter %1 refers to the name of the factor map (e.g. SlopeClass).
// The parameter %2 refers to the domain of the factor map.
//This could be the same as the name of the map but could also be different. So write here the name of the domain.
//The parameter %3 refers to the name of the landslide map, which should be a binary map with 0 and 1 values

Figure 6-2: Weights of evidence script used in the ILWIS software.

The calculation of the Weights of Evidence is carried out using a script in the ILWIS software. A script contains a series of commands that allow the automatic execution of a series of calculation steps for different maps. The script used is indicated in the Figure 6-2.

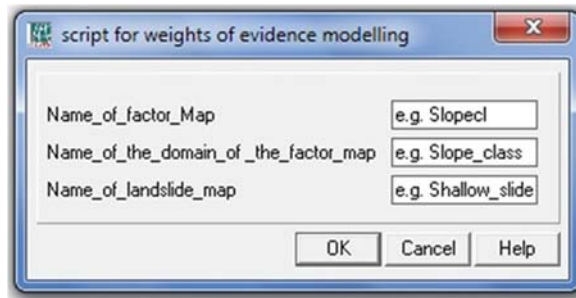
Figure 6-3: Input screen for the Weights-of-Evidence script used in the analysis. The script needs three inputs: name of the factor map (e.g. slopeclass, lithology), name of the domain of the factor map, and name of the landslide map, which should be a binary map (0= no landslide, 1= landslide).

When executing the script an input screen will ask for the input data (See Figure 6-3)

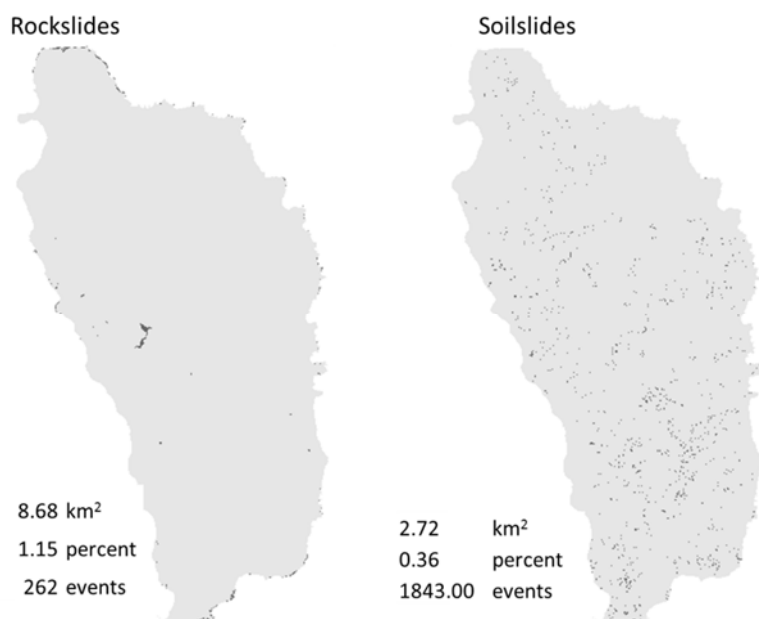
Figure 6-4: Landslide inventory maps for rockslides and soil-related landslides that were used in the analysis.

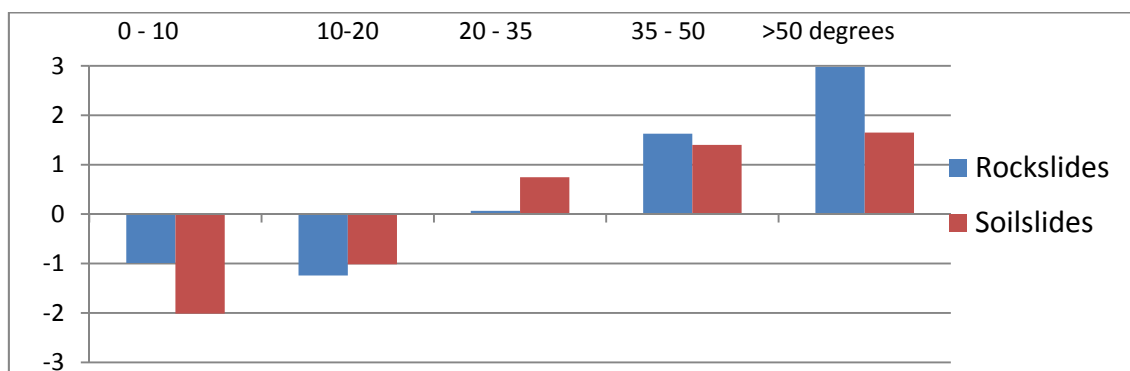
Figure 6-5: Contrast factors for slope steepness classes for rockslides and soilslides.

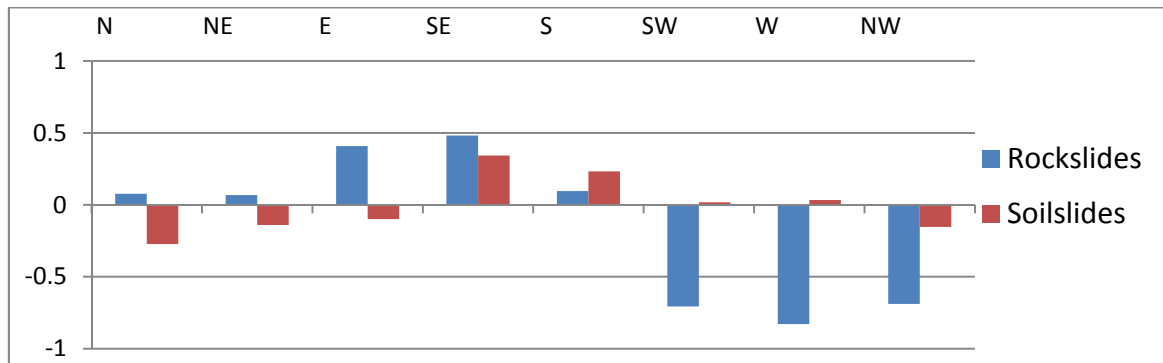
Figure 6-6: Contrast factors for slope direction classes for rockslides and soilslides.

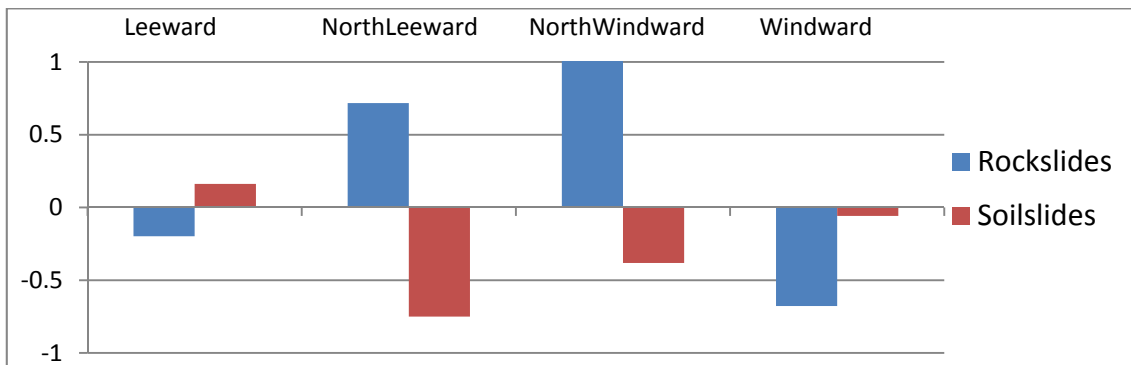
Figure 6-7: Contrast factors for main exposure classes for rockslides and soilslides.

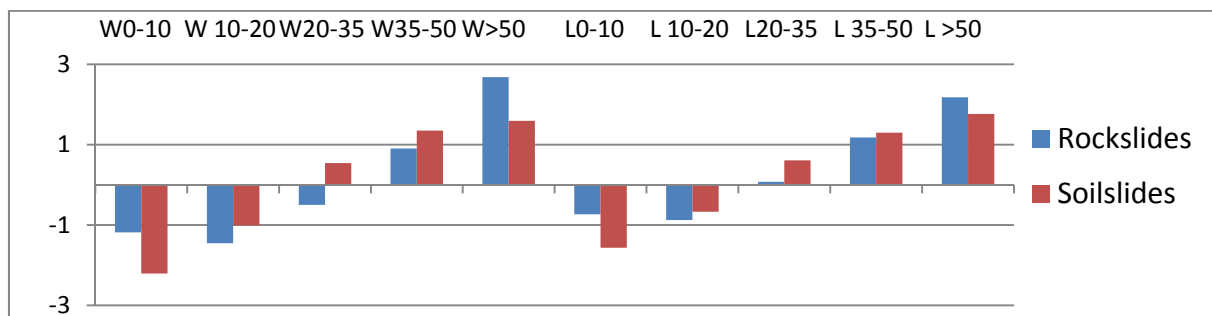
Figure 6-8: Contrast factors for the combination of the main exposure classes and slope steepness classes for rockslides and soilslides.

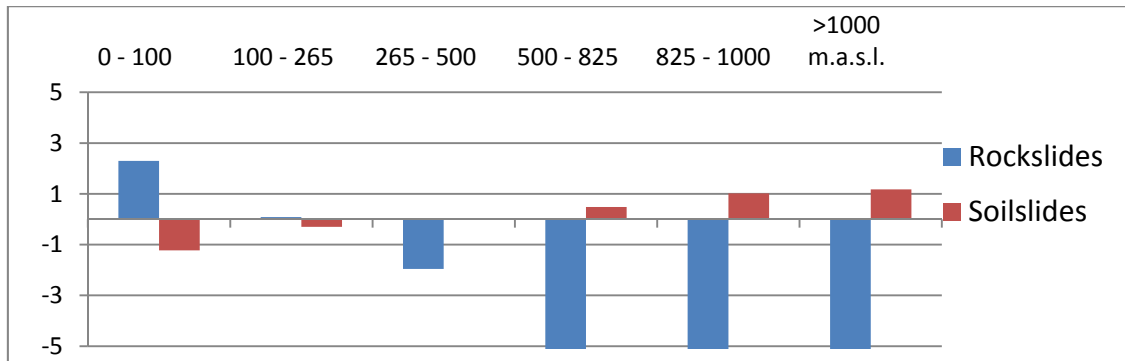
Figure 6-9: Contrast factors for elevation classes for rockslides and soilslides.

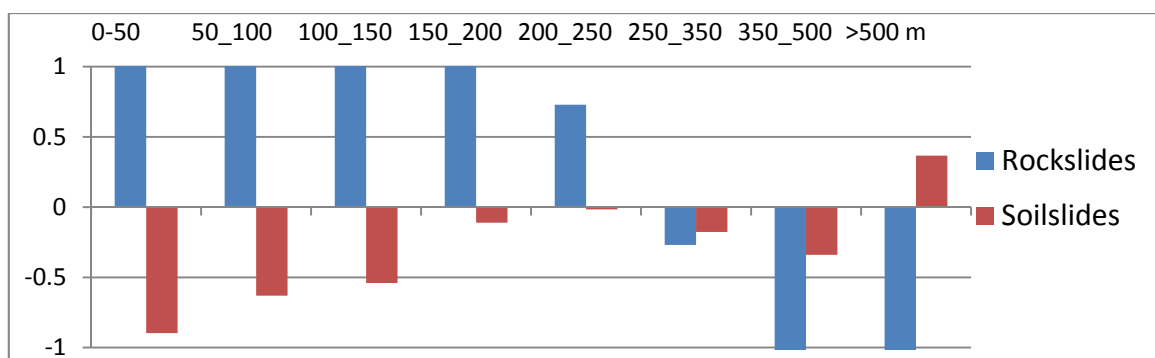
Figure 6-10: Contrast factors for distance to the coast for rockslides and soilslides.

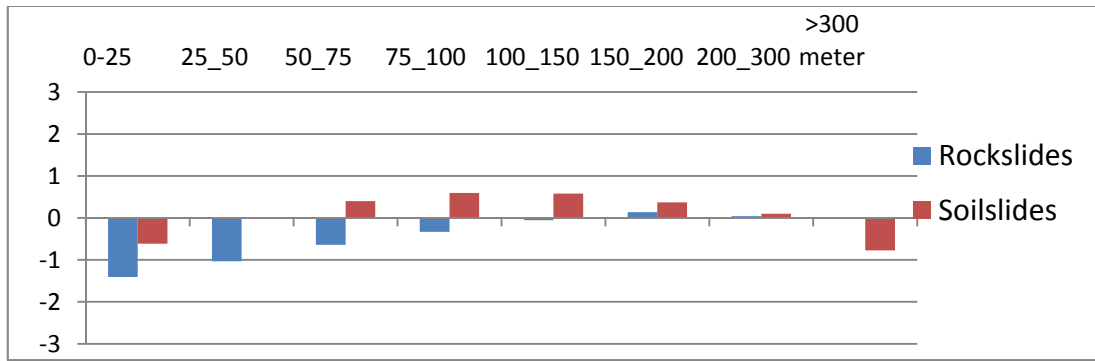
Figure 6-11: Contrast factors for distance to ridges for rockslides and soilslides.

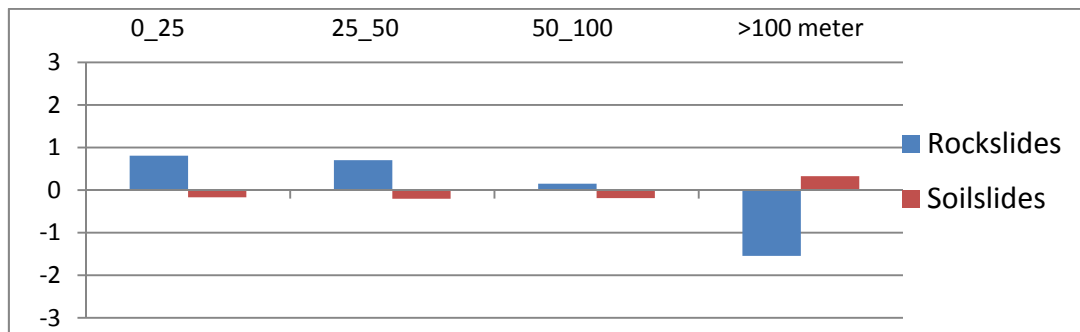
Figure 6-12: Contrast factors for distance to rivers for rockslides and soilslides.

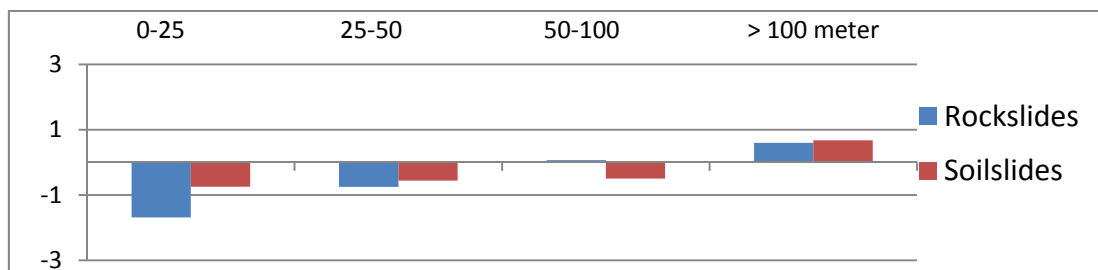
Figure 6-13: Contrast factors for distance to roads for rockslides and soilslides.

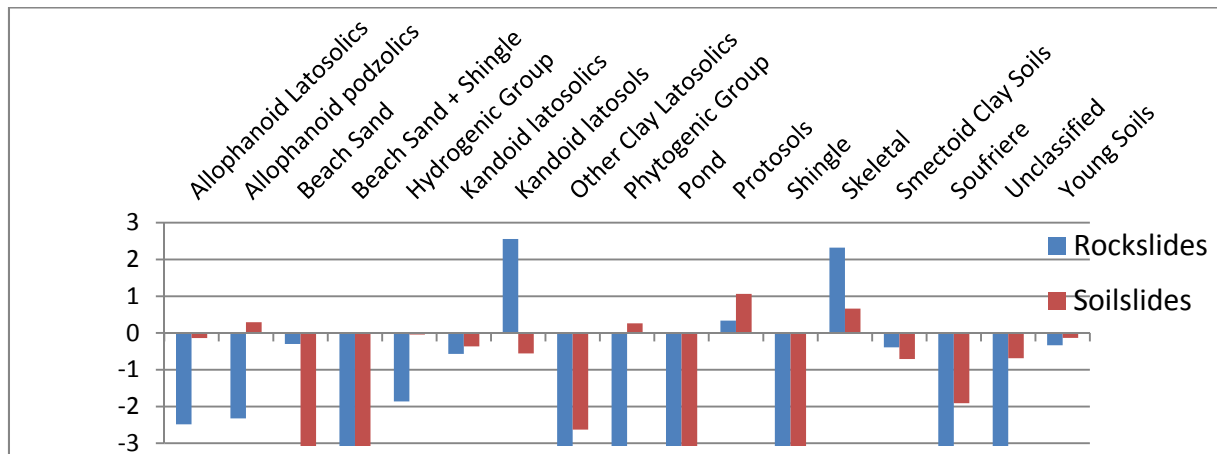
Figure 6-14: Contrast factors for soil types for rockslides and soilslides.

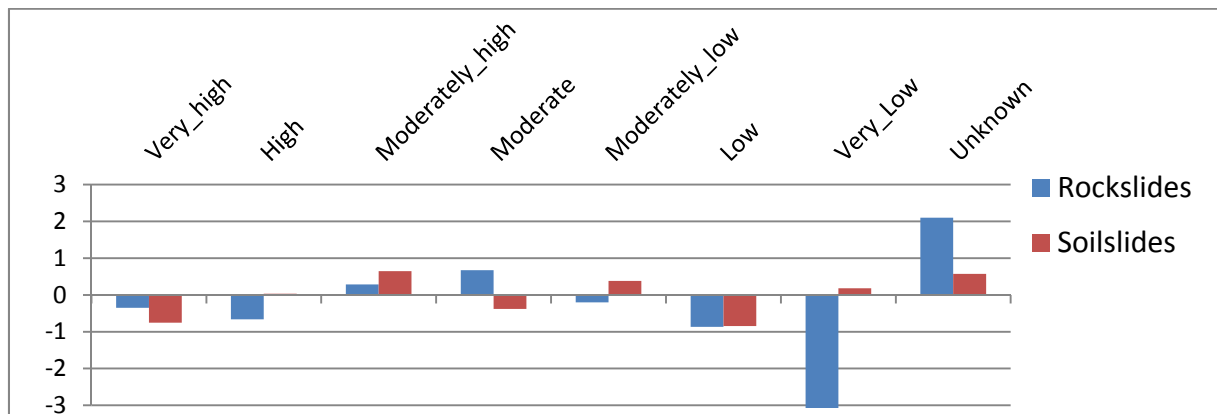
Figure 6-15: Contrast factors for soil erosion hazard classes for rockslides and soilslides.

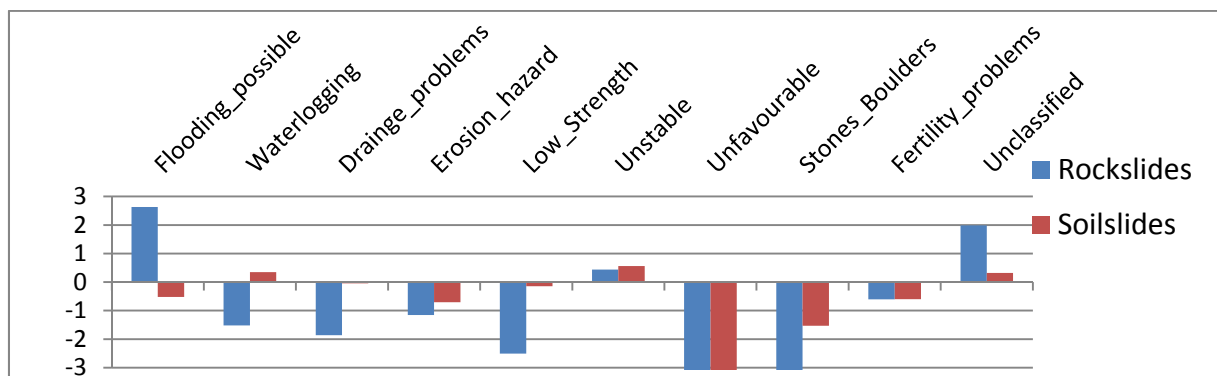
Figure 6-16: Contrast factors for soil-related problems for rockslides and soilslides.

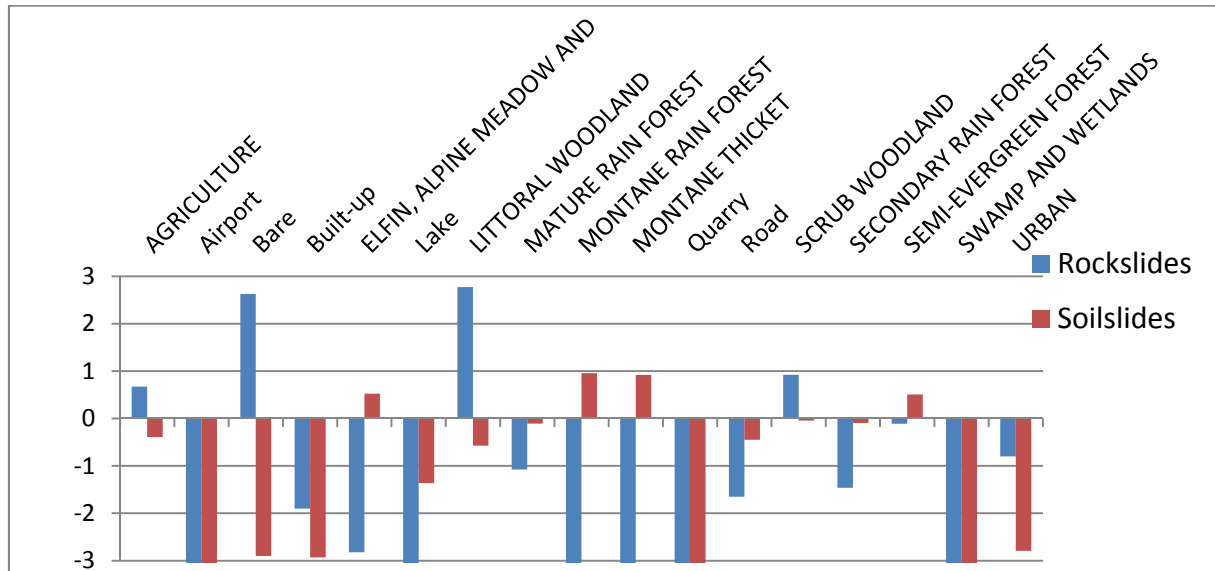
Figure 6-17: Contrast factors for land use classes for rockslides and soilslides.

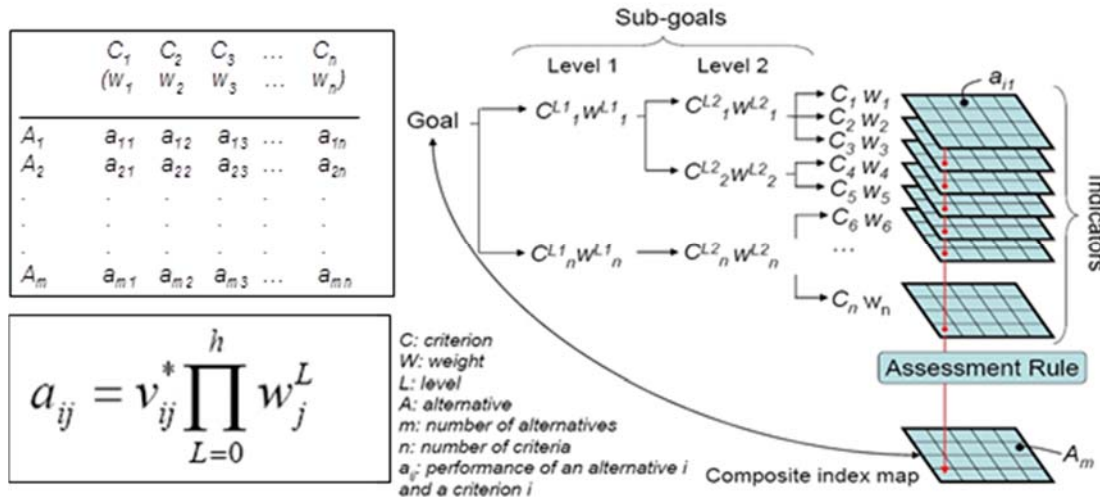
Figure 6-18: Schematic procedure for spatial multi-criteria evaluation based on the analytical hierarchical process

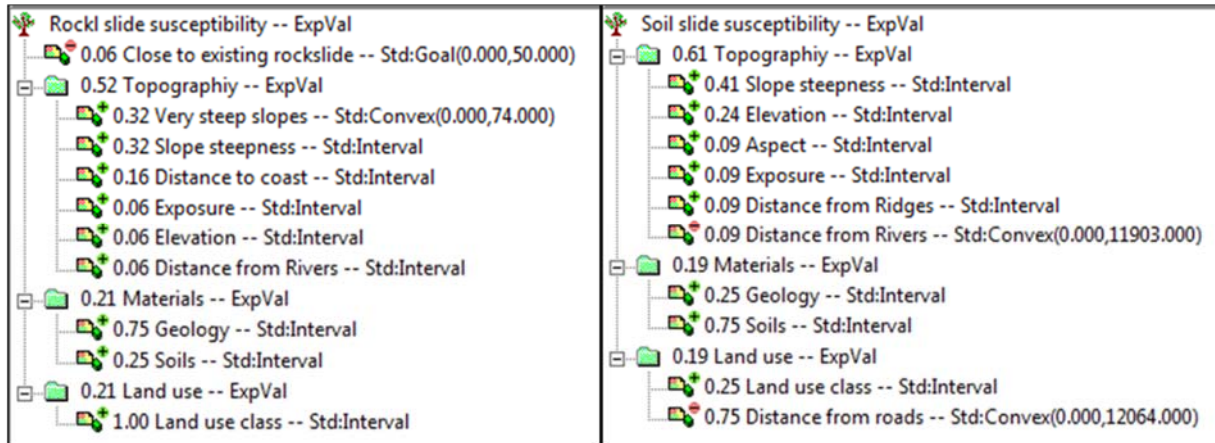
Figure 6-19: Criteria trees used for the susceptibility assessment of rockslides (left) and soil slides (right)

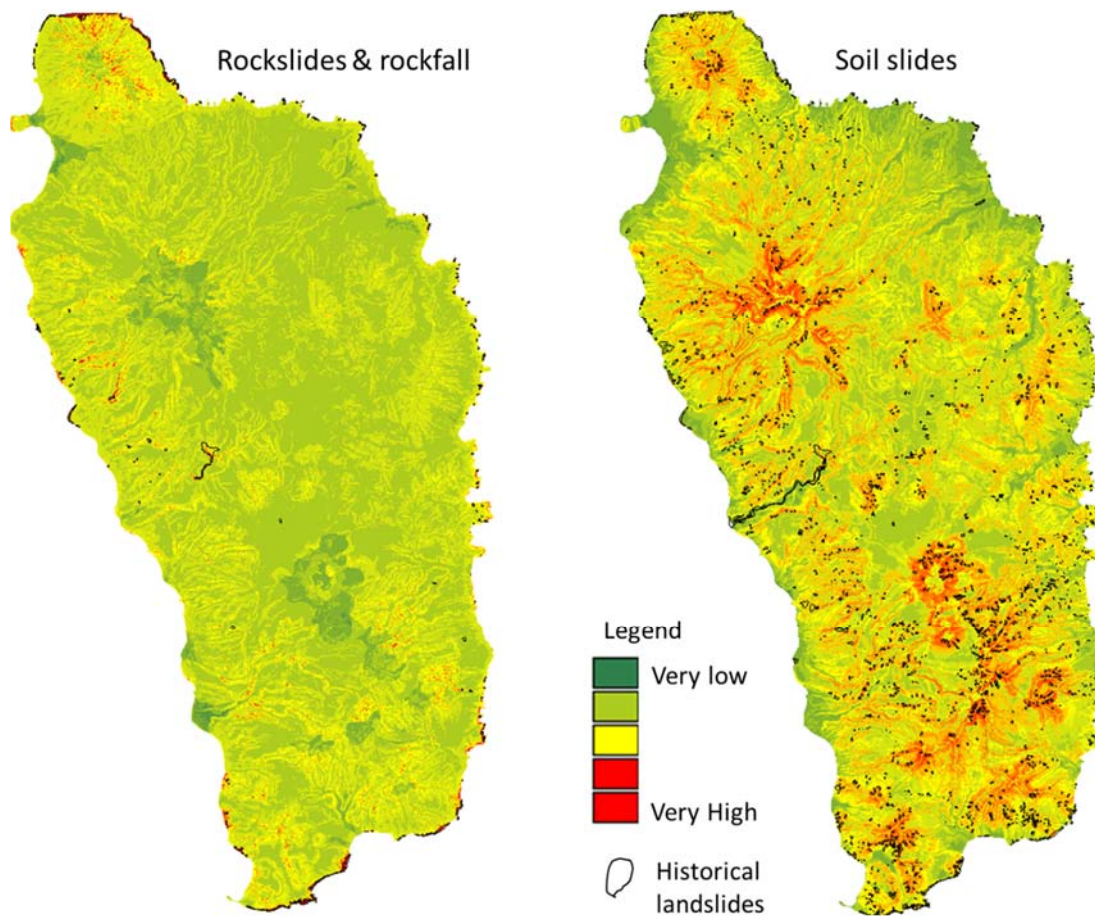
Figure 6-20: Unclassified susceptibility maps for rockslides (left) and soil slides (right) resulting from the SMCE analysis.

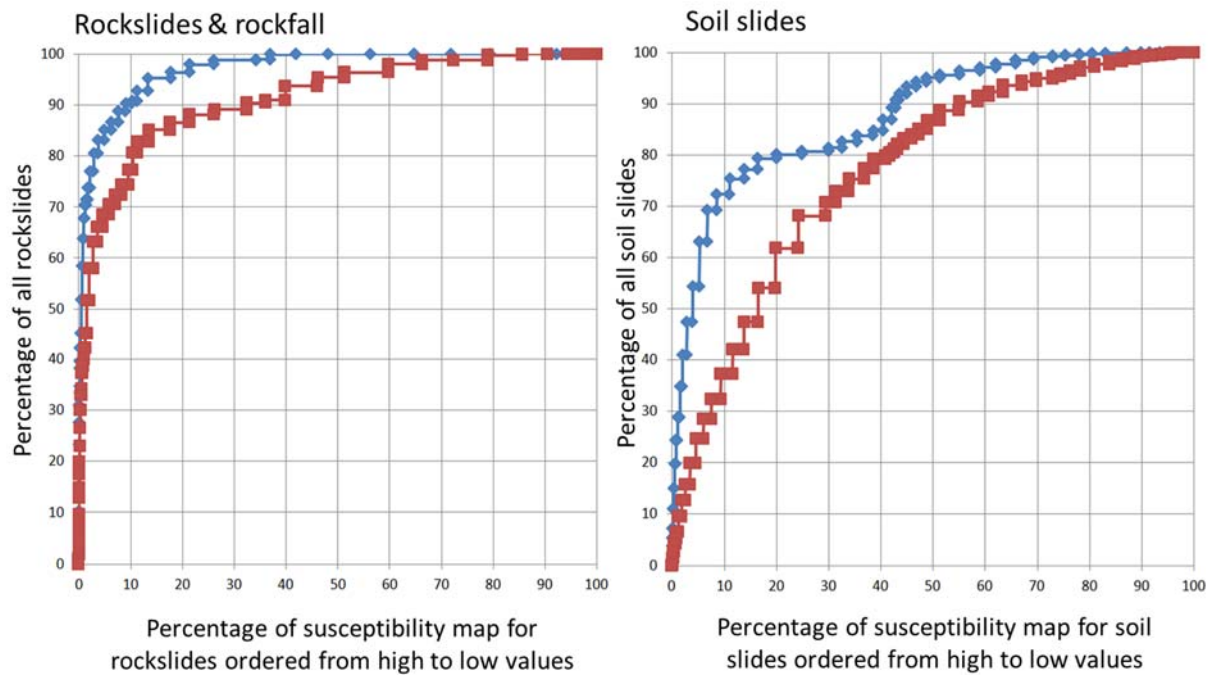
Figure 6-21: Success rate curves for the susceptibility maps for rockslides (left) and soil slides (right). For both the curves are shown without taking into account the factor “proximity to existing landslides” (red lines) and the ones that do take into account this proximity as a factor (blue curves).

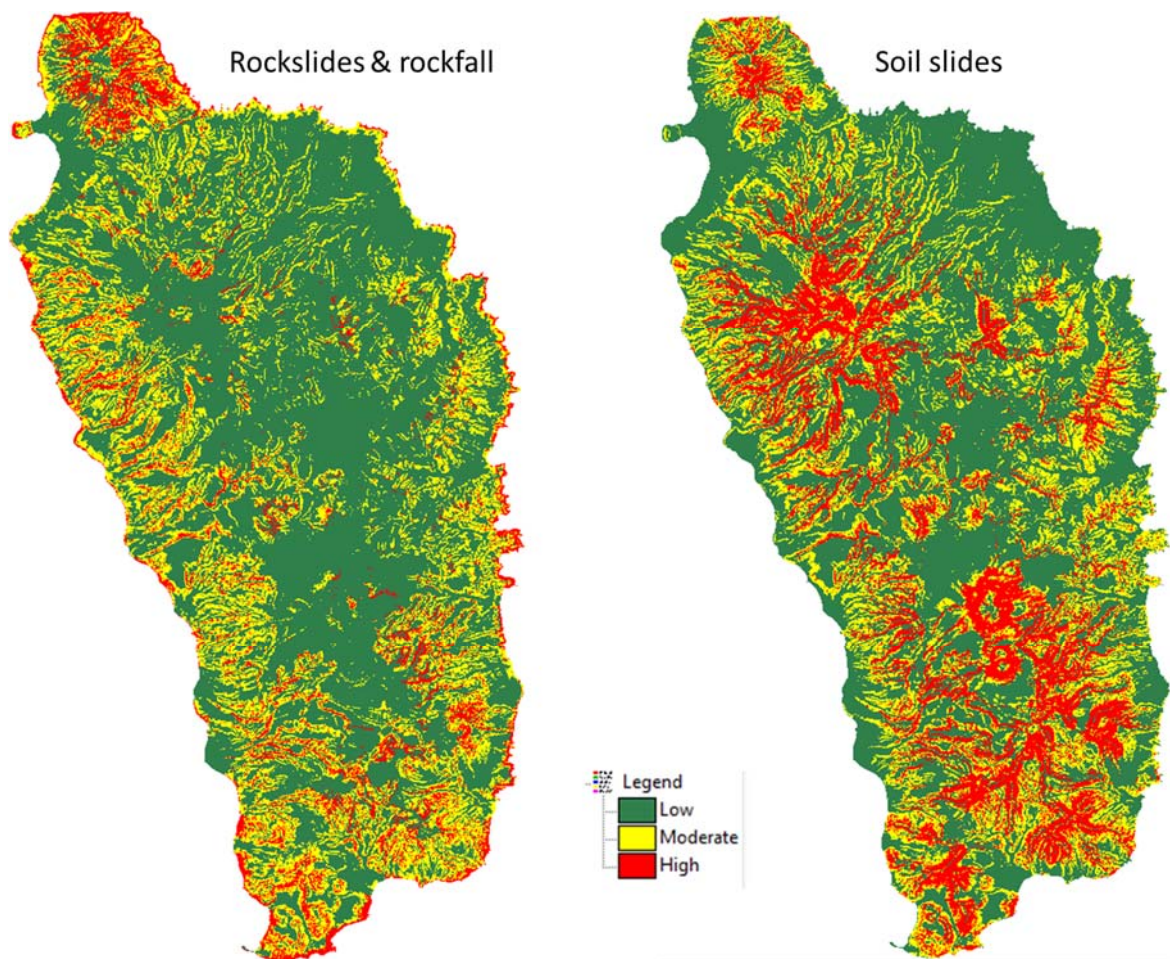
Figure 6-22: Classified landslide susceptibility maps for rockslides (left) and soil slides (right)

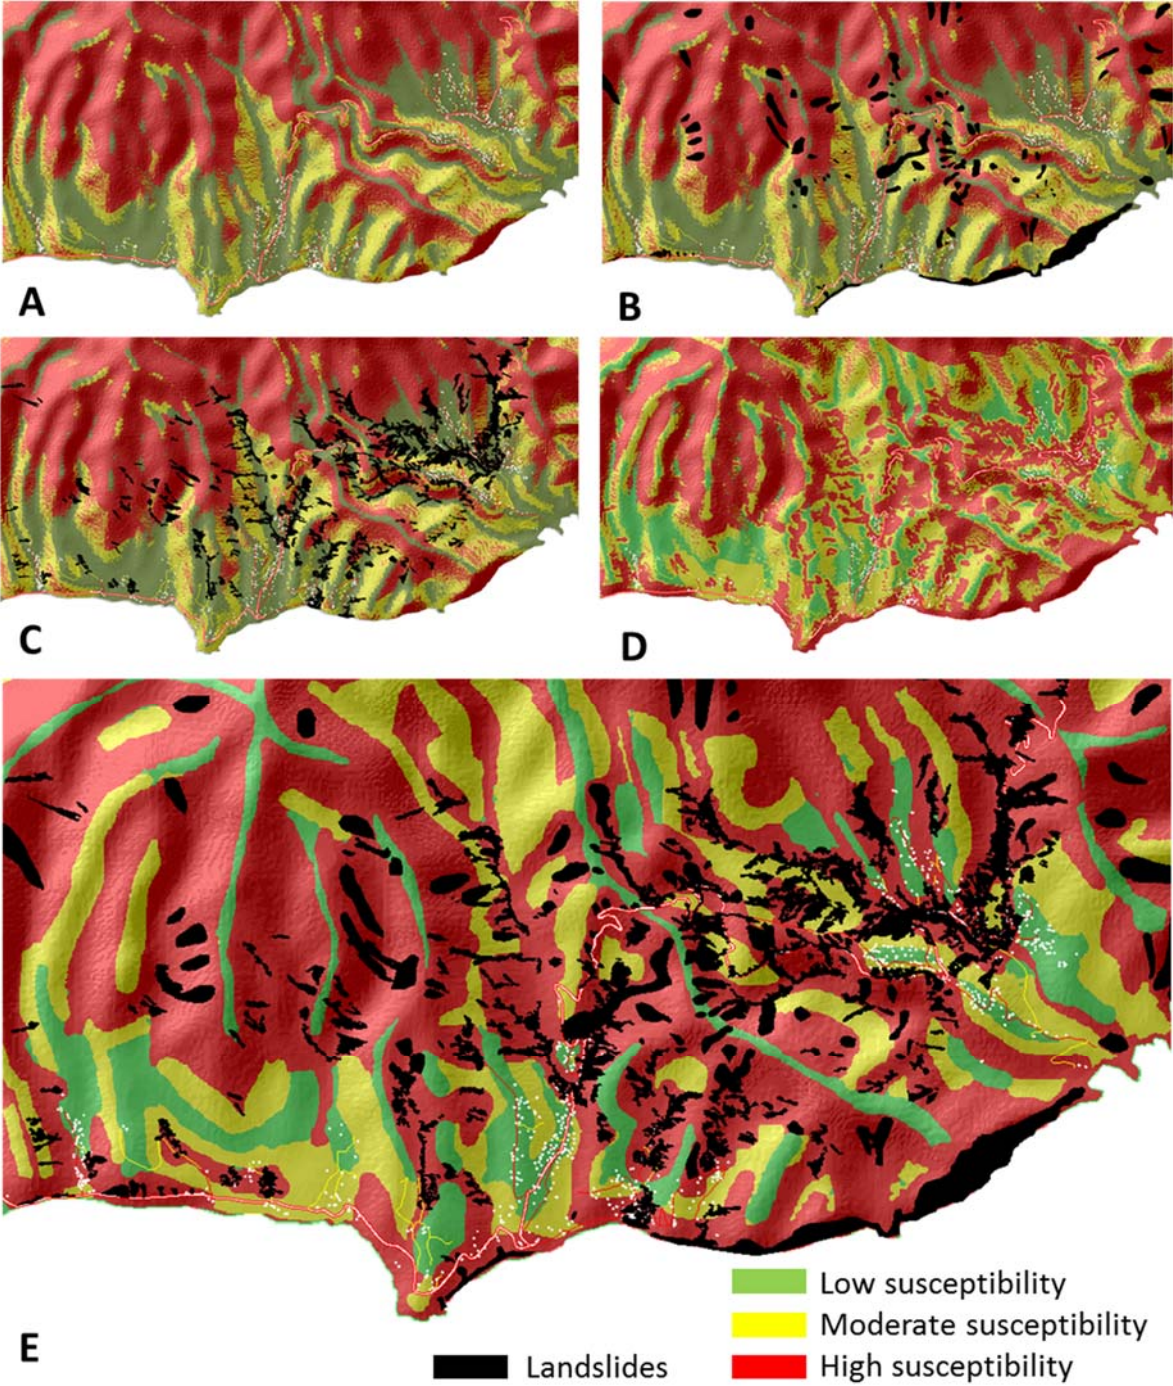
Figure 6-23: Different versions of the landslide susceptibility maps. A: combined soil slide and rockslide susceptibility map; B: overlay of all pre-2015 landslides; C: overlay of the Erika triggered landslides; D: incorporation of landslide inventories in the susceptibility map; E: final landslide susceptibility map generated after extensive editing.

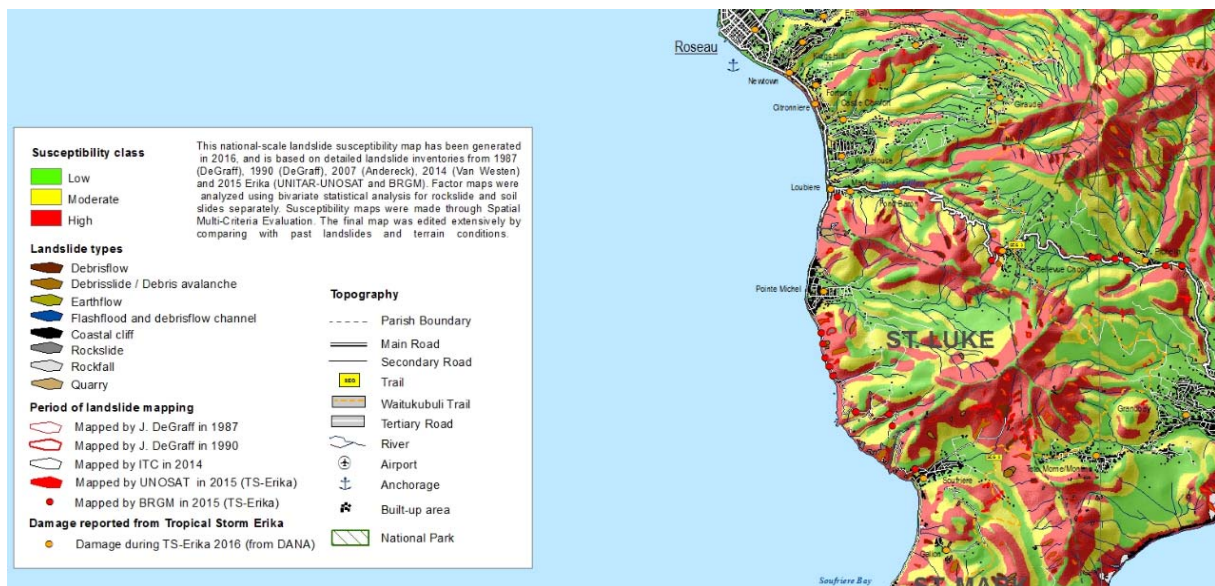
Figure 6-24: Legend of the final landslide susceptibility map for Dominica, and enlarged example of the Southwestern part.

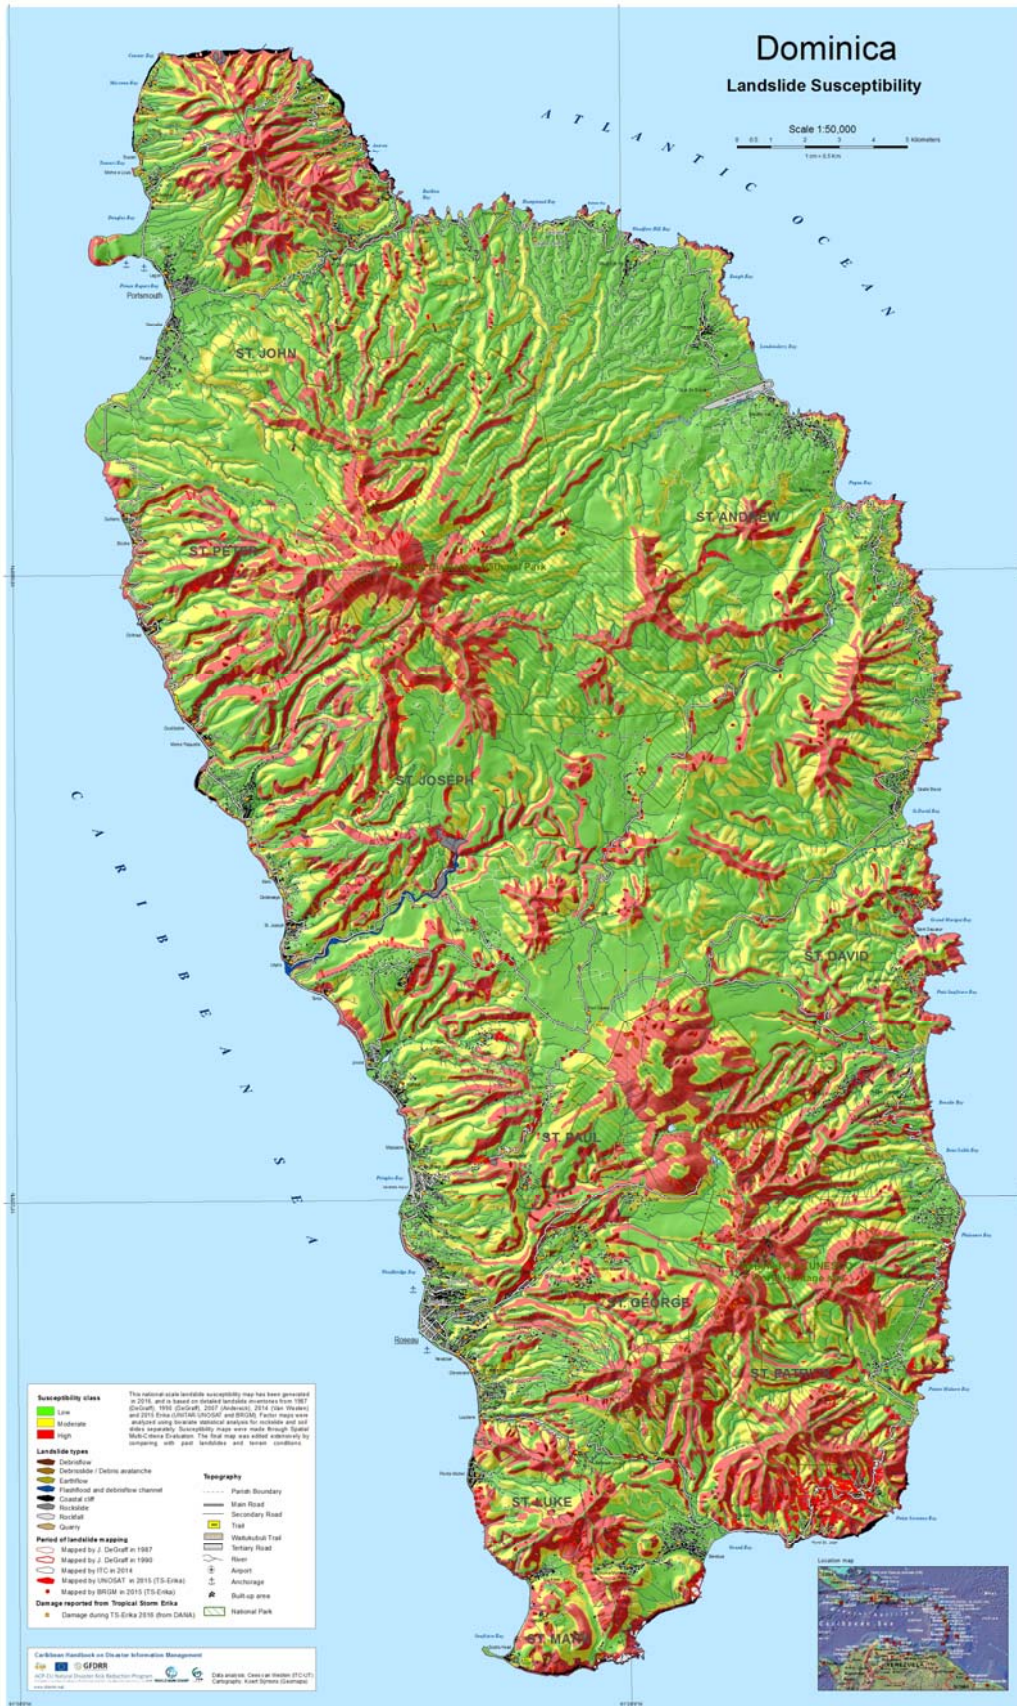
Figure 6-25: Final landslide susceptibility map for Dominica. The full map can be downloaded as pdf from the following website: <http://www.charim.net/dominica/maps>

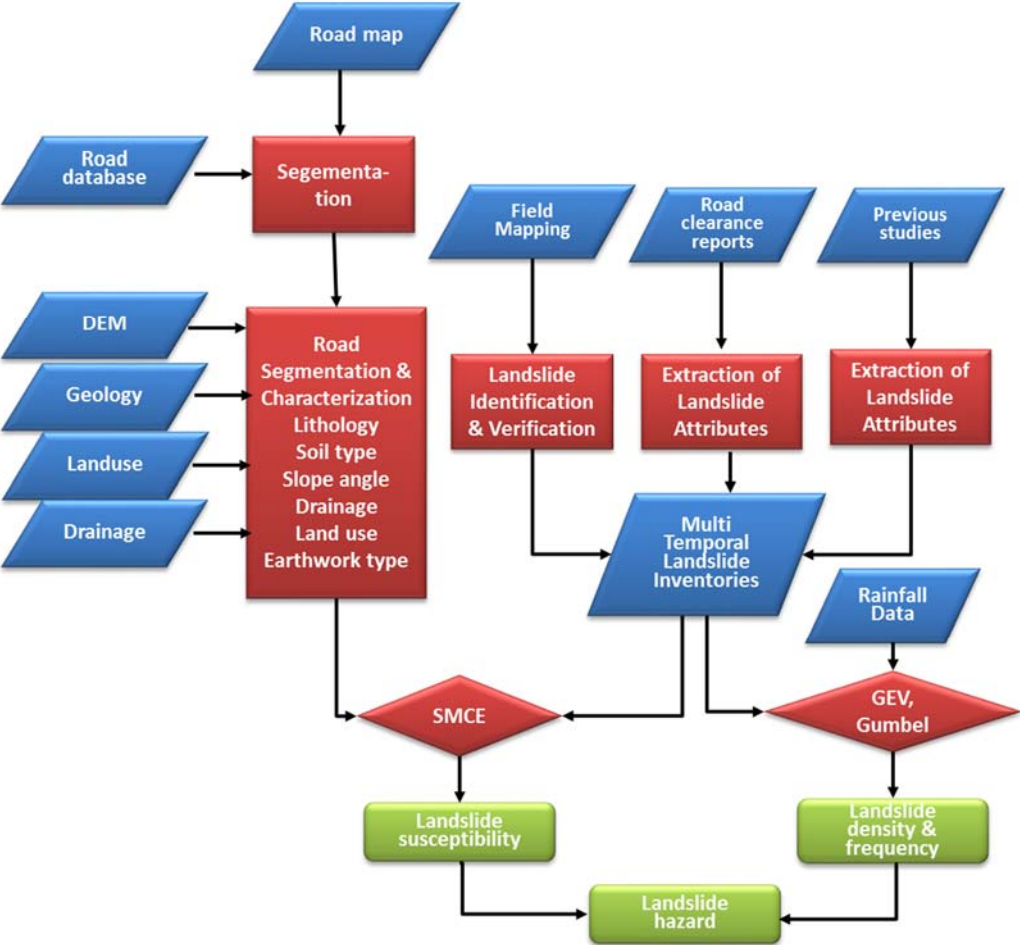
Figure 7-1: Method used for assessing the landslide susceptibility (and hazard) along the national road network in Dominica. Landslide hazard is obtained by combining the susceptibility classification with the results of the density-frequency analysis.

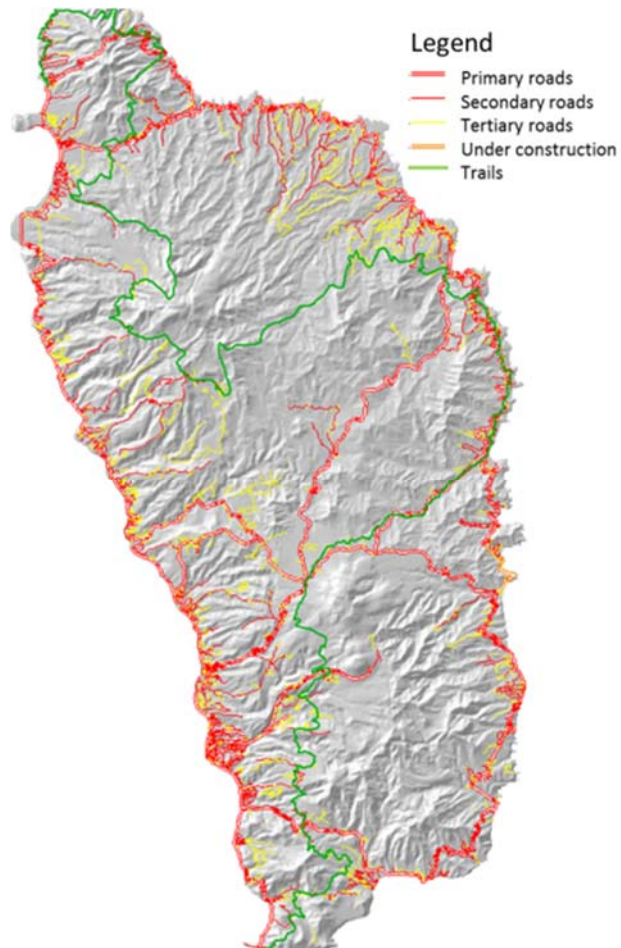
Figure 7-2: Roads and trails in Dominica.

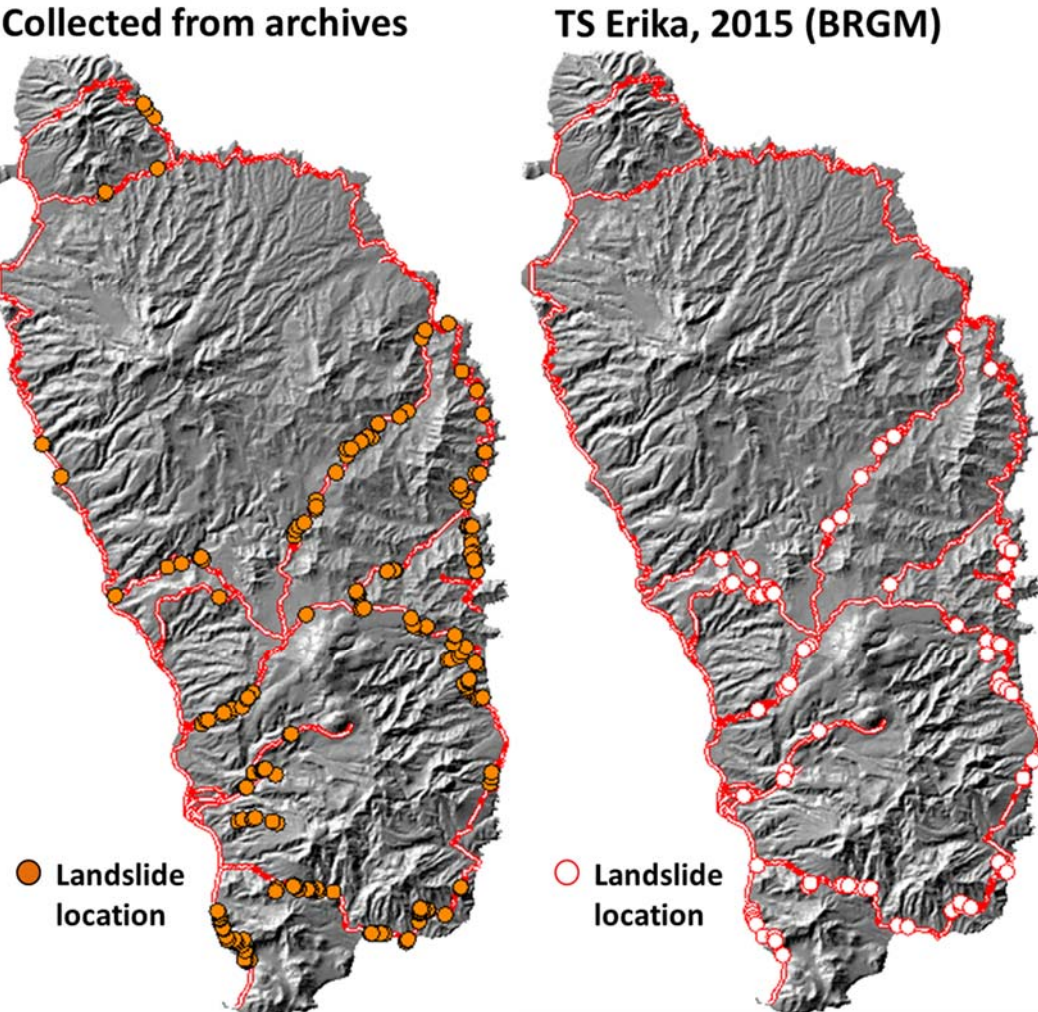
Figure 7-3: Landslide locations along the national road network. Left: collected from the archives of the road department and from field work in 2014. Right: landslides along the road caused by tropical storm Erika in 2015.

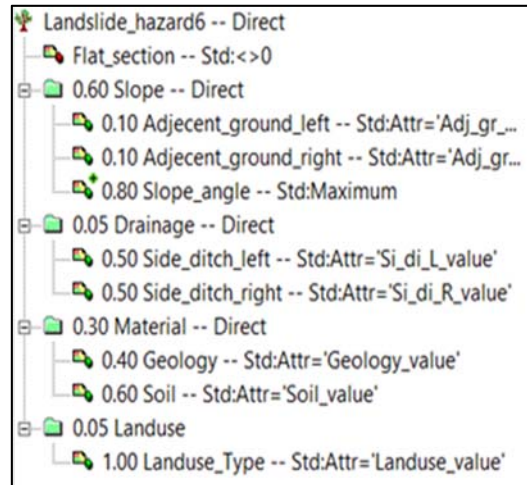
Figure 7-4: Criteria tree for analysing landslide susceptibility along the road network in Dominica.
