# National Scale Landslide Susceptibility Assessment for Dominica

Technical Report · May 2016

# **National Scale Landslide Susceptibility Assessment for Dominica**

**May 2016**

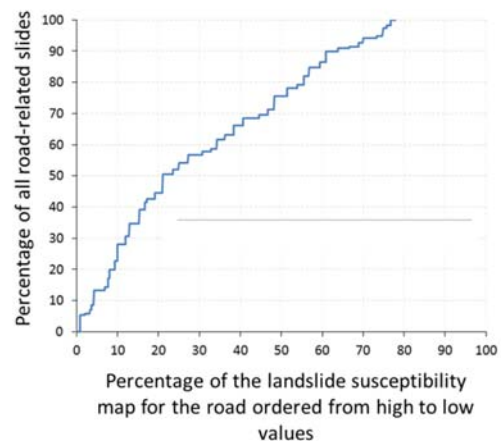
Figure 7-5: Success rate for the road-related landslide map.

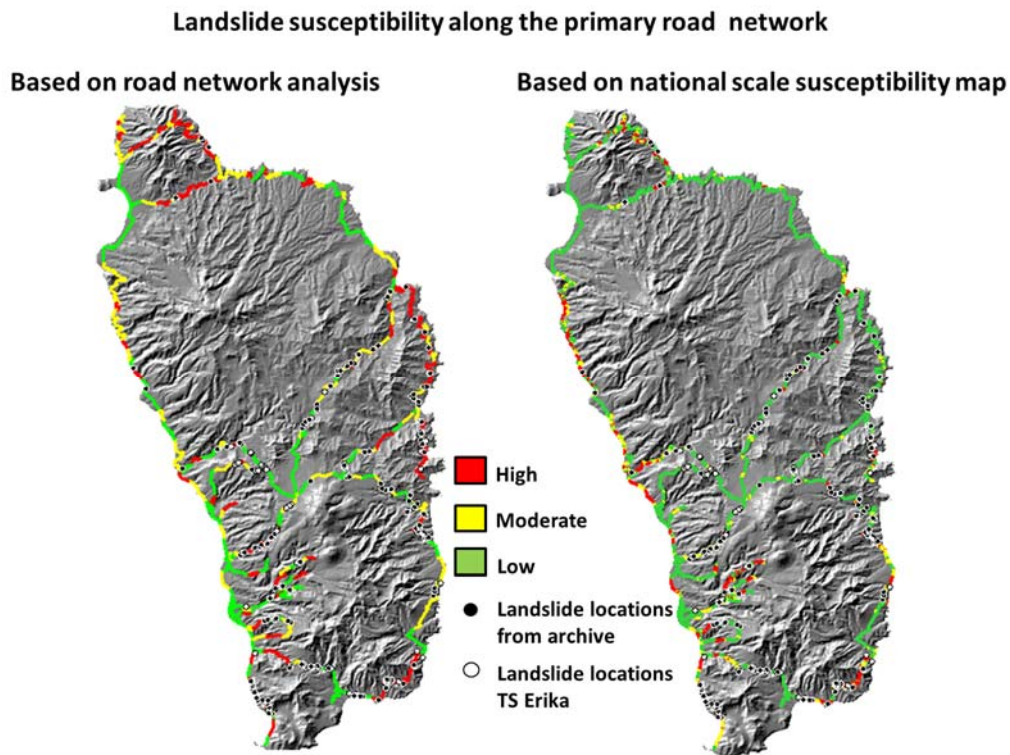
Figure 7-7. Left: Landslide susceptibility map along the major roads of Dominica as generated from the road analysis. Right: landslide susceptibility of the road network taken from the national scale landslide map.

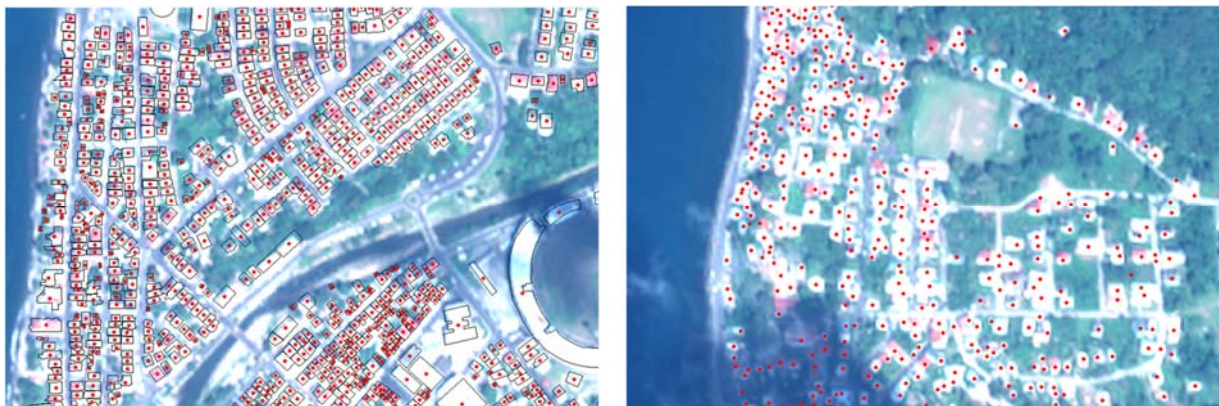
Figure 8-1. Example of the building extraction as points for the whole island of Dominica. Left: example for the centre of Roseau for which also building footprints were available show a good correlation. Right: example from Pointe Michel.

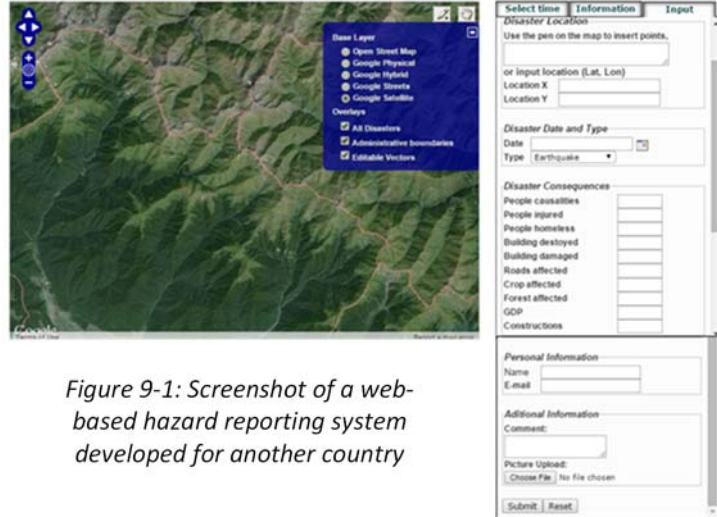
Figure 9-1: Screenshot of a web-based hazard reporting system developed for another country

There is a need to develop a national landslide database, which requires that one organization is made responsible for generating and maintaining such a database, and where several other organizations should contribute. This will require additional funding from a donor agency to set it up. The landslide inventory should be stored in a web-mapping application, with a Google Earth or other background, where various national and international organizations can consult the existing landslide information, and where new landslide events can be added by government organizations, local people, news media, NGO's etc. A close collaboration with the online newsmedia in Dominica (<http://dominicanewsonline.com/>) is highly recommended, as they have reported many landslide events, with additional photo or video footage, which could be easily linked to a geolocation, and stored in such a database so that the information is not lost. It is very important to get better data on the location, type, damage and especially the date of landslide events, so that in future a correlation between rainfall characteristics and landslide incidences, and the establishment of rainfall thresholds, and frequency/magnitude relationships can be properly carried out. These reported events would be stored in a separate database, which is used by the national responsible organization for landslide inventory mapping, as the basis for checking. These are added to the actual database only after they have been checked by an expert. This will also allow the continuation of the landslide database in future. It is essential that there is a close collaboration between the various national organizations that have to deal with landslides. However, one organization should be the nodal agency responsible for setting-up the national landslide database.
