External iliac artery injury following total hip arthroplasty via the direct anterior approach—a case report

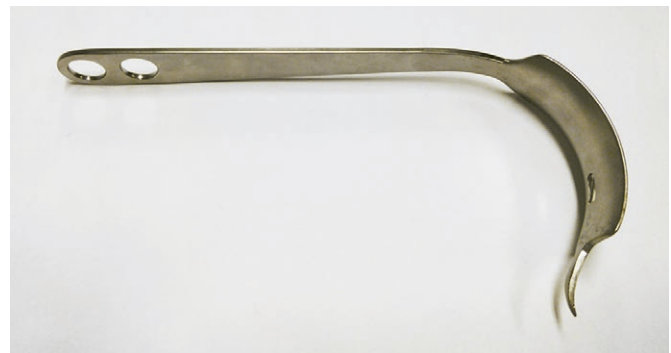
Figure 1. Type of Hohmann retractor used during the procedure.

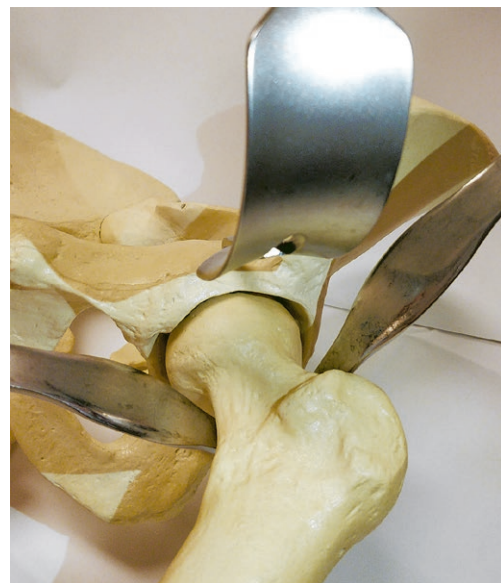
Figure 2. Hohmann retractors placed on a pelvis phantom.

The importance in prevention of vascular complications in THA is clear. Alshameeri et al. (2015) reported permanent disability due to ischemia (8%), amputation (2%), and mortality (7%) in 124 vascular injuries as significant consequences of this severe complication. Injury due to retractor misplacement is often described as a cause of vascular damage. It is paramount that patients should be placed in the correct position and that they are handled considering the anatomical location and integrity of the surrounding vascular structures. The neurovascular bundle that contains the external iliac artery travels along the iliopsoas muscle. The iliopsoas muscle bulk will

protect the neurovascular bundle against injury (Sullivan et al. 2019). Therefore, the retractor tips should be placed directly on the bone, and the iliopsoas muscle should not be interposed between the retractor and bone (Rue et al. 2004).

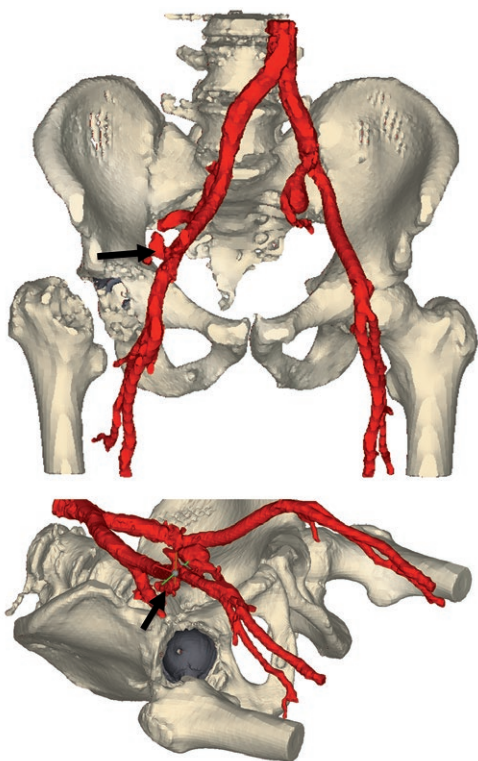
Figure 3. Segmentation of the contrast-enhanced vascular CT. Window ranges corresponding to intravascular contrast are colored red. The implanted metal backed cup is colored gray. The arrow is placed on the site of extravasation at the external iliac artery. Of note is the distance between the acetabular rim and the extravasation site.

Under the suspicion of persisting hemorrhagic shock a multiphase, multislice abdominal aorta-iliac and femoral contrast-enhanced CT scan (ceCTa) was performed. The ceCTa revealed a large retroperitoneal hematoma on the right, with extravasation of contrast in the arterial phase, likely from the distal external iliac artery. Beneath, an asymptomatic left common iliac artery aneurysm with a diameter of 3.5 cm was demonstrated (Figure 3).
