2011 International Conference on Green Buildings and Sustainable Cities

Auditoria and public halls. The preserved architectonic heritage, in the perspective of sustainability.

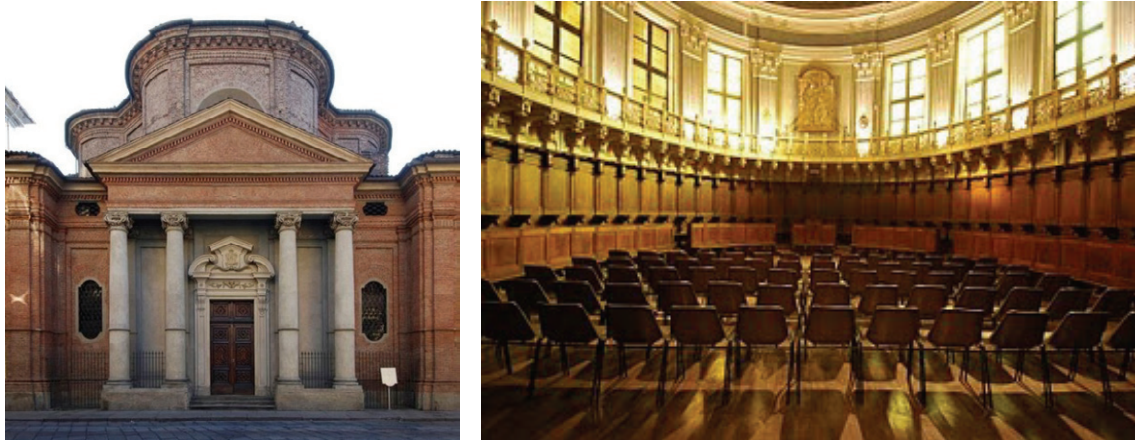
Fig. 2. (a,b) Church and Choir of Santa Pelagia, Torino. Choir detail. [Pictures © Bruna Biamino]

Air diffusion varies in the two areas: in the main hall the air supply is performed via jet nozzle diffusers masked by the choir wooden gratings of the mezzanine floor; the return air is instead performed via the grill inlets obtained in some doors leading to ancillary areas under the choir/organ.

In the hall of the large semi-elliptical choir, the supply has been carried out in the floor and the return takes place through gratings masked in the choir itself. Floor diffusers are placed under the choir stalls, along the whole perimeter of the semi-ellipsis.
