6th International Building Physics Conference, IBPC 2015

## "Retrofit of an historical building toward NZEB"

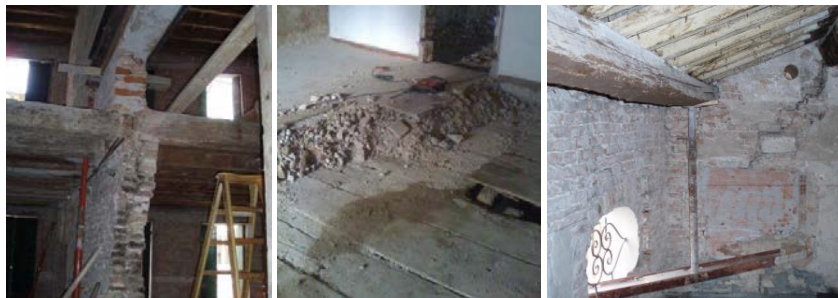
Fig. 2 Building envelope before renovation: a) crooked walls; b) demolished partition walls left and used as a substrate; c) beam support in the perimeter wall.

Building envelope before renovation presented a traditional construction system, based on bearing masonry with covered solid bricks. The floor had a wooden structure, while the ground floor leaned directly on soil. The roof is made of hollow tiles sheets with a wooden structure and a lightweight ceiling slab (Fig. 2).

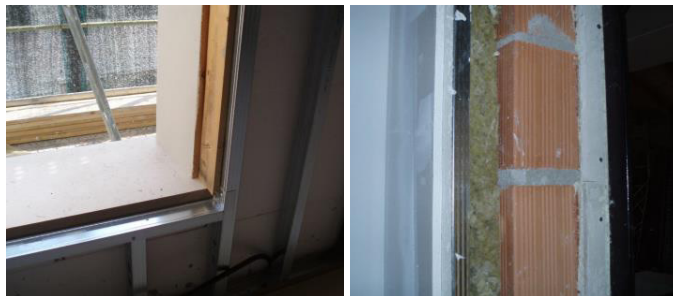
Fig. 3 Insulation on a) internal and b) external walls.

In the external walls the insulation is placed on the inner part (Fig. 3) and this solution meet the requirements of the Superintendence of Veneto Region, preserving the existing materials and the external architectural identity of the building. Specifically, two types of insulating are used: an expanded polystyrene (EPS) foam, placed directly on masonry, and a rigid mineral wool panel with a plasterboard cover. Roof was replaced with a new wooden structure and it was insulated with wood fiber and water tight covering. All existing windows are replaced with a low-energy double layer ones within wooden frames.

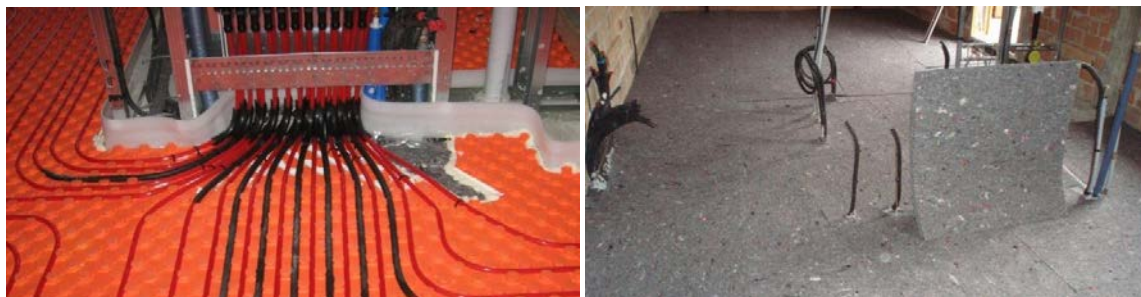
Fig. 4 Radiant system: a) collectors and b) TNT underflooring above system.

About technical systems, the HVAC generation system is a water to water centralized heat pump/chiller. The underlying well is the hot/cold water source and internal comfort is achieved exploiting a radiant system (Fig. 4) installed in the floor together with a dehumidification system for the summer period.

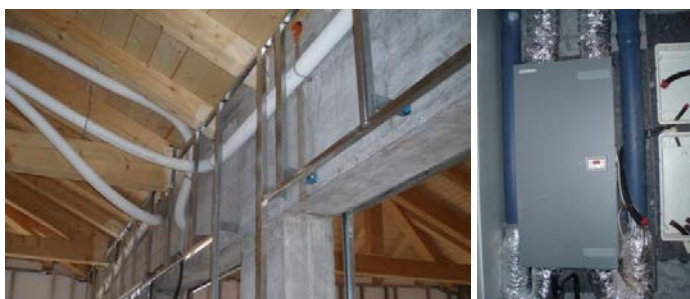
Fig. 5 Mechanical ventilation system.

For heating and cooling the system adopted is a 32 kW heat pump with a distribution by radiant floor system; another heat pump (20 kW) is installed for domestic hot water requirement (DHW); mechanical ventilation (Fig. 5) is provided by a system with heat recovery box (95% efficiency).
