# Electro-chemical Stabilization of Ground under Foundation

MATSUO, Shin-ichiro

MATSUO, Shin-ichiro. Electro-chemical Stabilization of Ground under Foundation. Memoirs of the Faculty of Engineering, Kyoto University 1958, 20(3): 149-162

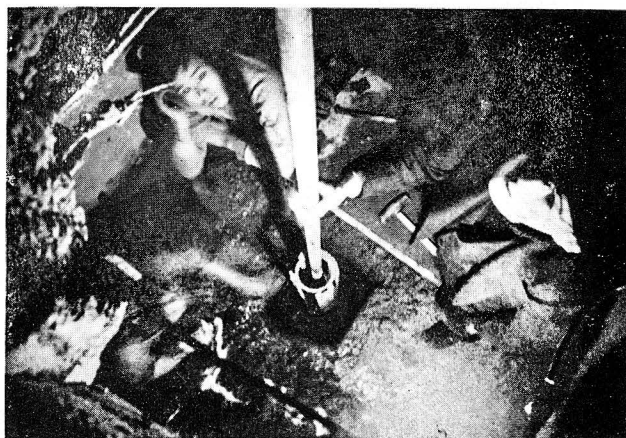
Photo. 2.

Photo. 2 was taken from obliquely above and the upper end of the cathode is just visible. The object projecting out at the center is the suction pipe.

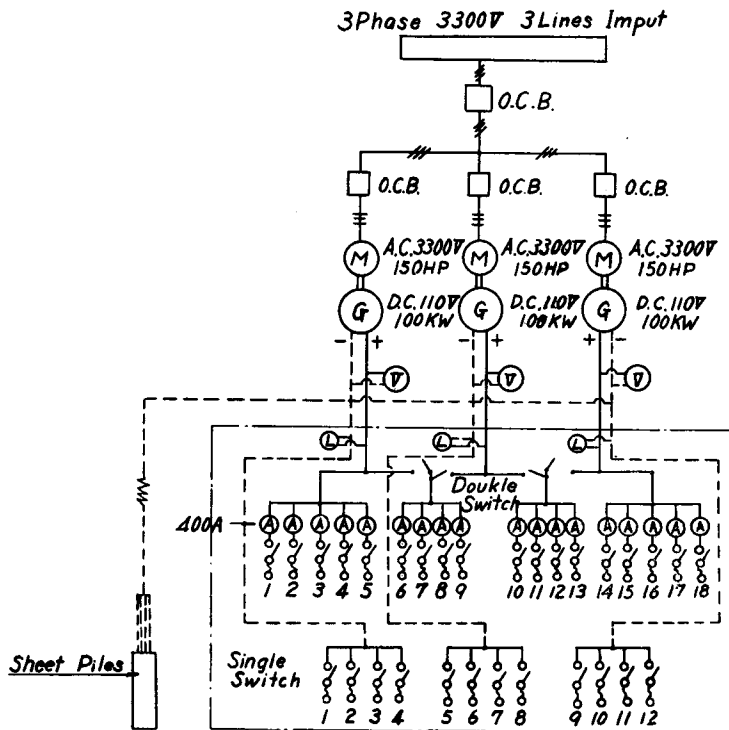
Fig. 3. Electric Power Supply and Circuit of Switch Board.
