## THE STONE ROOF OF THE *THOLOS* OF ATHENA PRONAIA IN DELPHI: STRUCTURAL HYPOTHESES STARTING FROM FRAGMENTS OF MARBLE TILES

**KEY WORDS:** *Tholos* of Delphi, Roof stone tiles, Wood, Conical dome, Elastic analysis, Limit analysis, Interlocking masonry, Structural archaeology.

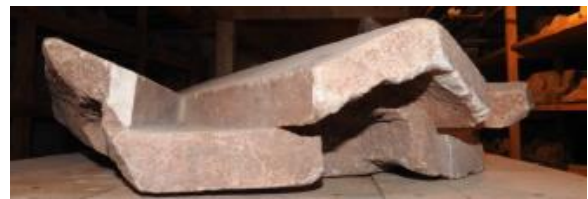
Figure 2. The largest of the stone tile findings.

The major uncertainties regard the structure of the roof. Scholars have debated over the role of interlocking tiles (Figure 2) as well as the presence of two different *sima*. The number of columns and the height of the wall of the cell have also been questioned. Moreover, the possible reconstructions have not been subjected to structural analyses, which has made it difficult to prove the feasibility of the hypotheses. In the following Section, the starting point is the visualization of the factor of tectonic quality of the structure, and the reporting of the uncertainties from the survey campaigns that affect the development of hypotheses. Eventually, to introduce the potentialities of an interdisciplinary approach, this paper discusses two substantially different structural solutions that could fit one of the most accredited reconstruction hypotheses: in Section 3, the possibility of a

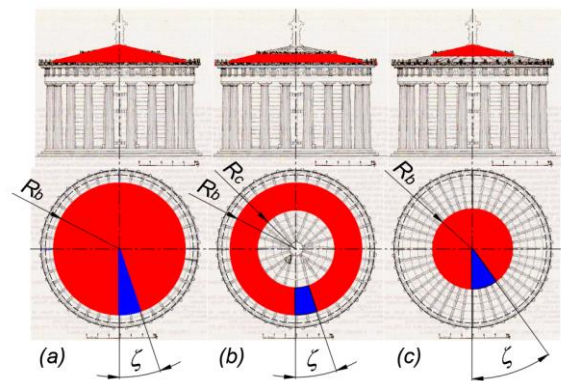
**Figure 14.** Three hypotheses of conical dome: (a) the dome covers the surface of the *tholos*; (b) the dome has a central *oculus*; (c) the dome covers the internal portion of the *tholos*.

Three hypotheses are examined (Figure 14): (a) the roofing dome covers the surface of the *tholos* entirely and is supported by the external colonnade; (b) the dome has a central *oculus* with a radius corresponding to that of the internal wall, and is supported by the external colonnade; (c) the dome covers only the internal portion of the *tholos*, and is supported by the circular wall.

As regards the geometrical parameters, the arrangement of the stone elements is not known, but two hypotheses are made on the thickness in the vertical direction,  $h = 0.14 \text{ m}$  and  $h = 0.21 \text{ m}$ , obtained from the geometry of the tiles shown in Figure 2. The aperture of the cone is defined by angle  $2\beta$ , with  $\beta = 76.19^\circ$  (Figure 15). The joints separating the stone blocks are assumed for simplicity to be orthogonal to the generatrix line of the cone. The base and cap radii defining the conical dome are read from the geometry of the peristyle and of the cell (Figure 3), and set respectively equal to  $R_b = 5.85 \text{ m}$ ,  $R_c = 0$  for case (a);  $R_b = 5.85 \text{ m}$ ,  $R_c = 3.53 \text{ m}$  for case (b);  $R_b = 3.53 \text{ m}$ ,  $R_c = 0 \text{ m}$  for case (c), see Figure 14.

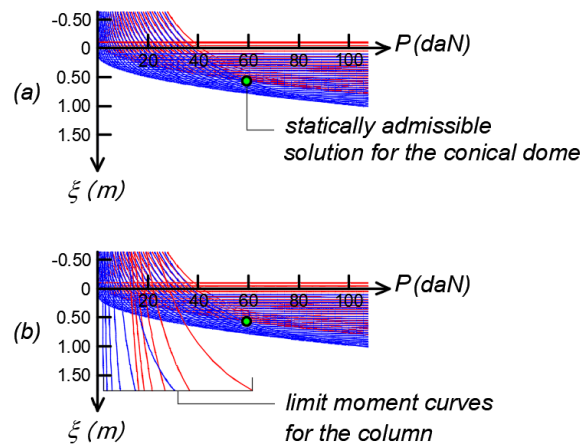
**Figure 17.** Statically admissible solutions in the  $(P, \xi)$  plane according to the stability area method: (a) for the conical dome, (b) for the dome-colonnade system (no solutions are found).

In Figure 17a, the area of stability related to the conical dome of Figure 14a is plotted, by assuming  $h = 0.21$  m. In the analysis, the conical dome is divided into 30 elements of equal length (with reference to the generatrix line of the intrados conical surface). For the assumed value of  $h$ , the area of stability does not identify statically admissible solutions for the independent lune. However, the conical dome - examined separately from the colonnade - has not reached a collapse condition, since the solution corresponding to the highest extrados hinge (see the green point in Figure 17a) does not match the occurrence of the collapse mode 1. By considering the corresponding thrust line, plotted in Figure 18a, this solution identifies an extrados hinge (the red dot), and an intrados hinge at the conical dome's springing (the blue dot). As regards the upper portion of the dome, it should be observed that the thrust line related to the independent lune would exit at some joints. Considering the action of hoop forces, for example, according to the procedure described in (Aita, Barsotti, and Bennati, 2019b) or in (Paris, Ruscica, and Mirabella Roberti, 2021), allows for finding fully statically admissible solutions for the conical dome.

On the contrary, the results related to the systems formed by the conical dome and the external colonnade (or the vertical load-bearing structure), show that these structures would collapse according to the collapse mode 1, since the horizontal thrust deriving from the meridian cracking of the dome is not compatible with the rotational equilibrium. As an example, the stability area (Figure 17b) related to the case of Figure 14a, with  $h = 0.21$  m, shows that statically admissible solutions are not found for the dome-colonnade system. In the analysis, the column has been divided into 5 blocks of the same height. The thrust line corresponding to the highest extrados hinge of the conical dome exits from the profile of the column, by identifying critical horizontal joints (see the pressure centres represented by the red dots in Figure 18b). This condition matches the collapse of the structure according to mode 1 (Figure 16b).

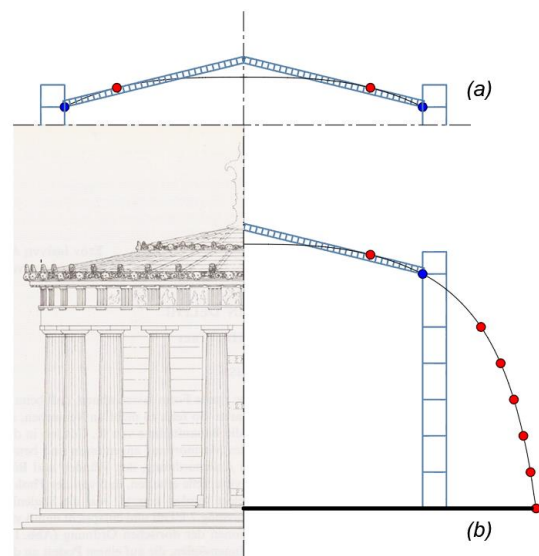
**Figure 18.** The thrust line corresponding to the green point of the  $(P, \xi)$  plane of Figure 17: (a) for the conical dome, (b) for the dome-colonnade system.
