Raw Earth Construction Perspectives in Italy: An Overview Through the Rehabilitations of Casa Fenu in Villamassargia, Sardinia, and Casa di Teresa in Casalincontrada, Abruzzo

Raw Earth Construction Perspectives in Italy: An Overview Through the Rehabilitations of Casa Fenu in Villamassargia, Sardinia, and Casa di Teresa in Casalincontrada, Abruzzo / Bocci, Martina. - In: JOURNAL OF TRADITIONAL BUILDING, ARCHITECTURE AND URBANISM. - ISSN 2660-583X. - 2(2021), pp. 409-422. [10.51303/jtbau.vi2.529]

Martina Bocci

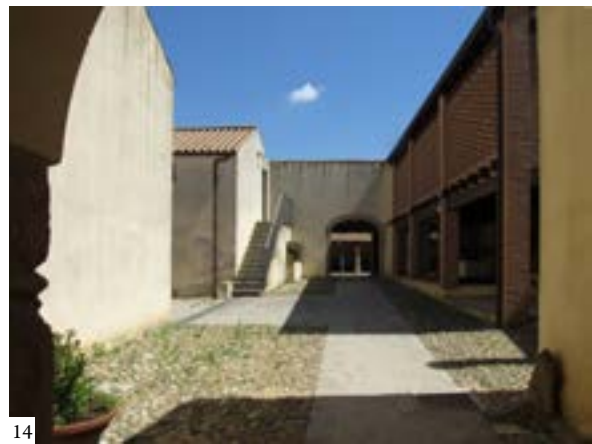
14

Figure 14: Courtyard I as seen from the entrance hall (1): on the left the staircase leading to building B, on the right building C made of fired bricks on the second floor, while glass curtain walls enclose the rooms on the ground floor (Ignazio Garau)
