The role of magnetic resonance in the evaluation of gluteoplasty: habitual aspects and complications

This article reviews magnetic resonance imaging aspects of aesthetic procedures of the gluteal region and its complications.

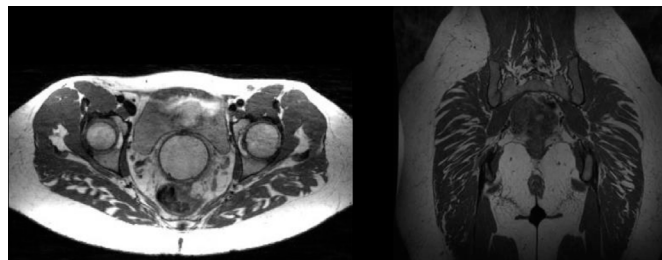
Figure 9: (a) Axial T1 (b) Coronal T1. Normal aspect of gluteal fat grafting on magnetic resonance imaging, with bands of fat permeating the most superficial fibers of the bilateral maximum glutes, makes it impossible to differentiate in the grafted material's subcutaneous tissue and the natural fat.

On CT or MRI images (figure 9), fat grafting on the subcutaneous is difficult to characterize due to similar characteristics with subcutaneous cellular tissue. On the contrary, the fat injected in the intramuscular region is easily identified by both methods, such as lobular foci of macroscopic fat, with low characteristic density on tomography (values of - 150 to -50 Hounsfield units), of permeate to muscle fibers, and with high signal in conventional sequences weighted in T1, on magnetic resonance imaging. The adipose nature is confirmed with the fat suppression sequences on MRI, presenting low signal, both in T1 and T2 weighting⁶.
