Landscape Online | Volume 98 | 2023 | Article 1113

Assessment of Landscape Changes caused by Highway Construction: Case Study of Ruta del Canal Pargua Highway in Chile

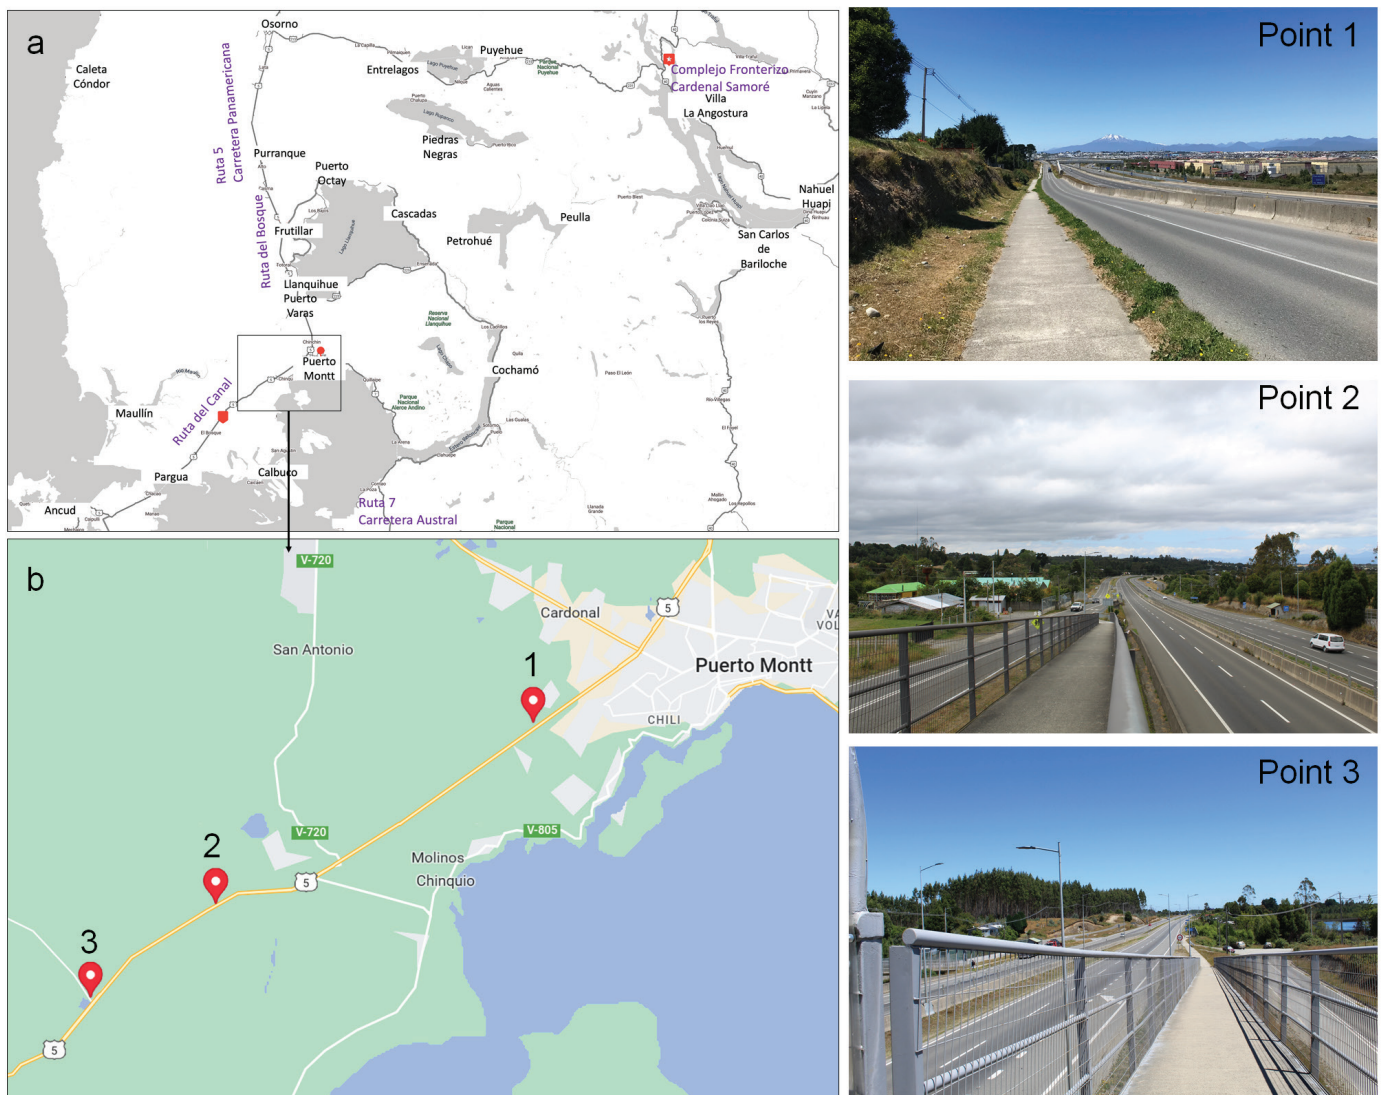
Figure 1. a) Road infrastructure managed by concessionaires in the Los Lagos region with the capital (Puerto Montt) and the frontier cross point Cardenal Samoré connecting Chile and Argentina, b) Observation points of the fieldtrips in 2022 (b) along the Pargua highway in southern Chile: Point 1 in Alto Bonito, Point 2 in Monte Verde, Point 3 in La Goleta sector. Sources: Google Maps and pictures from personal archive of the author, 2022.

For this study, three observation points were selected (Figure 1b) to represent built-up areas of housing developments, rural plots, industries, and the presence of existent wetlands alongside the highway: point 2 in Monte Verde (41°31’42.2”S 73°07’18.7”W) and point 3 in La Goleta (41°33’07.2”S 73°09’50.3”W). In addition, point 1 in Alto Bonito (41°28’58.4”S 73°00’54.9”W) was chosen to compare the landscape changes with the previous study of Ojeda (2018).

tactness, and cultural and heritage elements, where Alto Bonito obtained the lowest score. That pattern was reversed only for the horizon indicator, where Alto Bonito obtained the highest score due to its impressive view to the volcanoes (Figure 1).

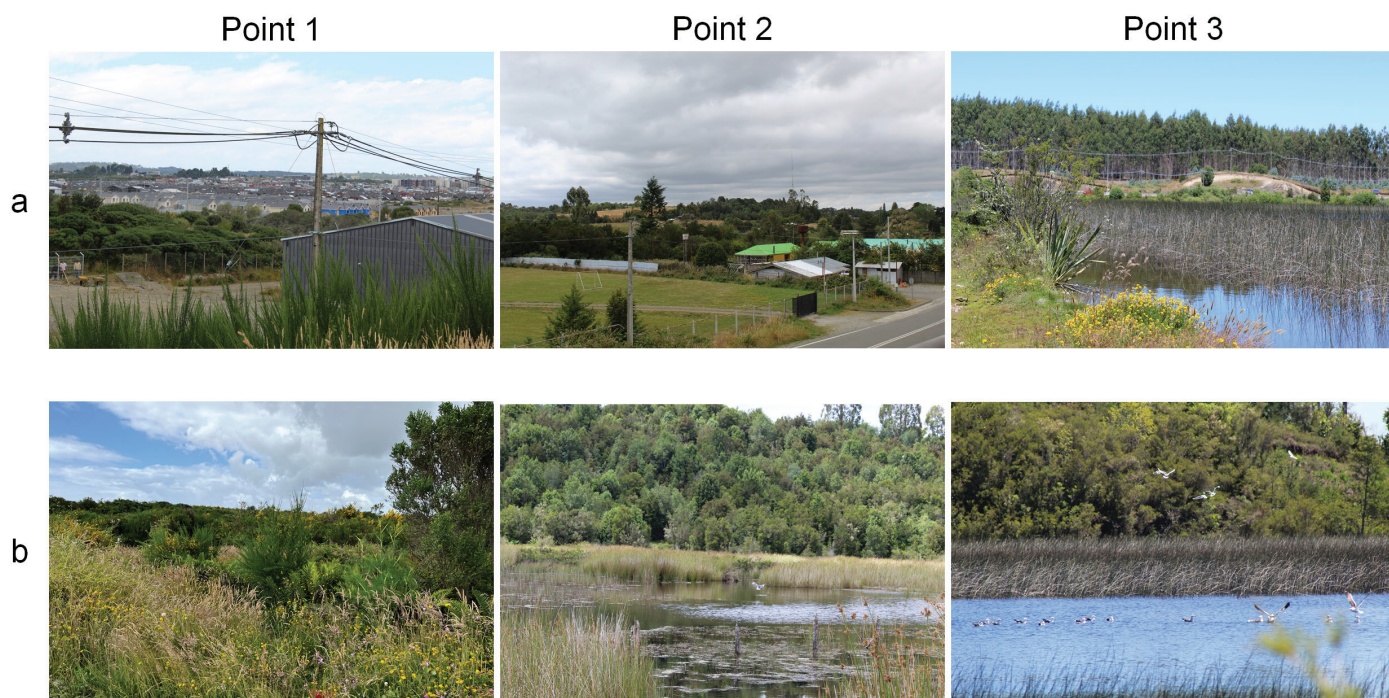
Figure 2. a) Landscape features and b) biodiversity along the Ruta del Canal Pargua – Puerto Montt in Alto Bonito (point 1), Monte Verde (point 2) and La Goleta (point 3.) Source: Personal Archive of the author, 2022.

In points 2 and 3, the management observed at the field trip was reserved to maintain the roadside vegetation within the road limits. However, it notoriously lacks protection for roadside wetlands from the constant noise coming from trucks and cars that disturb migratory birds and other wildlife unleashing biodiversity loss of Gaviota Andina (*Chroicocephalus serranus*), Yeco (*Phalacrocorax brasilianus*), Gaviota Dominicana (*Larus dominicanus*) and Gaviota de Franklin (*Leucophaeus pipixcan*) (Figure 2b) (CEAZA 2004).

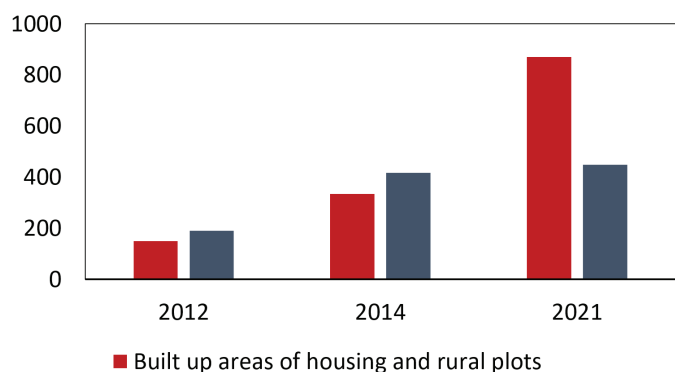
Figure 3. LULCC before the construction of Ruta del Canal Pargua highway (2012-2014), after the construction (2014-2021), and total change (2012-2021).

landscape homogeneity, accelerating the introduction of exotic species for monoculture (pines and eucalyptus), and favoring the urban/industrial sprawl alongside the road. These last three consequences were observed through a multitemporal LULCC (2012, 2014, and 2021 maps in supplementary material) focusing on the progression of urbanized areas of industries, housing, and rural plots alongside the main road (Figure 3).

In a more recent image (Figure 3, Figures S4 and S5), the conversion of agricultural and forestry land cover into an urbanized cover was fully consolidated and focused on the northeast side of Puerto Montt dominated by the addition of housing and rural plots. Following this, the Calbuco node, located in the middle of the highway, presented a circular expansion dominated by industrial lots and included a new southern branch to the seaport and the fuel reservoir. The exception was the small southern city of Pargua, for which land cover and urbanization levels remained the same.

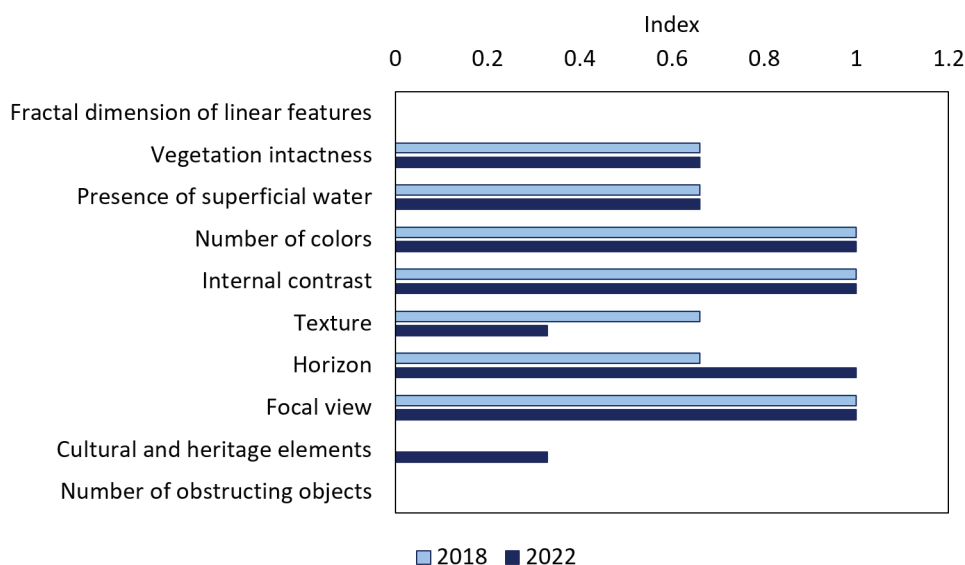
Figure 4. Comparison landscape visual quality and natural features for Point 1 Alto Bonito between 2018 and 2022. Results of 2018 were obtained from Ojeda Leal (2018).

In the previous study of 2018, Alto Bonito obtained an overall score of 5.64/10, and it changed in features like horizon, texture, and cultural and heritage elements (Figure 4). It could be inferred that the fast conversion of land covers and unorganized urban sprawl affected the highway’s natural features due to anthropogenic interference: noise pollution, water scarcity, landscape fragmentation, the proliferation of invasive species (i.e., *Rubus spp.*, *Úlex europaeus*), and wildlife deaths at the road. Also, it could be inferred that possible causes of this urban sprawl around the highway lie in increasing pressure to buy rural plots during the COVID-19 pandemic to acquire a vacation house, or a cabin to do remote work (Fitzroy 2021; Ciper Chile 2022), falling under the idea of paradise that grew stronger in the social imaginary (Chile Travel 2022; Booth 2010). Furthermore, it was noticed through LULCC analysis in point 1 that industrial factories added more pressure by acquiring more land searching to reduce their operation costs and add space to keep their work supplies, something that Puerto Montt’s capital city can no longer offer.

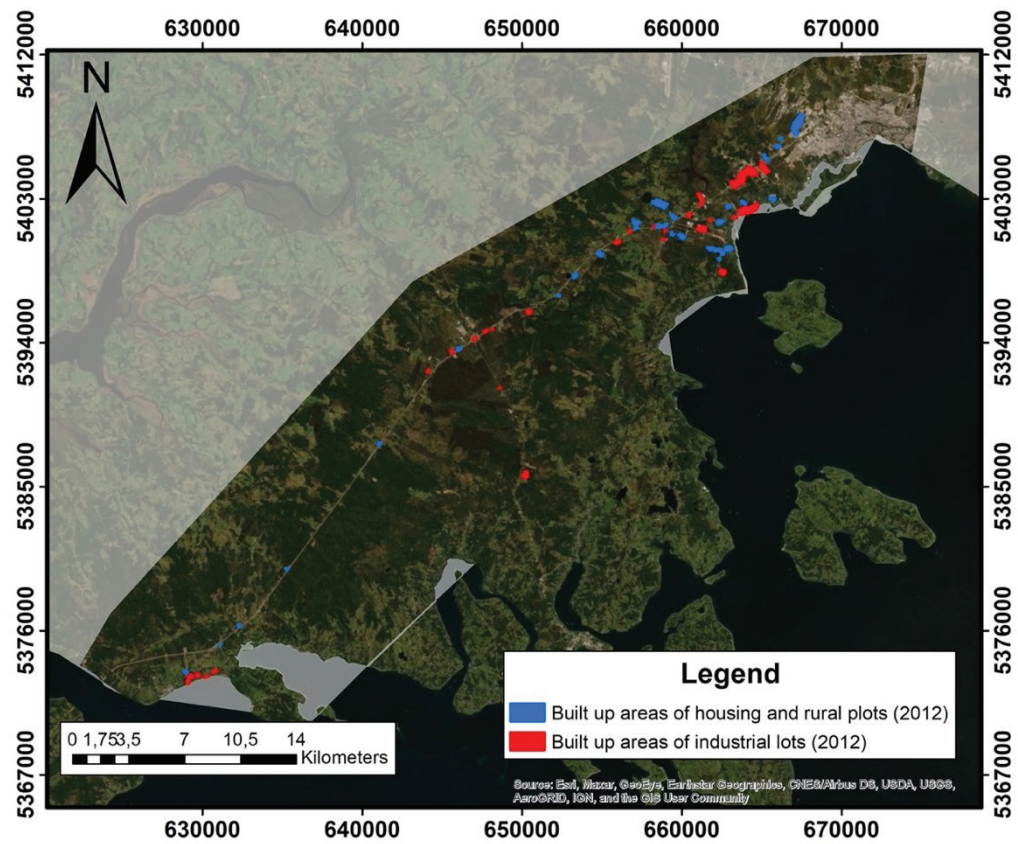
Figure S1. LULCC observed at Pargua Highway before the construction (2012) highlighting the changes in housing and rural plots (blue) and industrial lots (red). Source: Made with ArcGIS 10 by César Muñoz.

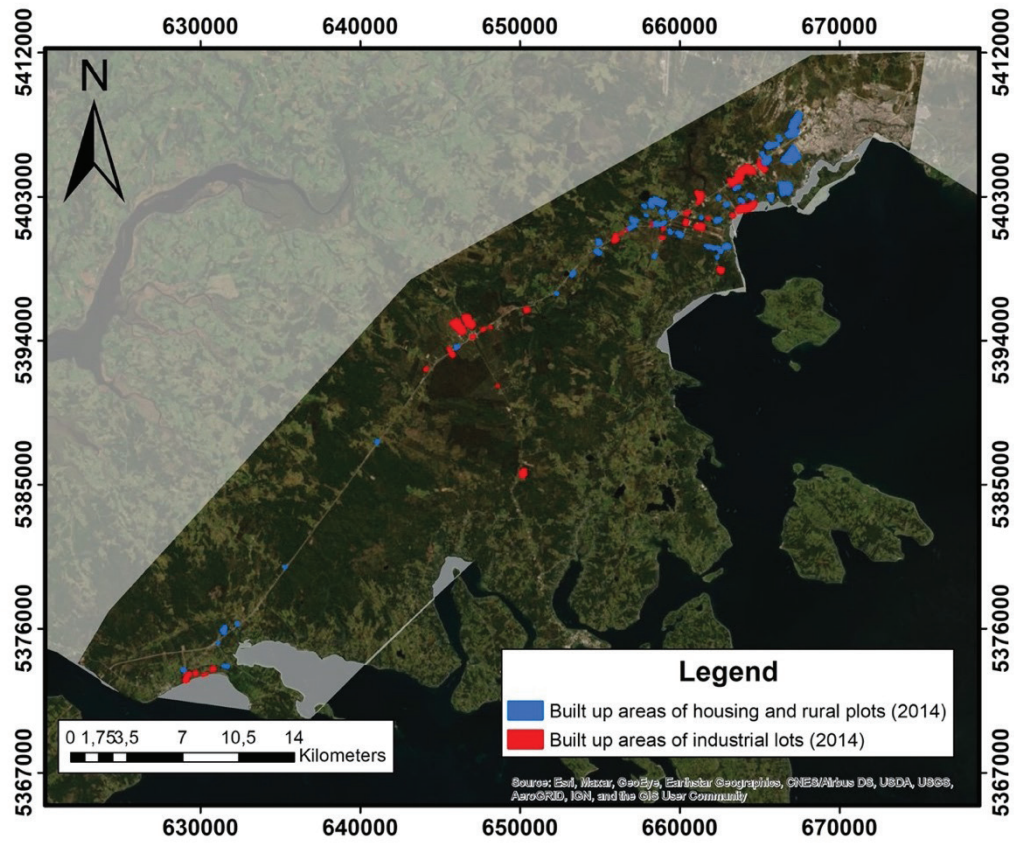
Figure S2. LULCC observed at Pargua Highway after the construction (2014) highlighting the changes in housing and rural plots (blue) and industrial lots (red). Source: Made with ArcGIS 10 by César Muñoz.

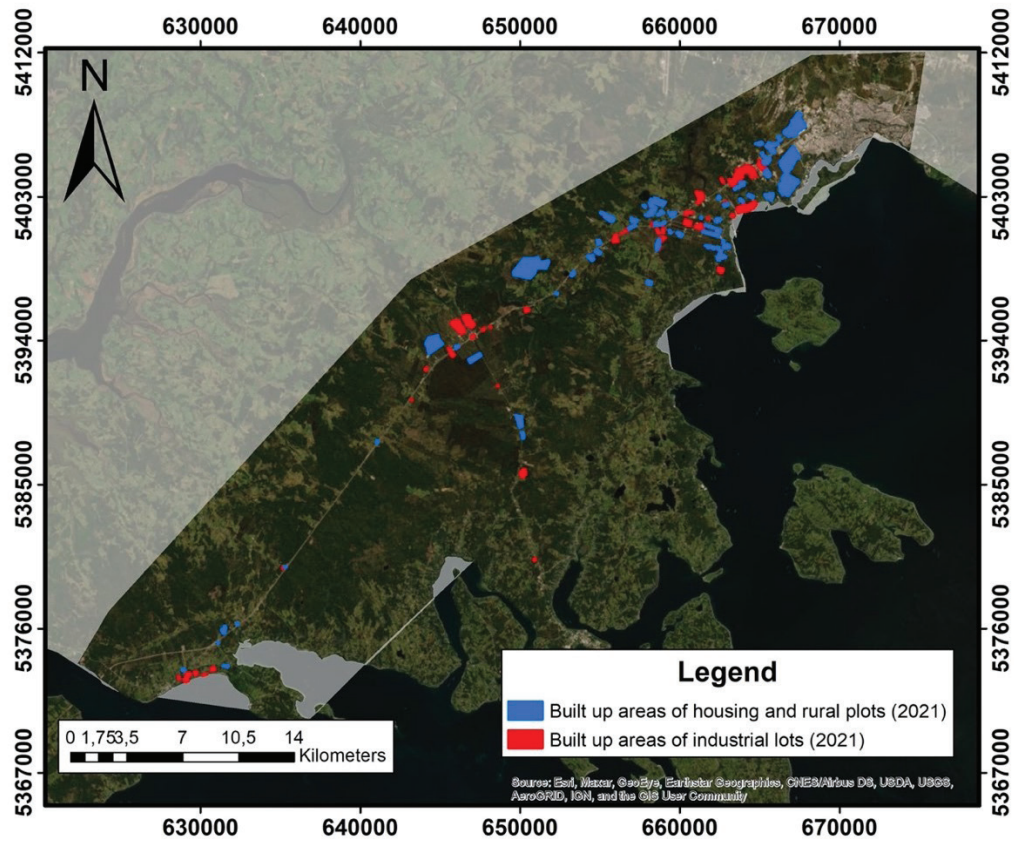
Figure S3. LULCC observed at Pargua Highway last year (2021) highlighting the changes in housing and rural plots (blue) and industrial lots (red). Source: Made with ArcGIS 10 by César Muñoz.

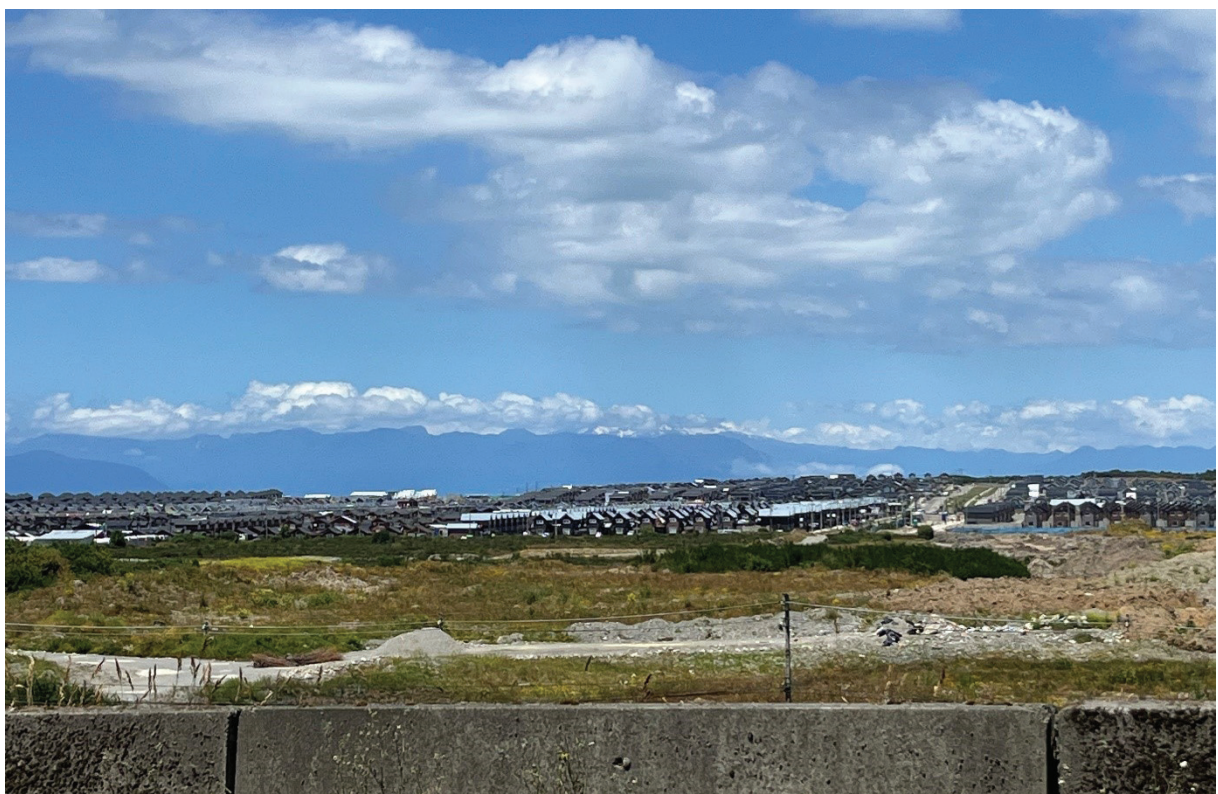
Figure S4. Concrete plant of Cemento Melón located a few km north to point 3 La Goleta which is a typical industrial plot. Source: Google Street View, 2023.
