Utilizing CFRP Sheet for Strengthening Extended Concrete Beams

Abstract. This research investigates the behavior of extended reinforced concrete beams that have been enhanced using CFRP at the extension points. Five reinforced concrete beams with measurements of 2500 mm in length, 150mm in width, and 260mm in height were built and extended in different types. The studied cases included varied CFRP strengthening schemes for the splice joints. The findings conclude that the inclusion of horizontal stirrups on the complete top of the beam produced comparable results to those of the reference beam. Additionally, the spliced beams glued at their lateral faces and strengthened by vertical CFRP laminates provided a marginal increase in their ultimate loads. The results also showed that the strengthening with carbon fibers exhibited lower crack width than the reference beam in general.

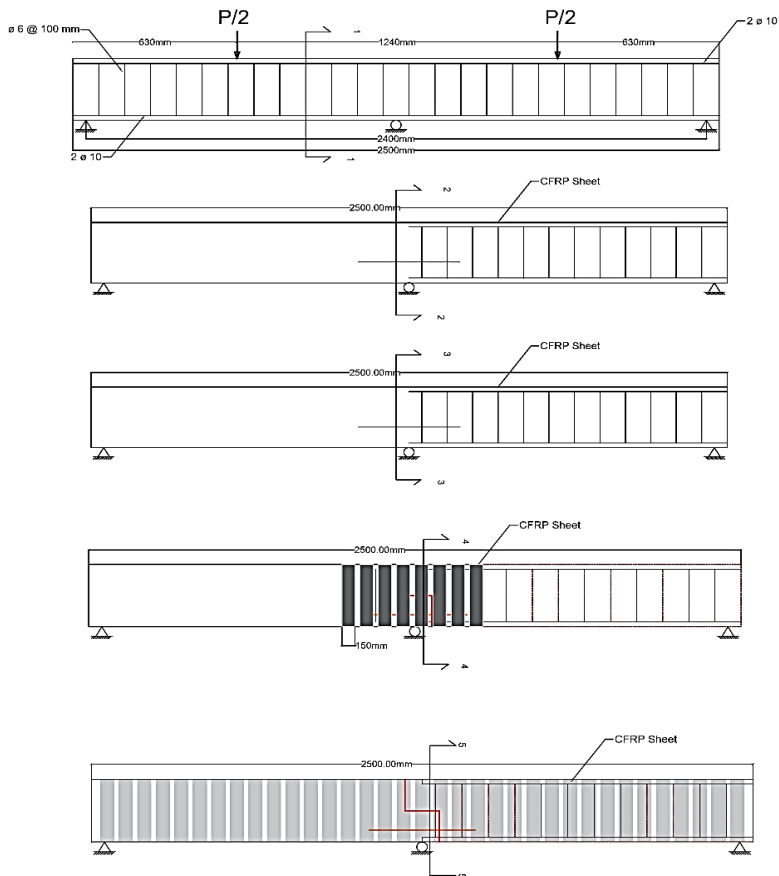
Figure 1: Specifics on the beam segment's reinforcing.

section. The stirrups were 6 mm in diameter and spaced 100 mm apart throughout the beam length. The control beam was designed in accordance with the ACI 318 Code [10]. The length of the splice region was equivalent to the development length of the expanded longitudinal bars. The descriptions for the extended and non-extended continuous beams were illustrated briefly in Figures 1 and 2 and Table 1.

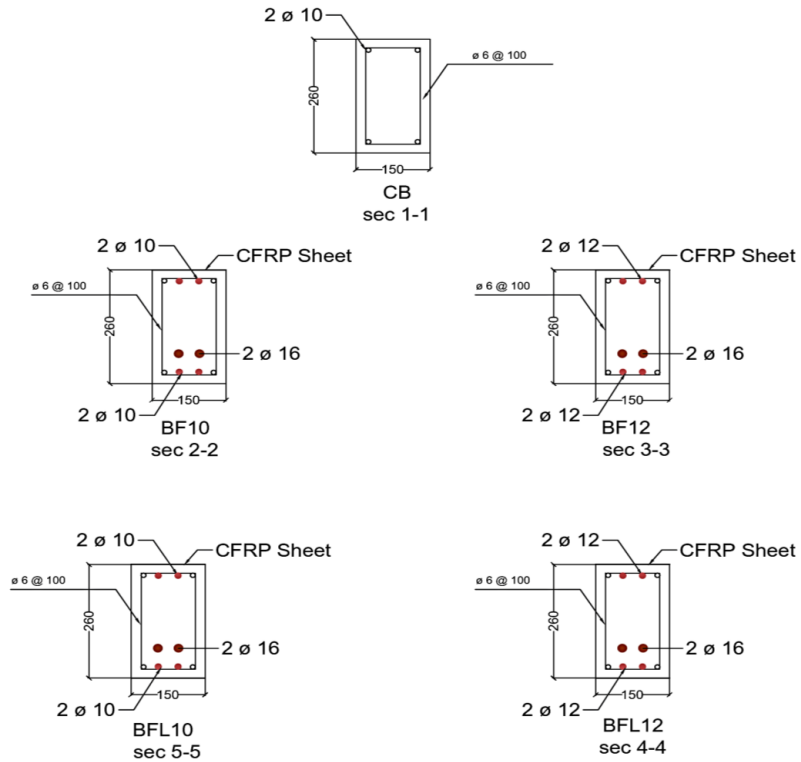
Figure 2: Reinforcement details in the beam segment portion (all measurements are in millimeters).

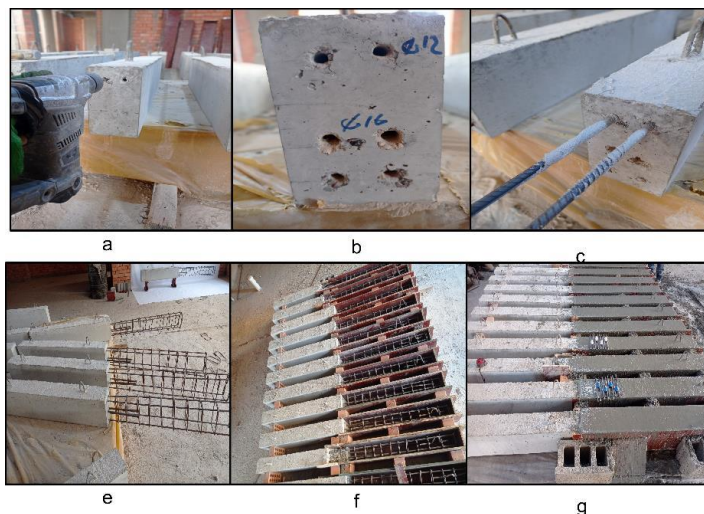
Figure 3: The application of extended region.

Carbon fibers that were used for the two models marked with (BF10 and BF12) were used along the upper surface of the beam with dimensions of (150×2500)mm. The concrete mix was (1:1.33:1.3) using a super plasticizer-to-cement ratio of 1% and a water-to-cement ratio 0.3. For all beams, ready-mixed, standard-weight concrete is utilized. With a 100 mm slump, the concrete's compressive strength was 36 MPa. The Sika Wrap®-300 C, a CFRP, was employed in this investigation. The type epoxy adhesive Sikadur®-330 is a two-component, solvent-free, moisture-tolerant, high strength, high modulus structural epoxy adhesive, as shown in Figures 3 and 4.

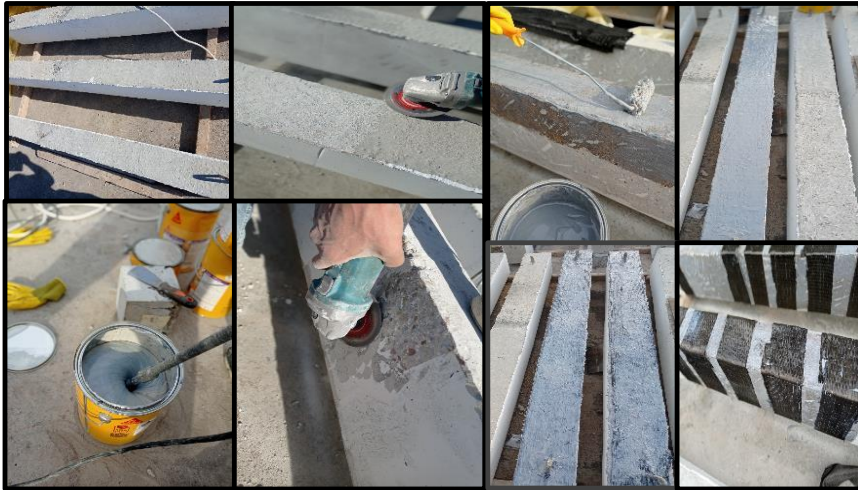
Figure 4: The application of CFRP Sheet.

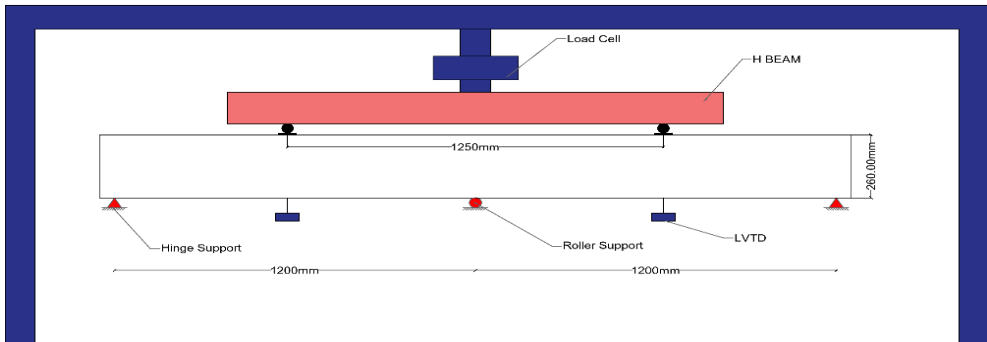
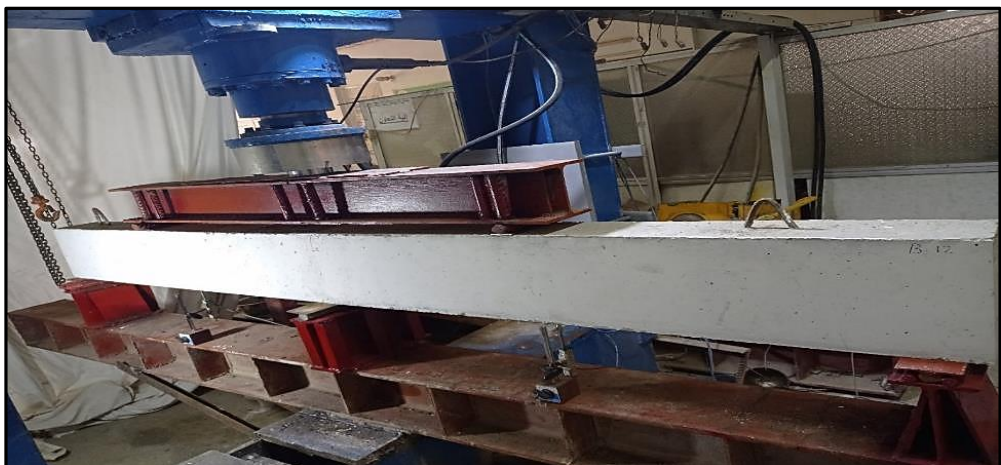
Figure 5: Preparation for loading.

A 2000 kN capacity servo-hydraulic actuator was used to test the beams. The beams were loaded monotonically in 10 kN increments. Deflection measurements at mid-span and the breadth of the fractures were taken at each load stage, as shown in Figure 5.

(a) Setup for testing.

(b) Beam segment before applying the load.

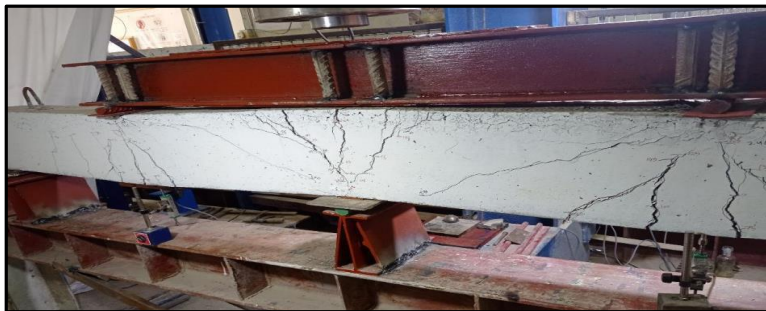
(a) Cracks pattern of CB.

According to the experimental findings, three different types of cracks were developed in the extended beams due to loading. The most frequent forms of cracks were flexural, diagonal, and interface cracks. First, flexural cracks were seen at the middle span joint, followed by further cracks on the lower face. Several cracks began to move diagonally when the load was around 80% of the maximum load. During this phase, the precast segment's interface experienced cracks. Figure 6 displays the failure mechanisms and crack patterns for the extended beams. It was found that while extended beams collapsed via flexural followed by direct shear, non-extended beams fractured due to a failure in the tension steel reinforcement (control specimen).

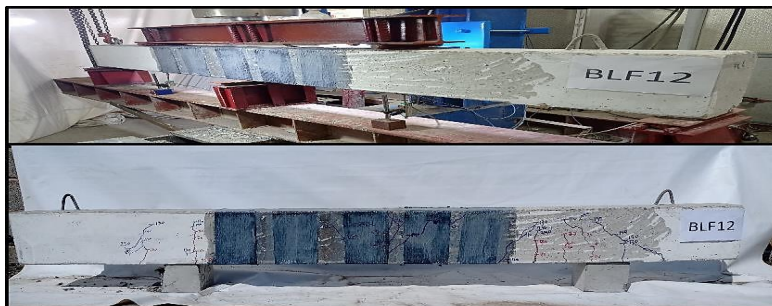
(b) Crack patterns in the tested extended continuous beams at the failure stage (BLF12).

Figure 6: Crack patterns in the tested extended continuous beams at the failure stage segment.

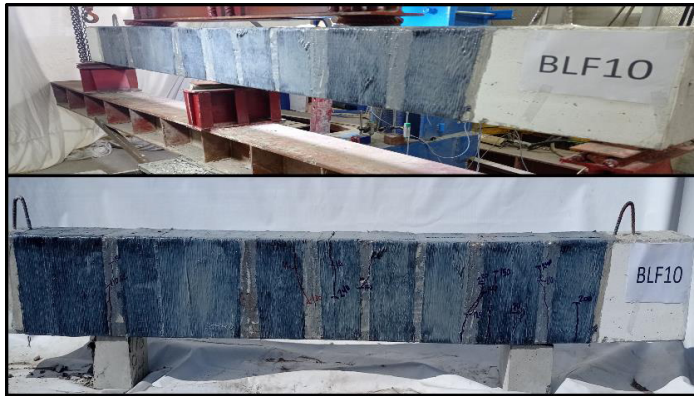
(c) Crack patterns in the tested extended continuous beams at the failure stage (BLF10).

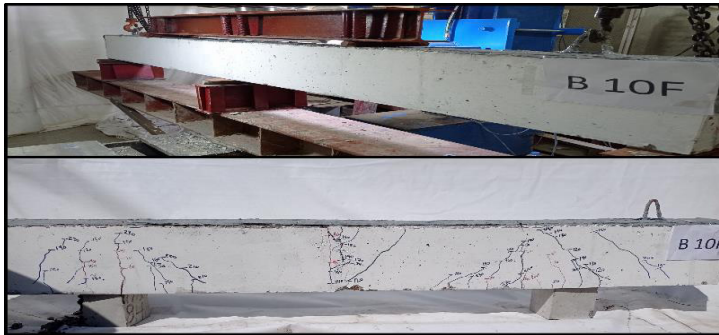
(d) Crack patterns in the tested extended continuous beams at the failure stage (BF10).

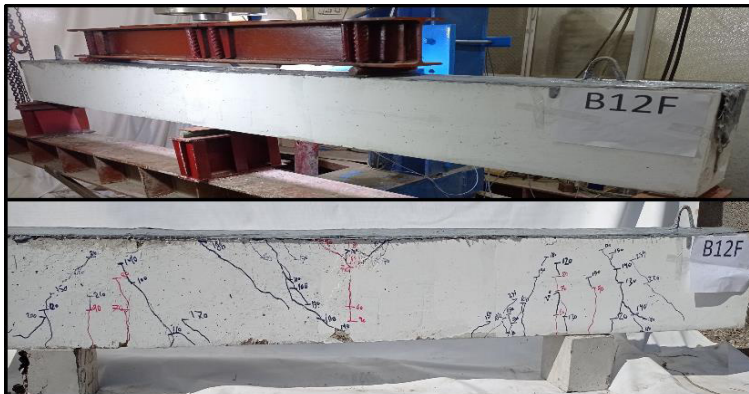
(e) Crack patterns in the tested extended continuous beams at the failure stage (BF12).

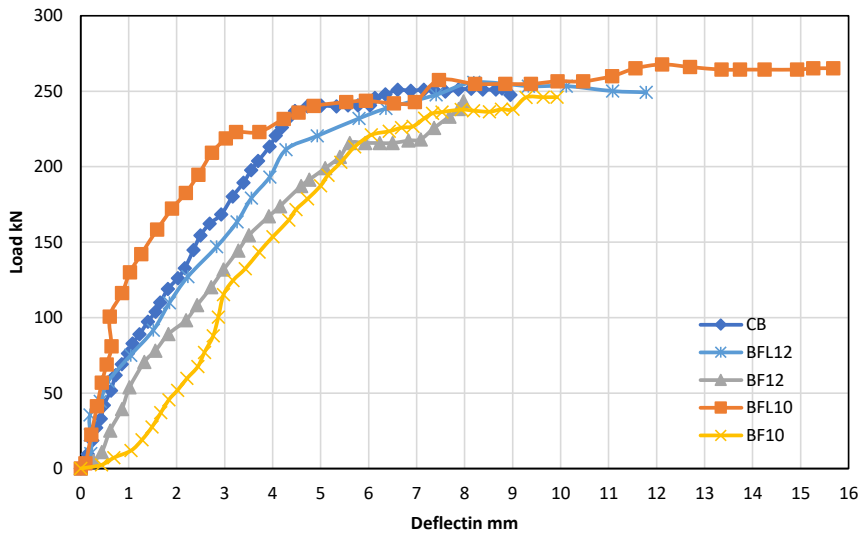
Figure 7: Load-deflection curves for extended reinforced concrete beam CB.

Under the impact of the applied loads, the load-deflection curve significantly impacted the general behaviors of the concrete beams. According to the findings, the control beam experienced a flexural failure at a load of 248 kN, while the ultimate load of the strengthened beam spliced in was either less or more than the non-extended beam by 1.5%. Figure 7 displays the load-deflection curves for extended reinforced concrete beams, the effects of the method, and the addition of CFRP sheet reinforcement in the splice zone.
