Bartoli F, Isola D, Casanova Municchia A,  
Kumbaric A and Caneva G (2023) Science for  
art: multi-years' evaluations of biocidal efficacy  
in support of artwork conservation.  
*Front. Microbiol.* 14:1178900.  
doi: 10.3389/fmicb.2023.1178900

# Science for art: multi-years' evaluations of biocidal efficacy in support of artwork conservation

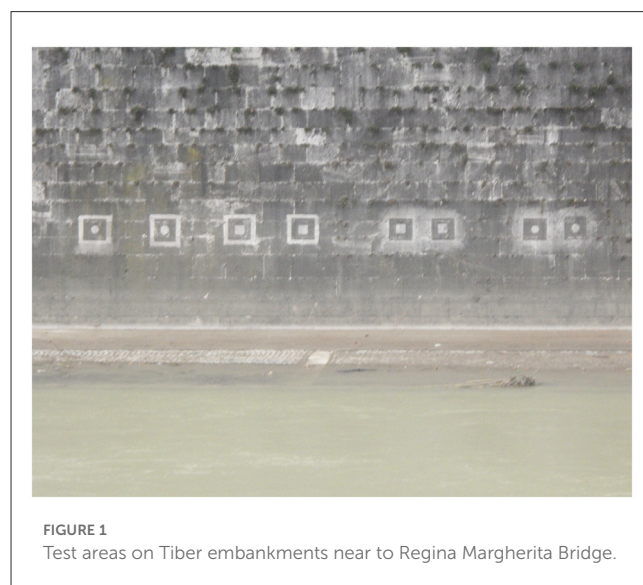
FIGURE 1  
Test areas on Tiber embankments near to Regina Margherita Bridge.

A stretch of the Lungotevere near the Regina Margherita Bridge was selected as a test area. In October 2014, eight squares of the embankment with an overall size of 64 × 64 cm were treated with the same techniques that were used by the artist while making the friezes, including white and gray areas, to simulate the nuances used in the drawings (Figure 1).

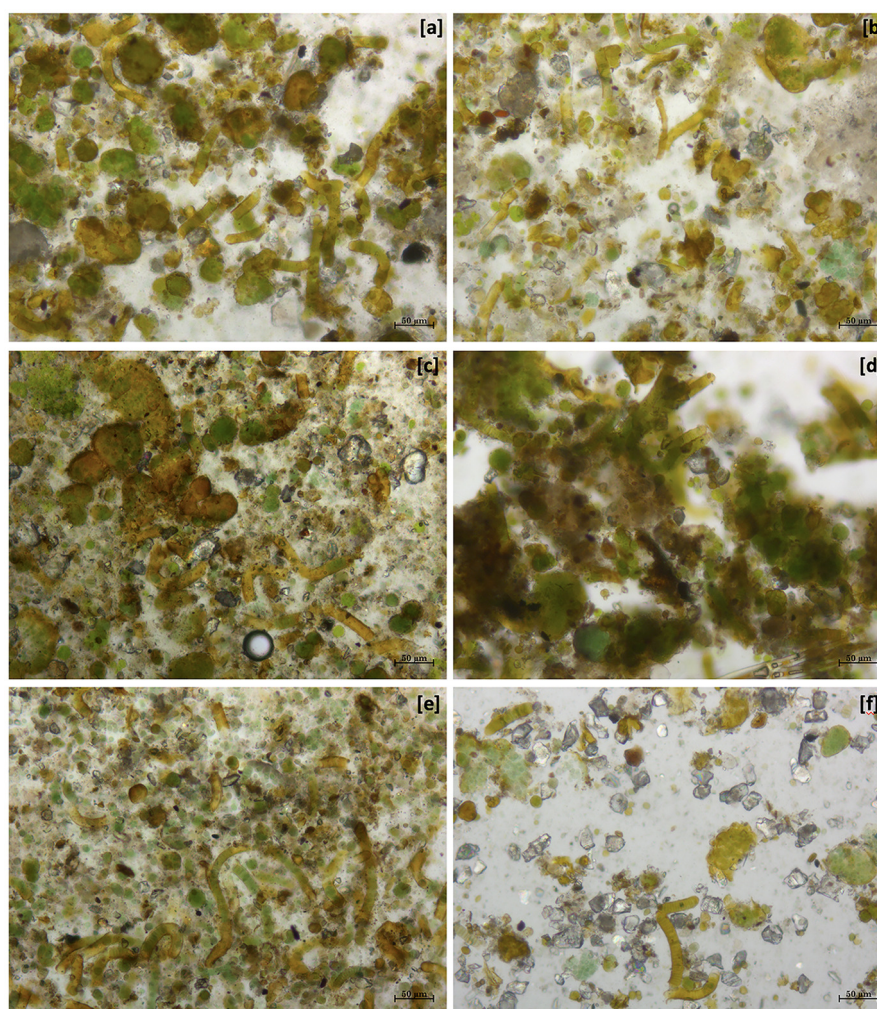
FIGURE 2

Optical image at 10X magnification of different dowels on 22 October 2022. (a) BO, the community without any kind of alteration; (b) BA, recolonizing communities after only physical cleaning; (c) T1' dowel, recolonizing community after 1 application of PR80 + Alg + Hydro-5% and (d) T1'', with three applications; (e) T3' dowel, recolonizing community after 1 application of PR80 + BTr + Silo-4% and (f) T3'', with three applications.

the species composition (Figure 2). The observation of the fresh preparations under an optical microscope at several magnifications highlighted that there was an evident difference in abundance of microorganisms during the recolonization phase.

The comparison between BO and BA (Figures 2a, b) showed the same composition, but in the second one, there is a smaller colonization, such as in the other comparison T1' vs. T1''' and T3' vs. T3'''. Moreover, the microscopic analysis showed that the three applications of PR80 + BTr + Silo-4% determined a considerable reduction of the recolonization rate (Figure 2f) but also a few changes in the biological colonization such as the absence of algal components in the community.

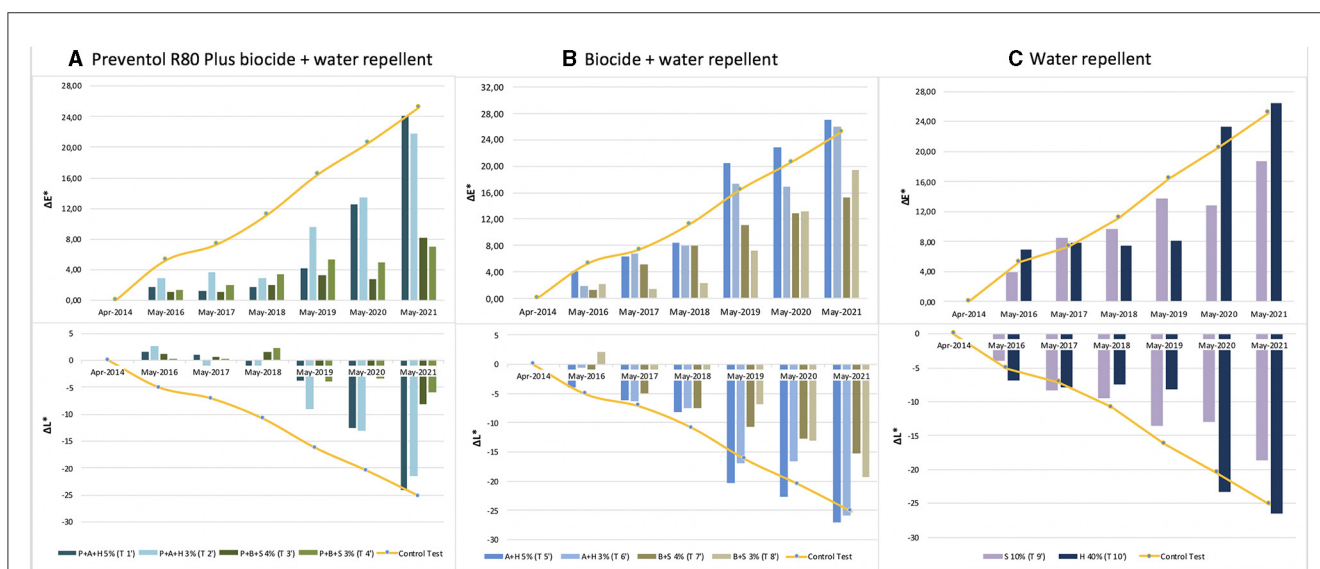
FIGURE 3 Color and lightness variation ( $\Delta E^*$  and  $\Delta L^*$ ) in the test areas treated with a single biocide application: (A) Preventol treatment followed by a mix of biocide and hydro repellent; (B) mix of biocide and hydro repellent; (C) only hydro repellent application. P, Preventol; A, Algophase; H, Hydrophase; B, Biotin R; S, Silo 111.

The color variation values  $\Delta E^*$  over the threshold value of four, as shown in Figure 3 and Table 2, were reached after 5 years (2019) with the application (repeated once) of all products, except for the product containing Preventol + Biotin R + Silo 111 with a 4% concentration. In May 2021, all test areas were completely recolonized (Figure 3). However, the recolonization is more evident in those areas treated with Preventol + Algophase + Hydrophase at both concentrations (5 and 3%), where the trend of  $\Delta E^*$  data was similar to the data of the control test area that was not treated. Although the areas treated with Preventol + Biotin R + Silo 111 at both concentrations (5 and 3%) also greatly exceed the threshold  $\Delta E$  value of four, they still appear to have a lower coverage than the areas treated with other biocide mixtures and the coverage of the control test areas.

The application of only the mixture with the biocide and water repellent without the preventive application of Preventol showed a test behavior like the natural situation recorded on the control tiles without the application of the products. Since 2017, three products (Algophase + Hydrophase 3 and 5%, and Biotin R and Silo 111 4%) out of four, applied once, had already exceeded the threshold  $\Delta E^*$  value of four CIELAB units, showing a visible recolonization of the surface (Figure 3, Table 3). In 2019, all the treated areas with the four products appeared visible ( $\Delta E^* > 4$ ). Test areas treated with Algophase + Hydrophase 3 and 5% followed the similar trend of the untreated areas of the control test (Figure 3). The

Since 2016, a single application of the hydrorepellent has shown an increase in the colorimetric variation  $\Delta E^*$  (Figure 3 and Table 4). In 2020 and 2021, the areas treated with Hydrophase had values comparable to those obtained in the control areas, underlining the ineffectiveness of the product in slowing down the colonization. The data about lightness values confirmed the darkening of the surfaces treated since 2016 (Figure 3). The decrease in  $\Delta a^*$  values (on average, in 2021,  $\sim -0.9$ ) confirmed the presence of photosynthetic microorganisms that increased toward the end of the seven years (Table 4). An increase in the amount of the product with Silo 111, applied twice or three times, slowed down the recolonization. In fact, Figures 4, 5 showed a divergence of the data from the data of the control areas. However, as shown in Table 5, we registered major standard deviation values due to an extremely heterogeneous substrate in some test areas.

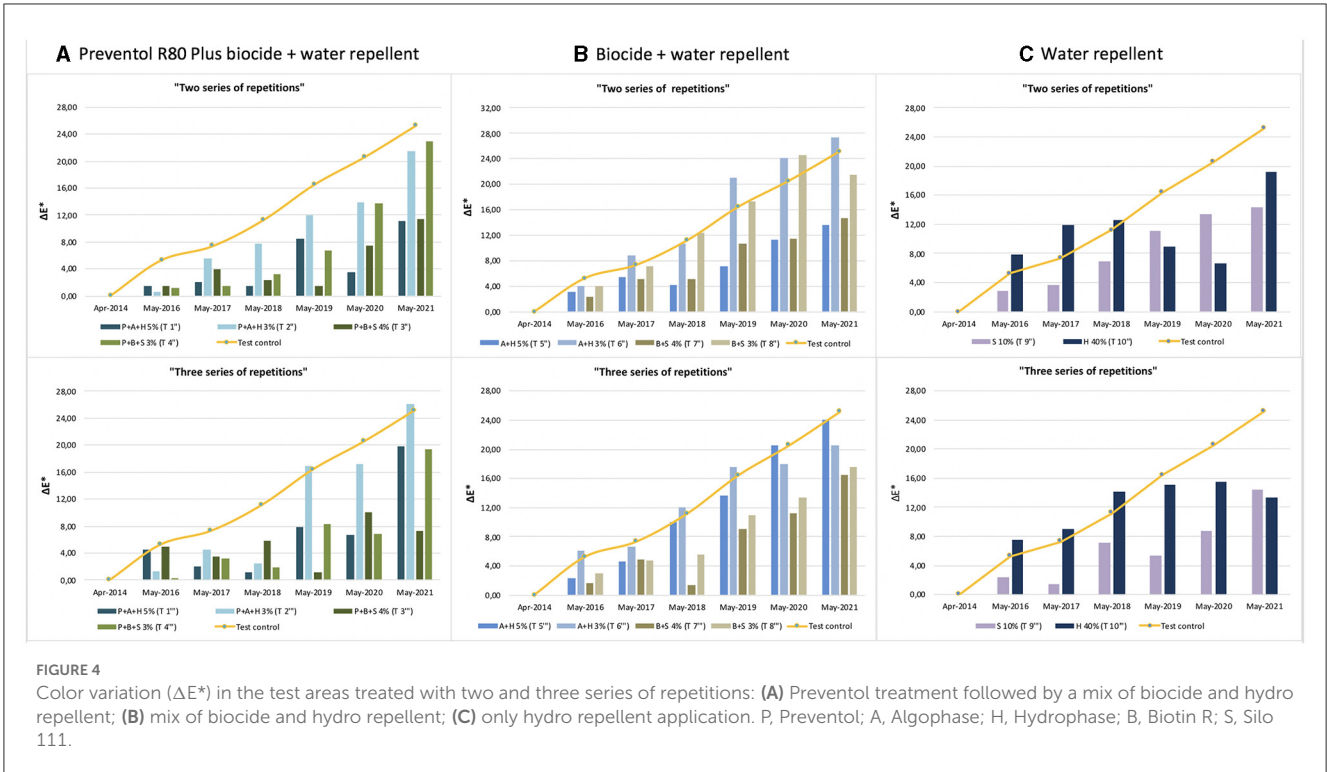
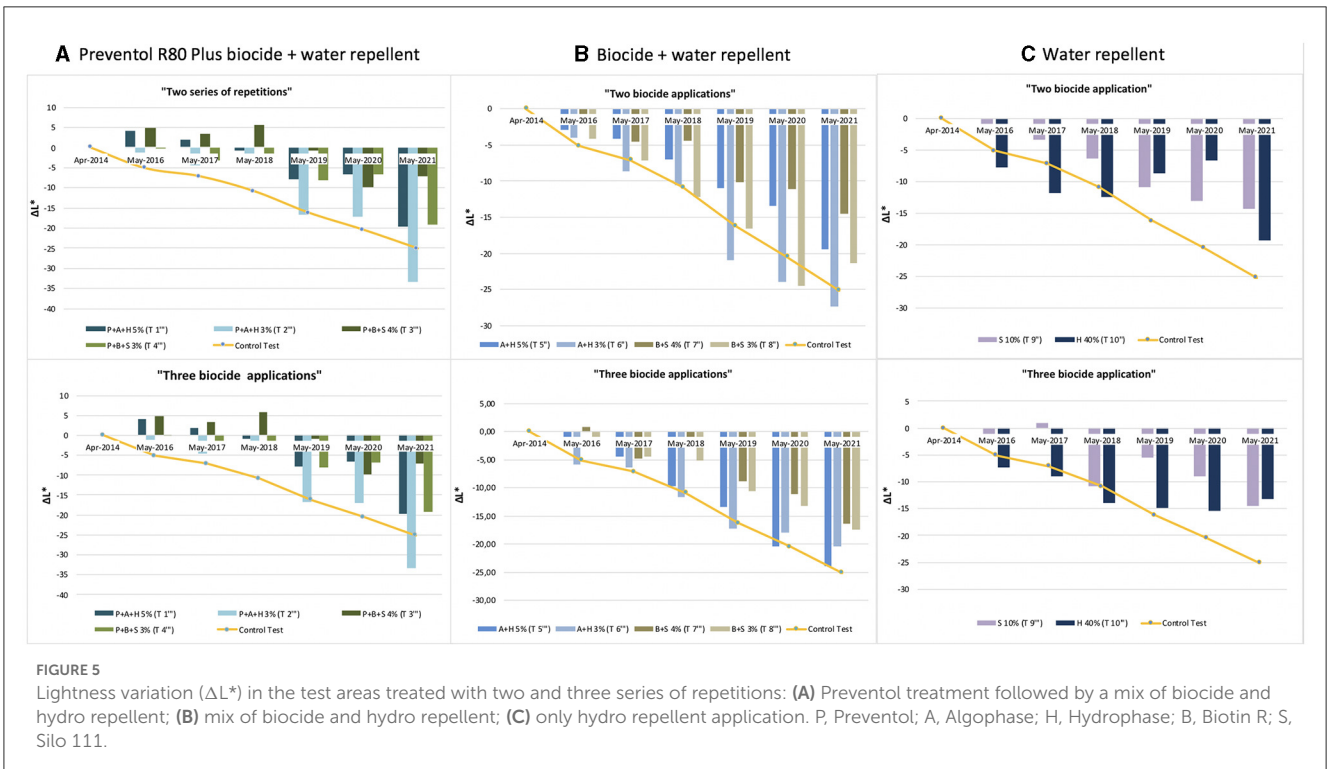
application of higher amounts of biocides has not slowed down the colonization. Figures 4, 5 show that since 2017 all the treated areas have darkened. Since 2017, the areas treated with products containing Algophase + Hydrophase have had the same trend as the untreated control areas. The repetitive application of biocides repetitions did not seem to influence the colonization behavior. In

fact, in 2021, a negative lightness value  $\Delta L^* = \sim -25$  was achieved in one, two, and three re-applications of the product (Figures 4, 5). The decrease in  $\Delta a^*$  values points out a potential presence of photosynthetic microorganisms that increased at the end of the seven years (Table 3). In October 2022, the dowels were no longer visible, so we could not monitor them.
