Article

Time-Lapse GPR Measurements to Monitor Resin Injection in Fractures of Marble Blocks

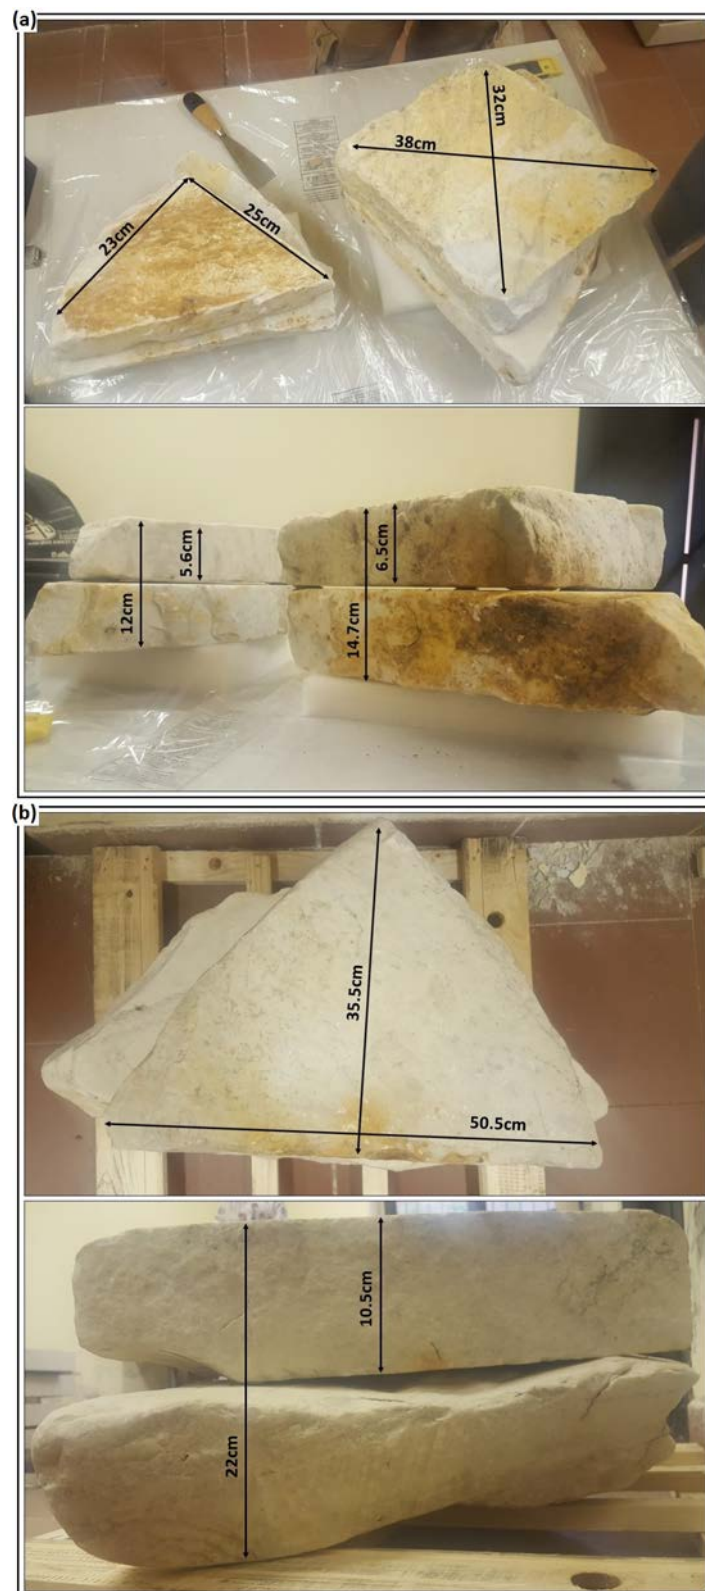
Figure 1. Top and side views of three fractured samples created for laboratory tests using six Carrara marble blocks. (a) Two small blocks (**left**) with the fracture modelled between them at the depth of about 5.6 cm with the average fracture opening of 3 mm. Two medium blocks (**right**) with the fracture modelled between them at the depth of about 6.5 cm with the average fracture opening of 3 mm. (b) Two large blocks with the fracture modelled between them at the depth of about 10.5 cm with the average fracture opening of 8 mm.

For laboratory tests, we used six small marble blocks selected from quarry wastes in Marina di Carrara, Italy. Using these six blocks, we prepared three specimens, shown in Figure 1, with slightly increasing dimensions. We created artificial and irregular fractures by placing the blocks on each other in pairs. To create artificial fractures, small PVC spacers with the height of 2 mm for small blocks (Figure 1a, left), 3.5 mm for medium blocks (Figure 1a, right), and 5 mm for large blocks (Figure 1b) were placed between each pair of blocks. The PVC spacers were positioned as close as possible to the edges in order to prevent their influence on the integrity of the resin after being dried. The inner surfaces of the blocks were not smooth or polished. As a result, the distance between the two blocks, i.e., the thickness of the simulated fracture, was not constant, especially for the large blocks (side view in Figure 1b) where the fracture thickness approximately varied between 1 mm and 15 mm. Based on the surface area of the blocks (Figure 1) and the volume of the resin required for the full injection, we calculated an average fracture opening of 3 mm for small blocks, 3 mm for medium blocks, and 8 mm for large blocks. Considering that the relative permittivity of the epoxy resin was expected to vary in the range 3.5–4.7, a quarter of the wavelength for the 3 GHz antenna used in this study was never less than 15 mm and the simulated fractures can be thus considered as thin layers. All specimens were surveyed with the GPR before and after resin injections in the laboratory.

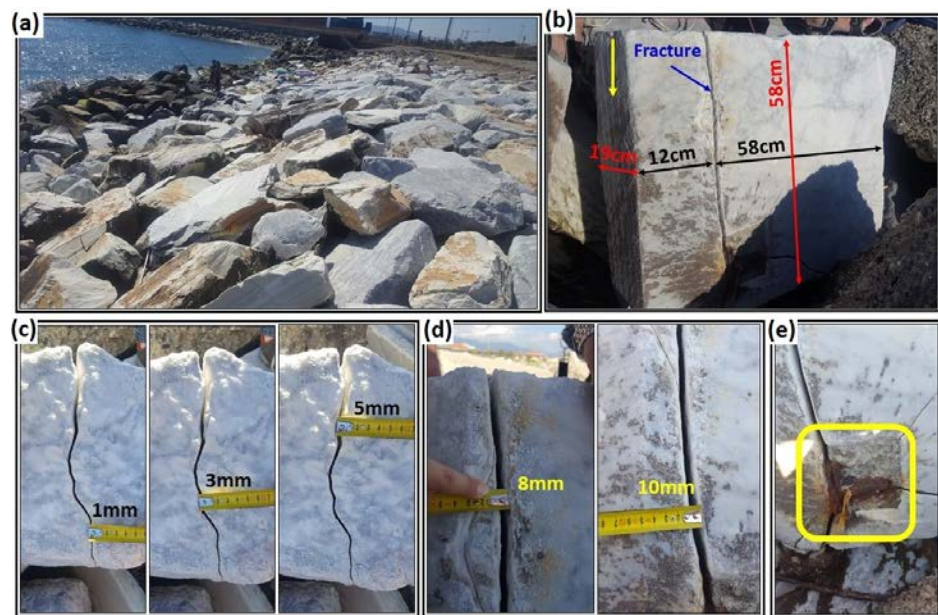
Figure 2. Carrara marble block for field test. (a) A pile of abandoned blocks on the Marina di Carrara coast. (b) The selected block with a vertical, visible natural fracture. The vertical yellow arrow shows the side selected for the GPR measurements. (c) Top view of fracture thickness. (d) Front view of fracture thickness. (e) Detail of a metal target embedded near the fracture in the lower part of the block.

We performed in situ measurements on a fractured marble block in Marina di Carrara where hundreds of irregular marble blocks were deployed on the shore to form a protecting barrier (Figure 2a). The selected block had the advantages of having a clearly visible air-filled fracture and an accessible side parallel to the fracture suitable for radar measurements (Figure 2b–d). Unfortunately, there was a small metal target embedded in the lower part of the block (Figure 2e), maybe related to a previous use of the block or used for block transportation. We performed time-lapse GPR measurements at the same locations before and after resin injections to repair the natural fracture of the selected block. As can be seen, the metal element shown on Figure 2e partially disturbed the radar measurements performed near the base of the block.

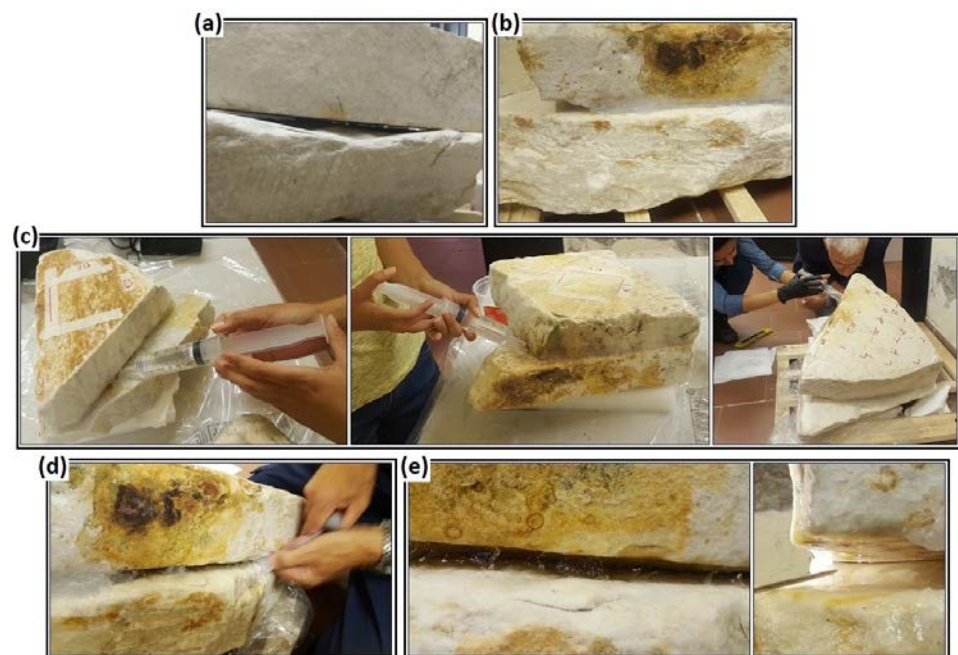
Figure 3. The process of simulating artificial fractures and resin injection in marble specimens. (a) Simulating a fracture by overlapping two blocks. (b) Sealing the fracture perimeter with silicone. (c) Resin injections inside the small blocks (**left**), medium blocks (**middle**) and large blocks (**right**). (d) Removing the dried silicone from around the blocks. (e) Checking that resin arrived at all the peripheral parts of the fracture.

To prevent the dispersion of the resin out of the fractures, both the artificial fractures between the overlapped blocks in the laboratory and the natural fracture in Marina di Carrara were properly sealed with silicone along their external perimeter with the exception of a small injection point (Figure 3).

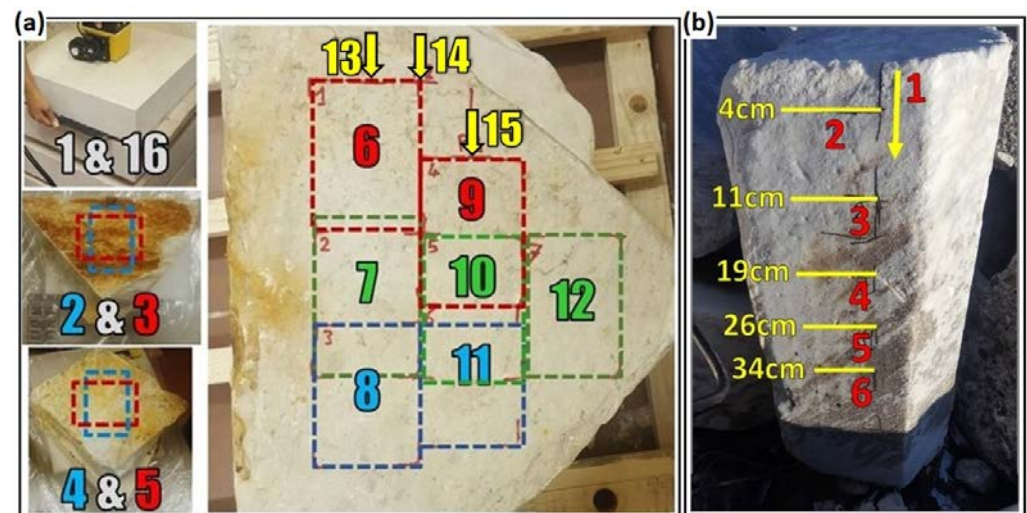
Figure 4. (a) The positions of the GPR antenna for different measurements performed in the laboratory. Records 1 and 16 were surveyed on marble blocks of Botticino for amplitude calibration at the beginning and end of each experiment. Records 2 and 3 were surveyed from the central position of the small blocks of Carrara (see Figure 1a, left). The antenna was rotated 90 degrees from record 2 to record 3. Similarly, records 4 and 5 were surveyed from the central position of the medium blocks of Carrara (see Figure 1a, right). Records 6 to 12 were surveyed on the large blocks of Carrara (see Figure 1b) by deploying the antenna at the fixed positions from 6 to 12. Profiles 13, 14 and 15 were recorded as continuous profiles parallel to the longer side of the blocks by moving the antenna from the positions 13, 14, and 15. (b) Measurements on the Carrara marble block with natural fracture used for field test (see Figure 2b). Profile 1 was recorded as a continuous profile from top to down. Records 2 to 6 were surveyed by placing the antenna at the positions 2 to 6, and yellow numbers are the distances of the antenna's positions from the top of the block.

GPR measurements were performed on the laboratory specimens for eleven days. In addition, measurements on the Botticino blocks were performed every day for amplitude calibration. Each set of measurements consisted of 16 records. Two records (n. 1 and n. 16) were surveyed on Botticino marble blocks at the beginning and the end of the measurements of each day to control the amplitude drift of the radar system. The reference signal used to control the antenna amplitude drift was the reflection from a metal shield inserted between the first and the second blocks measured by the antenna from the central position of the first block. The remaining fourteen records were surveyed at the positions shown in Figure 4a. All GPR measurements were performed as time-triggered surveys without moving the antenna from the fixed position, except for records 13, 14, and 15 that were surveyed as wheel-driven profiles by moving the antenna on the large blocks along short trajectories. Profiles 13 and 14 were about 18 cm and 22 cm long, respectively, while profile 15 was about 12–14 cm long.

the third day. The fracture created between the large blocks was progressively saturated with four injections. The large blocks were slightly dipping in such a way that the resin, injected from the block corner closer to position 6 (Figure 4a), was gently flowing by gravity towards the block side opposite to the injection point.

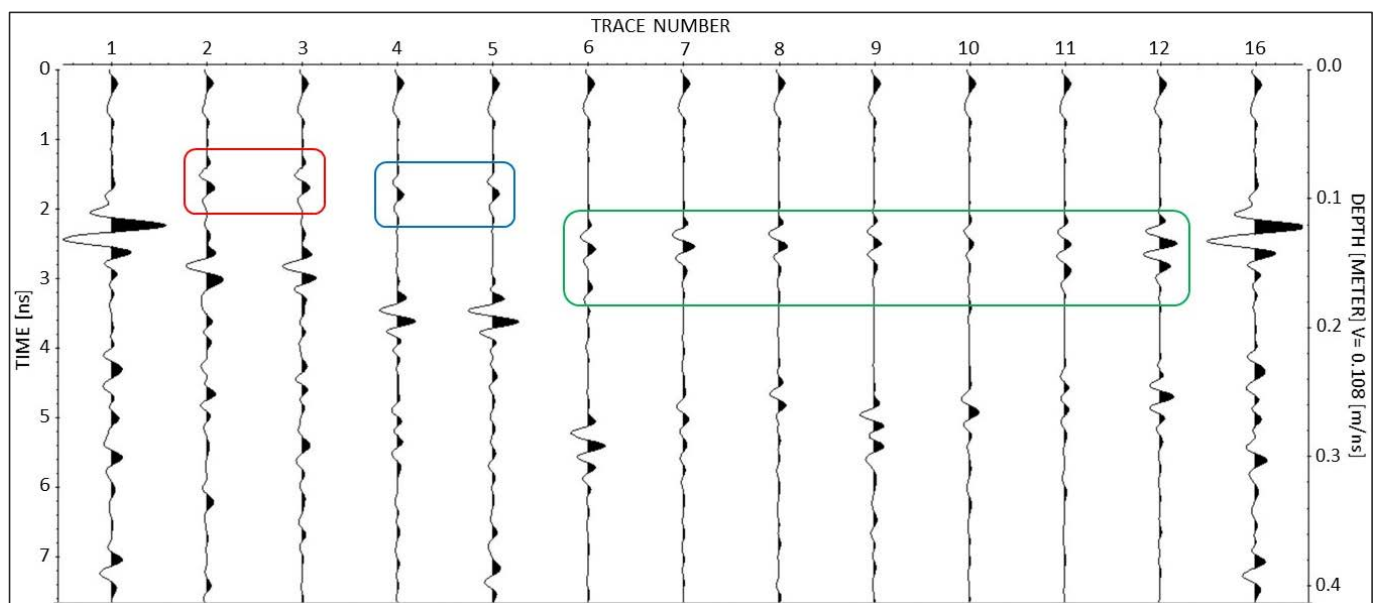
Figure 5. An example of a complete session of the laboratory time-triggered data after data processing and stacking. Traces 1 and 16 are the calibration records measured on the Botticino blocks. Traces 2 and 3 belong to the small blocks of Carrara. Traces 4 and 5 belong to the medium blocks. Traces 6–12 belong to the large blocks. The reflections of the artificial fractures are highlighted by three rectangles.

After stacking, all the time-triggered data of a measurement session, i.e., measurements related to the positions from 2 to 12 plus the calibration tests 1 and 16 (Figure 4a), were merged and compared on a single plot as shown in the example of Figure 5. The first and last traces relate to the Botticino blocks that were used for the calibration process. Trace numbers 2 and 3 showing a reflection at 1.2 ns (depth of about 6 cm) belong to the records of the small blocks of Carrara. Trace numbers 4 and 5 showing a reflection at 1.4 ns (depth of about 7 cm) belong to the records of the medium blocks. These pairs of records were measured in the same positions on the small and medium blocks using two orthogonal orientations of the antenna. Since the reflection came from the same reflecting point for each pair, the thin bed reflection was expected to show the same amplitude. On the contrary, for the records from 6 to 12 that belong to the large blocks and show a reflection at 2.2 ns (depth of about 11 cm), the reflecting position was changing, and this affected the amplitude of the reflection, as is clearly visible in Figure 5.

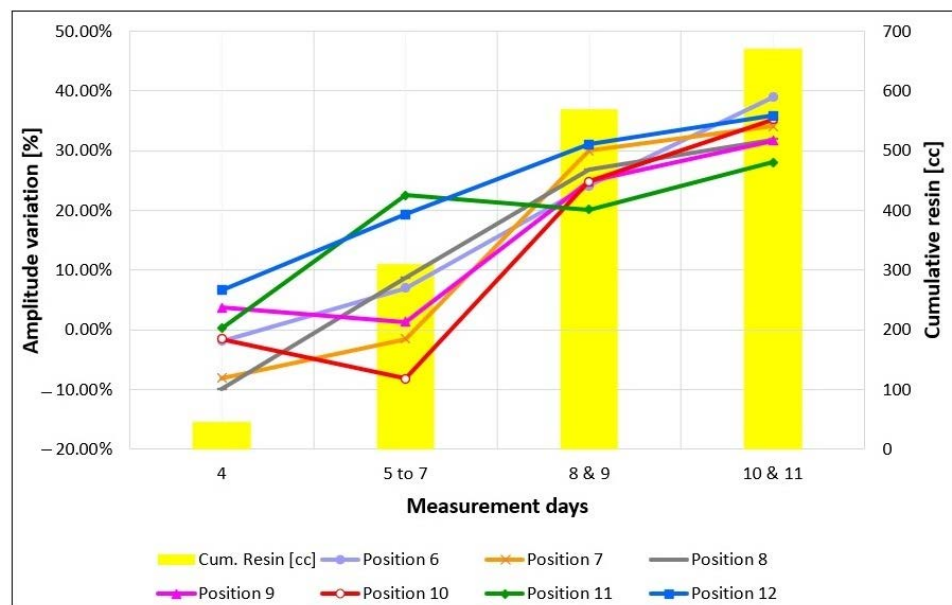
Figure 6. Amplitude percentage variations of the artificial fracture reflections measured on the large block at the selected positions after each injection phase. Positive numbers indicate amplitude decrease. Yellow bars indicate the cumulative amount of the resin injected after each phase.

Figure 6 shows the percentage variations measured after each injection phase on the seven different positions tested on the large blocks (positions 6–12 shown in Figure 4a). Except for the data points measured on the fourth day after the first injection of only 45 cc of resin, other data points are the average values of the measurements repeated on successive days, i.e., three times after the second injection, and two times after the third and the fourth injections. The yellow bars indicate the cumulative resin amount resulting after each injection phase.

By observing the graph in Figure 6, we understand that the first initial injection was so minimal (only 45 cc) that was not able to fill the fracture in any position, as proved by the GPR amplitude variations that are negative or close to 0% with a maximum positive value of 6.65% in position 12. Note that negative variations are obviously not attributable to the presence of the resin because resin injections cannot produce an amplification of the reflected wave. Thus, negative variations are the result of noise and residual drift effects. On the contrary, positive variations could be attributed to resin injections, but the values are too far from the theoretical expectations (about 38%) associated with a filled fracture. Moreover, positive variations never exceed 7% which is almost the standard deviation observed on the medium block test. Therefore, the positive variations are very likely attributable to noise and residual drift effects as well. After the second injection, resulting in a cumulative resin volume of 310 cc, the situation does not change for most positions except for positions 11 and 12 in which the amplitude variations rise to values close to, or a little larger than 20%, suggesting that the resin was mostly flowing towards these two positions. This is consistent with the expectations based on the inclination given to the specimen. A 20% variation cannot be confused with amplitude variations produced by noise or residual drift effects. Thus, it must be caused by resin injections; however, there might be the probability that the fracture was still not totally filled. After another injection, resulting in a cumulative resin volume of 570 cc, all amplitude variations approached values between 20% and 31%. This proves that resin has reached all the tested positions; however, in some points where the variations are still less than 25%, we might think that the filling is not complete. It is interesting to note that the amplitude variation at position 12 jumps up from about 19% to 31%, the highest value measured at this stage. This seems to confirm that the inclination of the specimen produces a preferential flow directed towards that position, which seems to be the first zone to be totally filled. After the last injection, resulting in a cumulative resin volume of 670 cc, all amplitude variations show further small increases, with all values in the range 28–39%. According to GPR, we conclude that the injections were successful at all positions. This is consistent with the fact that at this stage, no more resin could be injected inside the fracture, and we are mostly sure that the fracture was completely filled everywhere. It is interesting to note that the amplitude variation at position 6 moves from 24% to 39% at the final stage. This is the highest increase observed between stage three and stage four. Considering that the injection point was close to position 6, and that the specimen was gently inclined to favor the resin flow towards the opposite side of the block, it is quite reasonable that position 6 was not totally filled after stage three and was completely filled only after the final injection.

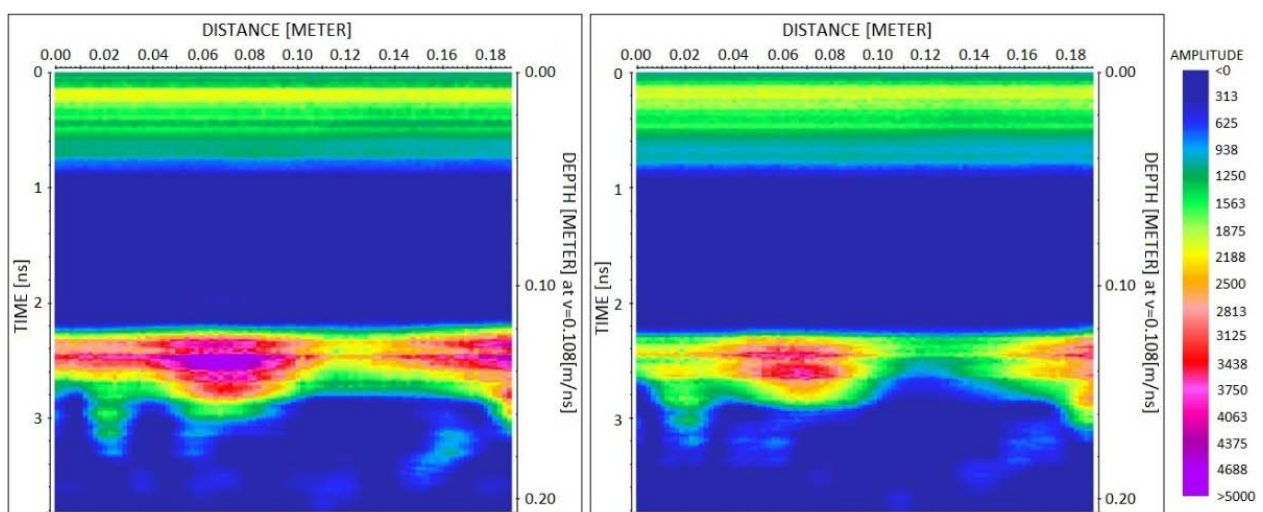
Figure 7. Comparison of profile 14 measured on the large specimen before and after injections on the third day (left) and on the last day (right), respectively. Data are plotted after time and amplitude calibration, dewow filter, and envelope extraction.

To illustrate the results obtained with the profiles 13, 14 and 15 measured by moving the antenna on the large specimen, Figure 7 shows the comparison of profile 14 measured on the third day, i.e., before injections (left image), with profile 14 measured on the last day, i.e., after full injection of the fracture (right image). Data are presented after applying the dewow filter and after time and amplitude calibration, by plotting the radar trace envelope with the same color scale to facilitate the amplitude comparison of the reflection from the fracture arriving at about 2.2 ns. For a more detailed comparison of the reflected amplitudes, a selection of the same data (one trace every eight traces), is compared in Figure 8 by overlapping the trace envelope before and after injections. Very similar images were also observed by analyzing profiles 13 and 15 measured before and after injections.

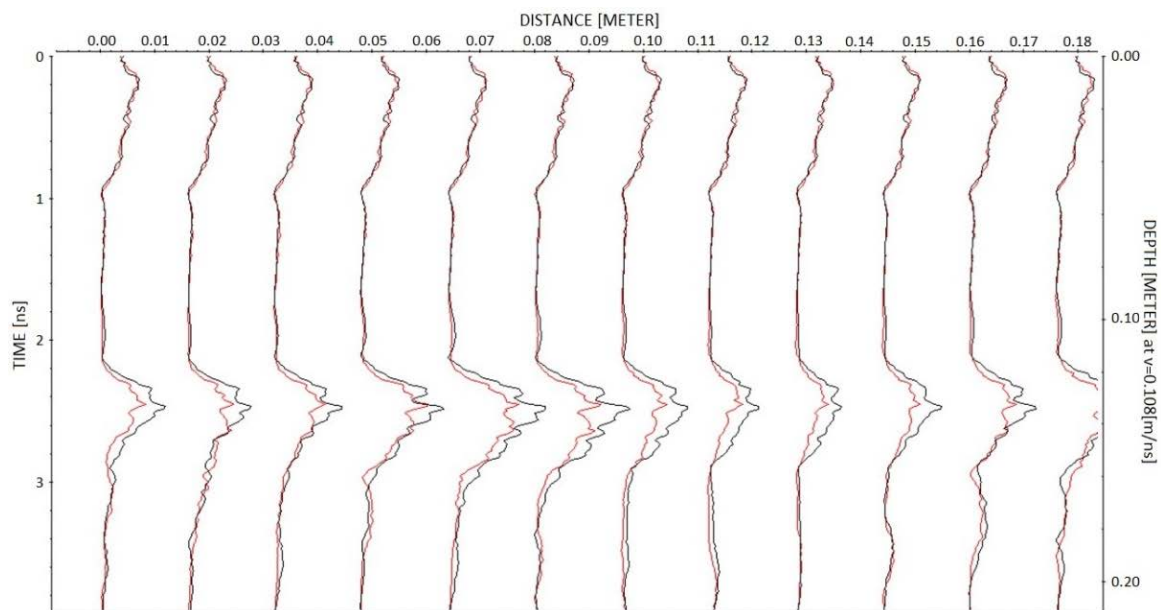
Figure 8. Data of Figure 7 overlapped after decimation by a factor of eight along the horizontal axis. In black, the data before injections, and in red, the data after injections.

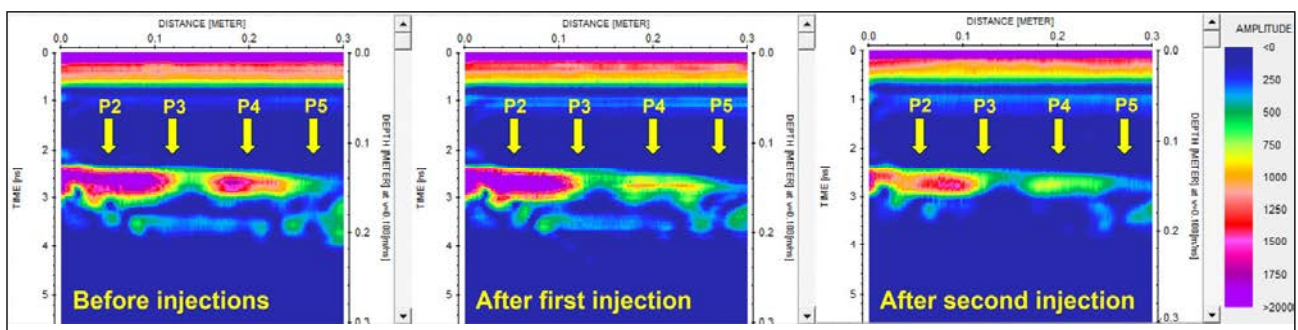
Figure 9. The radar profile measured on the fractured block on the Marina di Carrara before and after the two injection phases. Data are plotted after time and amplitude calibration, dewow filter, and envelope extraction. The arrows indicate the approximate positions of the point measurements reported in Figure 10.

Field data measured on the selected block in Marina di Carrara were processed using the same processing steps applied to the laboratory data. The vertical wheel-driven profile is shown in Figure 9 to compare the envelope amplitudes of the reflection before injections, after the first injection phase, and finally, after the concluding injection phase. The arrival time of the fracture reflection was 2.2 ns (about 12 cm) at the beginning of the profile (i.e., at the top of the block) and gently increased as the antenna moved down along the block face. At 30 cm from the initial position, the apparent depth of the fracture was about 14 cm. The profile was cut at 30 cm because the last part was disturbed by the diffraction produced by the metal target embedded in the block (Figure 2e). For the same reason, we analyzed the point data measured in positions 2 to 5 (Figure 4b), while we ignored position 6 which was too close to the metal element. The percentage amplitude reductions measured at these positions after the first and the second injections are illustrated in Figure 10. To compare the profile amplitude variations with the point measurements, Figure 9 shows the approximate positions of the selected points.

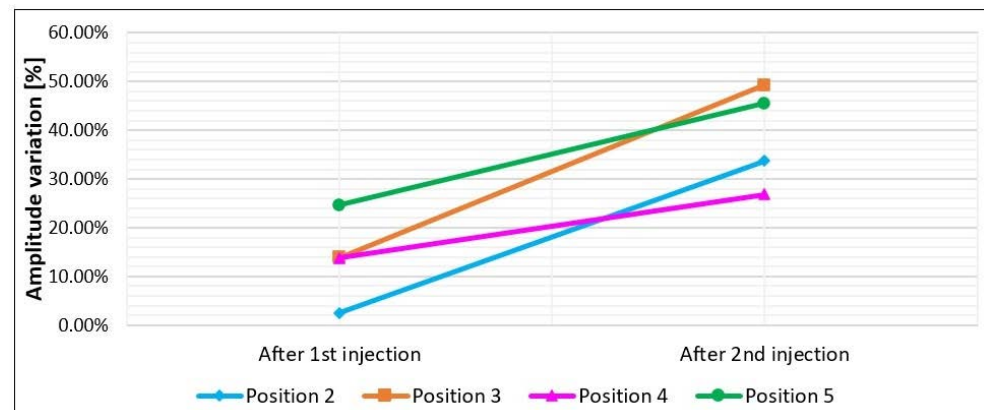
Figure 10. Amplitude percentage reductions of the natural fracture reflection measured at the selected positions after the first and the second injection phases. Position 6 is not reported because the fracture reflection was interfering with a strong diffraction generated by the metal element embedded in the block.

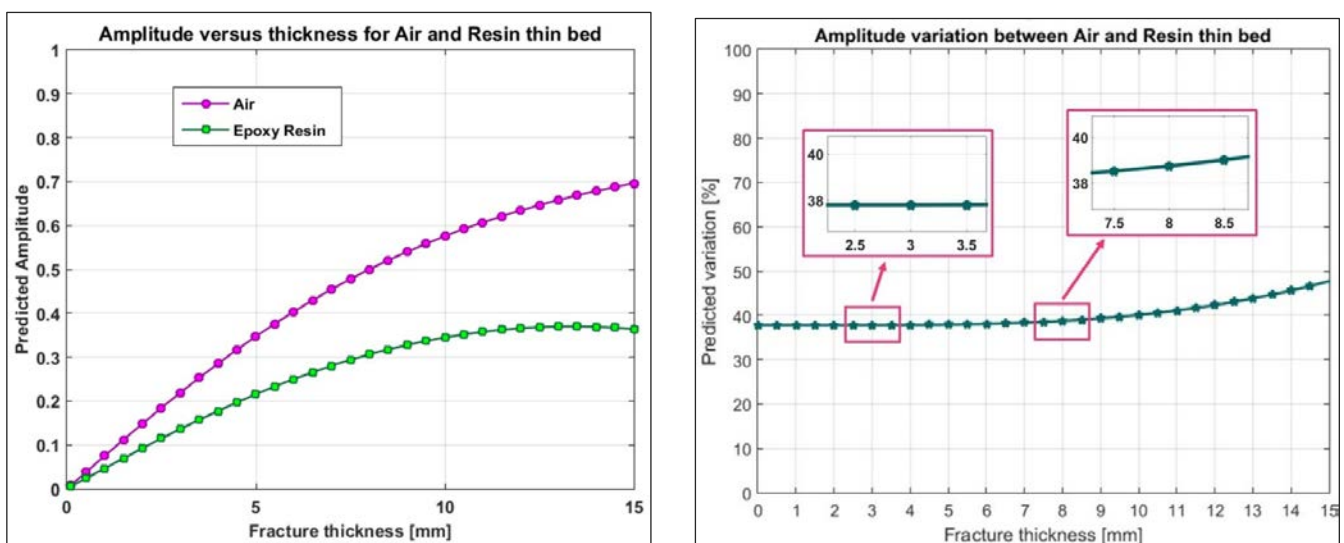
Figure 11. Comparison of the predicted amplitudes for the air-filled fractures (purple circles) versus the resin-filled fractures (green squares) for a 3 GHz antenna. Marble relative permittivity: 7.7. Resin relative permittivity: 3.5. The right plot shows the percentage amplitude reduction expected when the resin substitutes the air within the fracture.

Numerical simulations and analytical models can predict the difference between the air-filled and resin-filled fractures [18,21]. Figure 11 indicates the predicted theoretical difference between the air-filled and the resin-filled fractures obtained by tuning the analytical models to the actual marble velocity measured on the Carrara blocks (10.8 cm/ns). We assumed the relative permittivity of 3.5 for the resin. This is the minimum value of the expected range for resin (3.5 to 4.7) and thus, the results will illustrate the minimum theoretical differences that we can predict before and after injections. Based on Figure 11, if GPR detects an air-filled fracture, a minimum of 38% amplitude reduction is expected after the fracture is filled with the resin. In our laboratory tests, the predicted variation is about 38% for the 3 mm-thick fractures (the average fracture thickness for the small and medium blocks), and 39% for the 8 mm-thick fracture (the average fracture thickness for the large block). This percentage variation will increase to about 48% for thicker fractures (15 mm).

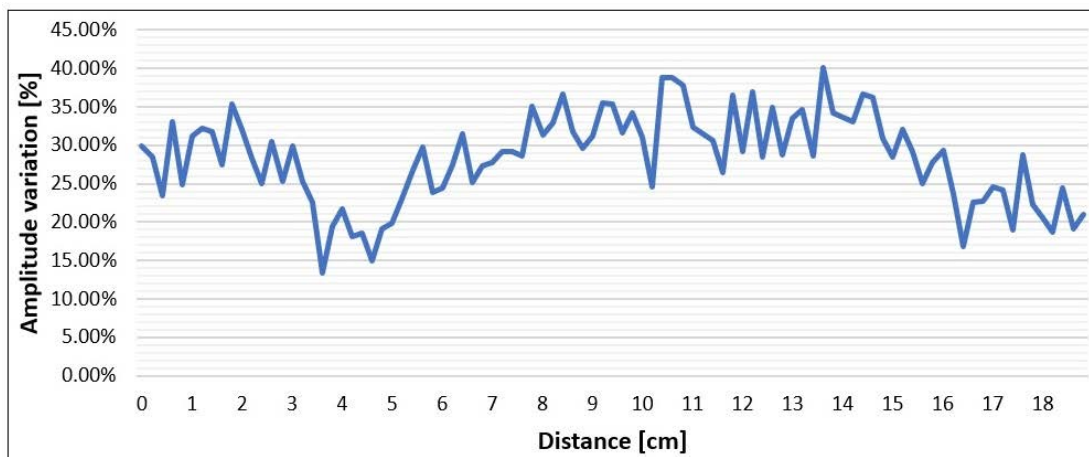
Figure 12. Percentage reduction in the reflected amplitude automatically picked along profile 14 measured on the large specimen before and after resin injections (third day and last day respectively).
