Diagnosis of accessibility in the FT/UFAM classrooms

Joseana Vinhote Melo; Dalzira de Sousa Pereira; Dr. Jonas Gomes da Silva; Dr. Nilson

Department of Industrial Engineering
EUREKA Laboratory
Federal University of Amazon (UFAM) - Faculty of Technology
Manaus – Amazon – Brazil

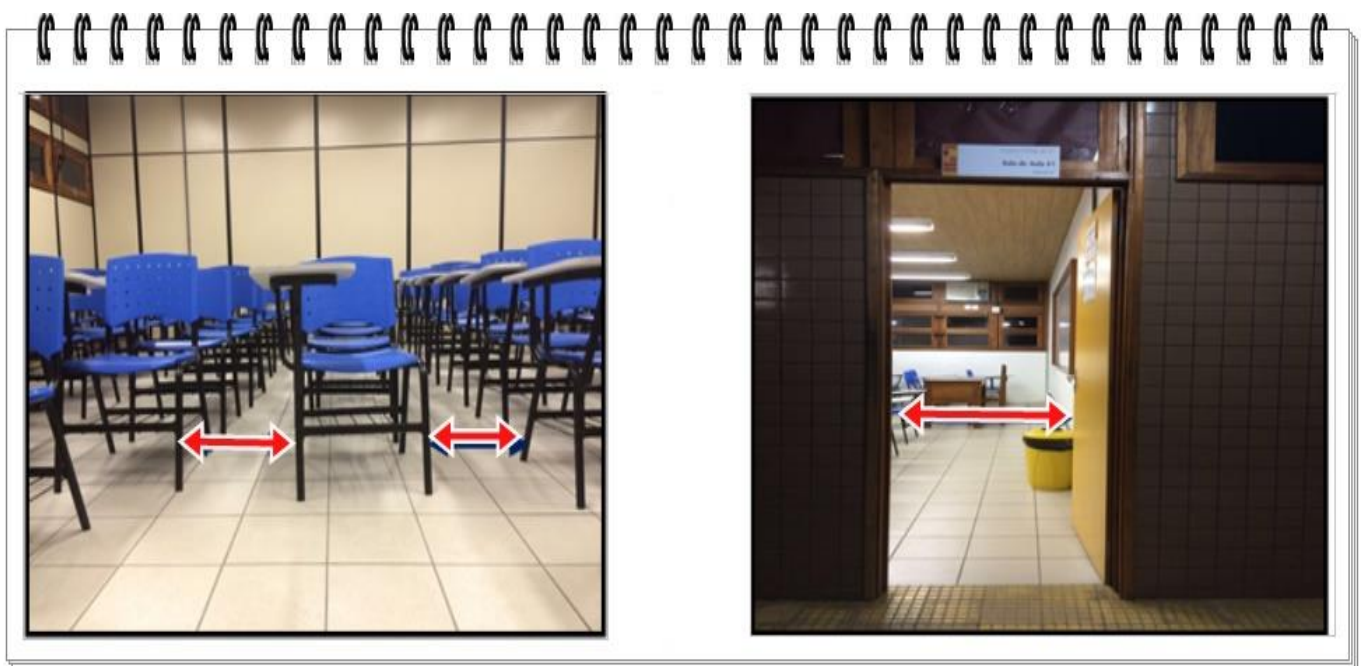
Figures 3 and 4 - Corridor between the rows of chairs (left) and classroom main corridor

The corridor between the rows of chairs is approximately 5.0 m long and the main corridor is approximately 9.0 m long, so the analysis took into account that the two corridors had to have a free space of at least 1.20 m width.

Figures 3 and 4 below represent the corridors existing in the classrooms and the arrows represent where measurements were taken for comparison with the standard.

It can be seen (Chart 3) that the corridors between the rows of chairs in the Engenheiro Nelson Ribeiro, Rio Tapauá and Rio Canumã pavilions do not meet item 6.9.1.1, which defines the width for corridors up to 10m must be 1.20 m, so they fail 100%.

On the other hand, the values raised in (Chart 4) the main corridor of the 3 pavilions meet the minimum requirement required by the standard and are 100% compliant since the lowest value found in the corridors was 1.38 m which shows that any person independent of his physical condition can move about him without any problem.

- b) One of the alternatives to overcome the problem to the corridors between the rows of chairs is to reduce the number of students in the classrooms, redistributing classes with more students to larger rooms. This alternative will help to improve access, circulation and learning in the classroom as the students at the back are very far from the blackboard and consequently from the teacher. It is recommended that a study be made on the demand for classrooms for each course, to better dimension the size of the FT UFAM classrooms;

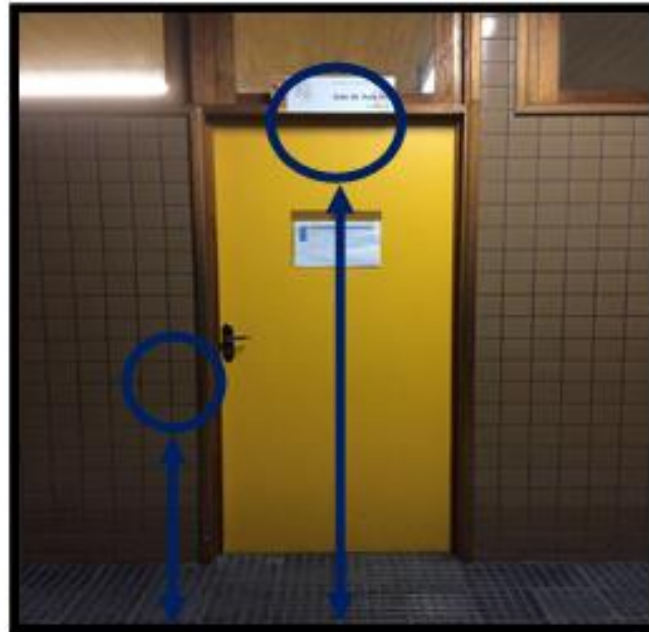
Figure 5 – Signaling at the doors

All visual signs on the doors of the pavilions are installed above 2.10 m in height. To reverse this situation, the college placed an improvised A4 sheet on the doors with information about the names of the subjects

and the times. Also, a student or teacher who has a visual impairment will have more difficulties in accessing the information in the classrooms, as in no pavilion there is tactile signage in Braille or embossed on the doors.

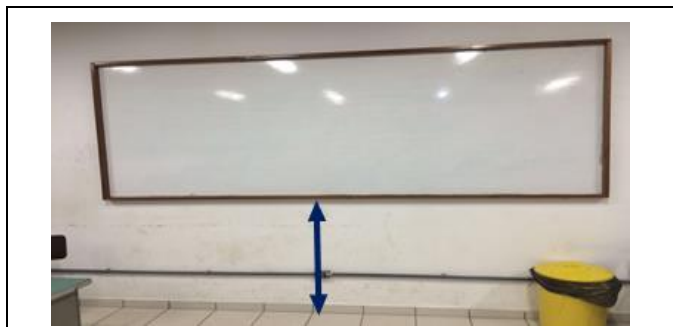
Figure 6 – One of the blackboards measured
Source: Author (2016)

Failure to comply with the height of installation of the blackboards can cause problems in the manual reach of teachers and students when they are going to use them, as a person to write will have to make a greater

effort to reach the top and also people with short stature or wheelchair users can reach only the center or bottom of the board, leaving little space for writing.

Pavilion	Height of Installation (0.90m)		
	Lowest Value	Medium Value	Highest Value
Engineer Nelson Ribeiro	0,95 m	1 m	1,22 m
Rio Tapauá	0,92 m	0,93 m	0,95 m
Rio Canumã	0,92 m

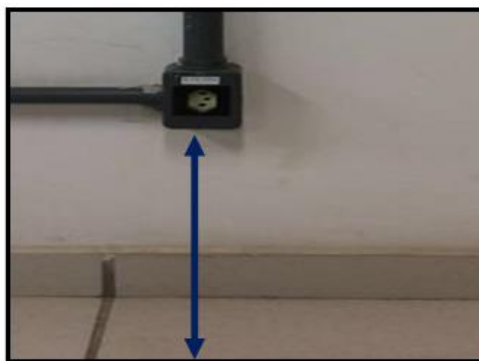
Figure 7 – Vertical socket.
Source: Author (2016).

For sockets, item 4.6.7 states that the recommended installation height is at least 0.40 and at most 1 m. Figures 7 and 8 represent the sockets found and their positions.

The results in Charts 8 and 9 show that the analyzed sockets failed 100% in both vertical and horizontal measurements. It is important to note that in the Rio Canumã and Tapauá pavilions there are no sockets in the horizontal position, which is why there are no values in Chart 8 for them.

Pavilion	Bottom height of the vertical socket (0,40 à 1m).		
	Lowest Value	Medium Value	Highest Value
Engineer Nelson Ribeiro	0,29 m	0,30 m	0,31 m
Rio Tapauá	0,22 m	0,23 m	0,25 m
Rio Canumã	0,22 m

The problem caused by the non-conformity of the sockets is concerning the manual reach and effort required to reach them, as students and teachers need to bend down out of the ordinary to be able to use a simple socket.
