Fire Performance of Steel-Timber Hybrid Beam Section

Mikko Malaska * and Mika Alanen , Tampere University, Tampere, Finland

Abstract. Slim-floor-type of steel-timber hybrid floor systems which use steel beams contained within the depth of the cross-laminated timber (CLT) floor slab offer many benefits, but there is still very little research available on the fire resistance performance of these systems. In the study presented in this paper two furnace tests and numerical simulations have been conducted to investigate the thermal profiles of the steel member and CLT slabs and to obtain information on the temperature development and charring of the hybrid beam section when it is exposed to standard fire conditions. Also, the effects of intumescent fire protection on temperatures and charring performance were investigated. Numerical 2D thermal simulations for unprotected and protected cases were conducted using SAFIR software, and the agreement between experiments and numerical-analysis predictions were in general very good. The results show that intumescent protection reduces the temperatures of the steel and CLT components as well as charring depth significantly, and the start of

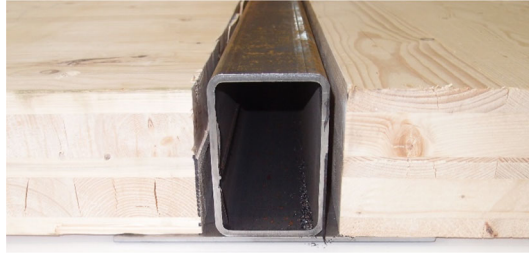
Figure 1. Slim-floor type of a steel-timber hybrid beam consisting of a CLT slab and a steel beam consisting of an RHS section and steel bottom plate.

Heinisuo et al. [4] have introduced a hybrid slim floor system consisting of CLT panels installed on the top of a steel plate welded to a rectangular hollow steel section, as shown in Fig. 1. No design guidance is available to help determine the amount of heat transferred through the steel hollow section into CLT slabs or to assess the char depths that occur locally at the slab support area. In the recommended practice by American Wood Council [5] it is required that all components of a connection are to be protected so that no part of the connection is exposed to an individual temperature rise of 181°C. The method limits the temperatures well below the charring temperature of timber and significant fire protection is required to meet this condition. Intumescent paint protection may only provide a limited solution as the paints are not fully active to limit the steel temperatures

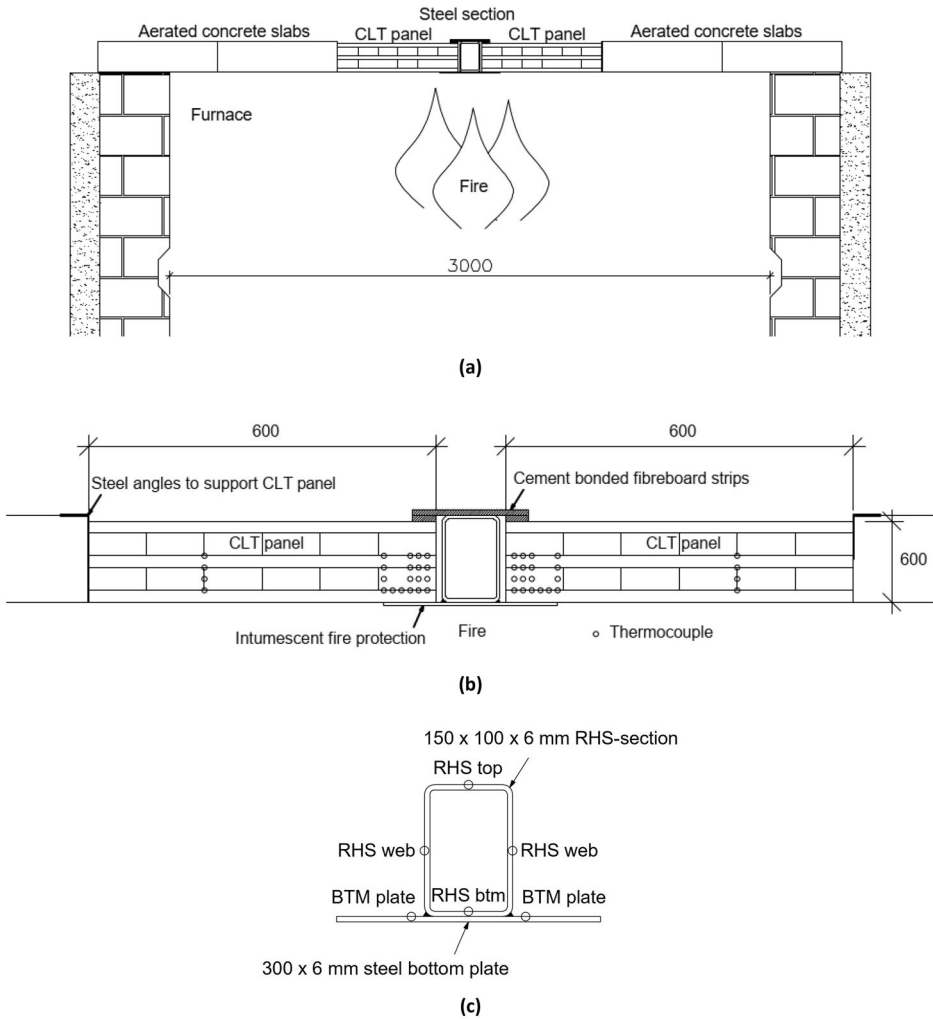
Figure 2. Schematic views of the vertical cross-sections through the (a) test furnace, (b) hybrid beam specimen and (c) positioning of thermocouples on a steel beam section.

Steel temperatures were recorded using fibreglass-wrapped Type K24-2-305 thermocouples. Five thermocouples with a welded junction were installed into pre-drilled holes in an RHS section, and eight thermocouples were weld-fixed to the steel bottom plate and the bottom flange of the RHS section. The positioning of these thermocouples are shown in Fig. 2c.

A total of 44 thermocouples were used to measure temperatures inside the CLT panels, as Fig. 2b shows. The distance between the vertical edge of CLT panels

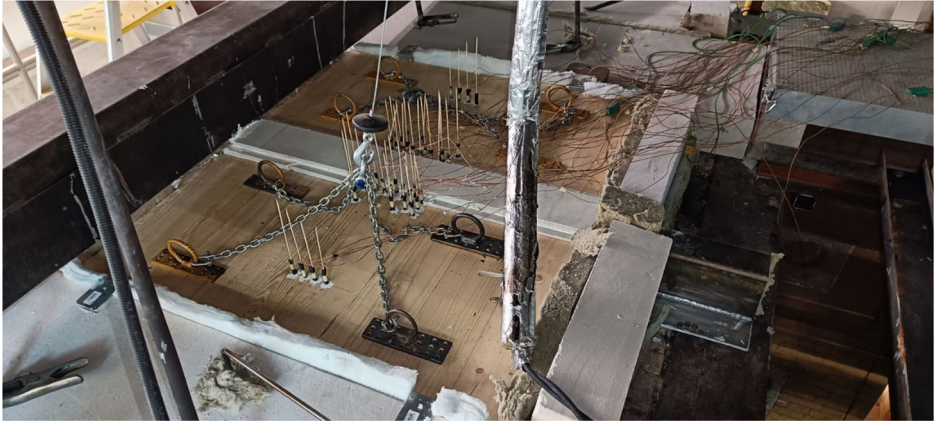
Figure 3. Test set-up seen from above.

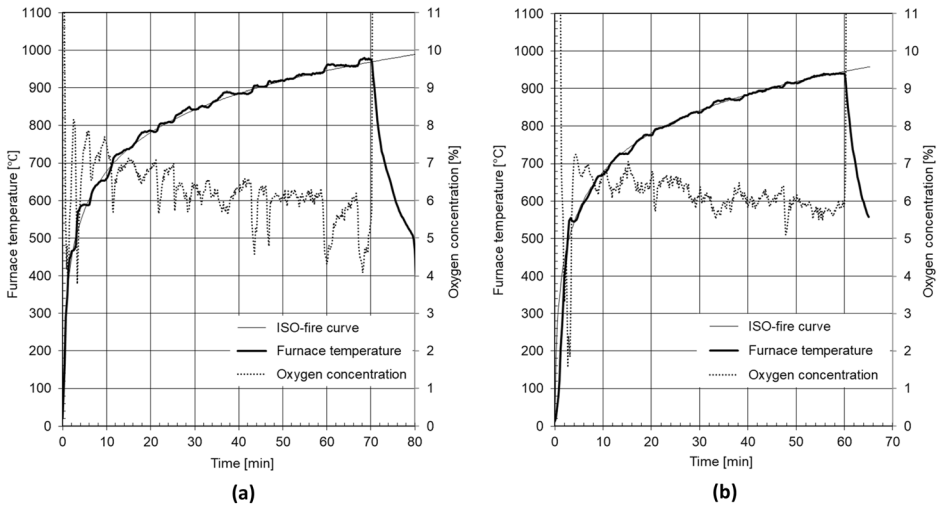
Figure 4. Furnace temperatures and oxygen concentrations measured during the fire tests for specimens (a) unprotected and (b) fire-protected floor beams.

During the tests, furnace temperature, specimen temperatures, oxygen content within the furnace and the pressure differences between the furnace and test hall were monitored. Four plate thermometers were used to monitor the furnace temperature. The oxygen concentration was monitored in the middle of the furnace chamber using a Dräger EM200-E multi gas detector and the oxygen levels varied between 4 and 8%. Furnace temperatures and the oxygen concentrations measured during the test are reported in Fig. 4. The furnace pressure at the furnace ceiling level was set to 20 Pa.

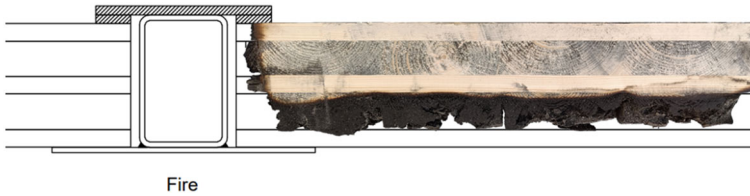
Figure 5. Residual cross-section of a CLT panel supported by an unprotected steel beam at 71 min of fire exposure. The CAD drawing corresponds to original dimensions.

Figure 5 shows the cross-section of the charred CLT panel supported by the unprotected steel bottom plate. This first test was terminated at 70 min, and the specimen was immediately extinguished. Based on visual inspection, the vertical charring had progressed through the first two lamella layers (20 mm + 40 mm). The charring depth is almost constant across the panel's width, and the steel bottom plate did not reduce charring behind the plate. Visual observations through the furnace camera showed that the first lamellae layer had fallen off at 36 min, but the part on top of the steel bottom plate remained in place until the end of the test. Horizontal charring depth measured from the vertical face of the top lamella adjacent to the steel web at 71 min was around 11 mm.

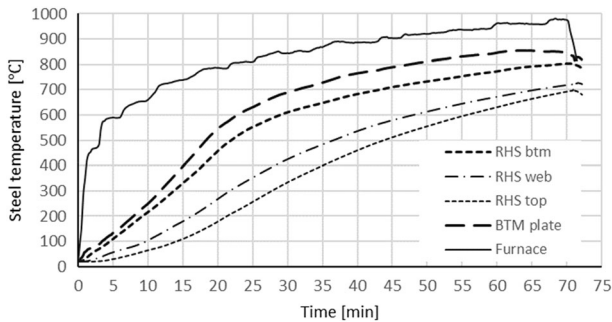
Figure 6. Temperatures of unprotected steel profile.

Figure 6 presents steel temperatures measured during the test. At 70 min, the temperatures of the steel bottom plate and the web were around 850°C and 700°C, respectively. At this stage, radiation from the steel web and the entry of hot gases through cracks formed in the charred layer above the steel bottom plate increased temperatures in the air gap and on the vertical surface of the CLT panel.

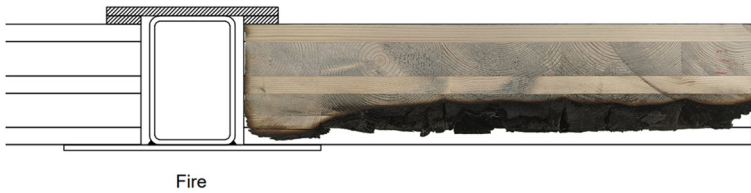
Figure 7. Charring of a CLT panel supported by a fire-protected steel beam at 61 min of fire exposure.

Figure 7 shows the cross-section of the charred CLT panel supported by a fire-protected steel bottom plate. Based on the visual observations through the furnace camera, the underside of the CLT panels started to char at 70 s after the commencement of the test and the reaction of the intumescent coating started at 120 s. The test was terminated at 60 min, and the specimen was immediately

extinguished. Based on visual inspection, the vertical charring of CLT panels far from the steel section was progressing in the second lamella layer. The position of the char line passed the first lamella layer and the mid-depth of the second layer at 30 min and 52 min after the commencement of the test, respectively. The temperature measured at the interface between the second and third layers at 60 min was 100°C. The charring depth was significantly reduced at the beam support, where the fire paint limits the heating of the steel. The charring affected the first lamella layer, and horizontal charring adjacent to the steel web was insignificant.

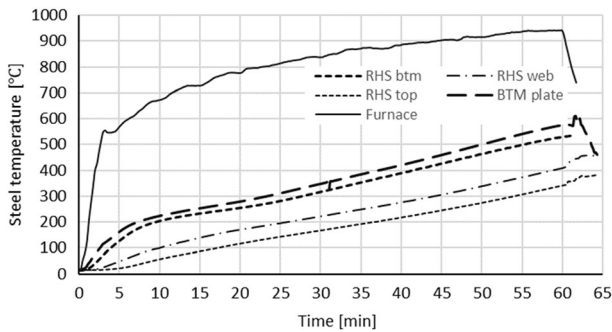
Figure 8. Temperatures of fire-protected steel profile.

Figure 8 presents temperatures of the fire-protected steel-beam members. The results show that the temperature of the beam bottom plate and the web were around 580°C and 400°C at 60 min, respectively. After the test, the thickness of the activated intumescent fire paint was measured using a vernier calliper. The average thickness of the ash layer was 10.0 mm, see Fig. 9.

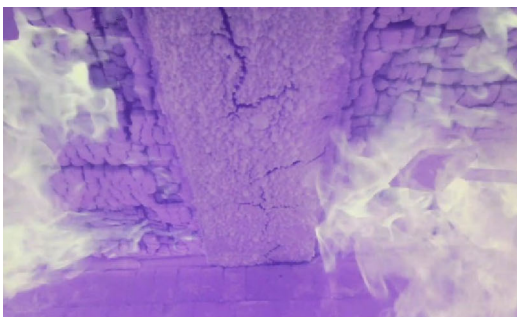
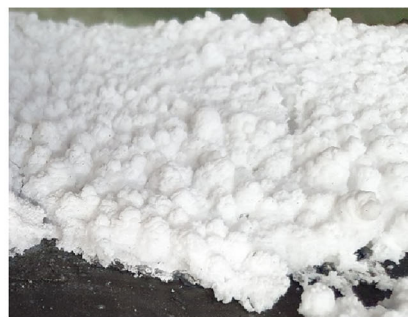
Figure 9. Intumescent fire protection (a) during and (b) after the test.

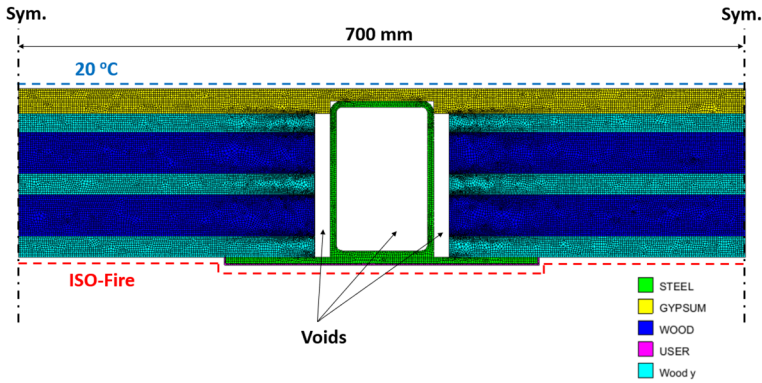
Figure 10. Numerical model of the fire-protected case.

Figure 10 presents the numerical model for the fire-protected case. The model for the unprotected case is similar but naturally does not include the fire protection material. ISO 834 [8] fire was applied to the model's lower edge, and 20°C

ambient temperature was applied to the model's upper edge. Symmetry-boundary conditions were applied on the model's left and right edges.

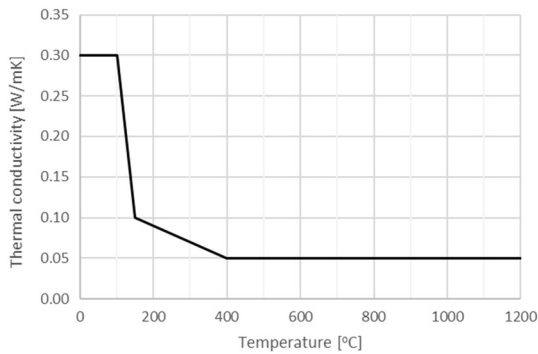
Figure 11. The applied model of the intumescent paint's thermal conductivity, based on [7].

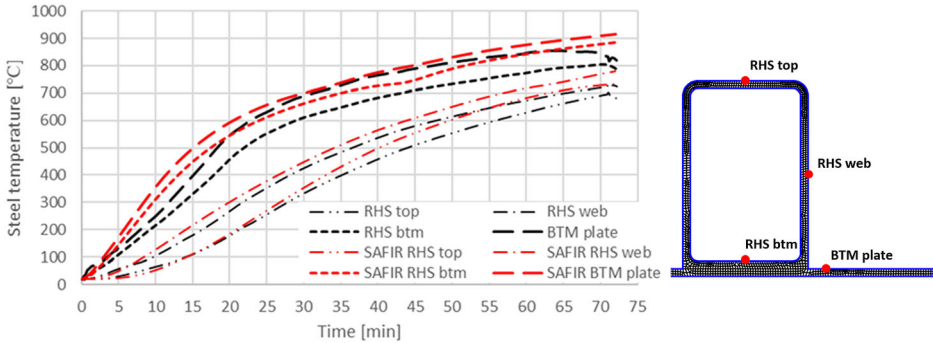
Figure 12. Temperatures of the unprotected steel profile from the numerical analysis as well as a comparison to test results.

Figures 12 and 13 present the temperatures of the steel profiles from numerical analysis and a comparison to test results. Based on the figures, it can be concluded that on average, the steel temperatures from numerical analysis are slightly higher (conservative) than those from the tests.

The curves in Fig. 12 show that the numerical model produces temperature values higher than the temperatures measured in the tests in the first 20 min, with steel temperatures ranging from 100° to 600° . One clear reason for this difference could not be identified. The surface emissivity used for the steel bottom plate was 0.7 as per EN 1991-1-2. This value corresponds to the oxidized steel surface. However, the material used in the test specimen was new and clean, so the actual value is likely to be less than the value used. A lower value would result in lower steel temperatures. Other possible factors include the coefficients of heat transfer by convection and the airflows that may occur in the cavities of the structure. Since the aim of the study was to produce a simple design model, there was no desire to use non-standard values for the solution.

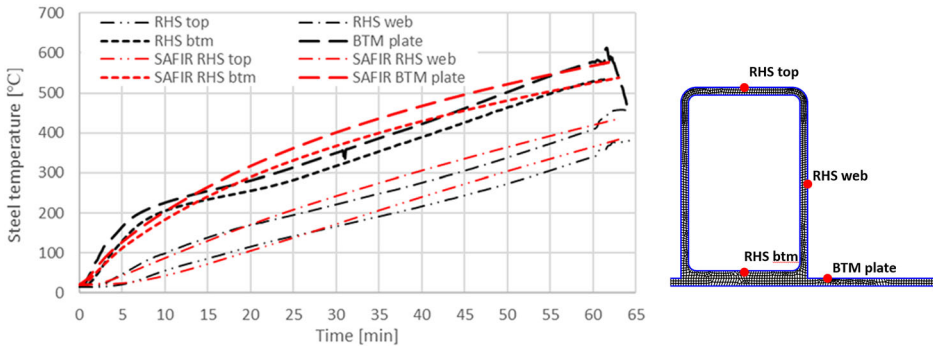
Figure 13. Temperatures of the fire-protected steel profile from the numerical analysis as well as a comparison to test results.

Figure 13 shows that the numerical model underestimates the protected plate's temperatures in the early phases of the fire (approx. 2–13 min), then overestimates the temperatures until approximately 55 min, and finally leads to approximately the same temperature with the tests at 60 min. This behaviour was expected

because in the test, the bottom plate heats up quickly during the first minutes of the fire because the intumescent paint has not swelled up yet. The thickness of the intumescent paint in the model (1.7 mm) was calibrated so that the temperature of the lower flange at 60 min was essentially the same as in the test. The swelling of the intumescent paint is not modelled i.e. the thickness remains the same the full duration of the analysis. In reality, the intumescent paint expands approximately to 10 mm thickness. As the swelling is taken into account indirectly (using temperature-dependent thermal conductivity), the model doesn't capture completely the actual behavior of the fire protection. Consequently, the results can't be perfectly accurate.

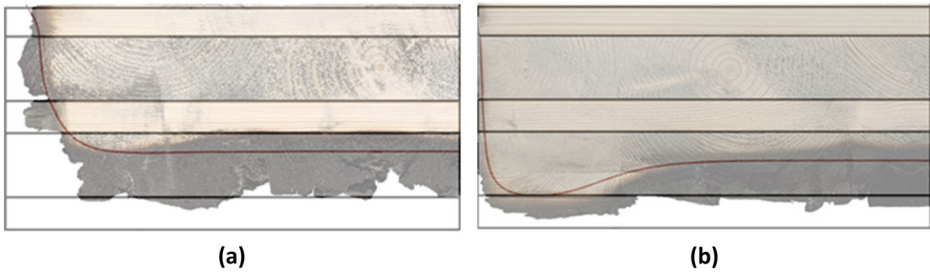
Figure 14. Comparison of test results with simulation results at the end of the tests. Charring depth of the CLT panel above: (a) the unprotected steel beam bottom plate at 71 min and (b) the fire-protected steel beam bottom plate at 61 min of fire exposure. The brown line indicates the 300°C isotherm from the numerical analysis.

Figure 14 shows a comparison of the experimental and numerical results at the end of the tests. The brown line indicates the 300°C isotherm from the numerical analysis and can be considered the charring line of the CLT panel. Figure 15a represents the unprotected and Fig. 15b fire protected steel section. Figure 15 presents the charred part of the CLT panel (300°C isotherm) from the numerical analysis at 60 min. Figure 15a shows the charring depth of the unprotected steel section and Fig. 15b of the fire protected section. The red portion indicates members and areas where temperatures are above 300°C. The figures show that numerical analysis predicts the charring depths relatively well at the support. For the unprotected steel beam, the horizontal charring depth is slightly underestimated

and on the unsafe side. For the protected beam, the horizontal charring depth is overestimated, leading to conservative results. In both cases, the vertical charring depth above the bottom plate is slightly higher than from the test, leading to a conservative estimate. However, when moving further from the support or the bottom plate, the numerical model underestimates the charring depth of CLT due to the delamination, for which the model does not account. This suggests that delamination should be included in the model if it is a relevant factor in the connection design. In this case, it is assumed that delamination does not affect the connection's behaviour but naturally needs to be accounted for in the fire design of the CLT panel.

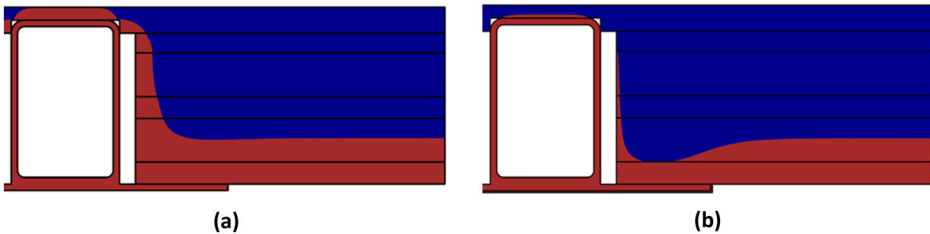
Figure 15. Charring depth of the CLT panel (300°C isotherm) from the numerical analysis at 60 min: (a) the unprotected beam section and (b) the fire-protected steel beam bottom plate. Red area representing areas where temperatures exceeded 300°C at 60 min.

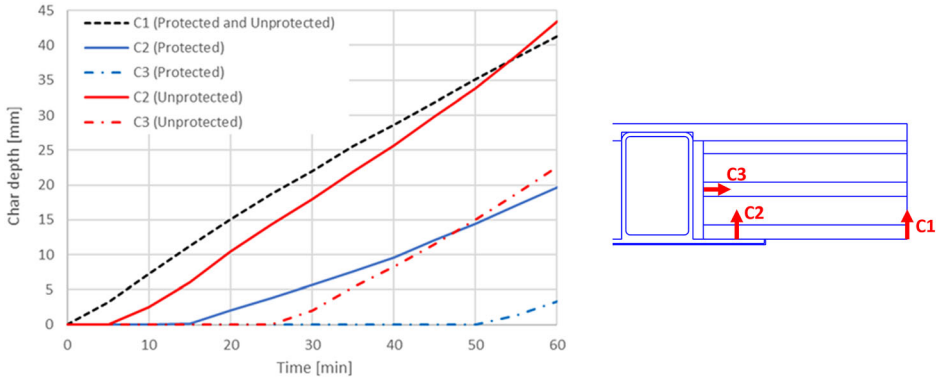
Figure 16. Numerically simulated charring depths of the CLT panel as a function of time in different locations.

Figure 16 presents charring depths calculated by numerical simulations in different locations and directions. C1 and C2 refer to vertical charring depth over time far from the beam support (symmetry edge of the model) and at mid-width of the steel bottom plate, respectively. C3 refer to the horizontal charring depth at mid-depth of the CLT panel.

The comparison between curves C1 and C2 (Unprotected) shows that the unprotected bottom plate causes a slight delay (approximately 5 min) in the vertical charring. However, after this initial delay, the charring rate is basically the same as in the CLT far from the beam support. Actually, in this case the rate increases to even higher values after approximately at 40 min because of the heat transfer and charring in horizontal direction (C3). In the protected case, the vertical charring rate at the support (C2, Protected) is clearly smaller than in the unprotected case. However, even this lower rate can be significant for the mechanical behaviour of the hybrid beam. If the design criteria do not allow charring of CLT panels at beam support, it may be challenging to meet the criteria by using intumescent coating as fire protection material.

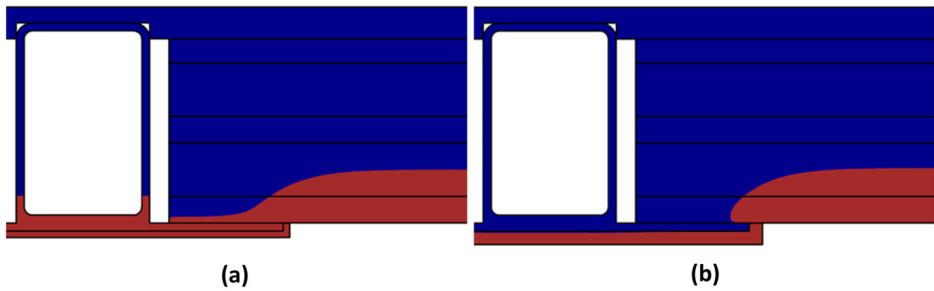
Figure 17. Charring depth of the CLT panel above the protected steel beam bottom plate at 60 min: (a) when bottom flange protected to 2-h (b) when bottom flange protected to 3-h.

- Fire protection thickness of the steel bottom plate was increased from 1.7 to 5 mm in the model. This effective protection thickness corresponds approximately 2-h protection to limiting steel temperature of 570°C;
- Fire protection thickness of the steel bottom plate was increased to 10 mm. This effective protection thickness corresponds approximately 3-h protection to limiting steel temperature of 540°C.
