Radiation experience with the CMS pixel detector

Viktor Veszpremi for the CMS Collaboration^{a*}

ABSTRACT: The CMS pixel detector is the innermost component of the CMS tracker occupying the region around the centre of CMS, where the LHC beams are crossed, between 4.3 cm and 30 cm in radius and 46.5 cm along the beam axis. It operates in a high-occupancy and high-radiation environment created by particle collisions. Studies of radiation damage effects to the sensors were performed throughout the first running period of the LHC. Leakage current, depletion voltage, pixel readout thresholds, and hit finding efficiencies were monitored as functions of the increasing particle fluence. The methods and results of these measurements will be described together with their implications to detector operation as well as to performance parameters in offline hit reconstruction.

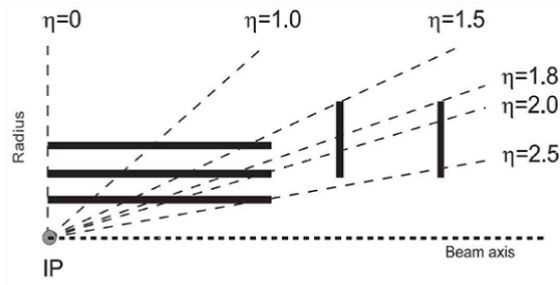
Figure 1. Quarter of a slice of the CMS pixel detector by a plane which contains its axis of symmetry. The centre of the detector is at the left-bottom corner of the drawing, in the interaction region. The horizontal axis, to which the detector has a cylindrical symmetry, is parallel to the LHC beams. The vertical axis points along the radius. Various pseudo-rapidity values are shown at the ends of the black dashed lines.

The pixel detector is the innermost component of the CMS tracker [2]. It was designed utilising a hybrid silicon technology. It comprises three layers in the barrel region at radii of 4.3 cm, 7.2 cm, and 11 cm, respectively (Figure 1). The barrel is closed at the two ends, in the endcap region, with a pair of disks at distances of ± 34.5 cm and ± 46.5 cm with respect to the interaction point, along the beam axis. Assuming a registered hit in the innermost layer (layer 1) of the barrel, this arrangement provides at least three measurement points for tracks originating from the CMS interaction region with a pseudorapidity up to $|\eta| \simeq 2.5$.

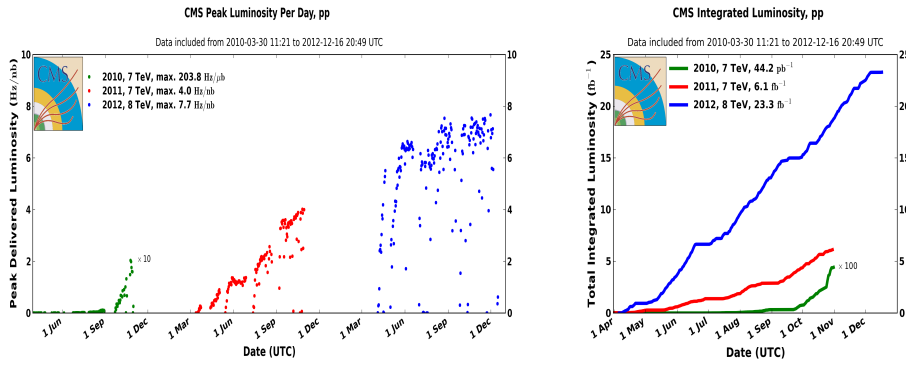
Figure 2. LHC beam parameters. Peak (left) and integrated (right) luminosities delivered to CMS during stable beams in p-p collisions as function of time. This is shown for 2010 (green), 2011 (red) and 2012 (blue) data-taking [5].

The first data-taking period of the LHC [4] between 2010 and 2013 is called Run 1. The instantaneous luminosity of the accelerator gradually improved over the years and reached its peak of $7.7 \times 10^{33} \text{cm}^{-2} \text{s}^{-1}$ in late 2012. During Run 1, the LHC delivered about 6.1fb^{-1} integrated luminosity of proton-proton collision data at 7 TeV and about 23.3fb^{-1} at 8 TeV (Figure 2). The charged track fluence integrated over the 30fb^{-1} of proton-proton collision data for layer 1, 2, and 3 were $9.3 \times 10^{13} \text{tracks/cm}^2$, $4.2 \times 10^{13} \text{tracks/cm}^2$, and $2.1 \times 10^{13} \text{tracks/cm}^2$, respectively, with about 20% uncertainty. The 2012 running period was interrupted by two technical stops in mid-June and mid-September. These beam-quiet periods provided the time to re-tune the calibrations of the detectors. The outcome of these calibrations are attested by most of the measurement results presented below. The inner and outer rings of the endcap disks experience a particle rate that is similar to layer 2 and 3 in the barrel. Since the highest particle fluence is measured in layer 1, we will mostly focus on measurement results obtained for the innermost layer.

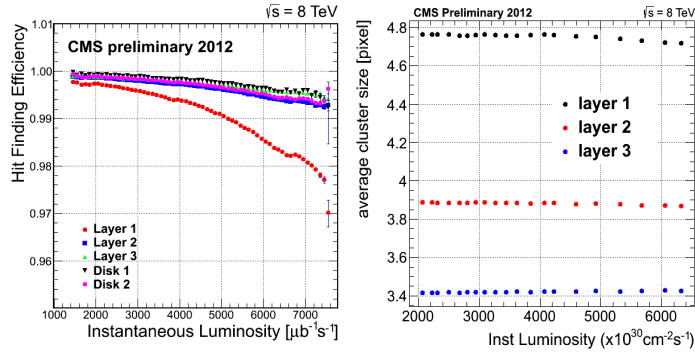
Figure 3. Cluster hit efficiency (left) and average cluster size (right) measured in various layers of the pixel detector. Chips experiencing SEUs are removed from the efficiency calculation [6].

Single event upsets (SEU) are a typical example for temporary effects caused by ionising particles flipping the state of a control register in the readout chips or token bit managers. An SEU may degrade or interrupt data-taking usually resulting in reduced cluster efficiency due to missing clusters. Properties of measured clusters remain unchanged. A reprogramming of all the registers triggered automatically by the readout front-end or manually based on feed-back from data quality monitoring provides remedy to this problem.

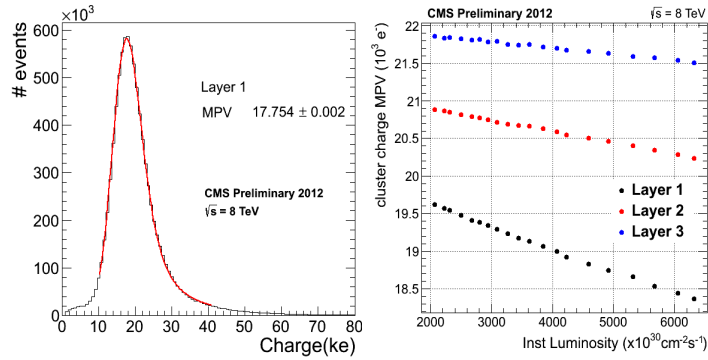
Figure 4. Cluster charge distribution normalised with the track incident angle at the end of 2012 (left) and the most probable value of its Landau fit (right) as a function of instantaneous luminosity [6] from a long LHC fill in 2012.

A high particle rate increases the power consumption of the readout chips, and therefore raises its operating temperature. The charge gain calibration was observed to be temperature dependent. Figure 4 displays a variation in the most probable value of the cluster charge as function of the

instantaneous luminosity which is more significant than it may be expected based on the variation in cluster size.

Long term variations are also observed in the cluster charge. The third plot in Figure 5 shows the most probable value of a Landau fit on the average cluster charge (see also Figure 4). Each sudden increase is due to the increased cluster size after every threshold readjustment. Each sudden drop appears after applying a new gain calibration. Since every threshold calibration is shown to restore the cluster size, the average charge should become automatically readjusted. The overall negative trend, which is observed instead, may imply a change in the gain calibration. The gain calibration associates an ADC value to an injected test charge.

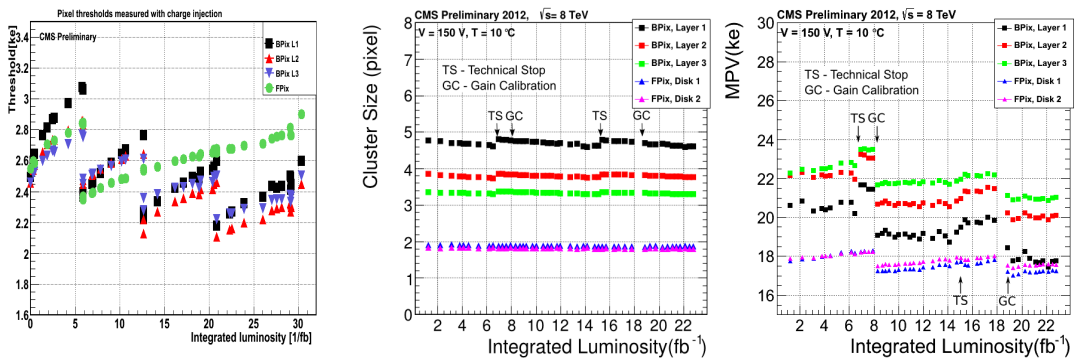
Figure 5. Plot of the pixel readout threshold (left) covering the integrated luminosity of Run 1, while data taken in 2012 starts at 6.1 fb^{-1} . The other two plots show the evolution of cluster size (middle) and the most probable value of the Landau fit of the cluster charge (right) as function of integrated luminosity in 2012 [6].

The left plot in Figure 5 shows the evolution of the pixel readout threshold. Thresholds in each layer are measured by injecting test charges into pixel cells in incremental amounts and determining the amount that corresponds to the efficiency turn-on point for half of the pixels. Discontinuities in the plot reveal when threshold readjustment took place: at the beginning of every data-taking year and during technical stops. A lower threshold leads to increased cluster size, which explains the jumps in the second plot (Figure 5), although their magnitude is inconsistent with the fact that later calibrations were observed to achieve lower thresholds. Such an effect may be possible if the

unit of the injected test charge shifts. In contrast, the gradual increase in the threshold observed between calibrations should result in diminished cluster size. While such a trend is slightly visible in the barrel layers, it does not appear in the endcap disks (FPix) where the thresholds were not readjusted in 2012 at all. The slow increase of the thresholds can, otherwise, be correlated with increased analog current measured at the power supply.

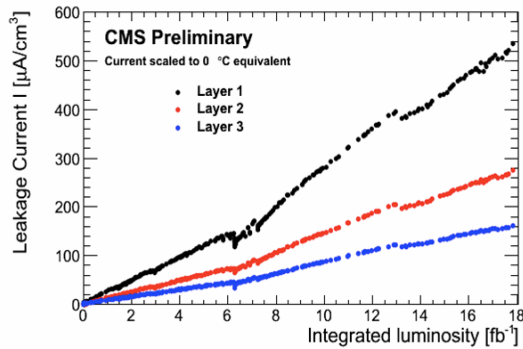
Figure 6. Leakage current scaled to 0°C operational temperature as a function of integrated luminosity until the end of Summer 2012 [7].

Radiation damage effects induced in the silicon bulk were monitored throughout Run 1. Figure 6 shows the leakage current normalised to unit volume and temperature of 0°C in the first 18 fb^{-1} of this period. The leakage current increases linearly with fluence. The drop observed at 6.1 fb^{-1} corresponds to annealing during the shutdown period between 2011 and 2012. In Run 1, the LHC beams were not perfectly centred at the CMS interaction region. The uneven particle rate produced an uneven distribution of leakage current over the azimuthal angle as shown in Figure 7 for layer 1. Each point corresponds to one of the 16 sectors that defines the surface of the barrel. On the top of a sinusoidal shape, a staggered pattern is also observed, which follows the staggered variation of the radial distance of modules in adjacent sectors. This geometry makes it possible to measure the leakage current as function of every module's distance from the interaction region also shown in Figure 7.

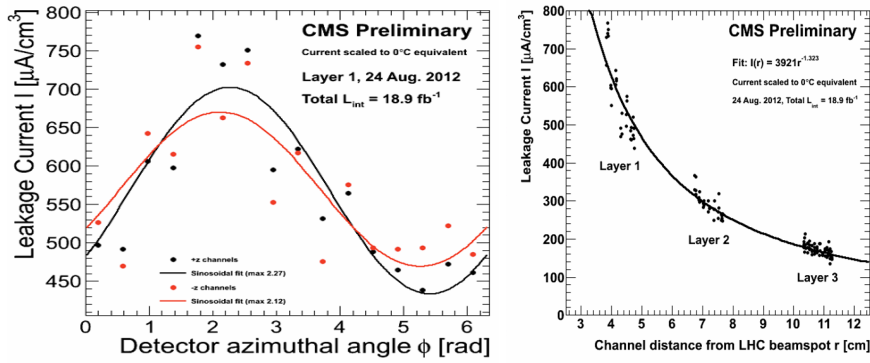
Figure 7. Leakage current scaled to 0°C operational temperature as a function of the azimuthal angle that circles around the symmetry axis of the detector (left) and as a function of the module distance from the LHC interaction region (right). The uneven leakage current in the azimuthal angle is due to an offset in the LHC beam position in the transverse plane. The data points taken in the positive and negative halves of the detector along z are fitted with sinusoidal curves [7].

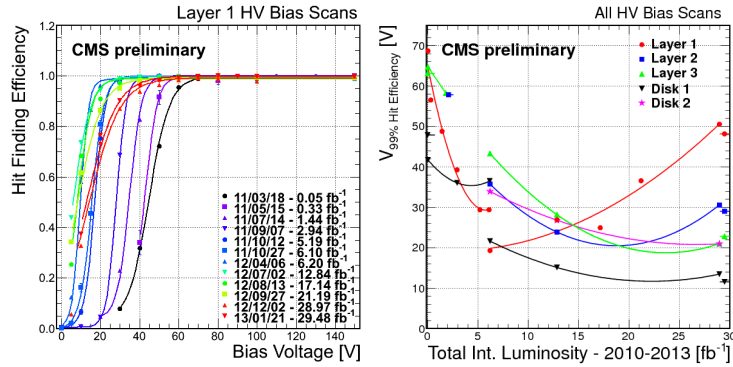
Figure 8. Bias scans performed on the pixel detector (left) and the bias voltage corresponding to 99% hit efficiency (right) as function of the integrated luminosity [6]. Multiple data points acquired in the same year are connected with quadratic fits in the right plot only in order to guide the eye, no underlying model is implied.

charge has proved to be difficult due to drifting threshold and gain calibration as described in the previous section, the data was evaluated by measuring the cluster hit efficiency. Figure 8 shows the efficiency curves as function of the applied high voltage after various amounts of irradiation. The bias voltage needed to reach a depletion depth which corresponds to the full cluster efficiency first decreases, then increases. The second plot shows the evolution of the bias voltage corresponding to 99% efficiency. Evidence of space charge sign inversion is observed in layer 1. Due to its insensitivity to cluster properties, however, this measurement cannot give account on the evolution of the charge collection efficiency when the major factor that describes radiation effects becomes charge trapping.

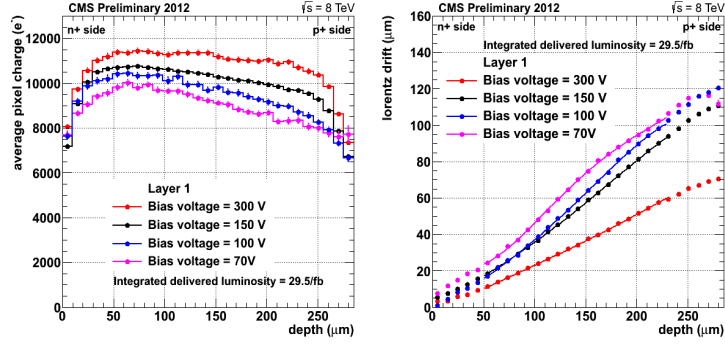
Figure 9. Charge collection profile that shows the pixel charge as function of the depth position of the charge deposit (left). Lorentz drift in the transverse plane as function of depth (right) [6].

Figure 9 shows the average pixel charge of clusters in layer 1 as function of the depth at which the charge was deposited by the traversing particles. The sensors are read out on their $n+$ side. The curves show signs of charge trapping which can be mitigated by increasing the bias voltage. The second plot shows the Lorentz drift distance of charges deposited in various depths of the sensor.

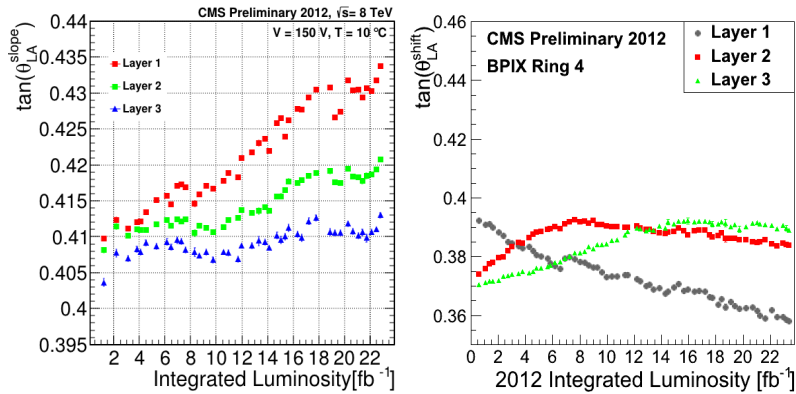
Figure 10. Lorentz angle measured near the mid-plane of the sensors (left) and Lorentz shift (right), an apparent movement of the cluster position due to the magnetic field as seen by the tracker alignment method, as function of integrated luminosity in 2012 [6, 8].

The slope of the Lorentz drift versus depth plot near the sensor mid-plane is called the Lorentz angle. Its evolution with irradiation in 2012 is shown in Figure 10. The cluster charge distribution gets wider and more tilted with higher Lorentz angle. However, this is not the only factor that influences the position measurement of a cluster. The second plot shows the shift of the reconstructed cluster position as seen by the tracker alignment algorithm. This shift is also translated into an angle. The reason why the two angles are different is currently not well understood. The value of the Lorentz shift is used as a correction on top of the Lorentz angle in the cluster position measurement algorithm in order to attain the best resolution.

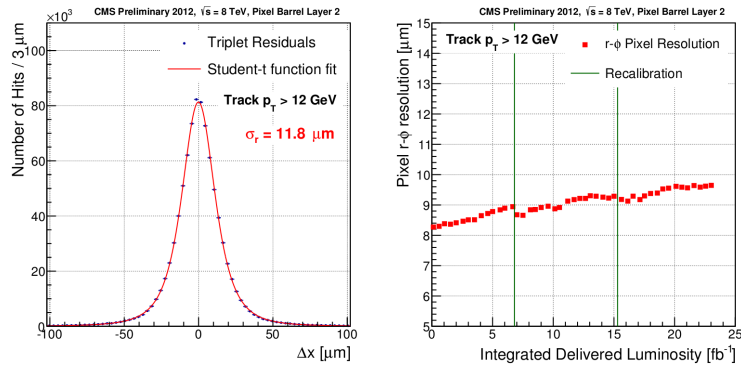
Figure 11. Triplet residual distribution for hits in layer 2 measured in the transverse plane (left) and the evolution of the corresponding resolution as a function of delivered integrated luminosity (right) [6].

The resolution of the barrel pixel is measured by re-fitting hit triplets with their reconstructed tracks whilst keeping the transverse momentum of the tracks and omitting from the fit the hit on the layer under investigation. It is derived from the distribution of the residuals between the expected and measured hit positions, shown in left plot in Figure 11 for layer 2. The measurement in layer 2 is more precise than in layer 1, since hits are used in the fit from radially adjacent layers both below and on the top of layer 2. The resolution is the width of the residual distribution after removing errors which propagate from the fit of the other two hits. Figure 11 on the right shows the resolution of layer 2 as function of integrated luminosity. Its value depends on various factors, such as the precise modelling of the charge sharing, the stability of the gain calibration, and the calibration of the readout thresholds. The re-calibrations of the thresholds which happened twice in 2012 are seen as slight improvements in the resolution.
