Article

Ecohydrologic Connections in Semiarid Watershed Systems of Central Oregon USA

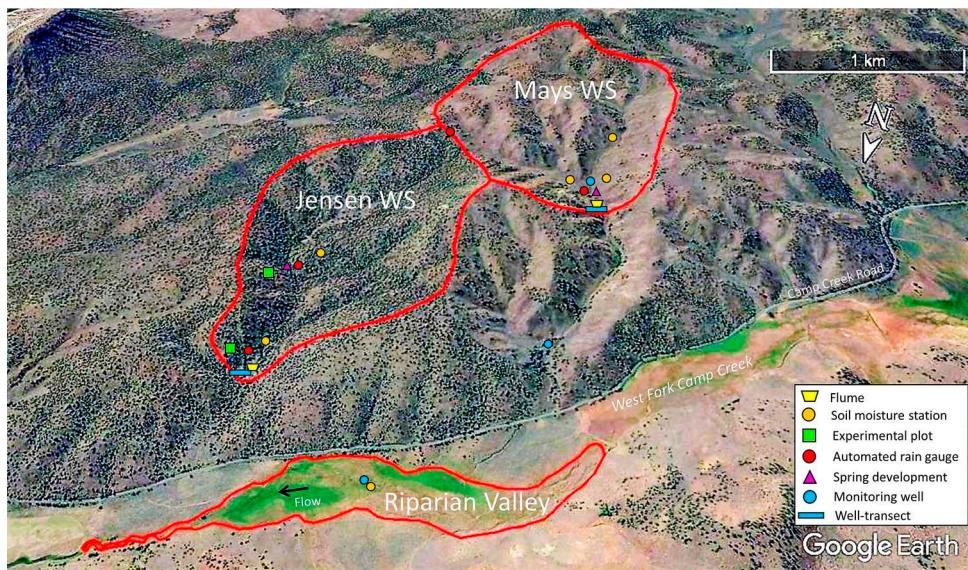
Figure 1. Map of the study area showing Mays WS, Jensen WS, and the Riparian Valley sites, indicating the location of different monitoring instrumentation used in this study.

In 2005, the two watersheds were instrumented to monitor multiple hydrologic variables including precipitation, soil moisture, runoff, and groundwater. Since October 2014, new instrumentation to measure selected variables (i.e., soil moisture, rainfall, and groundwater) has been added to expand the monitoring network in the watersheds and to include the Riparian Valley site (Figure 1).

The effects of tree-canopy cover on precipitation interception (I) and soil moisture content (θ) were evaluated at the plot scale in the Jensen WS (untreated). Two experimental plots of 2000 m² each were installed to collect canopy cover, precipitation, and θ data (Figure 3). One of the plots was located at the valley bottom near the outlet of the watershed and the second plot was located 650 m upstream at a west-facing hillslope (~25% slope) near the stream (see Figure 1).

watershed, 5 m upstream of the Type-H flume. The second well was installed 1000 m downstream of the watershed outlet well (see Figure 1). These two instream-wells were driven until bedrock was reached. The watershed outlet well was driven 1 m into the ground and the downstream well was driven 1.5 m. Beginning in 2014, all wells have been equipped with water level loggers (Model HOB0 U20-001-01, Onset Computer, Corp.; Bourne, MA, USA) and programmed to record data every hour. A water level meter (Model 101, Solinist Canada Ltd., Georgetown, ON, Canada) has been used to collect depth to water table during selected dates. These data were used for verification or calibration of the water level loggers. All wells were geo-positioned with a GPS unit (PN-60 GPS, DeLorme, Inc., Yarmouth, ME, USA) and surveyed to determine onsite soil surface and water table elevations.

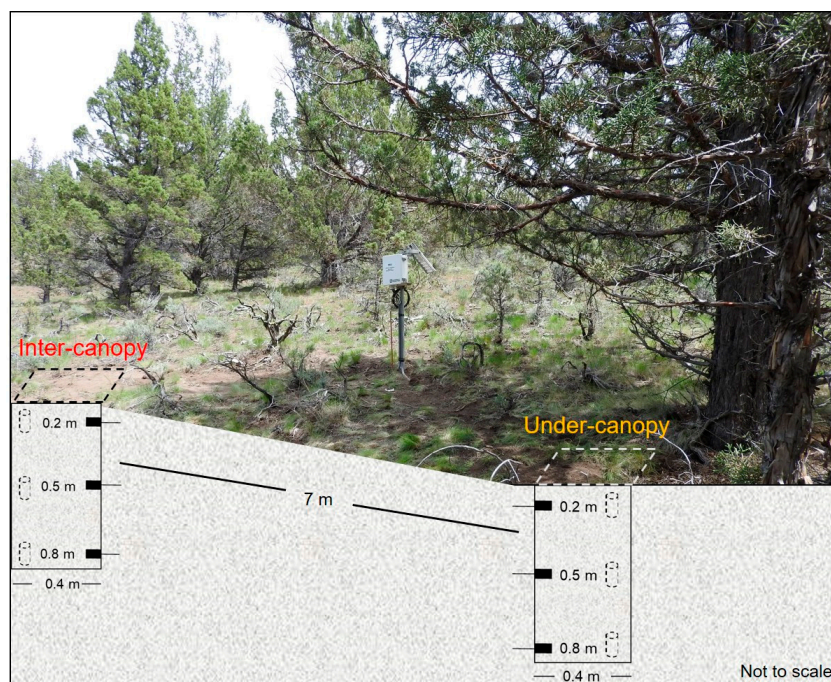
Figure 2. Schematic illustrating soil moisture sensor placement and soil sampling depth at under-canopy and inter-canopy locations in the upstream plot in Jensen WS.

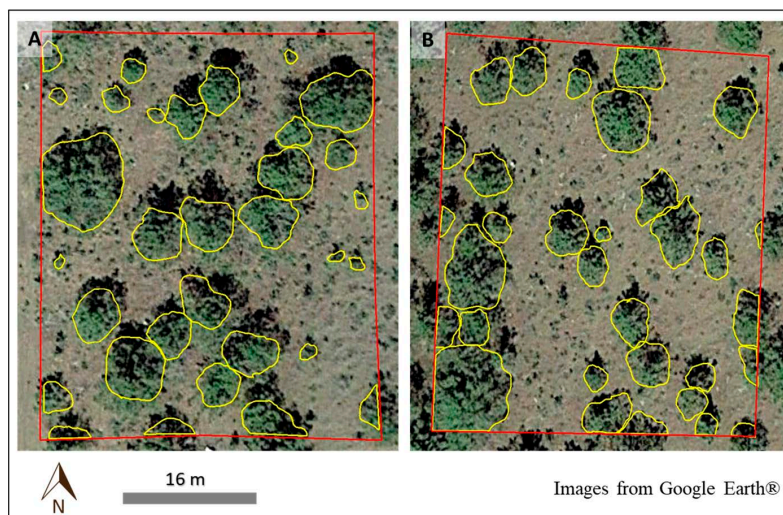
Figure 3. Satellite images illustrating juniper trees (outlined in yellow) in the downstream (A) and upstream (B) experimental plots.

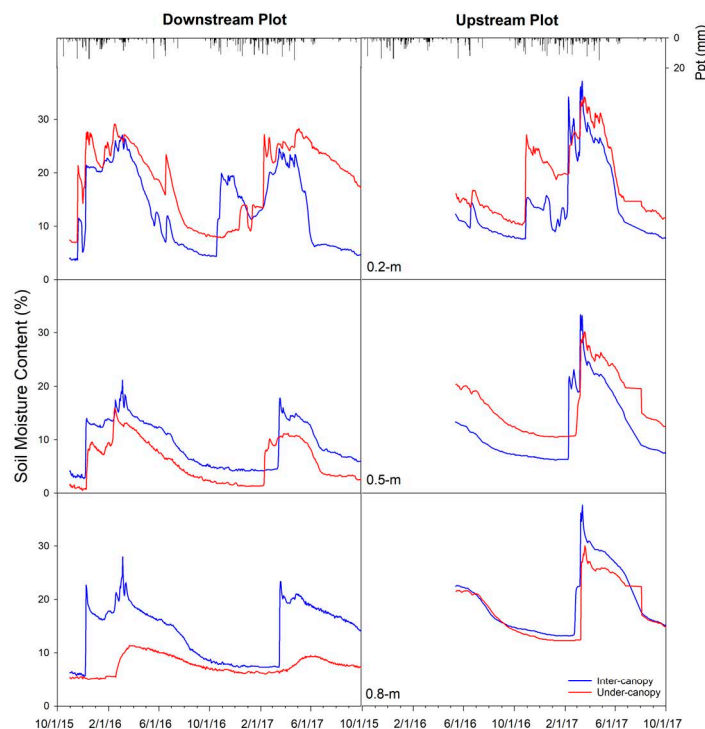
Figure 4. Daily-averaged precipitation and soil moisture content for the three different sensor depths (0.2, 0.5, and 0.8 m) at inter-canopy and under-canopy locations in both plots in the Jensen WS. x -axis indicates month/day/year.

A seasonal θ response to precipitation inputs was observed in the Jensen WS plots at all sensor depths. Figure 4 shows daily-averaged θ for the three different sensor depths (0.2, 0.5, and 0.8 m) at under-canopy and inter-canopy locations in both plots. Greater θ values were observed at the peak of the snowmelt runoff season in spring. The limited summer precipitation characteristic of the region was reflected in the decreasing θ values at all sensor locations during the dry season, reaching their lowest θ in fall and winter. The potential effects of tree canopy interception on θ were more evident in the deeper soil profile in the downstream plot. Greater θ levels were obtained at the inter-canopy location for both the 0.5 and 0.8 m sensor depths in this downstream plot. This may be due in part to higher sand content values at all depths at this location (Table A1). The effects of tree canopy interception on topsoil moisture were observed during periods of rain and early snowmelt runoff in January 2017. For example, greater θ levels were observed in the downstream plot for the 0.2 m sensor depth in the inter-canopy location in the fall of 2016. However, greater θ levels at the 0.2 m depth were generally observed most of the time for the under-canopy location in both plots (Figure 4).

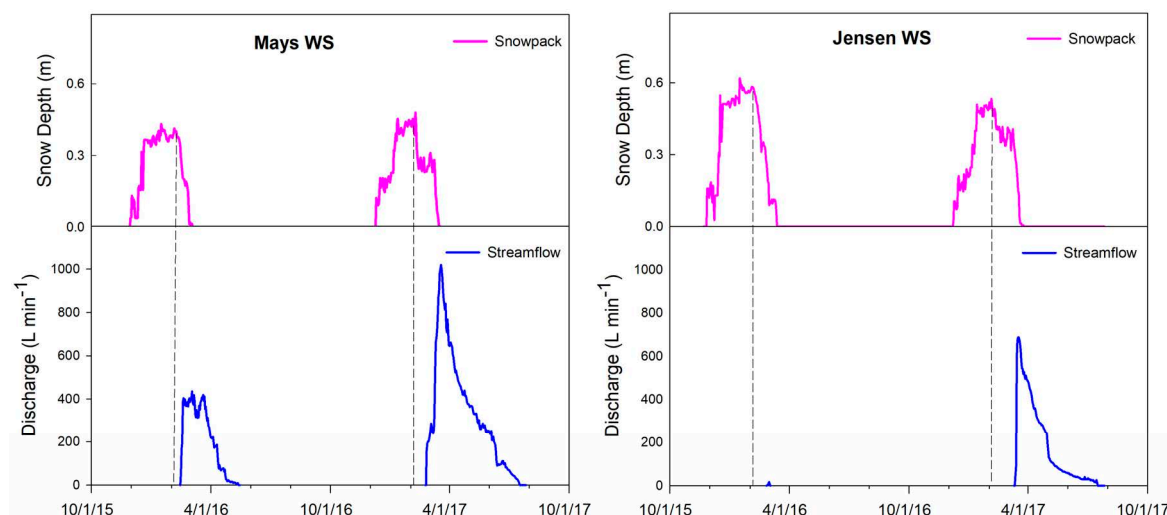
Figure 5. Snowpack depth and runoff discharge during 2016 and 2017 in both watersheds illustrating the relationship between snow melting and streamflow measured at each watershed. *x*-axis indicates month/day/year.

Snowpack and streamflow relationships during the years 2016 and 2017, when greater snowpack depths were observed, are illustrated in Figure 5. In 2016, snowpack depth rose to 0.4 m at Mays WS (treated) and to 0.6 m at Jensen WS (untreated) in mid-January and remained at that level until early February when it started melting. The snowmelt period that started in mid-February in 2016 generated almost an immediate streamflow response in Mays WS but not in Jensen WS. For Mays WS, streamflow peaked at 440 L min⁻¹ on 3 March. For Jensen WS, streamflow peaked at 24 L min⁻¹ on 1 March. In year 2017, snowpack began to build in early December and rose to 0.5 meters by mid-January in both Jensen WS and Mays WS. Snowpack in both watersheds persisted until early March when snow began melting, and within two weeks, the snowpack was negligible in both watersheds. Streamflow peaked at 1020 L min⁻¹ for Mays WS on 19 March. For Jensen WS, streamflow peaked at 687 L min⁻¹ on 17 March (Figure 5).

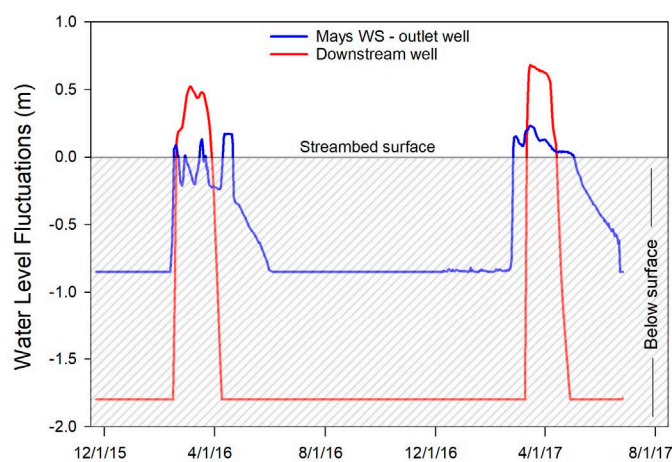
Figure 6. Surface and subsurface stream water level response to snowmelt runoff at watershed outlet and downstream well locations in Mays WS in years 2016 and 2017. *x*-axis indicates month/day/year.

Snowmelt runoff resulted in transient surface and subsurface flow connections in the stream in Mays WS. For example, Figure 6 shows streamflow response to the 2016 and 2017 snowmelt runoff seasons along the stream draining out of Mays WS. In the well installed in the streambed at the watershed outlet, the first response was observed below the surface on 11 February 2016. Water level rose sharply and peaked 7.5 cm above streambed surface on 19 February, then water level fluctuated above and below the surface until the end of April when it began a steady decline. The first response of the downstream well, located 1000 m downstream, was observed on 16 February. Water level in this well peaked at 0.5 m above streambed surface on 5 March, and remained above the surface for about three weeks until it dropped to baseflow conditions on 9 April 2016. In year 2017, the first response in the outlet well was observed below the surface on 25 February; water level peaked at 0.23 m above streambed surface on 16 March 2017, then returned to baseflow conditions on 2 May 2017. The first response in the downstream well was observed on 10 March, peaked at 0.7 m above streambed surface on 16 March, then returned to baseflow conditions on 14 April 2017 (Figure 6).

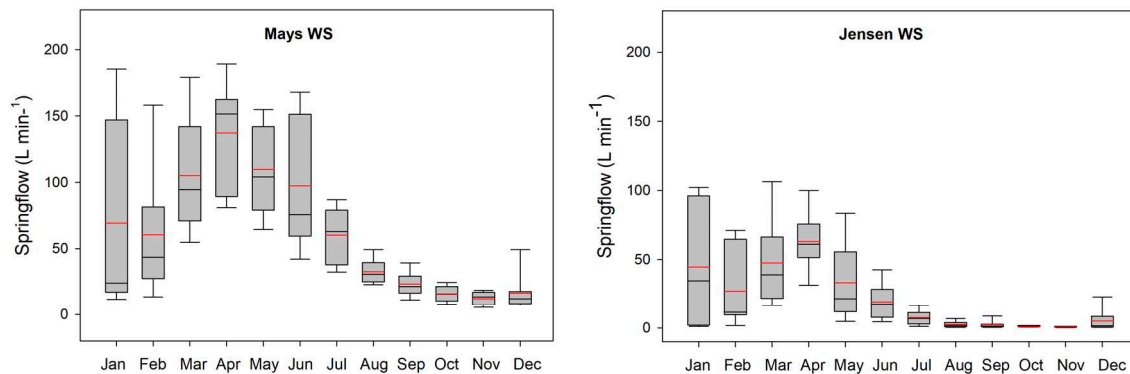
Figure 7. Box diagram showing springflow rate estimates for both watersheds over the period of record September 2004 through November 2017. Each box diagram shows the mean (red line) and median (black line). The lower and upper ends of the boxes represent the 25th and 75th percentiles respectively. Lower and upper error bars represent the 10th and 90th percentiles, respectively.

Greater springflow was observed in the Mays WS (treated) when compared to the Jensen WS (untreated). Figure 7 shows that springflow in both watersheds followed a seasonal pattern corresponding to regional precipitation dynamics (dry summers, wet winters). In general, springflow began increasing in late winter, peaked in mid-spring, and then followed a steady decline until reaching baseline levels in late summer.

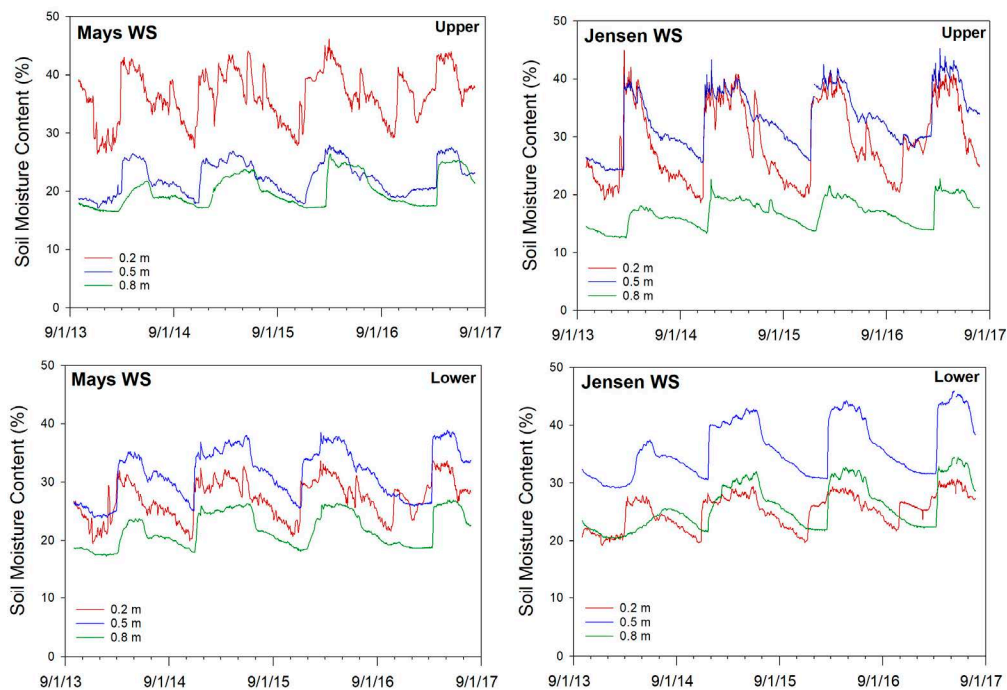
Figure 8. Soil moisture content fluctuations at different soil depths at upper and lower locations in both watersheds from 1 October 2013 through 27 July 2017. *x*-axis indicates month/day/year.

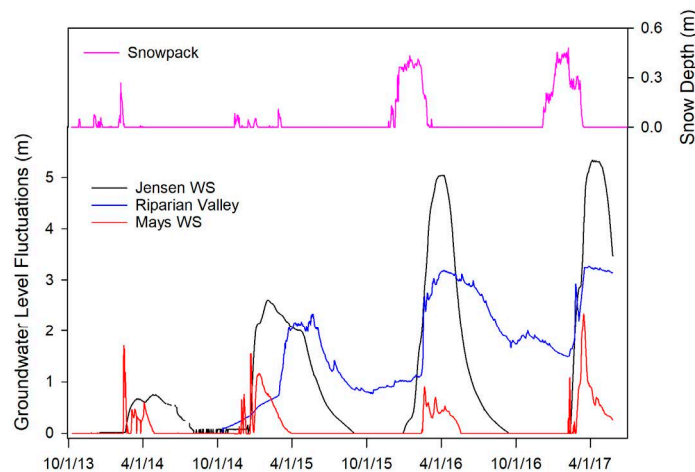
Figure 9. Snowpack depth and seasonal water table fluctuations in selected wells in Mays WS and Jensen WS and in the Riparian Valley from October 2013 through May 2017. Flat lines at zero groundwater level depict wells were dry. *x*-axis indicates month/day/year.

Figure 9 shows four years of snowpack depth in Jensen WS and shallow aquifer fluctuations in both watersheds and in the Riparian Valley. It can be observed that snowpack accumulation was considerably higher in 2016 and 2017 than in years 2014 and 2015. Also, groundwater level rises were considerably higher in the Jensen WS and Riparian Valley well locations in 2016 and 2017 when compared to previous years. Peak groundwater-level rises over 5 m were observed in Jensen WS during the snowmelt runoff season in years 2016 and 2017. Early in the aquifer recharge season, a relatively rapid groundwater level rise and decline pattern was observed in Mays WS during most years evaluated. The location of the Mays WS wells in mostly fractured rock substrate may have contributed to the quick transport of groundwater out of the site that resulted in less pronounced groundwater mounds observed during the aquifer recharge season. A faster response and a higher groundwater level peak were observed in the Riparian Valley well in 2016 and 2017 when compared to the response in the previous, drier, year 2015. Soil moisture content in the Riparian Valley remained at

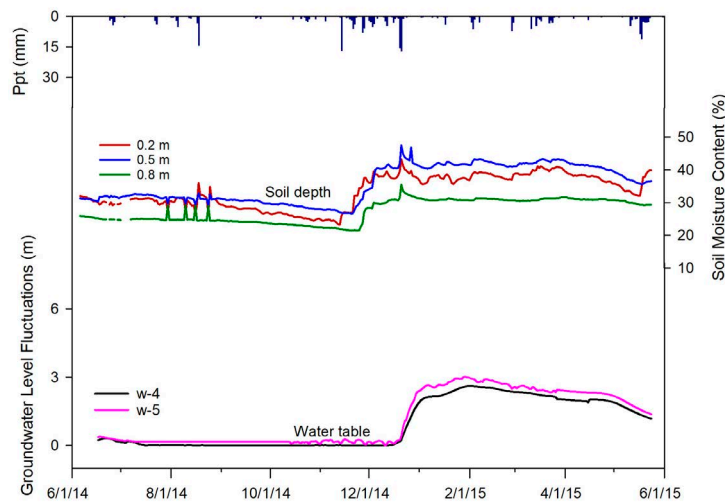
Figure 10. Soil moisture and shallow groundwater level response to precipitation inputs in two wells (w-4 and w-5) in the well transect (see Figure 1) in Jensen WS during June 2014 through June 2015. x-axis indicates month/day/year.

A closer look at precipitation, soil moisture, and shallow groundwater relationships in Jensen WS during June 2014 through June 2015 is illustrated in Figure 10. It can be observed that summer precipitation had an effect on θ levels but not on groundwater. Winter precipitation considerably increased θ levels at all sensor depths and had an effect on shallow groundwater level response three weeks after θ increased in the deepest soil sensor at 0.8 m. Groundwater level fluctuations in the transect wells, as illustrated by wells w-4 and w-5, peaked at the end of January and stayed above two meters for most of the winter and spring, until they started declining in May (Figure 10). A similar response was observed during all four years (2014–2017) evaluated in the two watersheds.

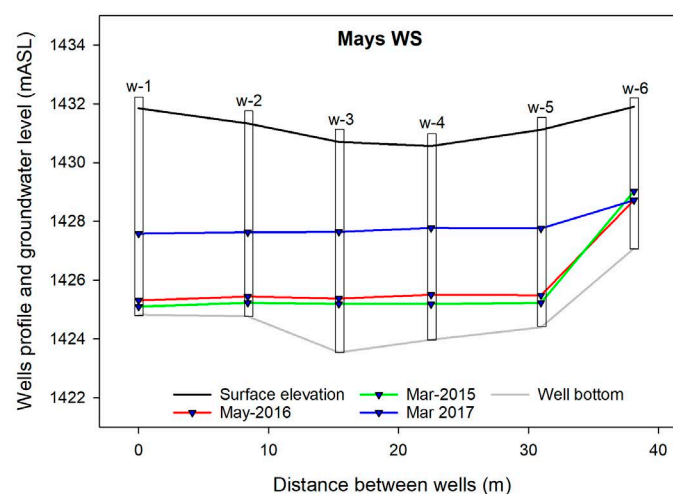
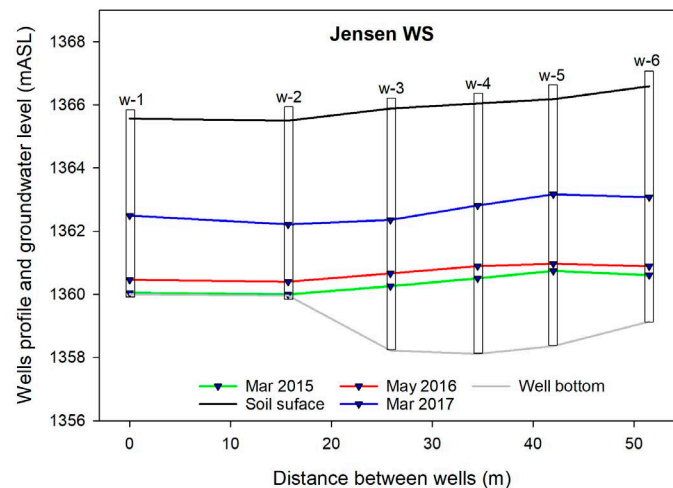
Figure 11. Shallow groundwater levels at selected dates during runoff season in well-transects in both watersheds.

Figure 11 shows a cross-sectional view of groundwater level fluctuations along the 6-well transect installed in each watershed. Manual measurements of depth to water table, depth to well bottom, and soil surface elevation were used to construct the cross-sectional profile in each watershed. The bottom of all wells are at, or very close to, bedrock level, thus it reflects a significant section of the underground channel profile at the outlet of each watershed. Depth to water table was substantially shallower in March 2017 when compared to the March 2015 and May 2016 readings in all but w-6 in Mays WS. Since juniper removal, w-6 in Mays WS has consistently remained at shallower groundwater depth than the rest of the wells in that transect, this was also shown during the three different dates evaluated. The highest water table levels were observed in March 2017 when a depth to water table of 3.2 m was measured in w-4 in Mays WS and w-5 in Jensen WS. This contrasts with the lower water table levels observed in March 2015 when depth to water table was 6.8 m in w-1 in Mays WS and was at 6 m depth in w-6 in Jensen WS (Figure 11).
