# MARINE WOOD MAINTENANCE MANUAL: A GUIDE FOR PROPER USE OF DOUGLAS-FIR IN MARINE EXPOSURES

JEFFERY J. MORRELL  
GUY G. HELSING  
ROBERT D. GRAHAM

**FOREST RESEARCH LAB**

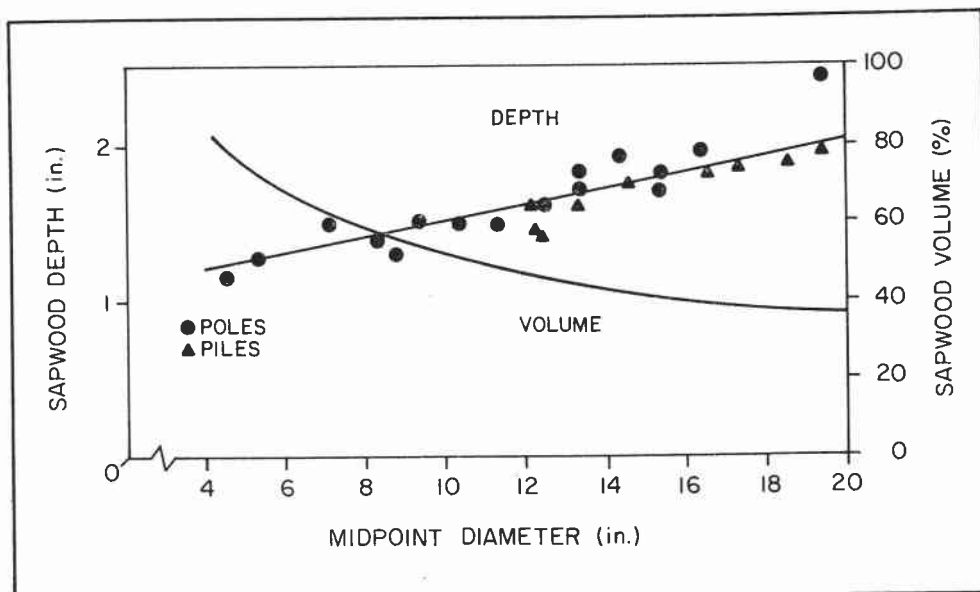
FIGURE 2.  
 VARIATION IN DEPTH AND VOLUME OF SAPWOOD WITH INCREASING POLE DIAMETER OF COAST DOUGLAS-FIR. FROM GRAHAM AND HELSING (1979).

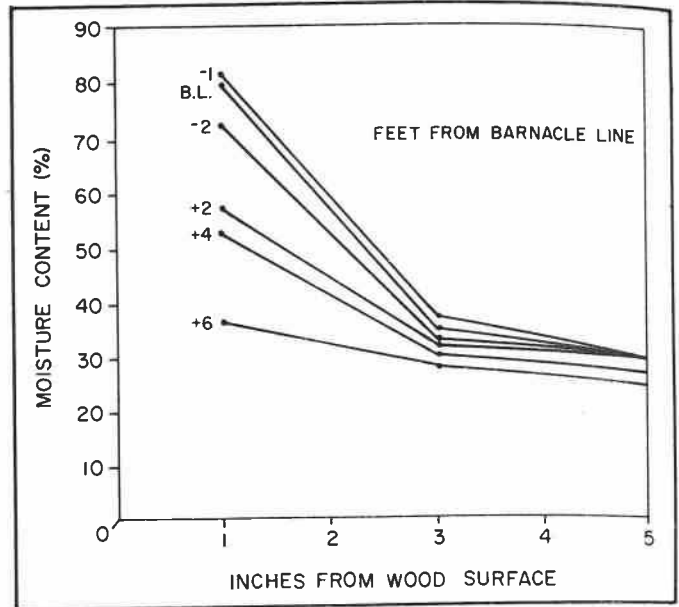
FIGURE 4.

MOISTURE CONTENT OF CREOSOTE-TREATED MARINE PILING AT VARIOUS DISTANCES FROM THE BARNACLE LINE AND DEPTHS FROM THE WOOD SURFACE.

for 12 years and creosote-treated piles in service for 30 years (Fig. 4).

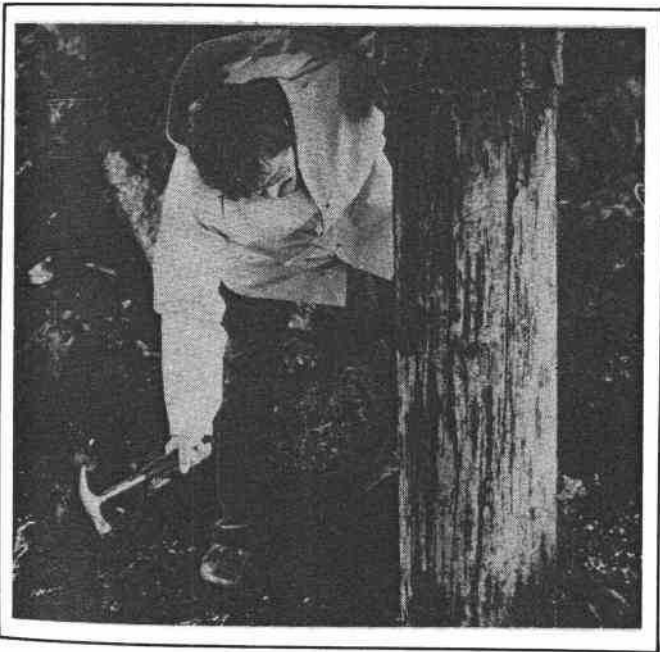
FIGURE 25.

SOUNDING A PILE WITH A HAMMER CAN REVEAL LARGE VOIDS IN THE WOOD.

The hammer is a simple, effective tool for sounding piles and large timbers in order to detect advanced internal decay (Fig. 25). A light-weight hammer that is both comfortable to use and strong enough to stand repeated blows is recommended. Sound wood is indicated by a sharp ring, while a hollow sound or dull thud indicates some defect. Because wood defects other than decay can affect sounding, it is important to drill or core the suspicious area.

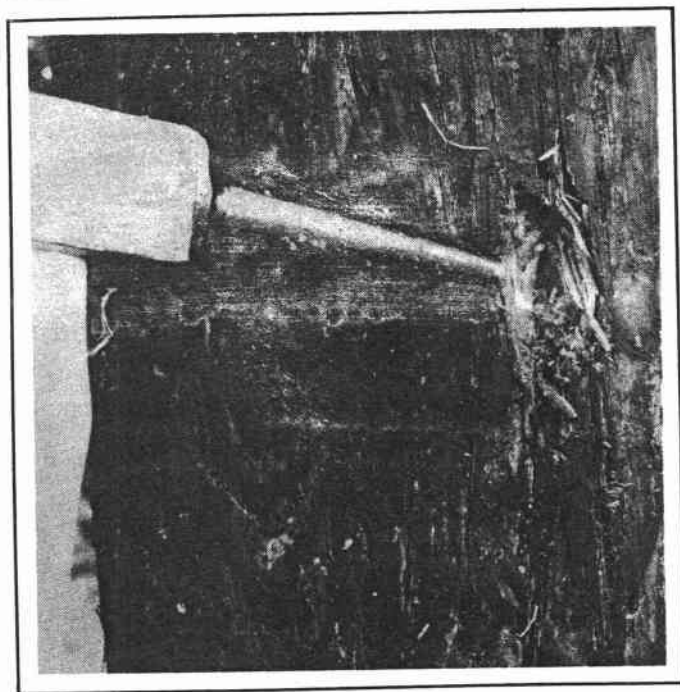
FIGURE 27.

A LEATHER PUNCH WELDED TO A HAMMER CAN SPEED INCREMENT CORING BY CREATING STARTING HOLES.

1. To speed coring and decrease the risk of breakage, make starter holes 1/2 to 3/4 inch deep with a hammer-mounted metal punch (Fig. 27).
2. If boring resistance increases sharply, first back out and remove the core, then bore deeper.
3. Apply moistened soap to the exterior of the borer to decrease boring resistance.
4. Periodically sharpen the borer with a fine hone to ease coring and reduce risk of breakage.

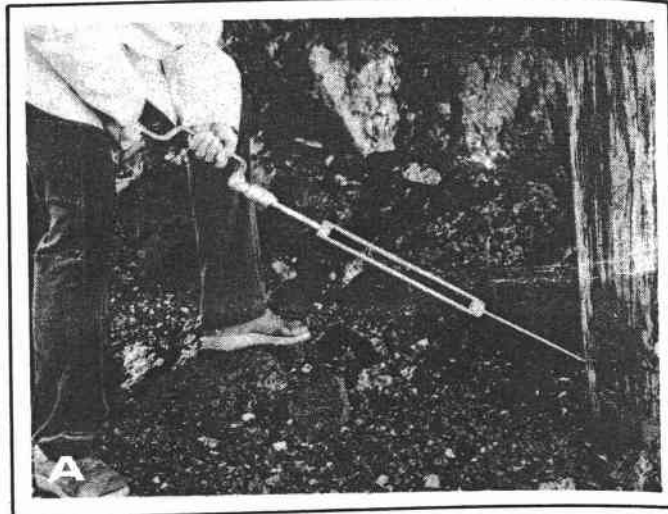
FIGURE 28.

MOUNTING THE BIT FROM AN INCREMENT BORER INTO (A) AN EXTENSION OR (B) AN ELECTRIC DRILL CAN SPEED CORE REMOVAL.

While coring can be done by hand, the process can be made easier by mounting the bit in an extension chucked into a brace and bit (Fig. 28A) or directly into a power drill (Fig. 28B). Be sure that the extension is open at one side to permit extraction of cores, and remember that, while mechanical boring works well, it reduces one's ability to "feel" the borer and increases the risk of bit damage.

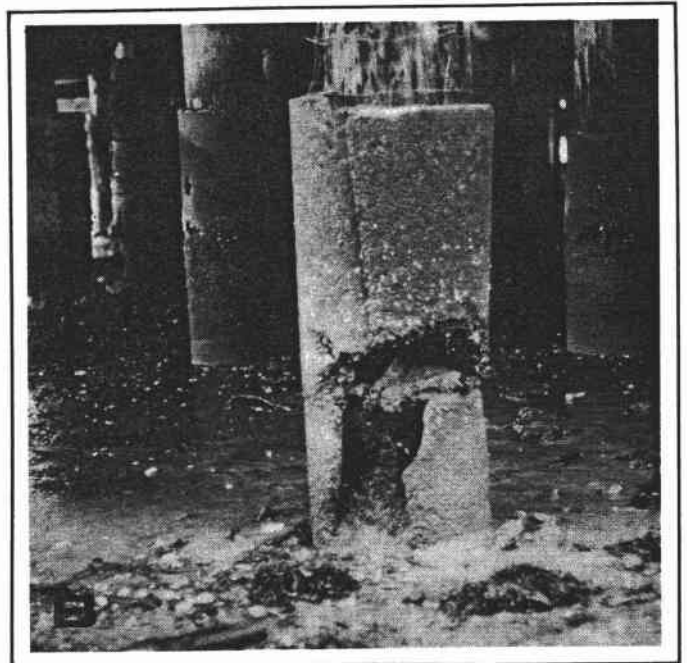
FIGURE 36.

A: CONCRETE CAN FORM AN EFFECTIVE BARRIER AGAINST ATTACK BY MARINE BORERS. B: CONCRETE BARRIERS ARE ONLY EFFECTIVE IF THEY REMAIN INTACT; ONCE BROKEN DOWN, THEY MAY ACTUALLY ACCELERATE DETERIORATION.

Concrete barriers, in addition to preventing marine borer attack, can add support to partially degraded marine structures (Fig. 36); however, it is essential that a zone from below the mudline to above the high tide line be completely encased with at least 2 inches of concrete. Failure to encircle the pile completely will result in localized attack of unprotected areas and eventually lead to pile failure.

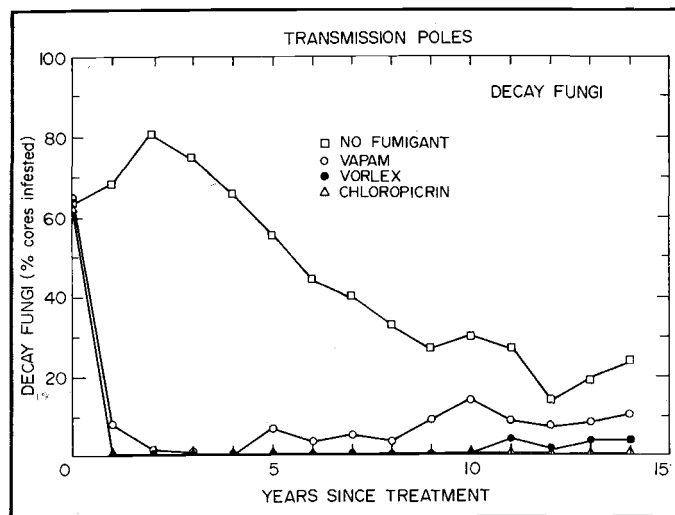
FIGURE 38.

ANNUAL CHANGES IN THE POPULATION OF DECAY FUNGI ISOLATED FROM PRESSURE-TREATED DOUGLAS-FIR POLES AFTER APPLICATION OF VARIOUS FUMIGANTS. NOTE THE LOW LEVELS OF DECAY FUNGI PRESENT IN FUMIGANT-TREATED POLES. FUNGI IN POLES WITHOUT FUMIGANT DECLINED BECAUSE OF THE DEPLETION IN AVAILABLE WOOD. FROM MORRELL AND CORDEN 1984.
