"The Lesson of the Quebec Bridge"

Wilfred G. Lockett

Scientia Canadensis: Canadian Journal of the History of Science, Technology and Medicine / Scientia

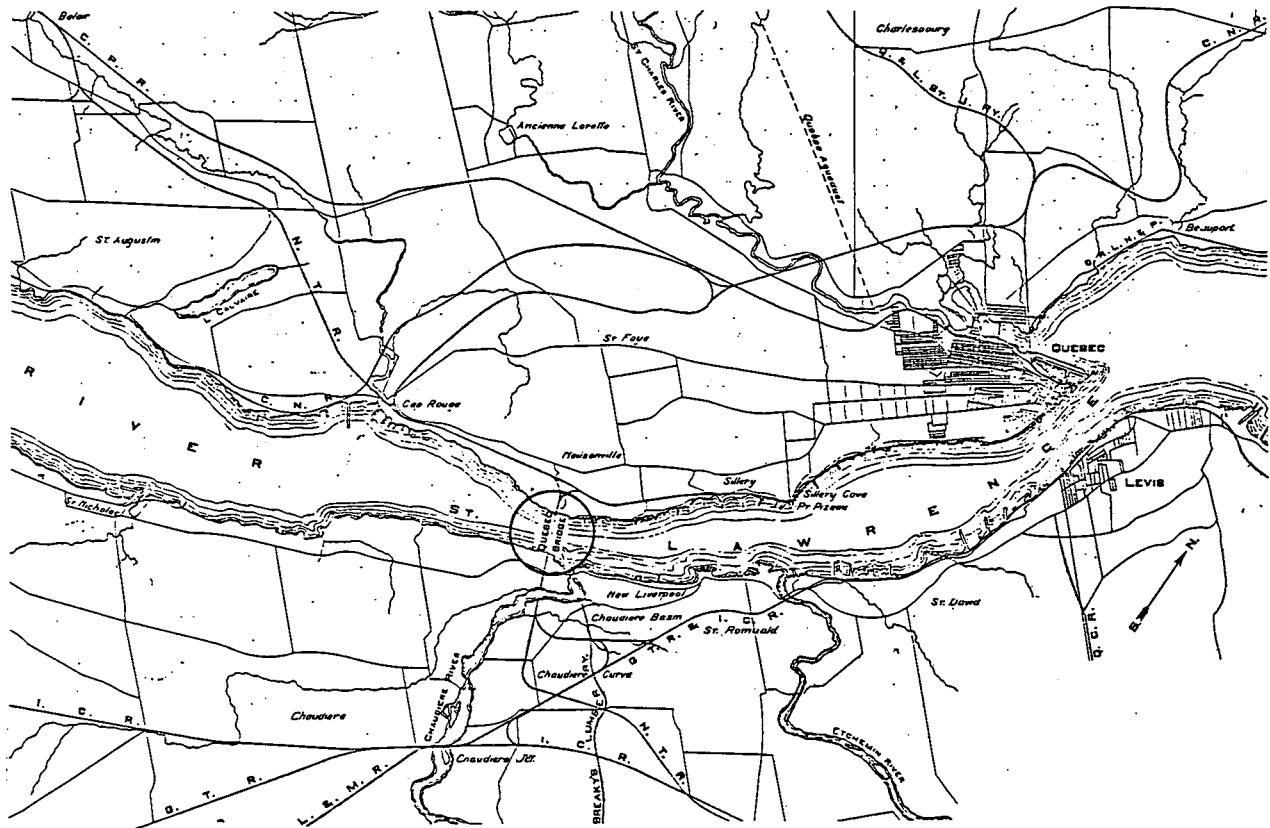
FIGURE 1

Perhaps the most notorious failure in Canadian engineering history was the collapse during construction of the bridge over the St Lawrence near Quebec City (see Figure 1). In the calamity, which occurred on 29 August 1907, 74 of the 85 men working on the bridge at the time lost their lives. The *Engineering News* commented 'The fall of this bridge ranks with the greatest engineering disasters in history.' [3]

LOCATION OF QUEBEC BRIDGE

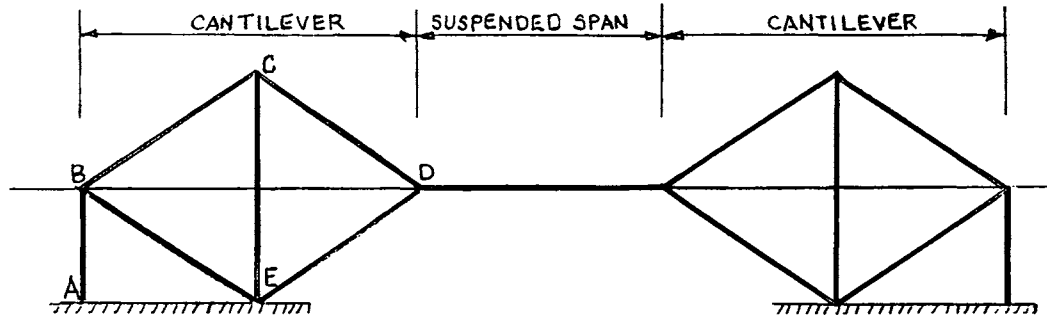
Figure 3

Anchor Post AB.....*in tension*
 Upper Chord BC, CD.....*in tension*
 Central Tower CE.....*in compression*
 Lower Chord BE, ED.....*in compression*

THE CANTILEVER PRINCIPLE

The fundamental elements of the cantilever structure are shown on Figure 3, and comprise essentially a bracket, jutting out from a tower which is prevented from overturning by a similar bracket firmly anchored to a solid foundation. A pair of these structures support between them the suspended span which completes the crossing of the river. We will later have to consider some of the basic engineering involved in the design of the structure, but in the meantime we should note that the upper members of the cantilever are in tension, while the lower members act as struts and are in compression.

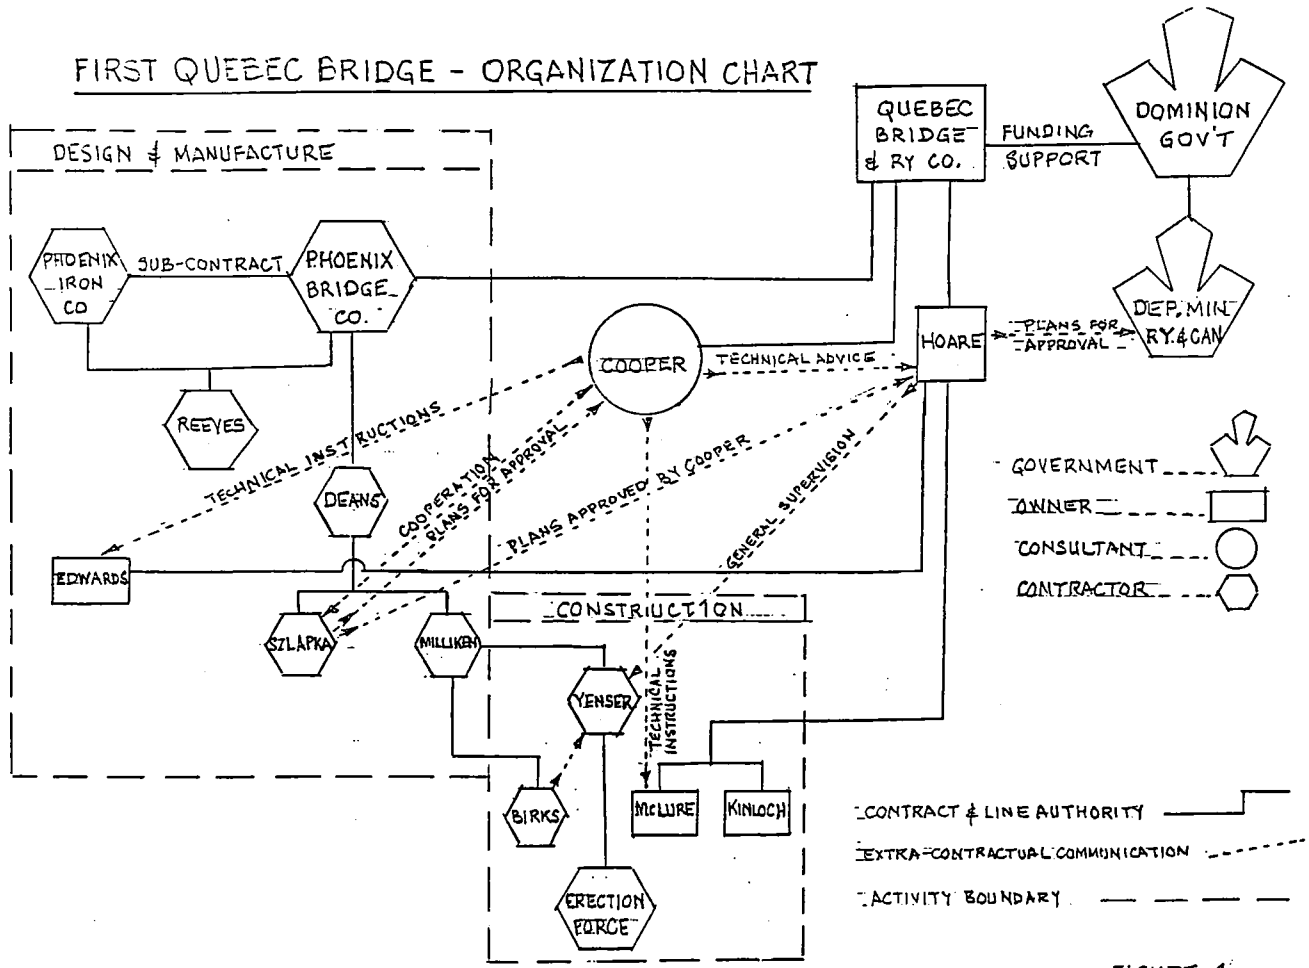
FIGURE 4

FIRST QUEBEC BRIDGE - ORGANIZATION CHART

The organization which evolved to carry out the design and construction of the bridge is illustrated in the diagram on Figure 4.[11]. The Company's Chief Engineer, E.A. Hoare, was in principle the senior man on the whole project, responsible to the Company for final decision-making, at least in technical matters. But his lack of experience in major bridges led him to defer greatly to the Consulting Engineer, Cooper, who effectively assumed the reins of Chief Engineer.

The Organization Chart shows the formal procedure for approval of plans: Szlapka -> Cooper -> Szlapka -> Hoare -> Deputy Minister. In practice, as indicated in a table of dates at which various operations were performed,[12] when approved drawings were

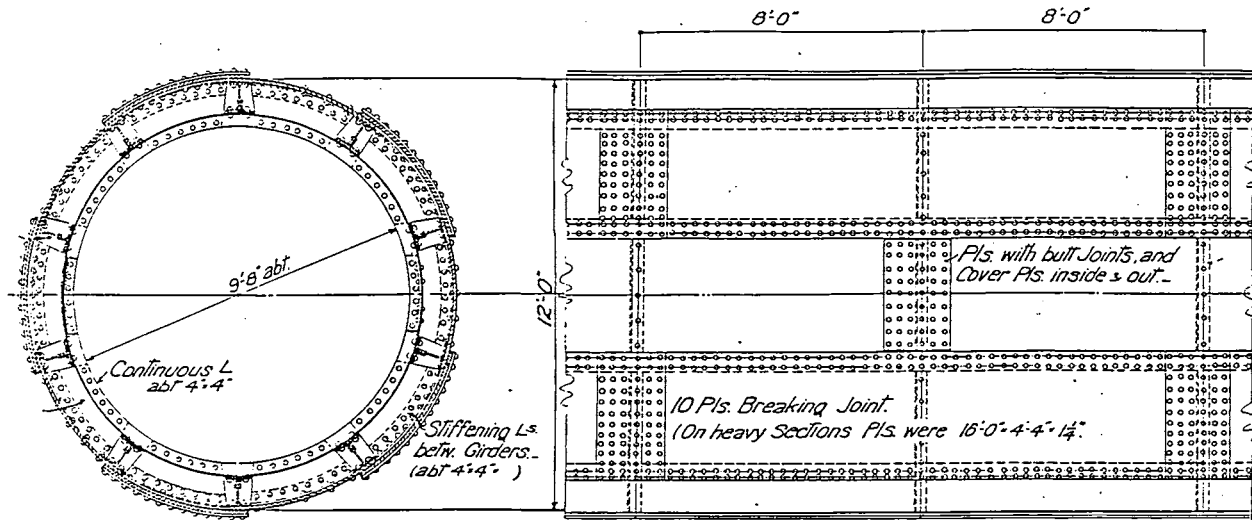
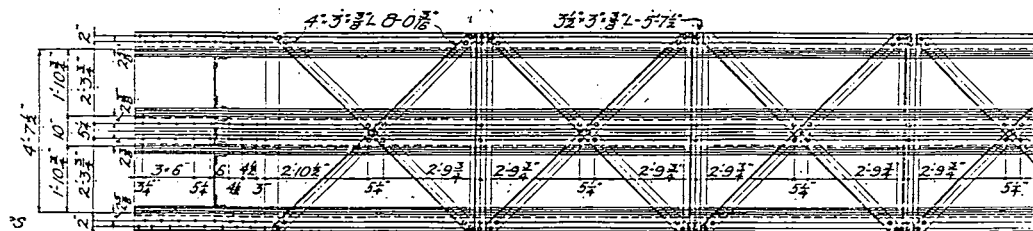
FIGURE 5

(a) FORTH BRIDGE COMPRESSION MEMBER - SECTION AND ELEVATION

SECTION

PLAN ON A-A

(b) QUEBEC BRIDGE COMPRESSION MEMBER

We have now to consider the design of the compression members and in particular those of the lower chord, that part of the cantilever incorporating the distinct curve shown in Figure 2(b). As noted above, the strength of a compression member or strut depends principally on its resistance to buckling. In the case of the Forth bridge this was neatly accomplished by giving the members a cylindrical form, which during the erection stage involved the building up of the member curved plate by curved plate, a procedure well suited to the skills of Scottish shipwrights. But in North America the accepted practice was to use standard rolled steel sections (angles, flats, I-beams, etc.) in the fabrication of structural members. In the Quebec bridge the struts were built up from an array of parallel flat plates. Figure 5 shows a comparison of the compression members of the Forth and Quebec bridges. The bracing introduced for stiffening the latter may be clearly seen. The active cross-sectional area was about 800 square inches in Forth bridge and 842 square inches in the Quebec bridge.

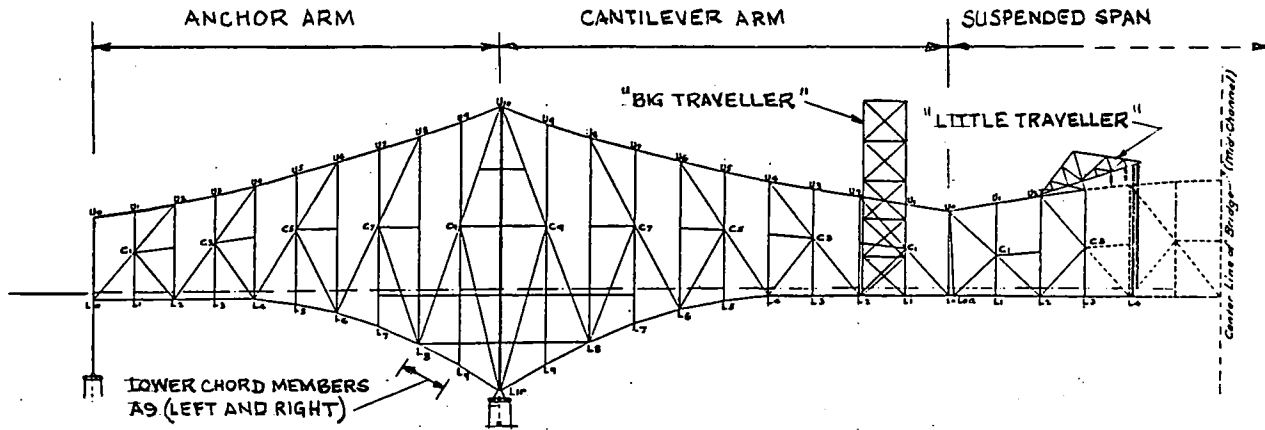
FIGURE 6

CONDITIONS ON AUGUST 29, 1907

By August, 1907, construction had reached the stage where the south cantilever had been completed and erection of the suspended span, jutting out from the end of the cantilever, was in hand. The 'big traveller,' a movable gantry used in the handling of components, was being dismantled in anticipation of transferring it to the north bank, and a 'little traveller' was in use for the work on the suspended span (see Figure 6).

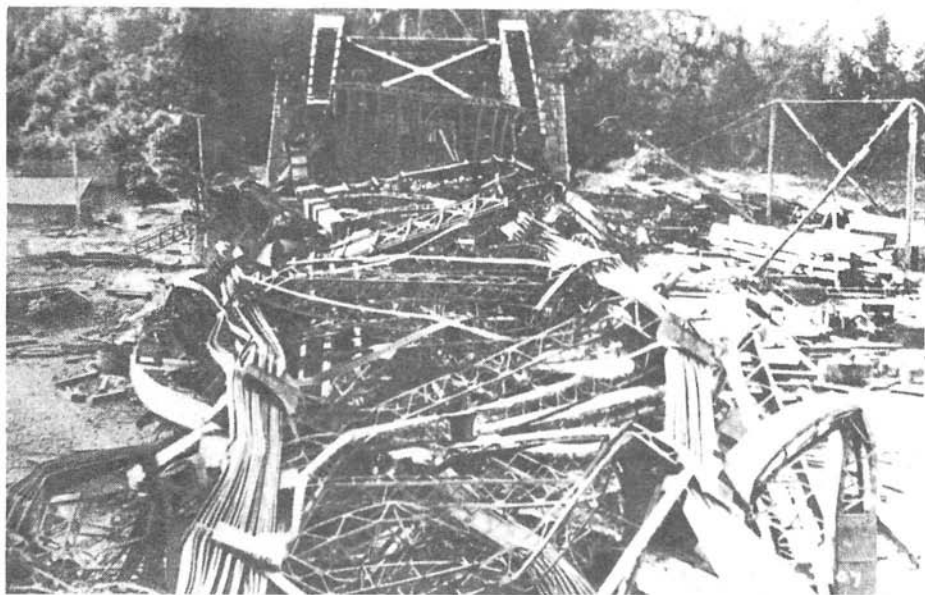
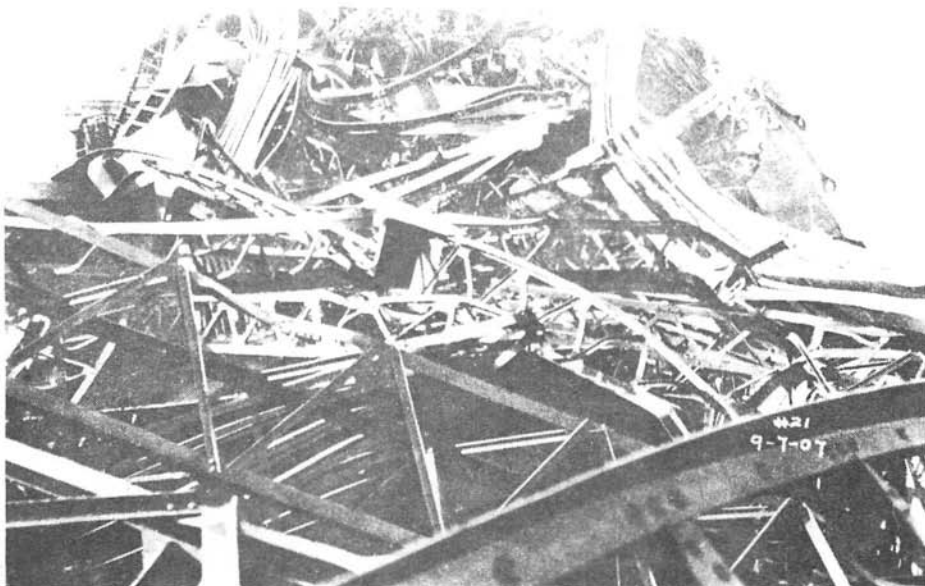
Figure 7(a) Wreckage, looking south [top]; 7(b) looking north

Cooper instructed McLure to discuss the problem with Deans. McLure's arrival in Phoenixville, at about 5.00 pm on Thursday, 29 August, coincided with the collapse into a tangled heap of the whole superstructure, taking the lives of 74 men, including Yenser and Birks. (Figures 7)

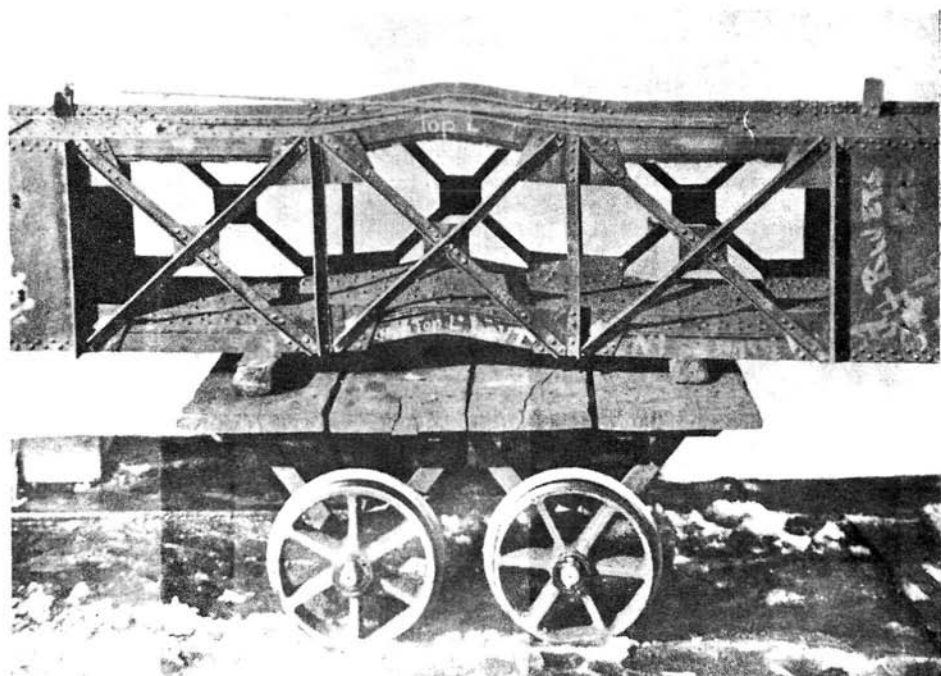
Figure 8: Test of model chord

built and tested a model of the A9 chords, scaled down to 1/3 full size to bring it within the capacity of the machine. Subsequently other models were made and tested at the request of the Commission. The tests clearly demonstrated how, for the load-bearing webs to buckle, the latticing must fail first. (Figure 8)
