Management of midline diastema using pressable ceramics and zirconia crowns: a case series

Sunil Rayavarapu^{1,*}, Kalyan Yelisetty¹, Anil Budumuru², N V Teja Varma¹, Prem Sagar Yekula³

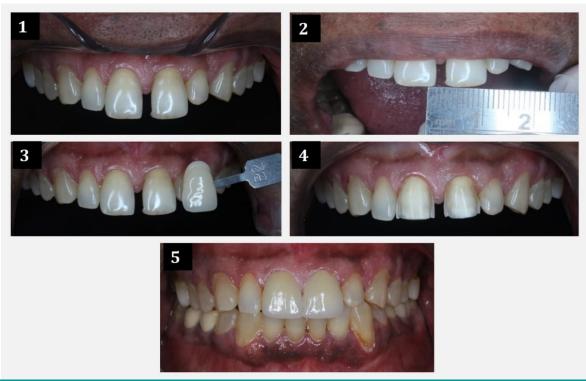
Figures 1 – 5. 1. Pre-operative photograph, 2. 3mm diastema, 3. Shade selection, 4. Tooth preparation, and 5. Post-operative photograph.

A 50-year-old male reported to our clinic with maxillary midline diastema between the two central incisors (Figure 1). Clinical examination revealed a 3mm gap between the two central incisors (Figure 2) and class 1 dental relationship. Intraoral photographs were taken along with shade tabs to determine the shade of the tooth (Figure 3). The patient was given multiple options for closing the diastema, including orthodontic and restorative procedures. Due to the prolonged time for the orthodontic procedure, the patient chose to restore the teeth with e.max (pressable) veneers.

A putty index was made before tooth preparation to check the labial reduction. Tooth preparation was performed at an enamel depth of 0.5-1 mm on the buccal side and 1.5 mm on the incisal side using a depth-cutting tapered diamond bur [4] (Figure 4). The chamfer finish line was given at the cervical region. Proximal reduction was performed beyond the contact point on the mesial surface to avoid black triangles.

Impression was made using A-silicone (Photosil putty and light body, DPI, Mumbai) impression material. A two-step technique was followed during the impression procedure. Putty impression was made initially and allowed to set as per manufacturer's instructions. Space was created in the impression and a light body was injected onto the tooth surface and also into the impression tray and seated in the patient's mouth. It was removed after the complete setting of the light body. Impressions were sent to the lab, and veneers were received after one week. Cementation of the veneers was done using self-cure resin cement (RelyX U100, 3M, ESPE), and margins were cured with UV light (Figure 5). Excess cement was removed using an explorer.

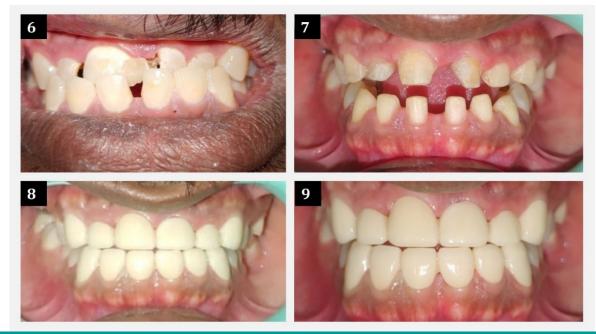
Figures 6-9. 6. Pre-operative photograph, 7. Tooth preparations, 8. Bisque trail, and 9. Post-operative photograph.

A male patient reported to our clinic with the chief complaint of the gap between his upper and lower teeth (Figure 6). Upon intra-oral examination, diastemas were present between central, lateral and canines in both upper and lower teeth. Radiographic and intraoral examination revealed a prognathic mandible. The patient underwent orthodontic treatment but discontinued the treatment. The patient was given different treatment options, but the patient chose complete coverage crowns for both upper and lower anterior teeth.

Tooth preparations were done for teeth 13 to 23 and 33 to 43 (Figure 7). Root canals were done for teeth 11,12, 21 and 22. Putty impressions were made with A- silicone (Photosil putty and light body, DPI, Mumbai) impression material.

Bite registration was made using jet bite registration paste (Coltene, Whaldent, Switzerland). Temporary crowns were made for a trail look and cemented with Freeugenol cement (GC Corporation, Tokyo, Japan). Final impressions were sent to the lab for fabrication of zirconia crowns after the trail was checked (Figure 8). Cementation of zirconia crowns was done using self-cure resin cement (RelyX U100, 3M, ESPE), and excess cement was removed using an explorer (Figure 9).

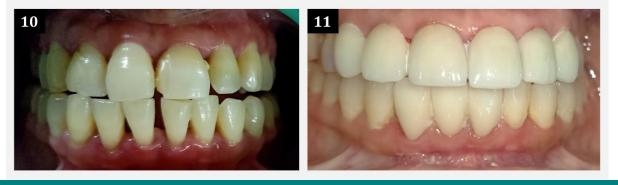
Figure 10. Pre-operative photograph, and Figure 11. Post-operative photograph.

A 45-year-old female patient was reported to our clinic with diastema in the upper and lower teeth. Intraoral examination revealed mild diastema of 1 mm in the maxillary anterior teeth and 2 mm diastema between the lower central incisors (Figure 10). The patient chose to have International Journal of Dental Materials 2023;5(4):111-113 © IJDM 2023

zirconia veneers for the upper anterior teeth i.e., from 13 to 23 and zirconia crowns for lower anterior teeth i.e., from 41 to 32. Tooth preparations were done to receive veneers for 13 to 23 and full coverage crowns from 41 to 32. Putty impressions were made using A-silicone (Photosil putty and light body, DPI, Mumbai) impression material. Impressions

were sent to the lab, and the prosthesis was received after one week. Cementation of veneers and crowns was done using self-adhesive resin cement (RelyX U100, 3M, ESPE) (Figure 11).
