Ergonomic evaluations and environmental factors in an agroindustrial company of plant products

Abstract: The search for greater productivity due to the growing demand for food can lead to arduous work, with exhausting and inadequate conditions. Thus, the aim of the study was to carry out a postural evaluation in five different activities in an agroindustrial company, as well as to measure the environmental and organizational conditions of the site. The postural analysis was performed through images of the postures used in the work environment and the required forces, using the RULA method and Ergolandia 6.0 software, associated to a questionnaire evaluating the biomechanical conditions of the work station, applied to the employees. For the environmental factors, the noise analysis (NBR 10152 and NR 17), temperature (NR 17) and illumination (NBR ISSO / CIE 8995-1) were performed. Among the five activities analyzed, two presented a need for immediate postural intervention and modifications in the work environment. Also, when analyzing the biomechanical conditions of the environment, only two workstations presented good condition. Regarding the environmental factors, only one of the

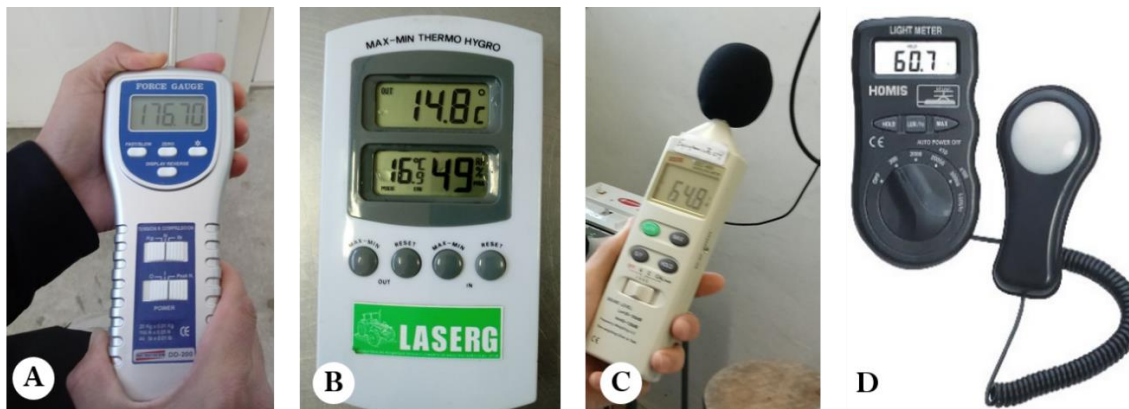
Figure 1 Equipment for analysis of environmental variables

and later determined the average among the data. However, these data was used only as input data in the RULA method to obtain the posture evaluation. Figure 1 shows the equipment used to measure environmental variables.

Note: a – Portable digital dynamometer; b – Digital thermometer; c – Decibel meter; d – Portable digital lux meter.

The measurement of noise level of the workstation, it occurred through the use of a decibel meter (set with the weighting circuit A expressed in dB and slow response ("slow")) being positioned close to the left and right ear of the employee and second the guidelines recommended by the NBR 10152 (1987). Four repetitions of the measurement were collected, later determined the average among the data and the results compared with NR 17 standart.

The measurement of the temperature was performed using a WIBGET digital thermometer, model RSS-241. The temperature index was measured by placing the thermometer next to the workstation, second second the guidelines recommended by the

For the measurement of the ilumination conditions, it was used a portable digital lux meter (expressed in lux), by placing the appliance next to the workstation and second the guidelines recommended by the ABNT NBR ISO/CIE 8995-1 norm (2013). Four repetitions of the measurement were collected and later determined the average among the data.

The measurement of the strength required to perform the tasks analyzed was performed using a portable digital dynamometer, with capacity of up to

20 kg (model DD-200). The strength was measured in the exact position where the task is performed, in the required posture and the type of movement to be made, in order to simulate a real situation. Similarly to the other analyzes, four repetitions were obtained
