Acoustic diagnosis of driving belt physical condition in enclosures

**37th International Congress and Exposition on Noise Control Engineering
26-29 October 2008·Shanghai·China**

Acoustic Diagnosis of Driving Belt Physical Condition in Enclosures

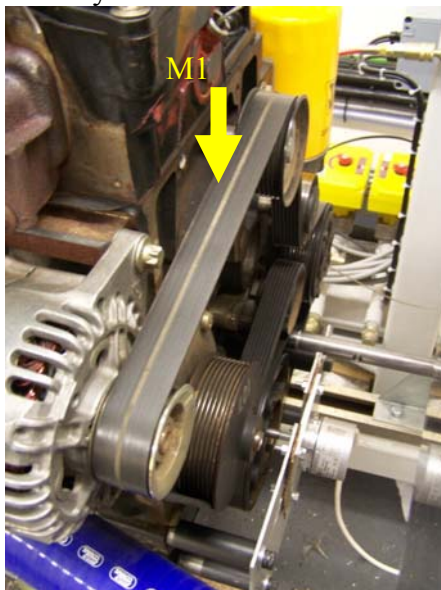
Figure 2 - Engine belt system and microphone M1 position. M1 has a very directional polar pattern

The belt under analysis is driven from the crankshaft and is part of the engine ancillary system that drives the alternator and the oil pump. Figure 2 shows a picture of the belt system under study.

The tension on the belt was maintained by a spring loaded pulley. The tension was altered by a mechanism that applies a torsional load in an anti-clockwise direction onto the spring loaded pulley, as shown in Figure 2. This reduces the tension by reducing the load that the spring applies onto the belt. To apply the load onto the pulley the mechanism uses a lever arm that has a load of 5kg at a distance of 235mm from the pivot, which reduces the tension load of the spring by 11.5Nm.

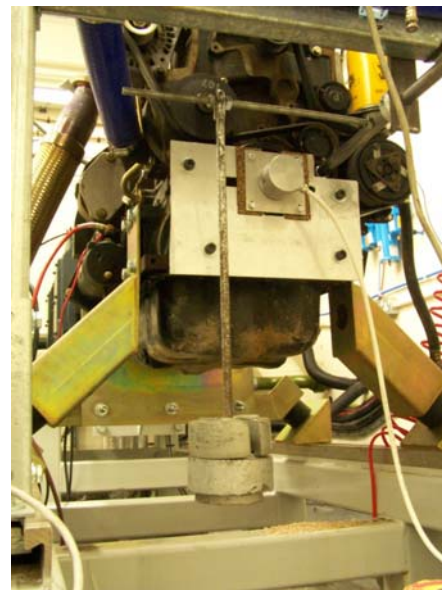
Figure 3 – Belt tensioner system

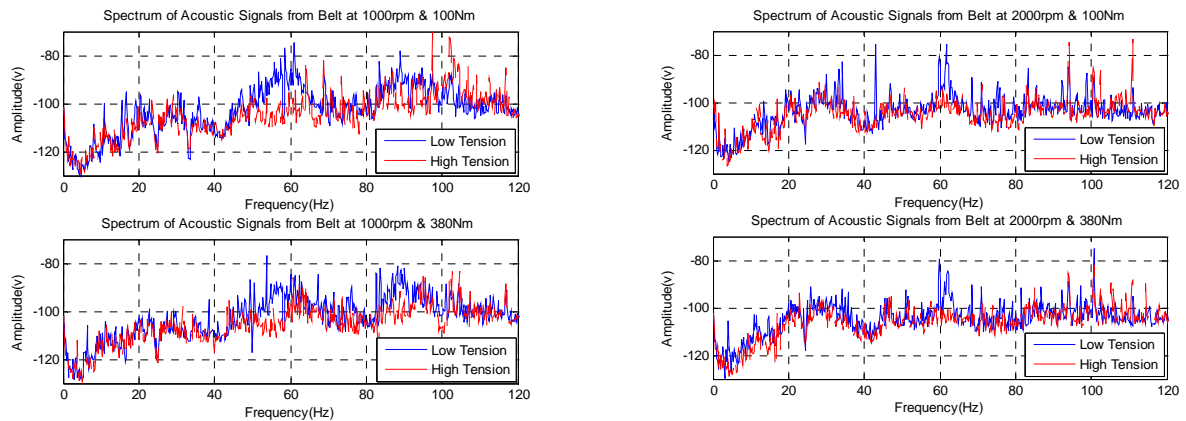
In order to separate the acoustic emission from the engine from that of the belt, a deconvolution technique was attempted [8]. This was obtained by multiplying the complex signal captured in the near field by the inverse of the one in the far field. The resulting data is shown in Figure 7. In this way the acoustic components such as fire frequency and its harmonics can be suppressed significantly and the resultant spectrum thus contains mainly the acoustic emissions from the belt.

Figure 7 - Spectral data for acoustic signal from belt deconvolved from engine and enclosure shown at different test cases. a) Speed of engine 1000rpm; b) Speed of engine 2000rpm

The differences observed between the two tension cases are now clearer. At high tension, a number of spectral peaks are more evident. However, corruption from engine noise is still evident. It is therefore early to make any clear distinctions between the cases and use this as a diagnosis method. Nevertheless, the technique appears promising and further studies are now being carried out that employ a spatial average of the far-field at various enclosure positions that may improve the separation between the data.

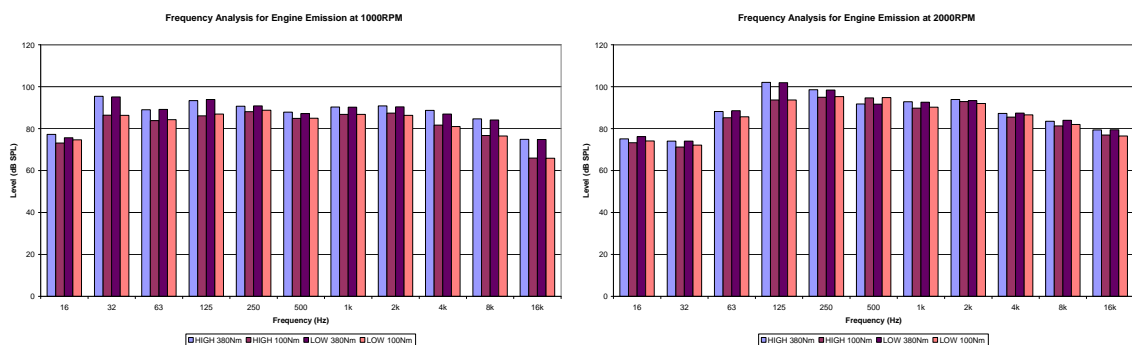
Figure 12 – Levels for Engine acoustic emission with engine running at 1000rpm and 2000rpm. The different tension and torque cases are presented.
