(2024) Non-chlorine detergent formulations as an alternative for unpasteurised milk removal from stainless steel surfaces. *Journal of Food Engineering*, 374. 112031 ISSN 0260-8774

# Non-chlorine detergent formulations as an alternative for unpasteurised milk removal from stainless steel surfaces

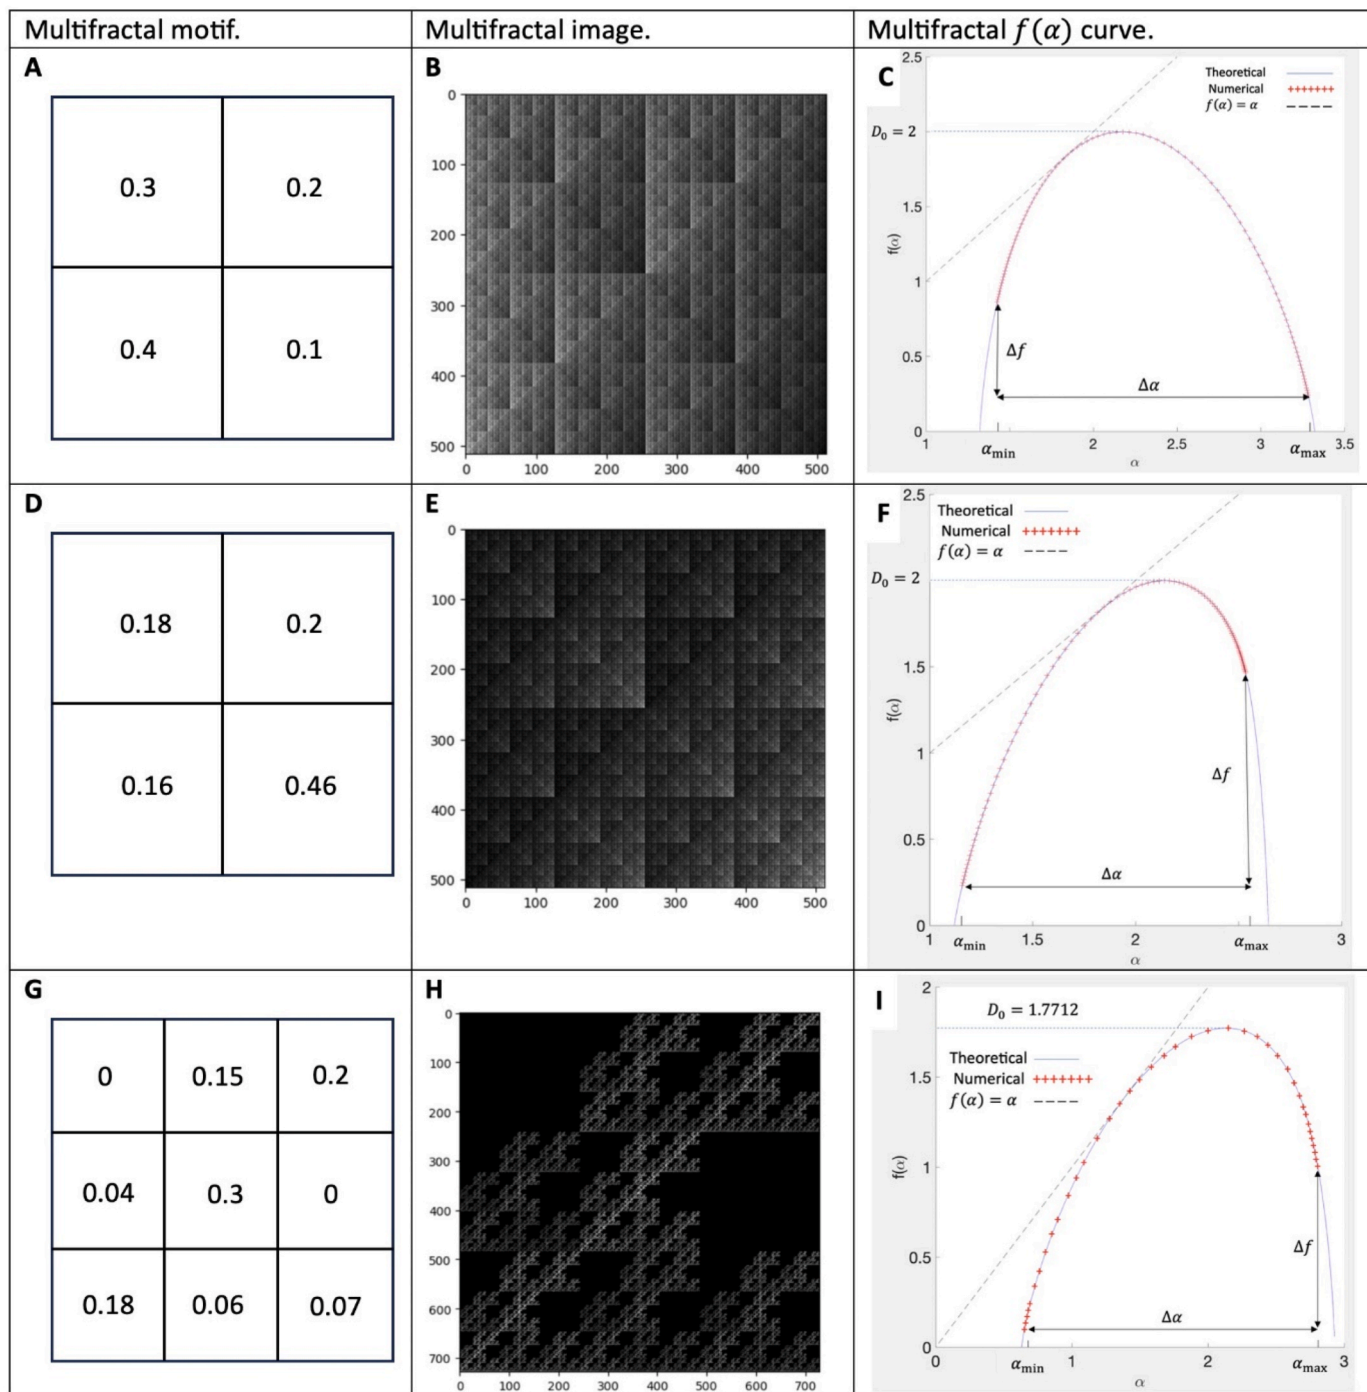
Fig. 1. Multifractal motifs, images and  $f(\alpha)$  curves. (A)  $2 \times 2$  motif; (B)  $512 \times 512$  image; (C)  $f(\alpha)$  curve, asymmetry shows clustering of brighter pixels; (D)  $2 \times 2$  motif; (E)  $512 \times 512$  image; (F)  $f(\alpha)$  curve, asymmetry shows clustering of darker pixels; (G)  $3 \times 3$  motif; (H)  $712 \times 712$  image with holes; (I)  $f(\alpha)$  curve, asymmetry indicates clustering of gaps. Notice that  $D_0 = 1.7712$  is the fractal dimension.

Multifractal analysis can be used to measure density, dispersion, and clustering of objects on a surface using mathematical packages (Lynch, 2023). Fig. 1 shows examples of surface multifractals generated with certain motifs. To obtain multifractal surfaces, one simply assigns weights (or probabilities) to the subdivided areas of a square. In Fig. 1A and D,  $2 \times 2$  motifs were used, whereas in Fig. 1G–a  $3 \times 3$  motif with

holes was used. The motifs were applied to smaller and smaller squares; thus, at stage one, for a  $2 \times 2$  motif (array), a  $4 \times 4$  array would be generated, and at stage eight, a  $512 \times 512$  array is formed. For the  $3 \times 3$  motif, stage five gives a  $729 \times 729$  array. The pixels in this array were assigned to the weights, and then an image was generated by adjusting the contrast of the image. Without the adjustment, the figures would be black as the numerical values are all very close to zero. A white pixel would have a numerical value of one, and a black pixel would have a value of zero. Values between zero and one are on a gray scale. Note that many of the pixels in Fig. 1H are black and represent holes in the

Fig. 1B–E, and H show the corresponding multifractal images, which can be generated using mathematical packages such as Python, MATLAB, Mathematica, and Maple. Fig. 1C–F, and I display the corresponding  $f(\alpha)$  curves.

gives the fractal dimension and is a measure of how much of the object covers the surface. In Fig. 1C and F, the dimension is two as the entire surface is covered. In Fig. 1I, two of the weights are zero, and hence, the multifractal has holes and does not cover the entire surface. In this case, the fractal dimension,  $D_0 = 1.7712$ , means that the multifractal object takes up more room than a straight line (which has dimension one) but less room than a plane (which has dimension two).

and gives a measure of clustering. In Fig. 1C,  $\Delta f$  is positive, indicating clustering of brighter pixels, as indicated in the corresponding motif and multifractal images A and B, respectively. In Fig. 1F,  $\Delta f$  is negative, indicating clustering of darker pixels, as indicated in the corresponding motif and multifractal images D and E, respectively.

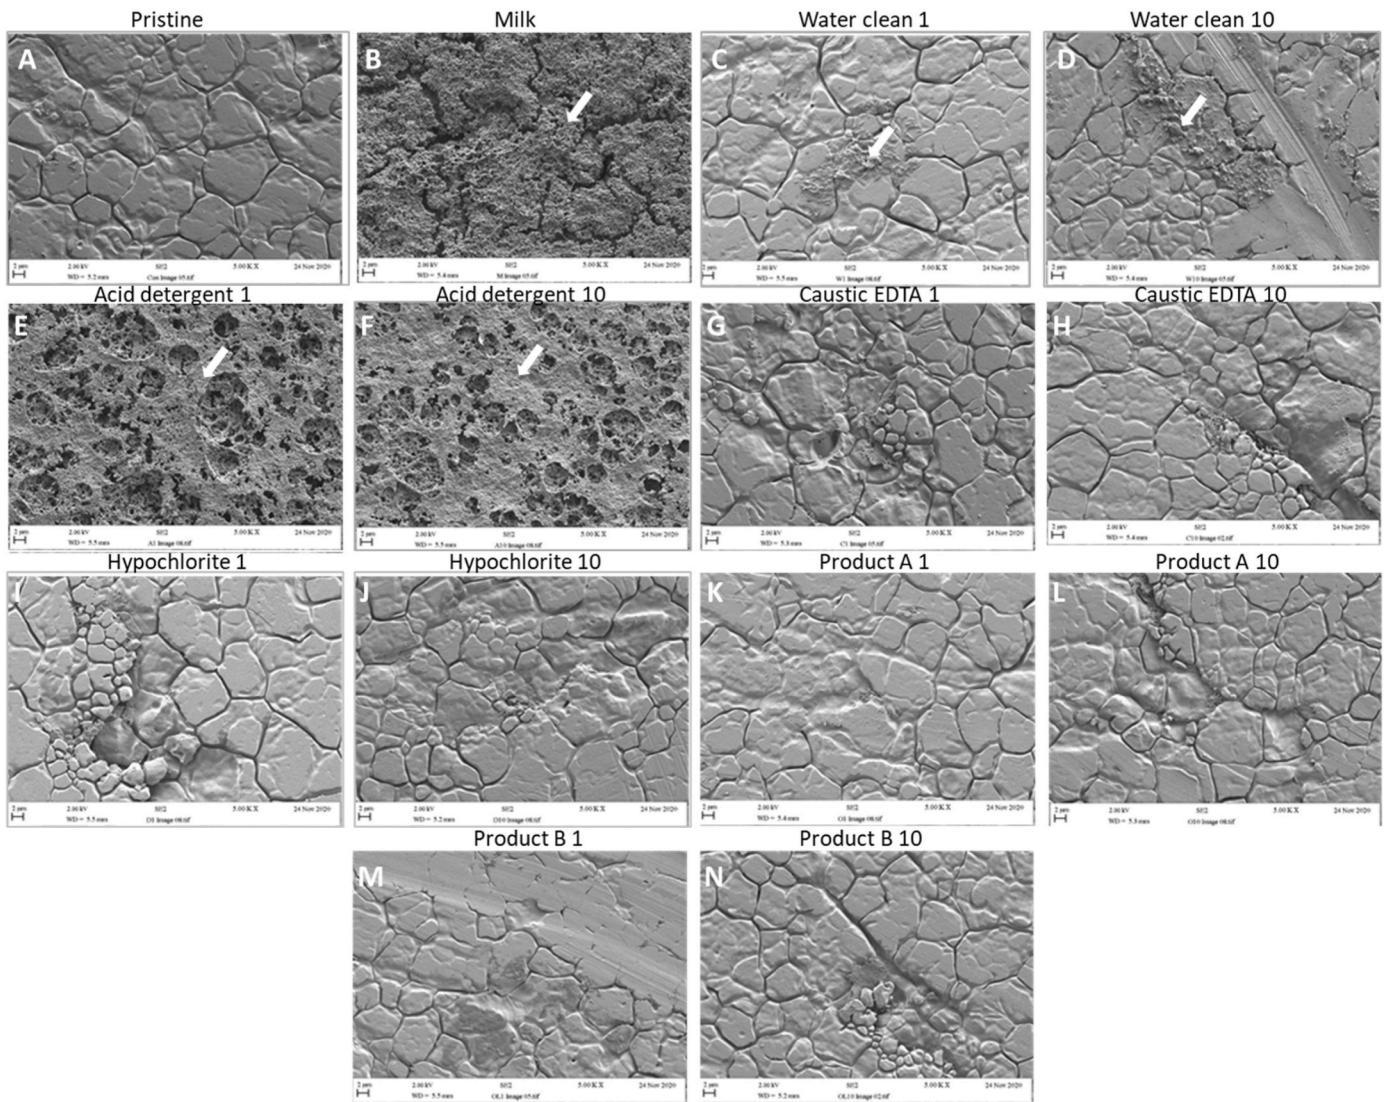
**Fig. 2.** SEM images of (A) unfouled stainless steel surface (pristine) and (B) stainless steel surfaces fouled with milk, along with images of stainless steel surfaces fouled with milk and cleaned using (C) water for 1 cleaning cycle, (D) water for 10 cleaning cycles, (E) acid for 1 cleaning cycle, (F) acid for 10 cleaning cycles, (G) caustic-EDTA for 1 cleaning cycle, (H) caustic-EDTA for 10 cleaning cycles, (I) hypochlorite for 1 cleaning cycle, (J) hypochlorite for 10 cleaning cycles, (K) Product A for 1 cleaning cycle, (L) Product A for 10 cleaning cycles, (M) Product B for 1 cleaning cycle, and (N) Product B for 10 cleaning cycles. White arrows indicate fouling regions. Scale bars of 2  $\mu\text{m}$ .

The SEM images demonstrated that the control (pristine) stainless steel (Fig. 2A) had no visual fouling, and the grain boundaries of the stainless steel were visible. When the stainless steel was conditioned with milk (Fig. 2B), the underlying surface was not visible since it was covered with a film of foulant. When the surfaces were cleaned with water (Fig. 2C and D) or acid (Fig. 2E and F), there was some visible fouling remaining on the surfaces. The fouled stainless steel surfaces that were cleaned using an acid detergent (Fig. 2E and F) demonstrated significant fouling. Cleaning with either one or 10 cleans using caustic EDTA, hypochlorite, Product A or Product B did not show any residual fouling left on the surface using this method.

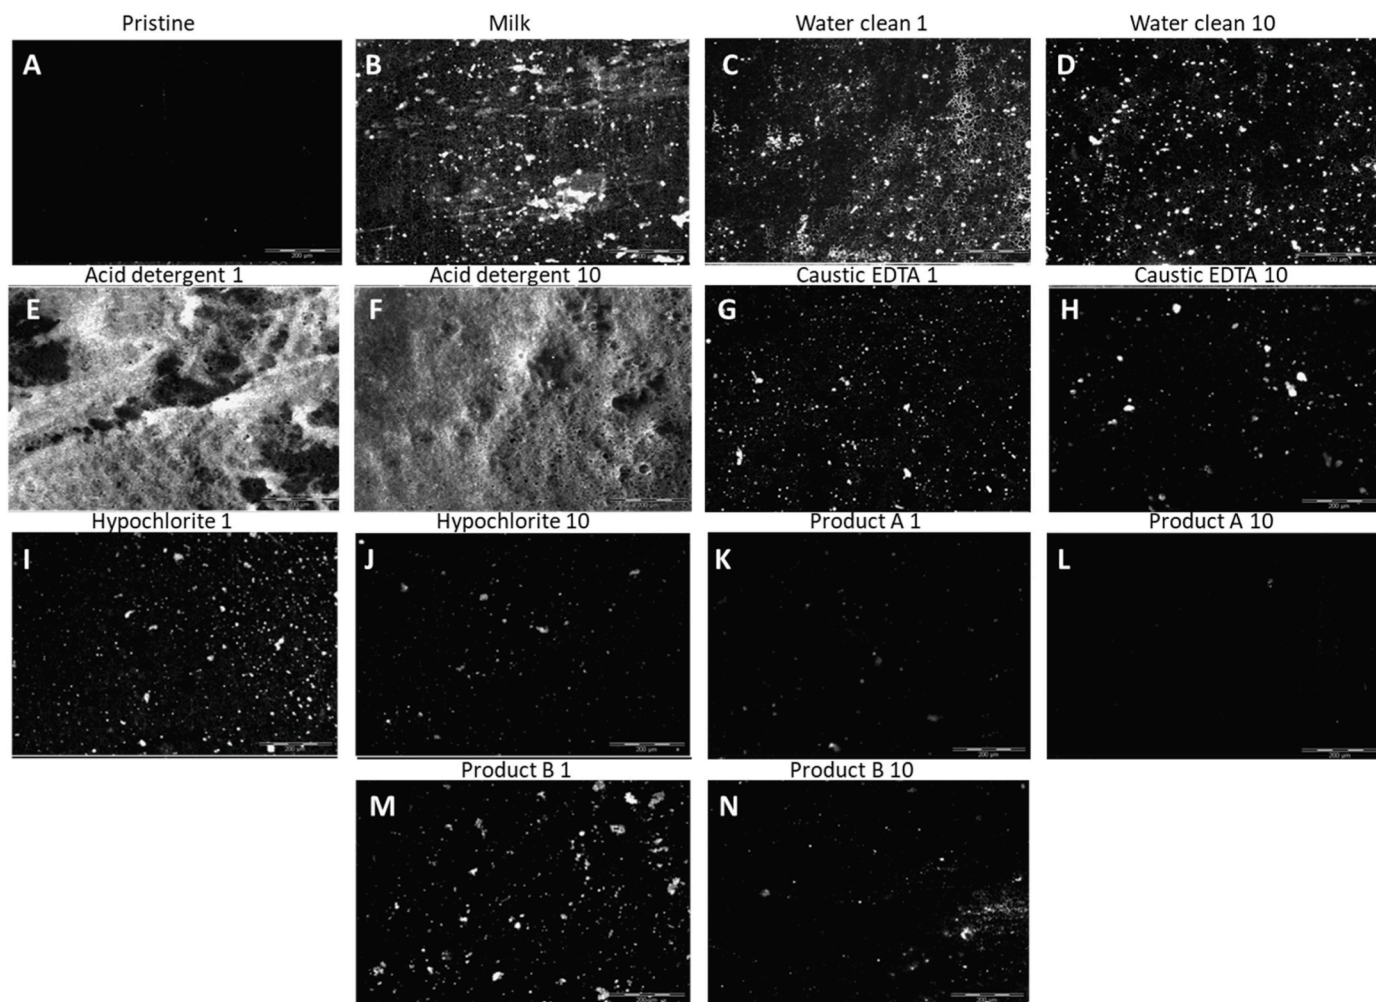
**Fig. 3.** Epifluorescence images of (A) unfouled stainless steel surface (pristine) and (B) stainless steel surfaces fouled with milk, along with images of stainless steel surfaces fouled with milk and cleaned using (C) water for 1 cleaning cycle, (D) water for 10 cleaning cycles, (E) acid for 1 cleaning cycle, (F) acid for 10 cleaning cycles, (G) caustic-EDTA for 1 cleaning cycle, (H) caustic-EDTA for 10 cleaning cycles, (I) hypochlorite for 1 cleaning cycle, (J) hypochlorite for 10 cleaning cycles, (K) Product A for 1 cleaning cycle, (L) Product A for 10 cleaning cycles, (M) Product B for 1 cleaning cycle, and (N) Product B for 10 cleaning cycles. Scale bars of 200  $\mu\text{m}$ .

The epifluorescence images of the control (pristine) stainless steel surface (Fig. 3A) showed little fouling of the surface, whereas the milk-fouled stainless steel surface (Fig. 3B) demonstrated heterogeneous fouling across the surface. The surfaces cleaned using only water (Fig. 3C and D) appeared to have globules on the surfaces. In addition, soil became retained within the grooves of the stainless steel surface. When an acid detergent was used to clean the surfaces (Fig. 3E, F), a layer of fouling was present on the surface, which was too thick to discern

globules or soil within the stainless steel grain boundaries. The retained soil within the crevices observed when cleaning using only water (Fig. 3C and D) was also present when either caustic-EDTA (Fig. 3G and H) or hypochlorite (Fig. 3I and J) was used after a single repetition; however, the soil was less visible for both cleaning agents after 10 repetitions (Fig. 3H–J). When the surfaces were cleaned using Product A (Fig. 3K and L), little fouling was observed, particularly after 10 repetitions (Fig. 3L). Fouling was more clearly visible after one and 10 cleaning repetitions with Product B (Fig. 3M and N).

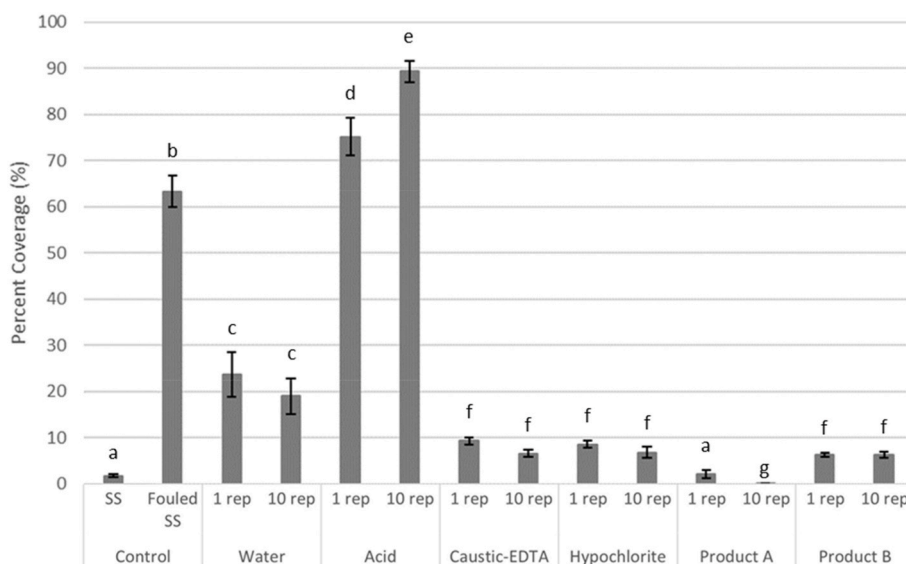
**Fig. 4.** Percentage coverage of stainless steel surfaces after one repeat (1 rep) or 10 repeats (10 rep) of fouling with unpasteurised milk followed by cleaning using either water or 2% (v/v) solutions of an acidic, caustic-EDTA, hypochlorite, Product A, or Product B detergent. Results are presented as average  $\pm$  standard error. Letters were assigned (from a to g) as long as statistically significant differences exist between surfaces (for a confidence level greater than 95%,  $p < 0.05$ ). This was evaluated by one-way analysis of variance (one-way ANOVA, Bonferroni's *post-hoc* test).

A pristine stainless steel surface was tested with no fouling as a control, and the percentage coverage results (Fig. 4) demonstrated minimal soil presence (1.8%). When milk was dried onto the stainless steel surfaces, the surface coverage significantly increased when compared to the pristine surface to 63% ( $p < 0.05$ ). When the surfaces were fouled with milk and cleaned once with water, significant soil coverage of 24% was observed, whereas after 10 repeated fouling and cleaning steps, the surface demonstrated 19% fouling ( $p < 0.05$ ). The

use of an acid detergent to clean the milk-fouled stainless steel demonstrated a significant increase in the amount of material present when compared to the control, with one fouling and cleaning repetition demonstrating 75% and after 10 fouling/cleaning cycles 89% fouling ( $p < 0.05$ ). The standard products that are typically used to clean milking equipment (caustic-EDTA or a hypochlorite product) showed no significant difference ( $p > 0.05$ ) in the levels of fouling after both one fouling and cleaning (9.3% and 8.6%, respectively) and 10 repetitions (6.6% and 6.8%, respectively). The lowest percentage coverage for a cleaning solution was observed when Product A was used to clean the surfaces (a statistically different result was observed when compared to all the other surfaces ( $p < 0.05$ )), with only 2.2% and 0.2% coverage after one and 10 repetitions, respectively. Product B performed similarly to the hypochlorite product whereby after one and 10 cleaning and fouling repetitions, 6.3% and 6.4% coverages were determined, respectively.

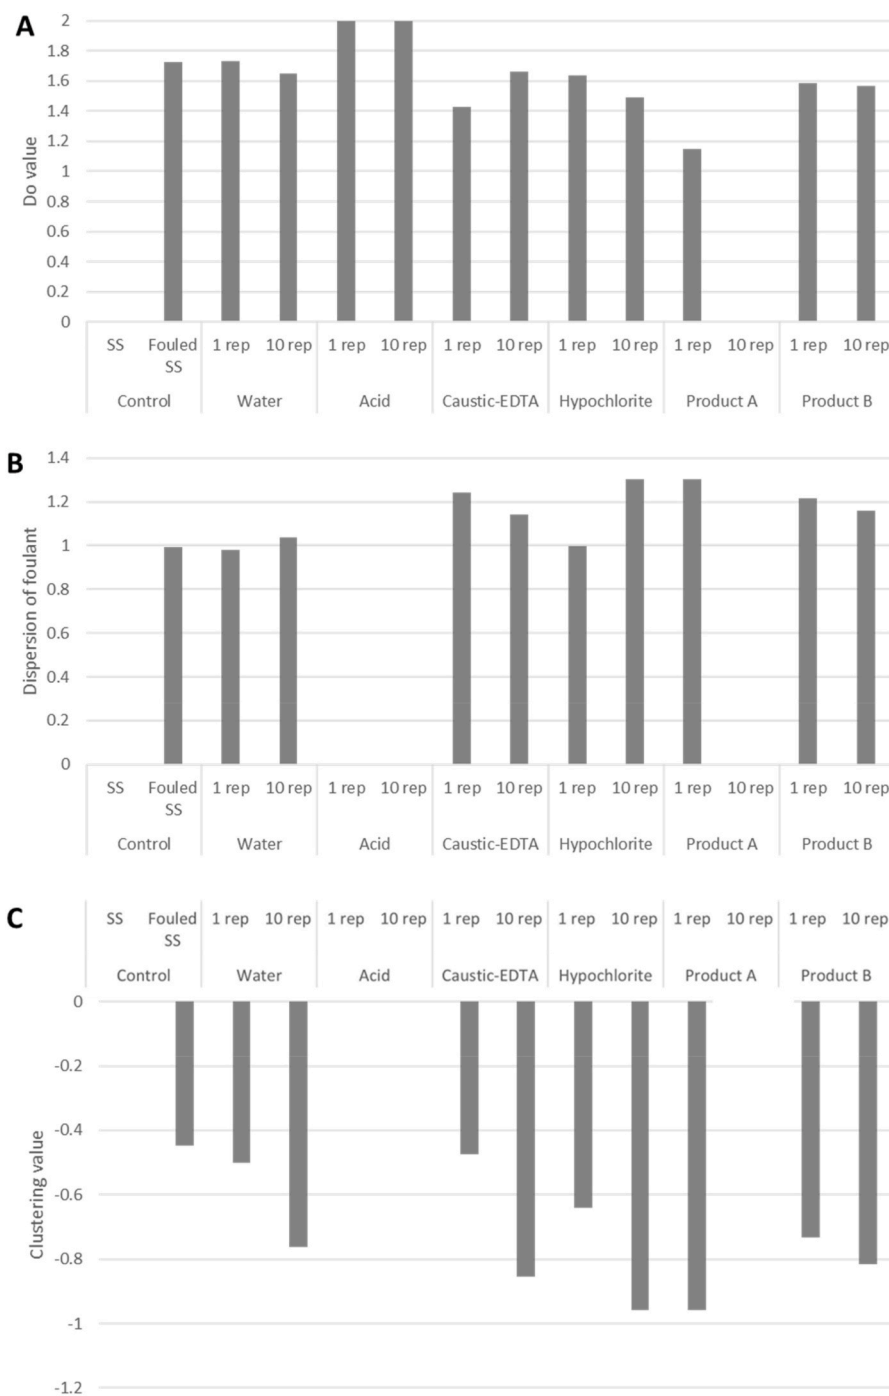
Fig. 5. Multifractal analysis of the surfaces demonstrating the (A) density, (B) dispersion, and (C) clustering of the soil retained on the unfouled stainless steel surface and stainless steel surface fouled with milk and cleaned using either water or 2% (v/v) solutions of caustic-EDTA, hypochlorite, Product A, or Product B after one (1rep) or 10 repetitions (10 rep).

cleaned surfaces ( $D_0$  values of 2) since these surfaces were completely covered with material. In contrast, the control stainless steel and stainless steel cleaned 10 times with Product A demonstrated no surface coverage of the residual foulant (Fig. 5A). Generally, the pattern of density of fouling retained on the surface was more dense for the fouled control ( $D_0 = 1.7$ ), water ( $D_0 \approx 1.7$ ), caustic-EDTA after 10 cleans ( $D_0 = 1.7$ ), acid-treated surfaces ( $D_0 = 2$ ), or Product B ( $D_0 = 1.6$ ), and less dense on the surfaces treated with caustic-EDTA after one clean ( $D_0 = 1.4$ ), hypochlorite after 10 cleans ( $D_0 = 1.5$ ), or Product A after one clean ( $D_0 = 1.1$ ).

The dispersion of the retained fouling across the surfaces (Fig. 5B) showed an opposite trend to that of the density. The surfaces cleaned for one or 10 repetitions with caustic-EDTA (1.1, 1.2), hypochlorite (0.9, 1.3), Product A (0.0, 1.2) or Product B (1.2, 1.2) presented a wider pattern of dispersion between the retained fouling, whereas the control surfaces (0.0, 1.0) or those cleaned with water (1.0, 1.0) or acid (0.0, 0.0) demonstrated that the retained foulant was closer together (Fig. 5B).

Analysis of the clustering of the fouling across the surfaces (Fig. 5C) demonstrated that the surface cleaned by the acid solution after both one and 10 repetitions was completely covered, and thus a value could not be obtained because there were no clusters of foulant to measure. After one cleaning cycle, Product A provided the least number of

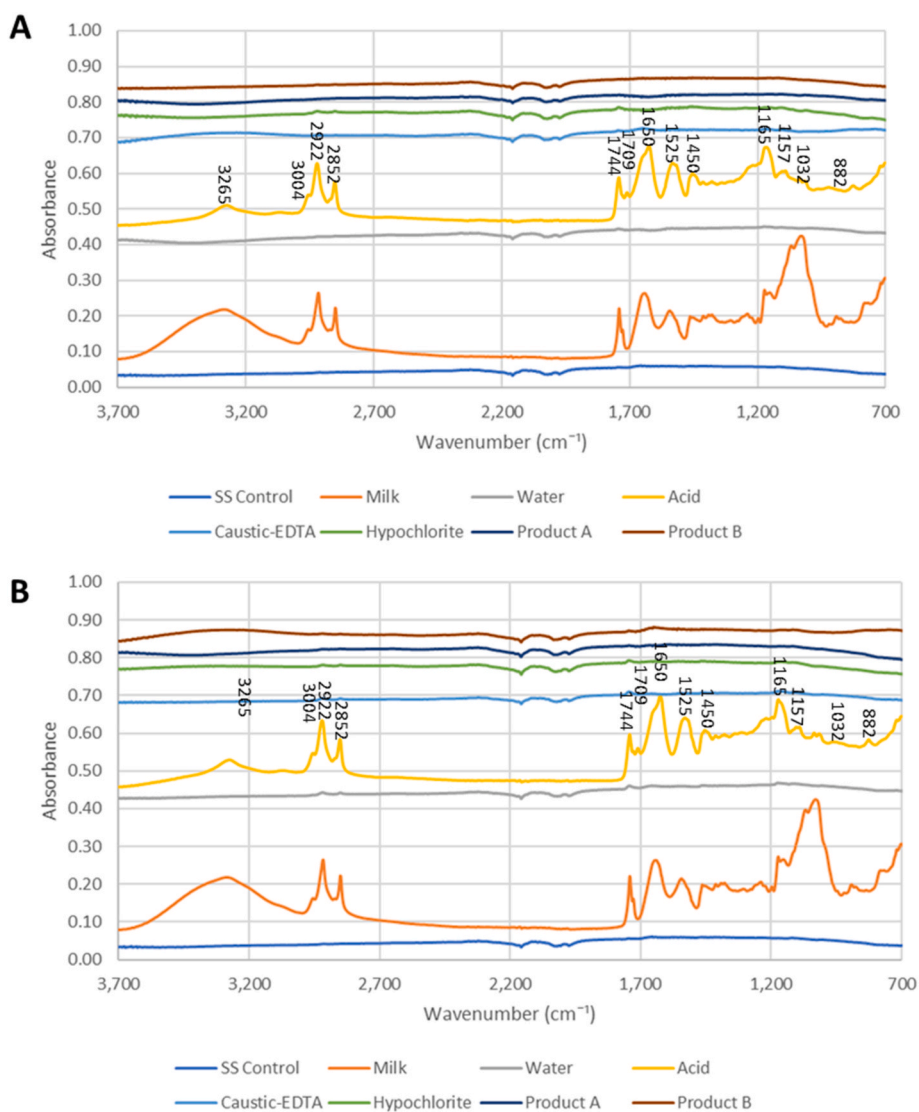
**Fig. 6.** FTIR of all fouled and cleaned surfaces after (A) one or (B) 10 repeated fouling and cleaning cycles, as well as control stainless steel surface and stainless steel surface fouled with milk.

When ATR-FTIR was performed on the cleaned surfaces, no significant differences were observed between the spectra obtained from a single cleaning cycle (Fig. 6A) and those obtained after 10 repeated fouling and cleaning cycles (Fig. 6B). The main difference was in the spectra obtained for the surfaces cleaned with acid compared to those cleaned with different detergents. When water, caustic-EDTA, or hypochlorite was used, there was a small peak at  $\sim 1744\text{ cm}^{-1}$  representing a stretching vibration of the carbonyl functional group (C=O), which may have been indicative of the remaining fatty acids on the surface. This peak was not present when either of the novel compilations, Product A or Product B, were used. However, the use of an acid detergent caused a significantly different spectrum, resulting in increased and reduced absorption intensities at different points. Little differences were detected between the spectra obtained after one and 10 cycles. Compared to the control, the broad peak at approximately  $3265\text{ cm}^{-1}$  was reduced after cleaning with acid, which could be due to a reduction in the water content (O–H stretching), changes in the lactose content (also O–H stretching), part of the O–H stretching in fatty acids, or N–H changes in proteins. However, the other major water peak,  $1165\text{ cm}^{-1}$  (H–O–H scissoring), increased, whereas other peaks related to lactose were reduced, including those at  $\sim 1032\text{ cm}^{-1}$  (C–O/C–C/C–O–O/C–H functional groups) and  $\sim 882\text{ cm}^{-1}$  (a functional group with a vibration ring of lactose). On the milk alone and the hypochlorite-cleaned surfaces, many of the peaks that potentially indicated components of fatty acids demonstrated no significant differences in their biochemical structures. This included peaks at  $\sim 2922\text{ cm}^{-1}$  and  $2852\text{ cm}^{-1}$  representing  $\text{CH}_3$  stretching both asymmetrically and symmetrically, respectively, a peak at  $\sim 3004\text{ cm}^{-1}$  due to the cis olefinic stretching of a C=C bond, which may be indicative of molecular vibrations in the middle of the unsaturated fat chain, and a peak at  $\sim 1744\text{ cm}^{-1}$  representing a stretching vibration of carbonyl functional group (C=O) possibly at the end of the fatty acid chain. However, there was an increase in the intensity of the peak at  $\sim 1157\text{ cm}^{-1}$ , indicating either H–C–H wagging or a C–O ester group, whereas the presence of a new peak at approximately  $1709\text{ cm}^{-1}$  supports the possible presence of a fatty acid ester. Peaks found in the regions of  $1450\text{ cm}^{-1}$  (C–H bending),  $1525\text{ cm}^{-1}$  (N–O stretching), and  $1650\text{ cm}^{-1}$  (C–H bending) were also found on the milk and acid-cleaned

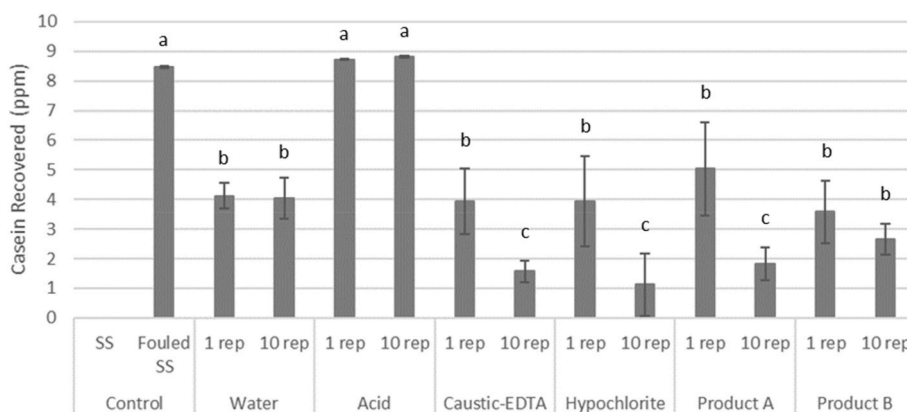
Fig. 7. Amount of casein recovered from unfouled stainless steel surfaces, milk-fouled stainless steel surfaces, and stainless steel surfaces fouled with milk and cleaned using water, acid, caustic-EDTA, hypochlorite, Product A, and Product B after one (1 rep) or 10 repetitions (10 rep). This was determined by ELISA after surface swabbing. Results are presented as average ± standard error. Letters were assigned (from a to c) as long as statistically significant differences exist between surfaces (for a confidence level greater than 95%,  $p < 0.05$ ). This was evaluated by one-way analysis of variance (one-way ANOVA, Bonferroni's *post-hoc* test).

The casein ELISA results (Fig. 7) demonstrated that the control stainless steel surface had no recoverable casein present on the surfaces. The surfaces fouled with milk demonstrated 8.5 ppm of casein recovered, which was around the maximum detectable level. When the surfaces were washed using water, there were no significant differences between one repetition (4.1 ppm) and 10 repetitions (4.0 ppm), but the result was significantly reduced compared to the fouled control ( $p < 0.05$ ). Likewise, there was no significant difference between one repetition (8.7 ppm) and 10 repetitions (8.8 ppm) for the acid-washed surfaces, but both values were around the upper limit of detection ( $p > 0.05$ ). When the other products were tested, there were no significant differences in the levels of recovered casein after one repetition between Product A and water, caustic EDTA or hypochlorite cleans ( $p > 0.05$ ). After 10 repetitions, the recovered casein levels were at 1.6 ppm for the caustic-EDTA product, 1.1 ppm for the hypochlorite product, 1.8 ppm for Product A, and 2.7 ppm for Product B. Product B demonstrated significant differences to the results from cleaning using Products A, hypochlorite or caustic EDTA ( $p < 0.05$ ).

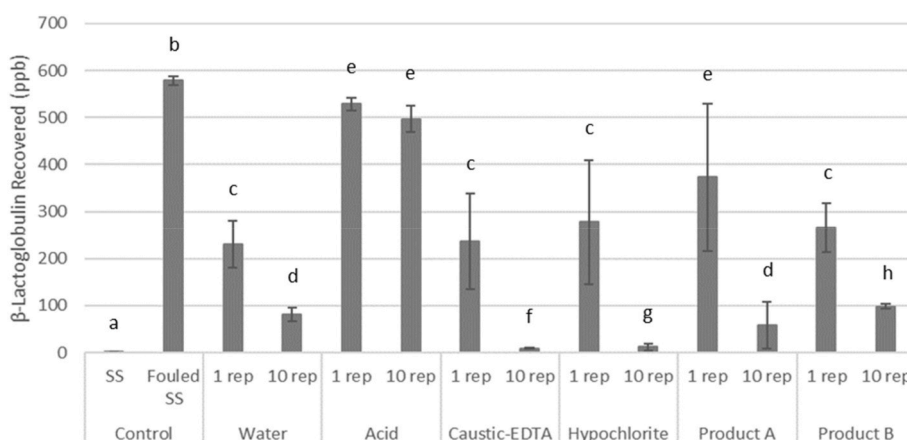
Fig. 8. Amount of beta-lactoglobulin recovered from unfouled stainless steel surfaces, milk-fouled stainless steel surfaces, and stainless steel surfaces fouled with milk and cleaned using water, acid, caustic-EDTA, hypochlorite, Product A, and Product B after one (1 rep) or 10 repetitions (10 rep). This was determined by ELISA after surface swabbing. Results are presented as average ± standard error. Letters were assigned (from a to h) as long as statistically significant differences exist between surfaces (for a confidence level greater than 95%,  $p < 0.05$ ). This was evaluated by one-way analysis of variance (one-way ANOVA, Bonferroni's *post-hoc* test).

Similar to the casein results, the ELISA test for  $\beta$ -LG (Fig. 8) demonstrated almost no recovered allergen from the control stainless steel (1.3 ppb). The surface fouled with milk demonstrated a recovery level of 579 ppb, which was the limit of detection of the instrument. The recovered  $\beta$ -LG after washing with water was 230 ppb after one repetition and significantly reduced after 10 repetitions (80.6 ppb) ( $p < 0.05$ ). When acid was used, the results were similar to casein, with  $\beta$ -LG recovery after both one and 10 repetitions (529 and 497 ppb, respectively) being significantly greater than that of all other detergents used. After a single repetition, the results for the caustic-EDTA (237 ppb), hypochlorite (278 ppb), Product A (373 ppb), and Product B (267 ppb) detergents all demonstrated recovery levels greater than that of the water control. However, after 10 repetitions, the caustic-EDTA (9.2 ppb), hypochlorite (11.9 ppb), and Product A (58.4 ppb) demonstrated reduced recovery compared to the water control. After one clean, all the surfaces cleaned with caustic EDTA and Product A were found to recover significantly different amounts of  $\beta$ -LG ( $p < 0.05$ ). Following 10 cleans,
