HISTORICAL MONITORING OF SHORELINE
CHANGES IN CORPUS CHRISTI,
NUECES, AND OSO BAYS

R. A. Morton and J. G. Paine

Prepared for the
Texas Energy and Natural Resources Advisory Council
Division of Natural Resources
Under Contract No. IAC(82-83)-1342

Bureau of Economic Geology
The University of Texas at Austin
Austin, Texas 78712

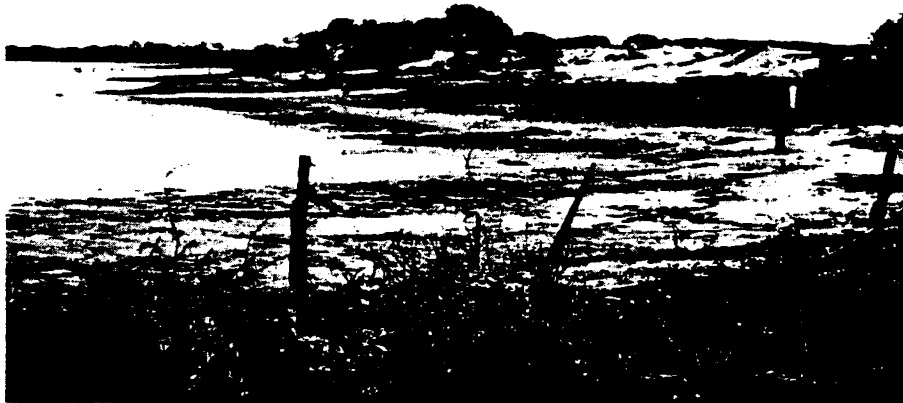
Figure 6. Sandy slopes of eastern Oso Bay.

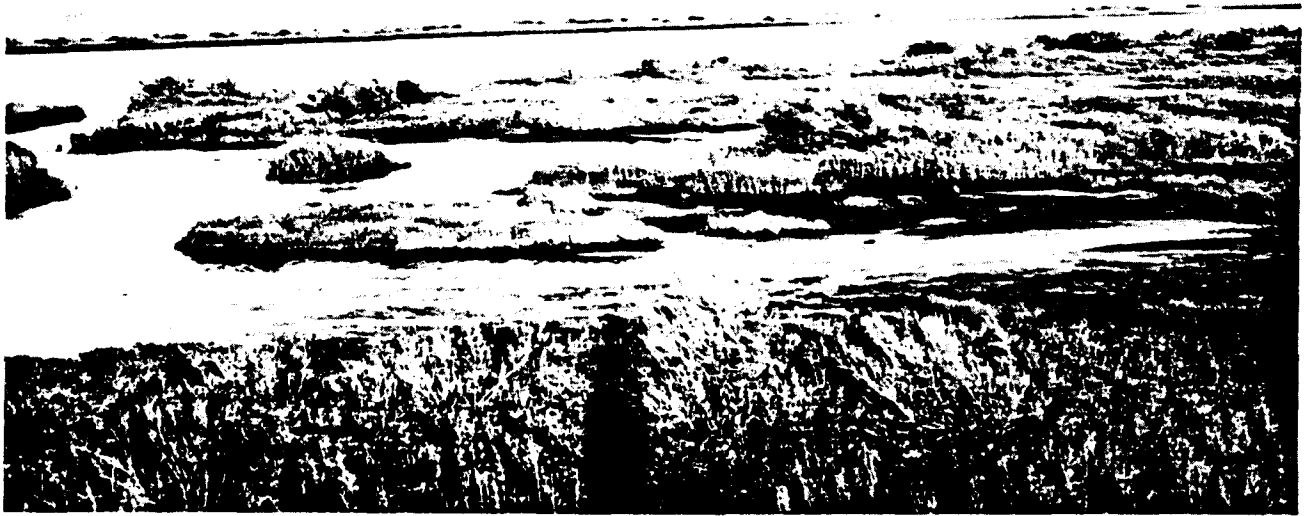
Figure 7. Broad salt-water marshes (Spartina alterniflora) of the Nueces delta, upper Nueces Bay. Photograph by W. A. White.

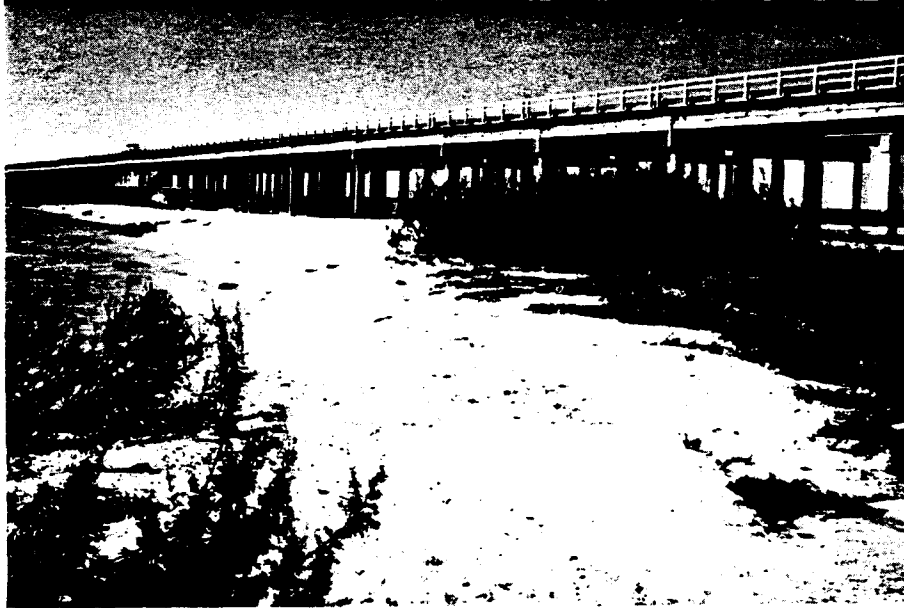
Figure 8. Low and narrow sand and shell beaches of Indian Point.

Shorelines composed of sand with varying amounts of shell are generally restricted to Corpus Christi Bay. They are located along Indian Point (fig. 8) and the bayside of Mustang Island, and formerly along North Beach. The beach along Shamrock Island contains the highest concentrations of shell debris, a mixed assemblage of mollusk species that live in the bay and

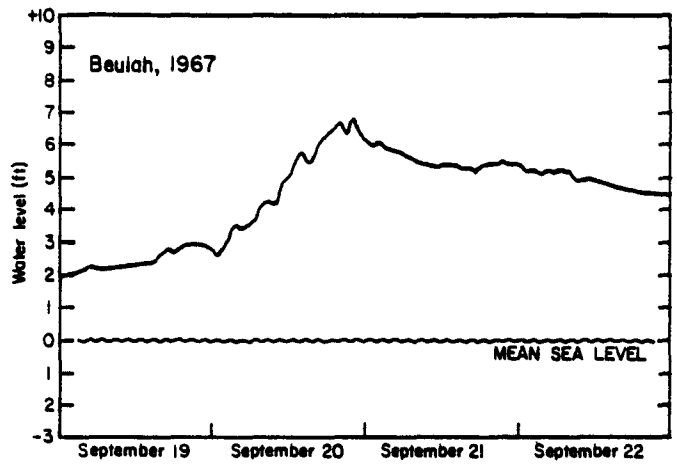
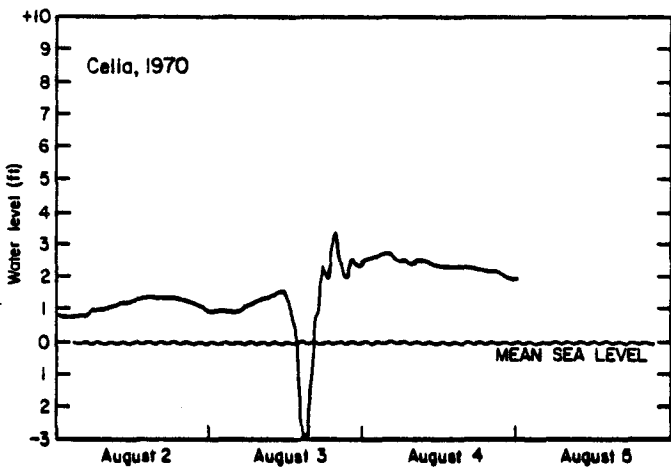
Figure 11. Storm-surge hydrographs for Hurricanes Carla, Beulah, Celia, and Allen recorded at Corpus Christi. Data from U.S. Army Corps of Engineers (1962, 1968, 1972, 1981).

During storms, high windspeeds and low barometric pressures raise bay levels to extraordinary heights (fig. 11) that may last for several hours or several days. The surge heights and consequently the damage to the beach that occurs during these peak periods depends on such factors as direction of storm approach, configuration of the shoreline, shape and slope of the bay bottom, maximum wind velocities, forward speed of the storm, distance from the eye of the storm, stage of astronomical tide, lowest atmospheric pressure, and duration of the storm.

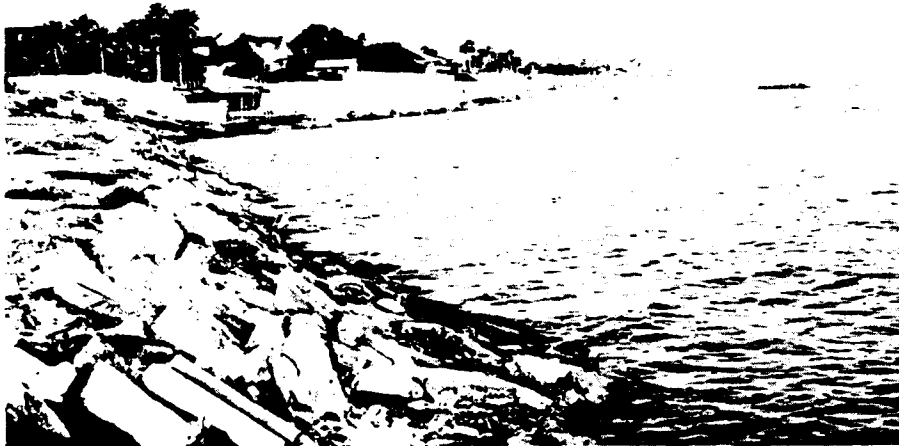
Figure 12. Concrete riprap used as shoreline protection near Ward Island, southern Corpus Christi Bay.

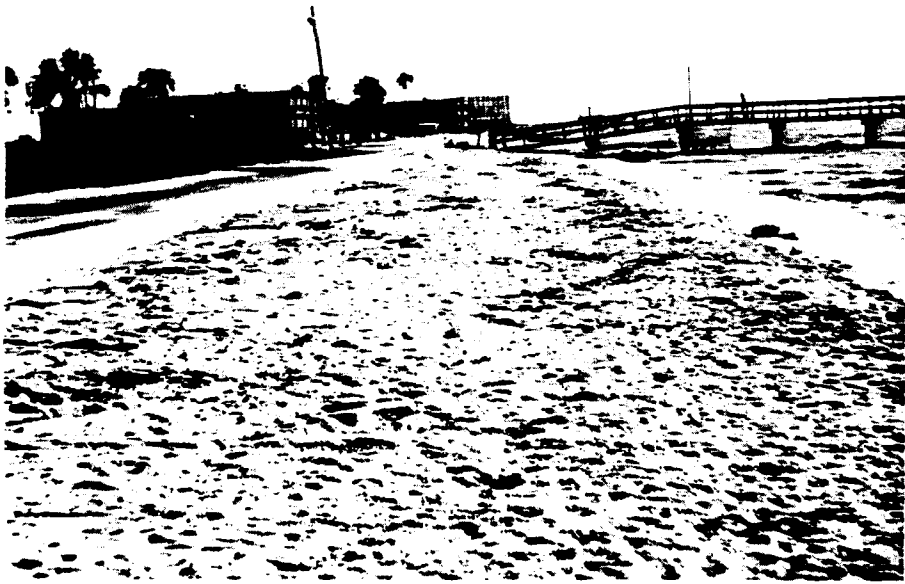
Figure 13. North Beach in 1974 before beach nourishment.

A major beach nourishment project was completed by the U.S. Army Corps of Engineers in 1978 for North Beach (figs. 13 and 14). This area was selected for nourishment because it has experienced consistent erosion in historical time, even though Rincon Peninsula is an accretionary feature when viewed in a geological context. The reclamation and nourishment of North Beach was accomplished by the importation of coarse sand from the Nueces River, which covered fill material dredged from Corpus Christi Bay (U.S. Army Corps of Engineers, 1974). Material was added to approximately 7,000 ft of shoreline; the restored beach width along this length was 300 to 400 ft (fig. 15). It is estimated that 125,000 cubic yards of cover material will be necessary every 5 yr to maintain the beach at its current size (U.S. Army Corps of Engineers, 1974).

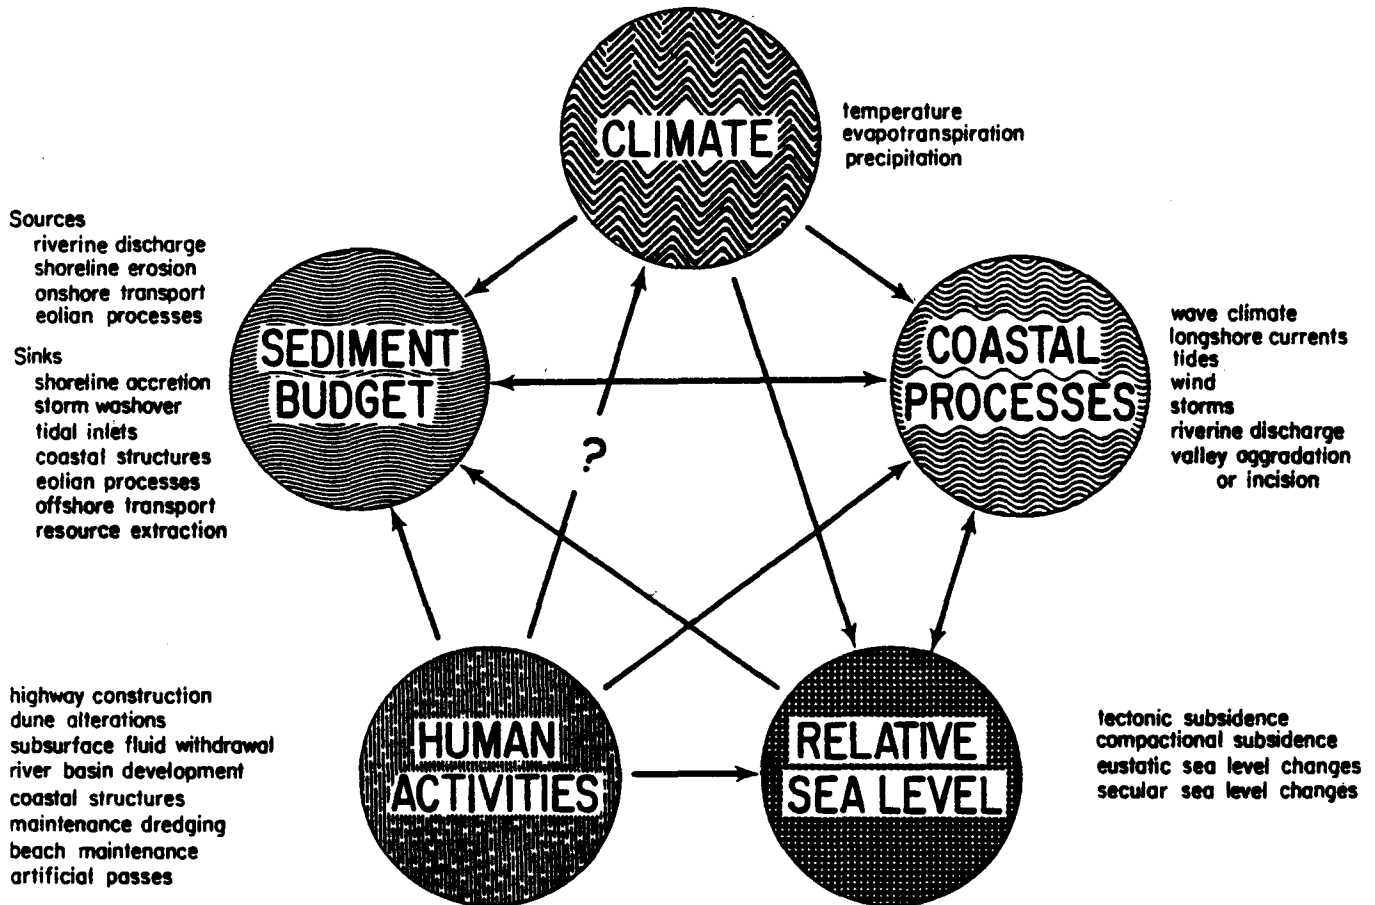
Figure 16. Interaction of factors affecting land losses. Arrows point towards the dependent variables: The number of arrows originating from or terminating at a particular factor indicates the relative degree of independence or interaction. For example, human activities are independent of the other factors, but they affect sediment budget, coastal processes, relative sea-level conditions, and perhaps, climate. From Morton (1977).

It is impossible to isolate and quantify the individual factors that cause shoreline changes (fig. 16). Despite the difficulties, evaluation of the various factors and their interactions is necessary to understand past shoreline changes and to anticipate future changes.

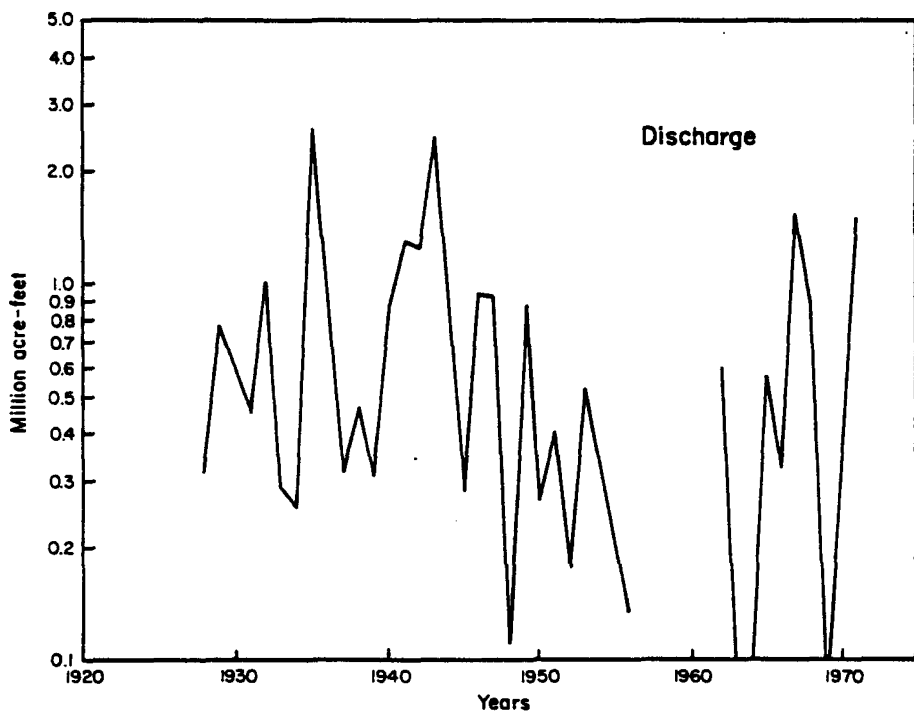
Figure 17. Total suspended sediment and discharge of the Nueces River at the Three Rivers Station (1928-1971). Data from the Texas Board of Water Engineers (1961); Texas Water Commission (1964); Texas Water Development Board (1967a, 1970, 1974).
