Spatial Patterns of Tank Decline and Rejuvenation in the Kaveri River Catchment, South India

Evans, C., Huck, J., & Dennis, M. (2024). Spatial Patterns of Tank Decline and Rejuvenation in the Kaveri River Catchment, South India. In *32nd Annual Geographical Information Science Research UK Conference (GISRUK)*

GISRUK 2024

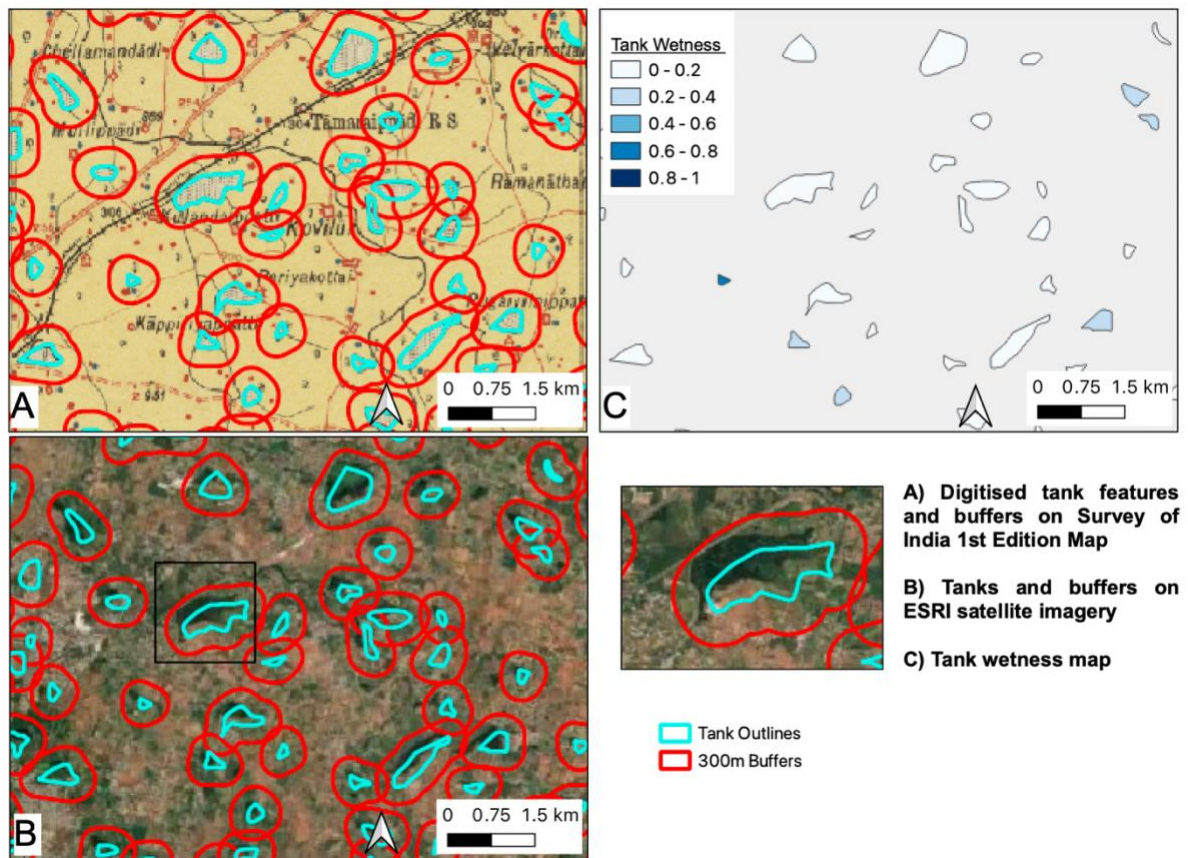
Figure 2 Buffered tanks, demonstration of offset on satellite imagery and tank wetness values (as per **Equation 1**)

However, there were some inconsistencies in the overlay of the tank features to satellite imagery (**Figure 2**), with tanks offset by up to 300m between the two datasets. This was rectified by creating a 300m buffer around each tank geometry and counting the number of cells intersecting the buffer where $MNDWI > 0$ was found. This number was then divided by the total number of cells intersecting the tank geometry, with the value capped at 1 (e.g., if the tank had expanded). This process was undertaken in Python 3.10 and is summarised in **Equation 1**.
